# **HISTORIC STRUCTURE ASSESSMENT REPORT**

## **VISTA HISTORIC SITE Lower Suwannee National Wildlife Refuge**

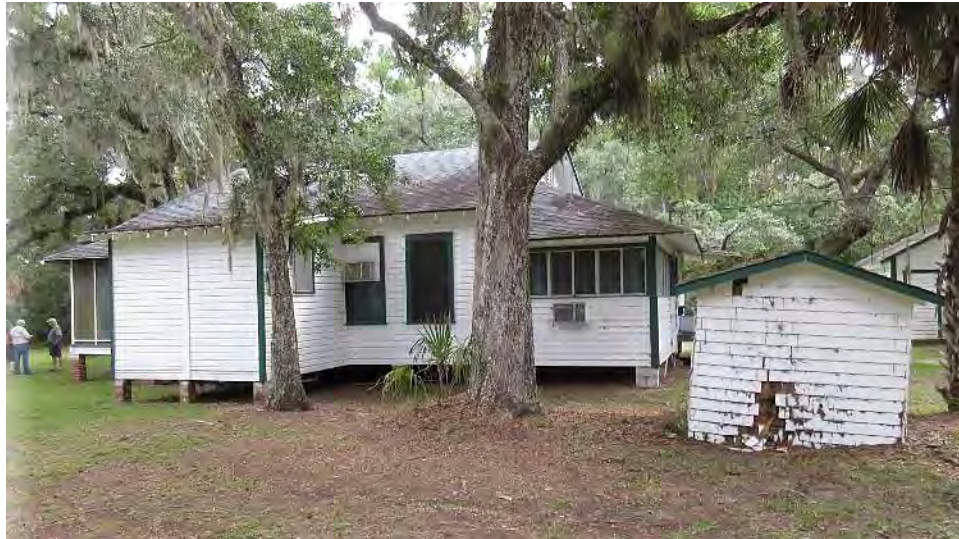
View of the west façade.

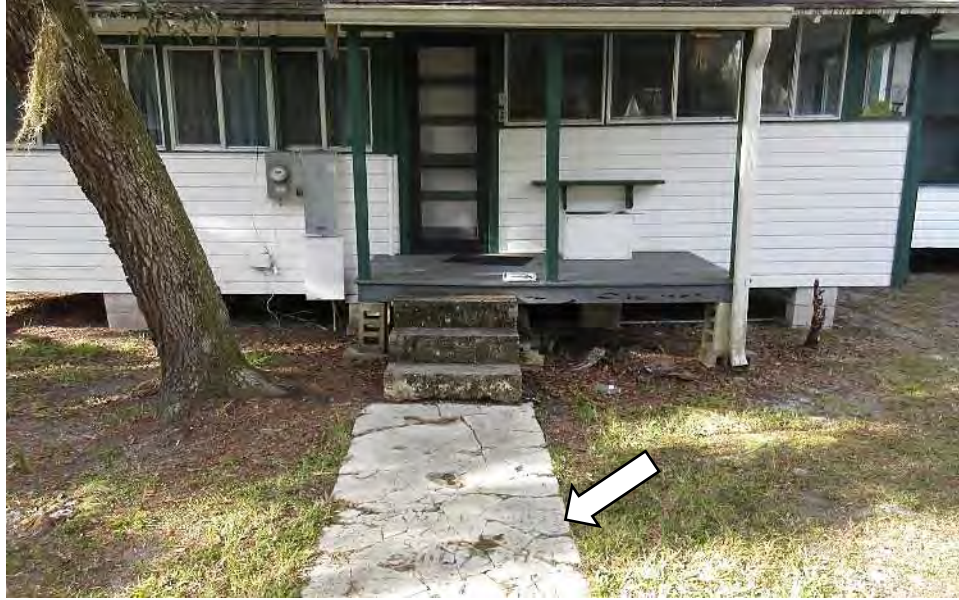
Detail of the back porch. Note the walkway inscription: “W. H. Leggett and Son, July 15, 1951.”

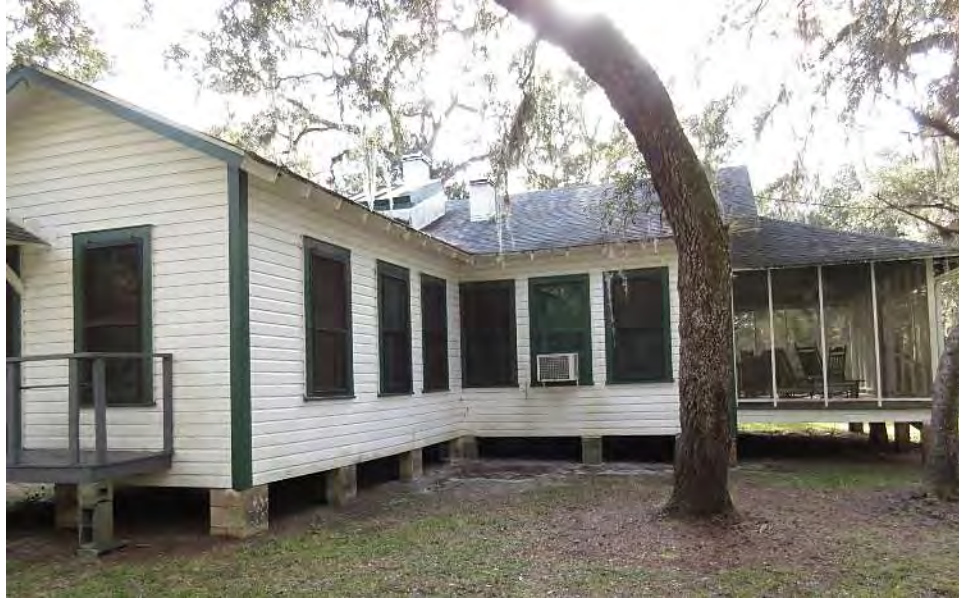
View of the northeast portion of the building with the dining room addition at left.

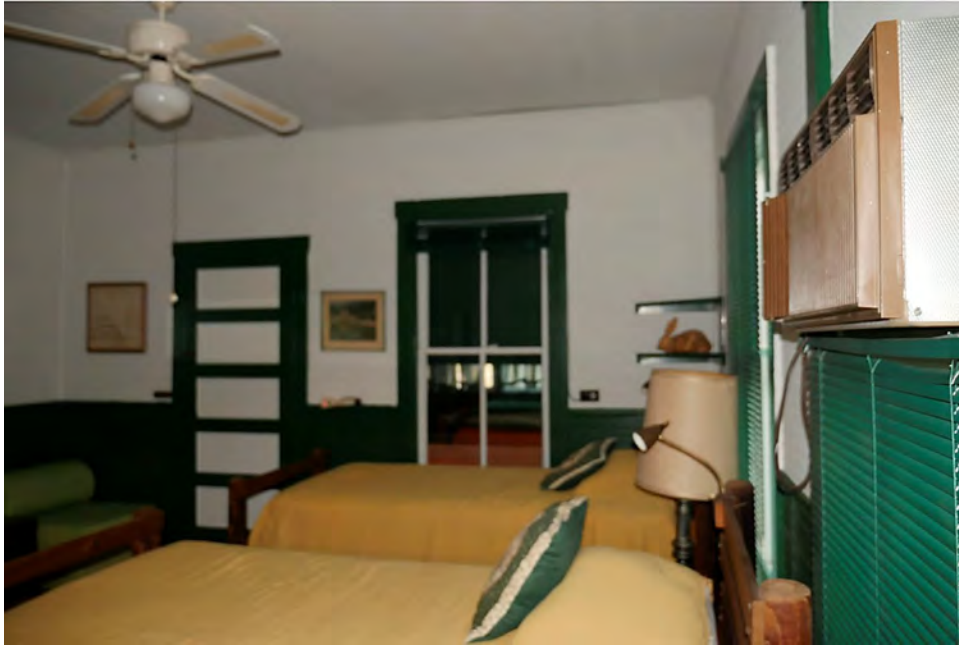
View south of Bedroom #2 toward Bedroom #3.

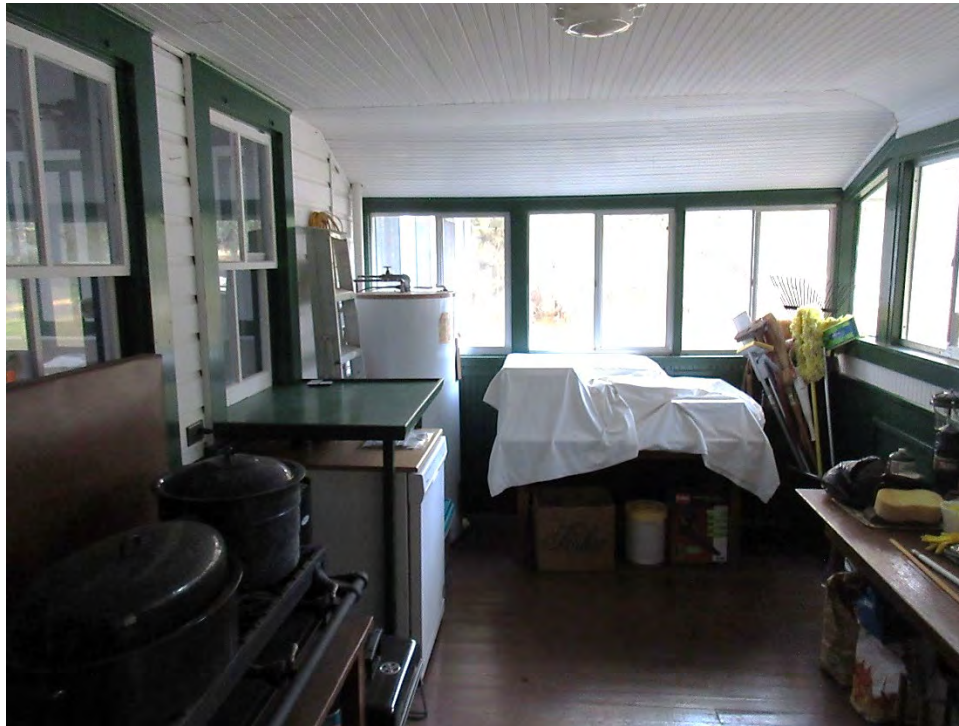
View east of the back porch.

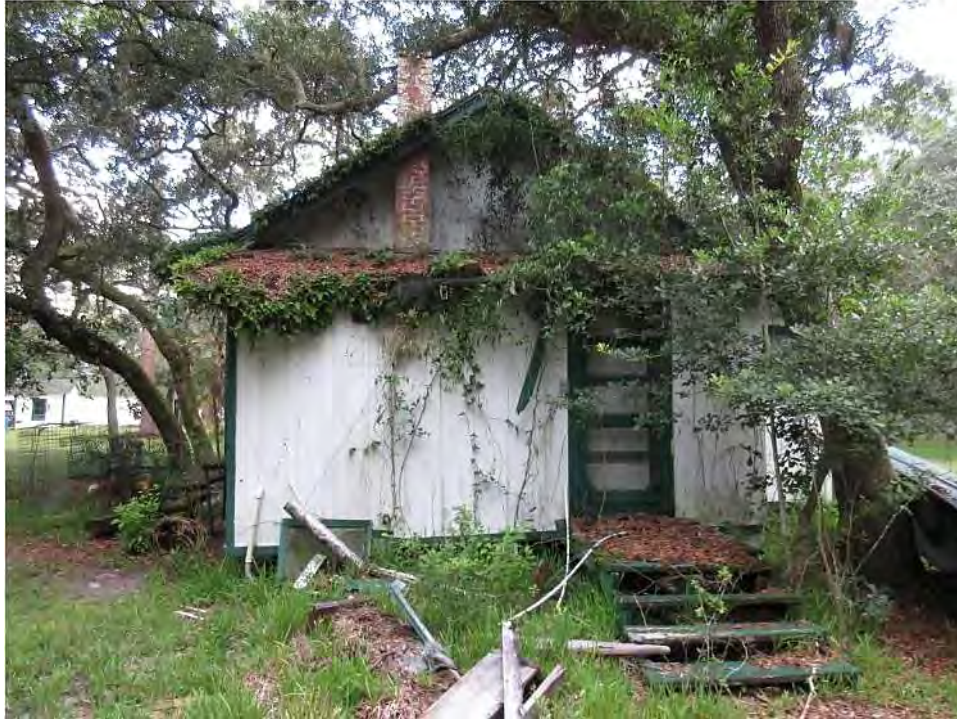
Rear (south) façade of the Cook's House.

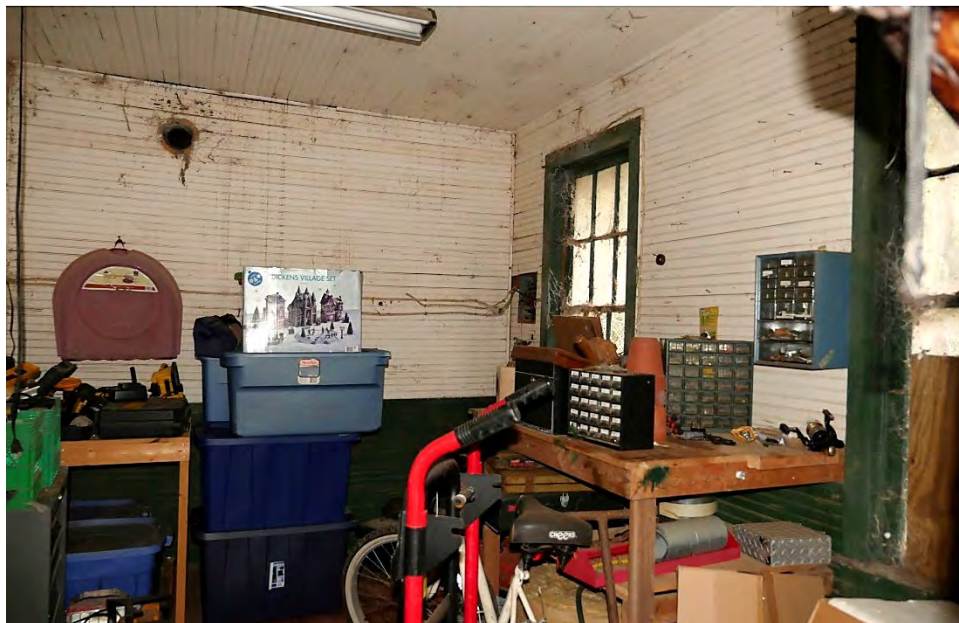
Interior of the Cook's house in the room at the northwest corner.

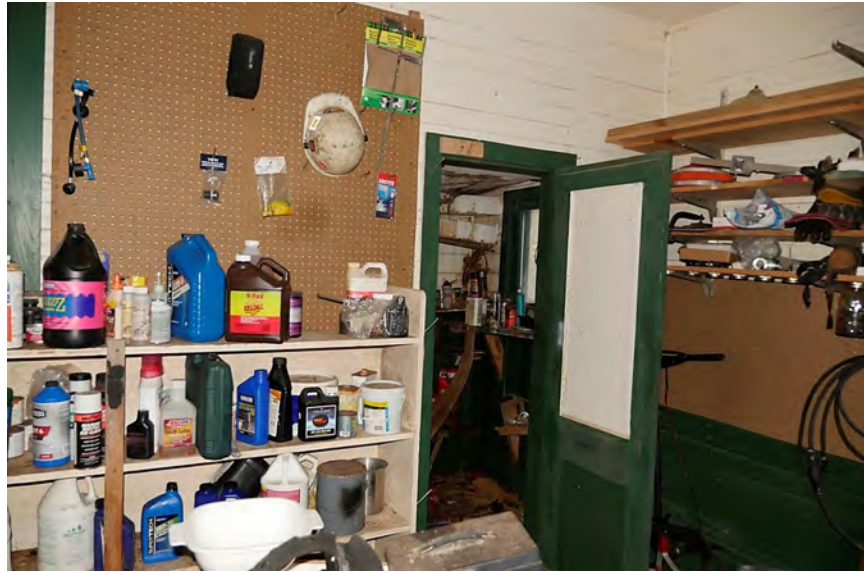
Interior of the Cook's House looking from the northeast front room to the door to the bathroom addition.

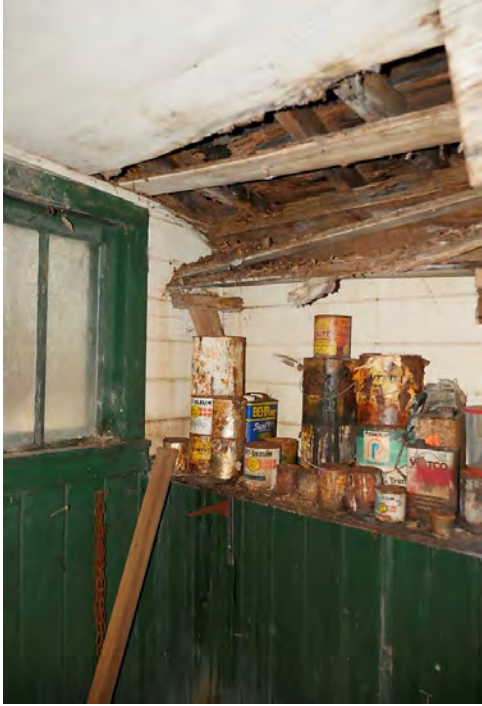
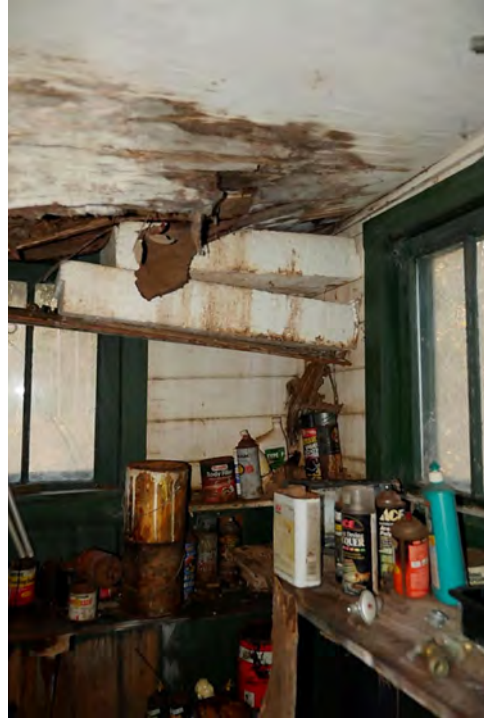
Photos of the bathroom interior showing the damaged ceiling.

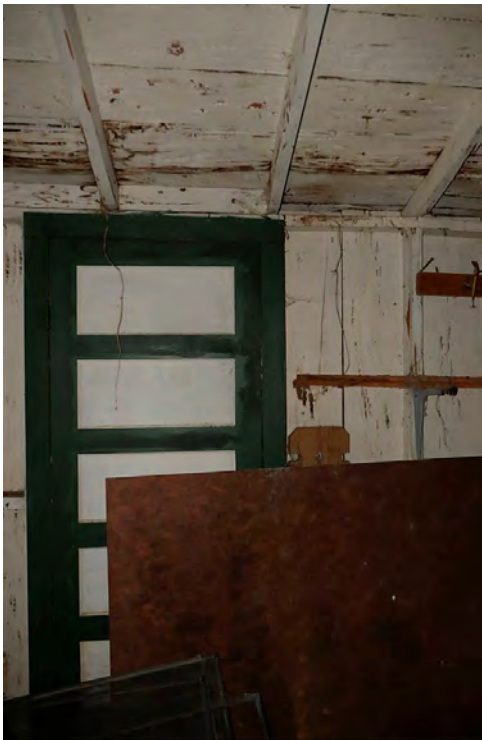
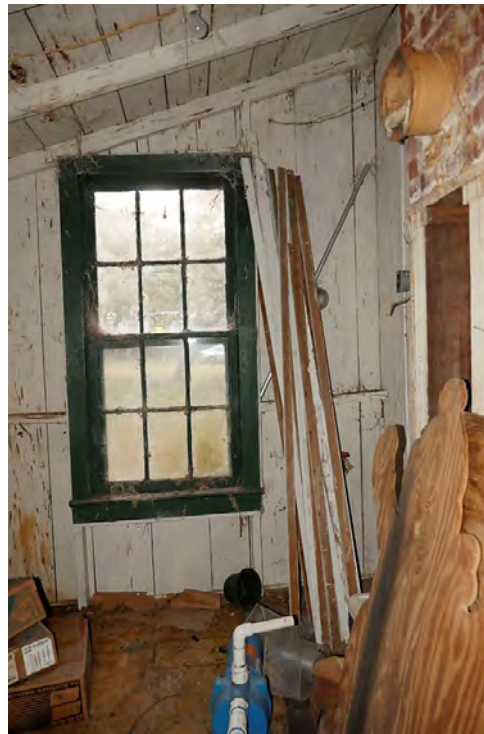
View of back porch toward the rear door (left). View to west wall (right).

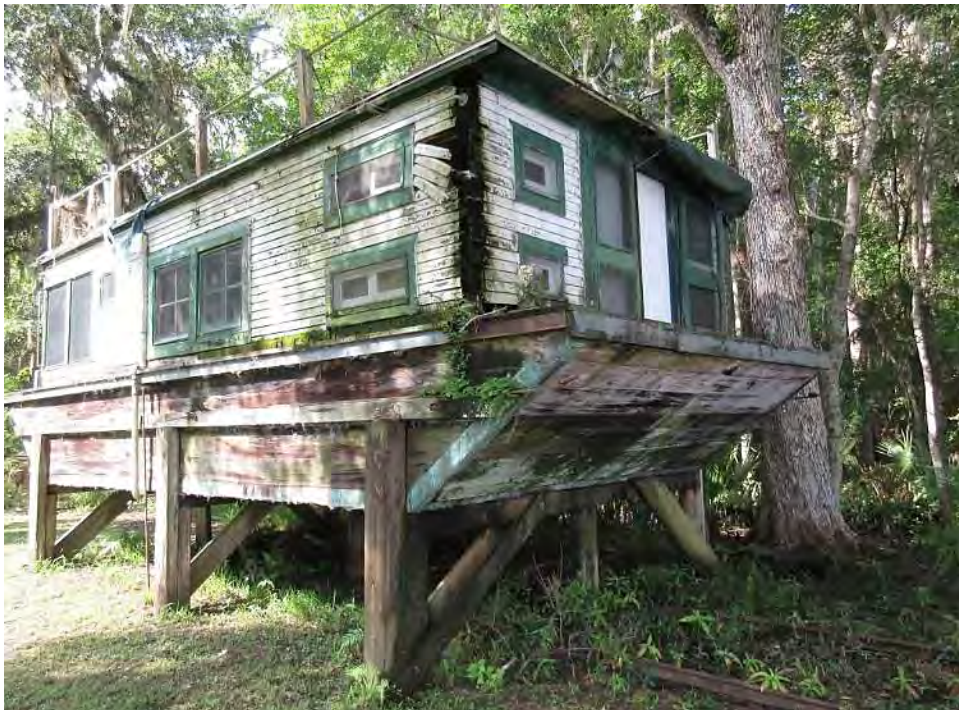
East and north sides of the Houseboat. Note wood rot damage at the northeast corner.

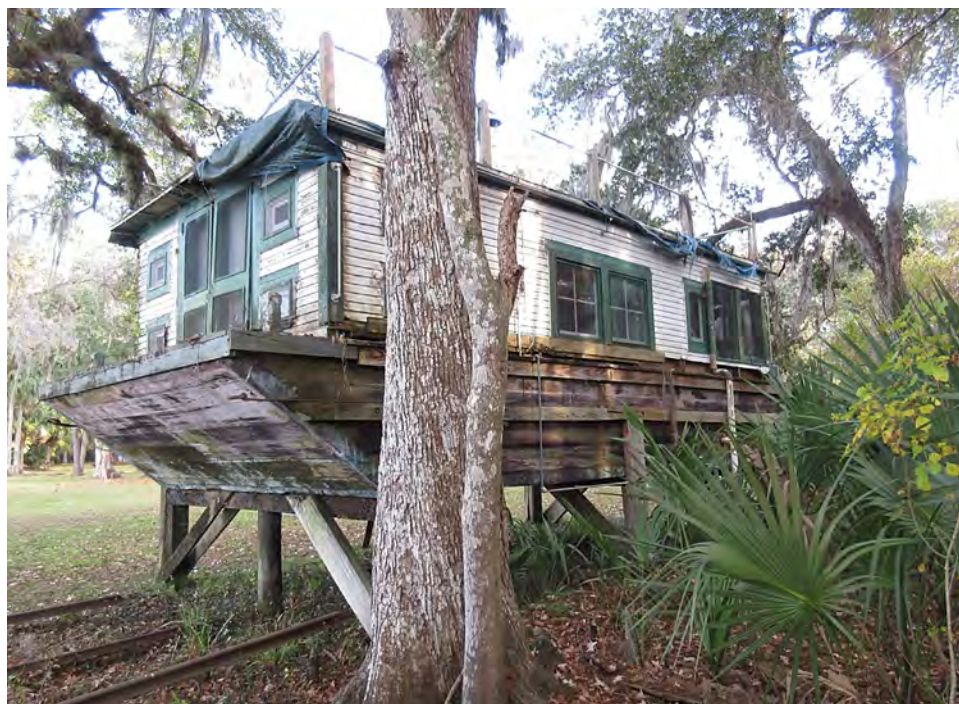
View southeast toward the starboard side of the Houseboat.

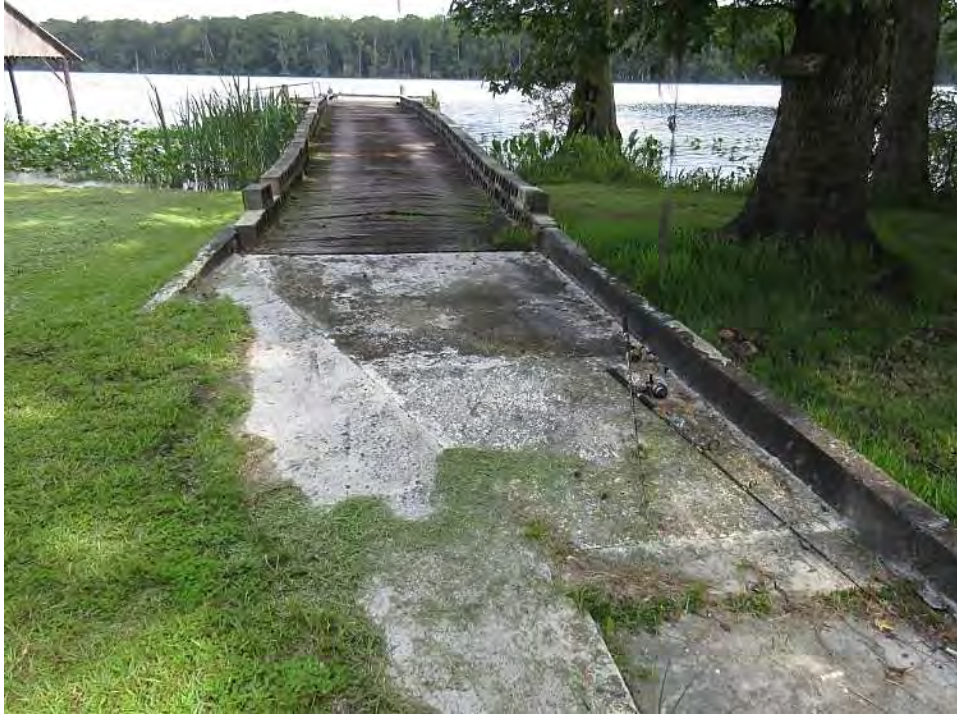
View north along the approach to the Dock from the Main House.

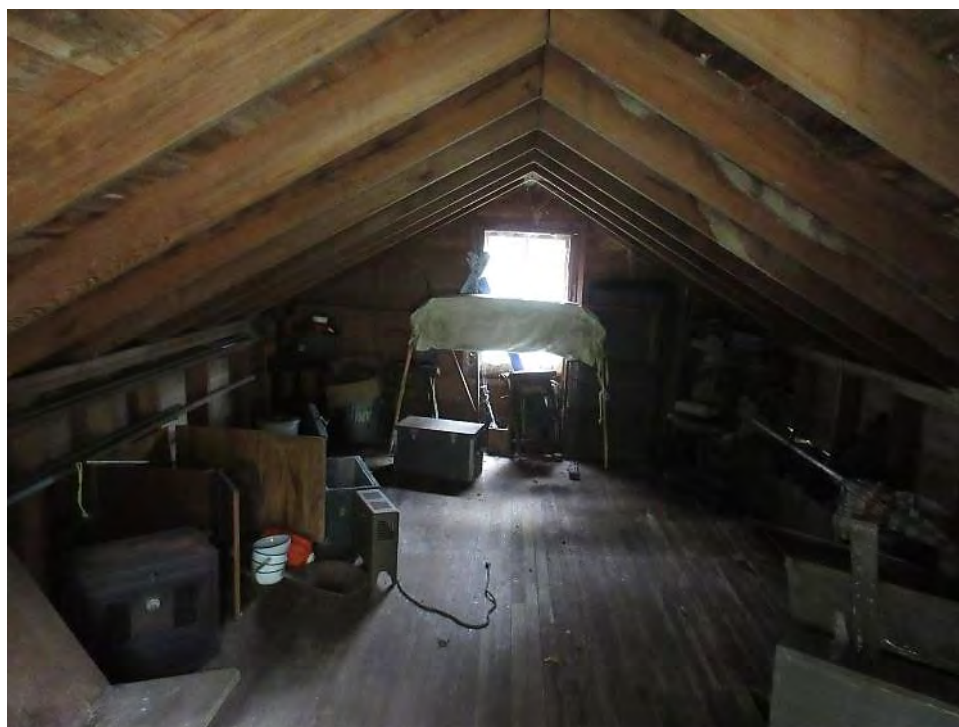
Interior of the Loft garage.

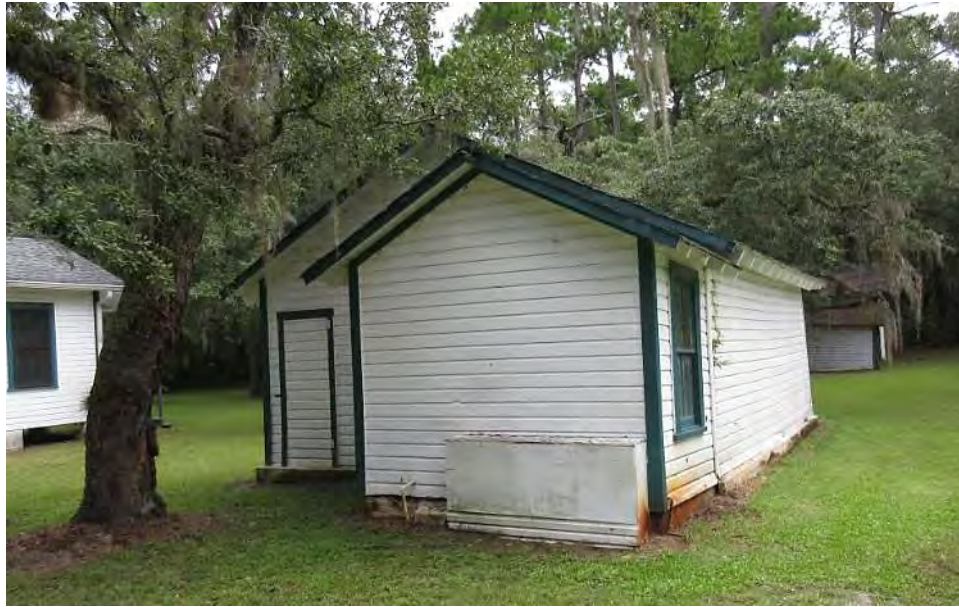
Rear (west) and south facades of the Garage.

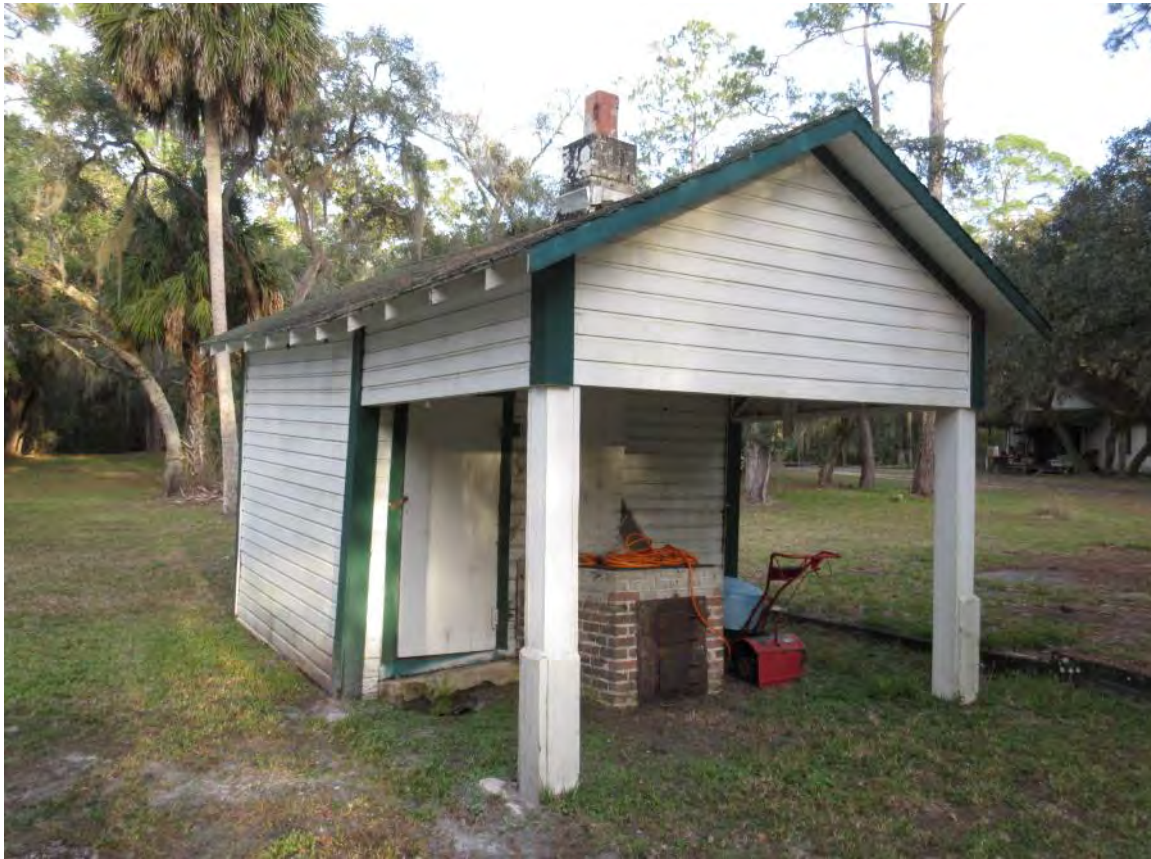
View southeast of the primary (west) and north facades of the Kettle Shed.

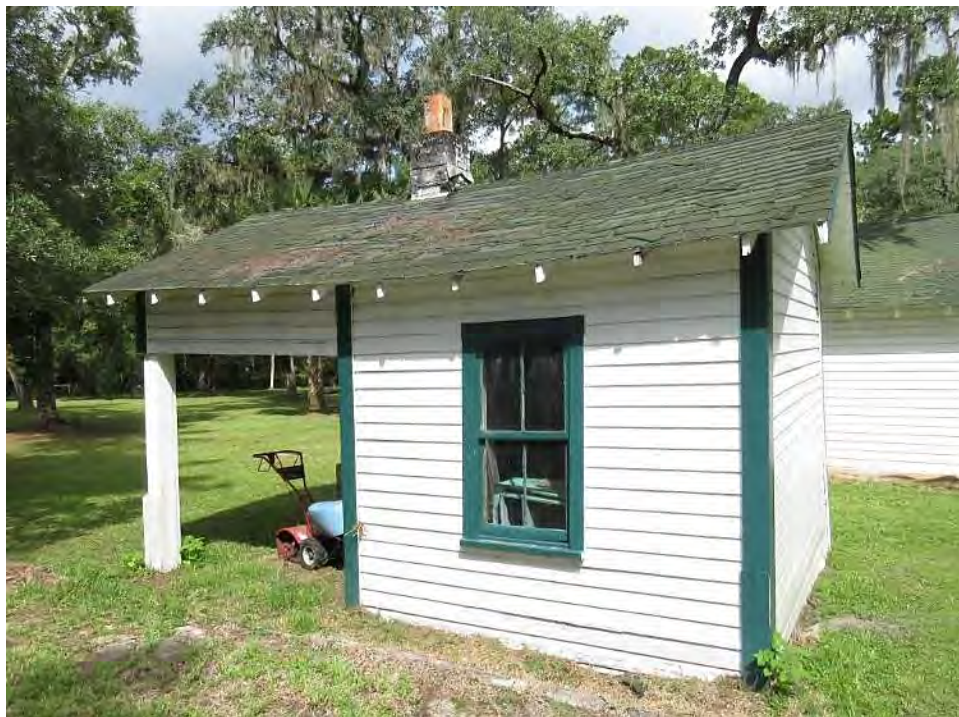
View north of the south façade of the Fryer Shed.

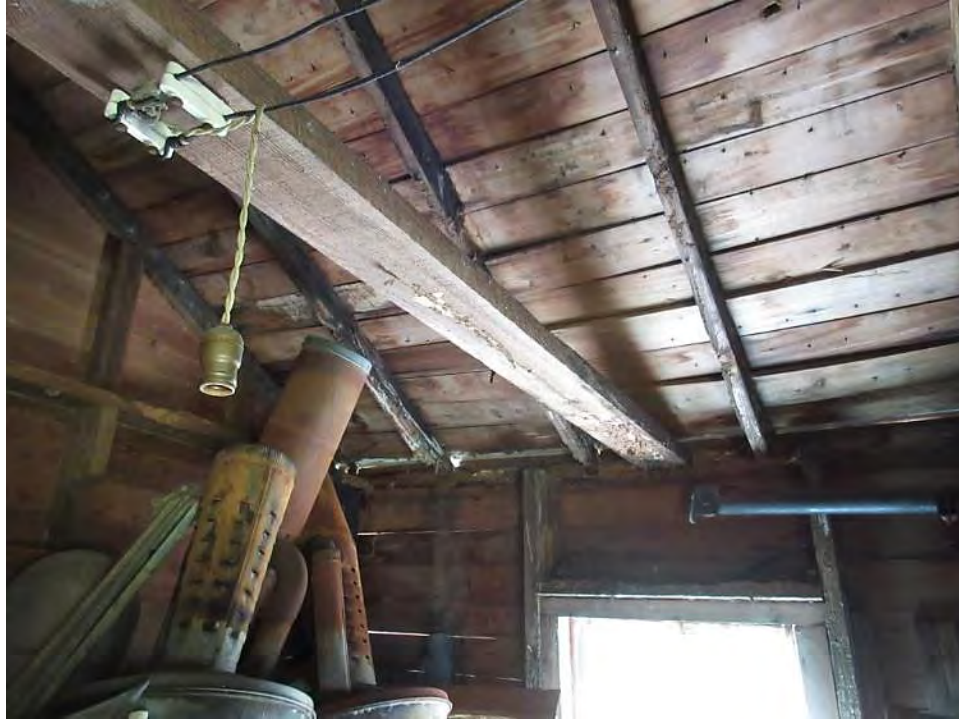
Detail of roof damage on the southern side of the interior storage area.

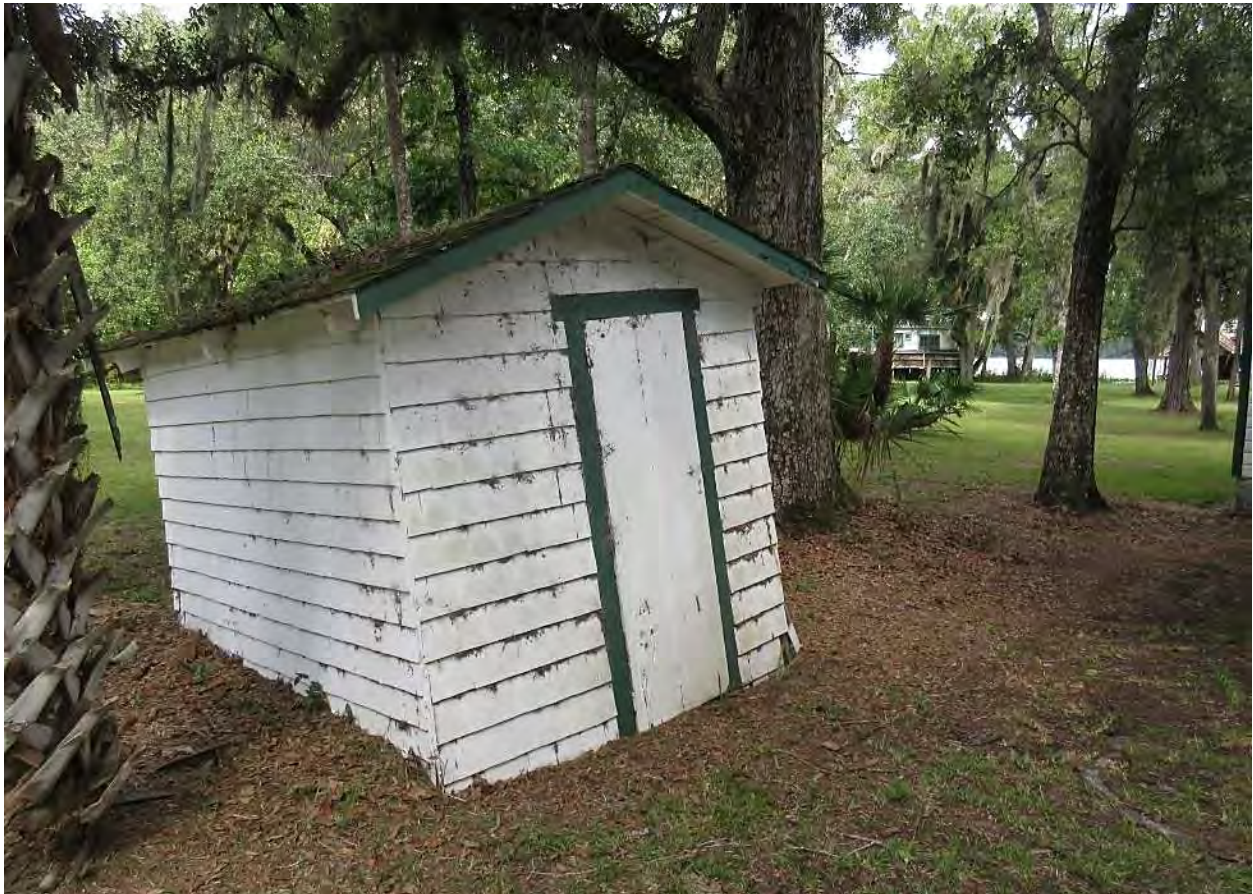
South and east sides of the Woodshed.

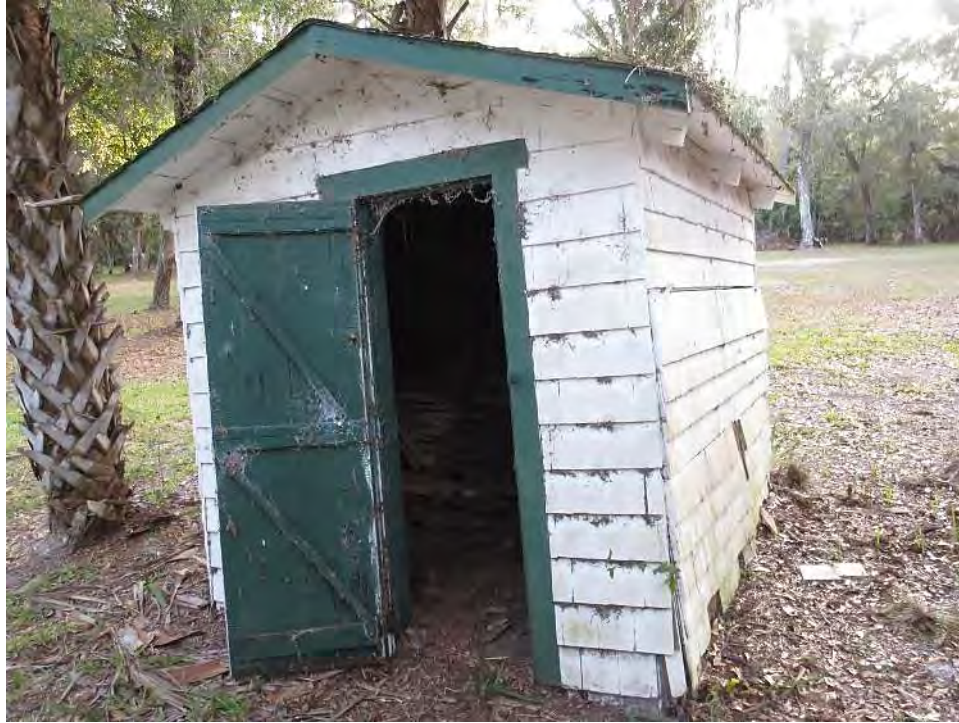
Detail view showing door construction.

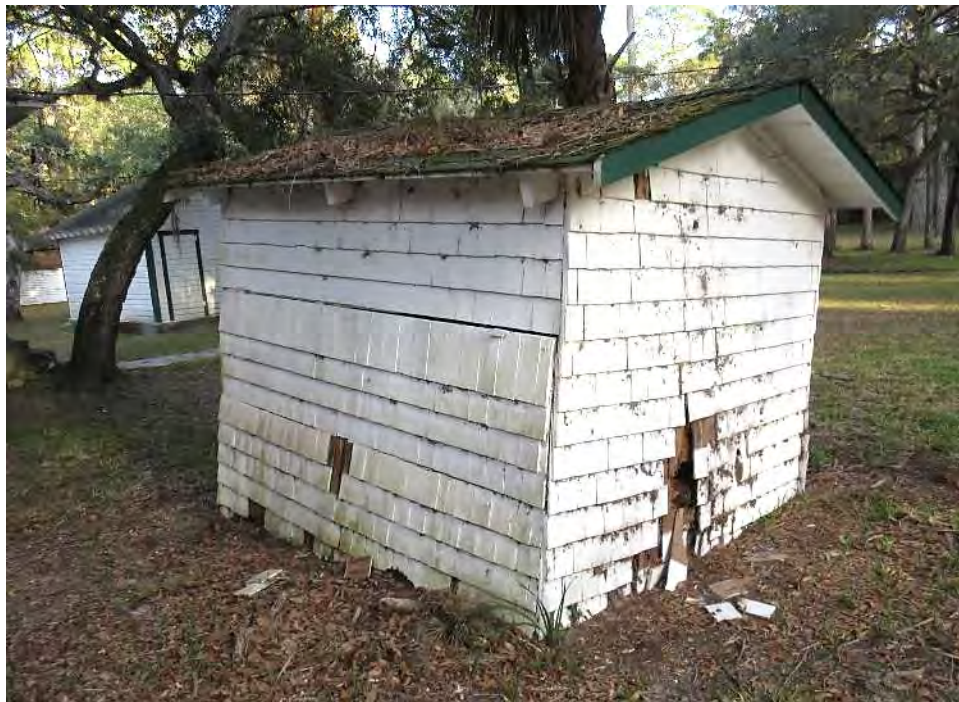
Detail view showing the access panel along the north façade, as well as the termite damage at the rear.

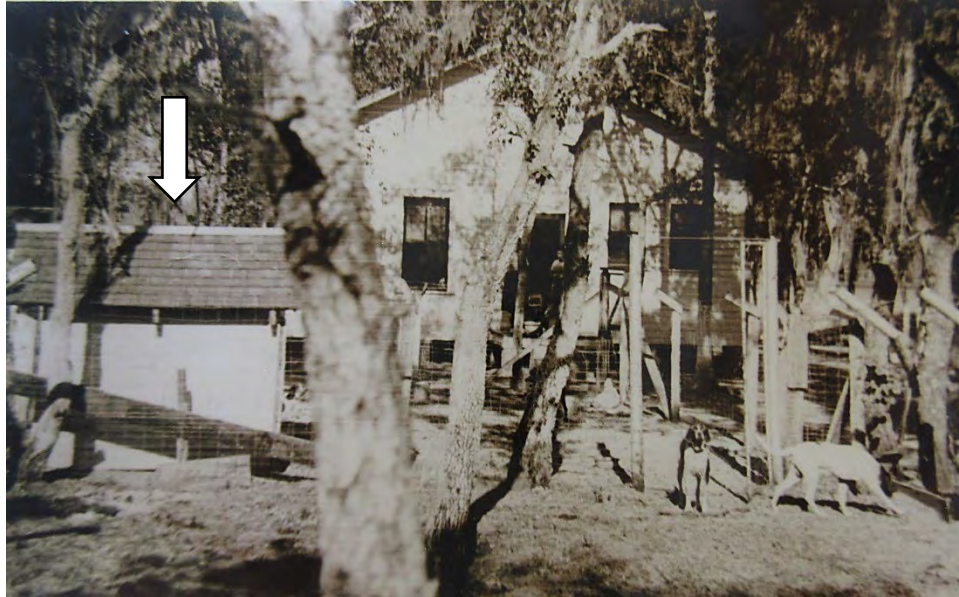
December 1939 view looking north toward the back of the Main House with arrow pointing to the woodshed. (Photo courtesy Bob McKinstry)

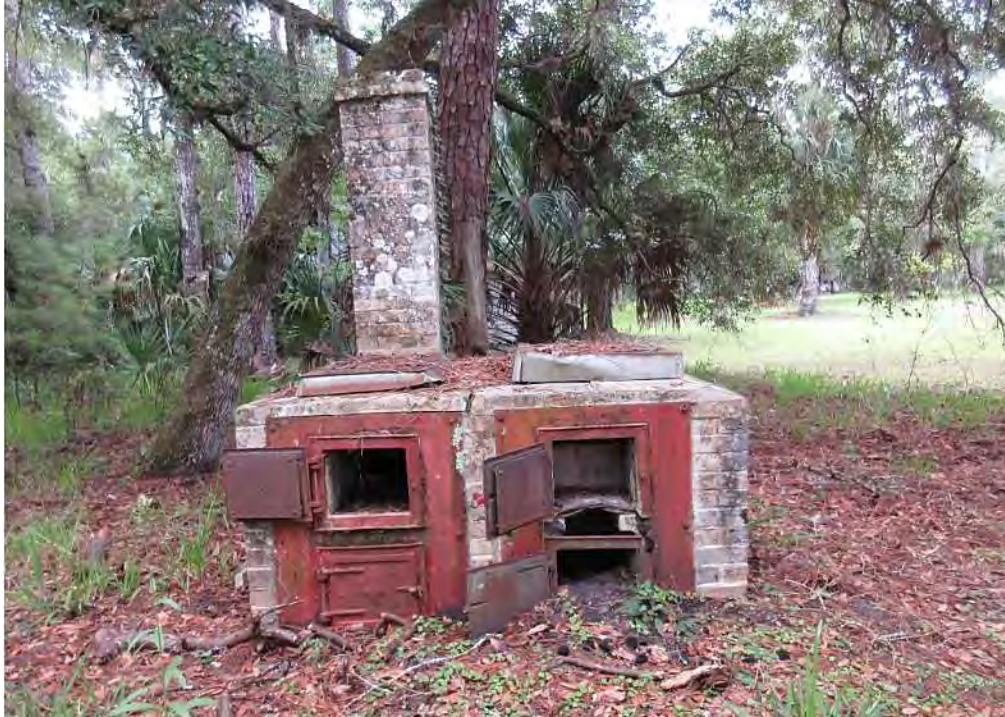
View of the Cahill fireboxes at the front of the Grill.

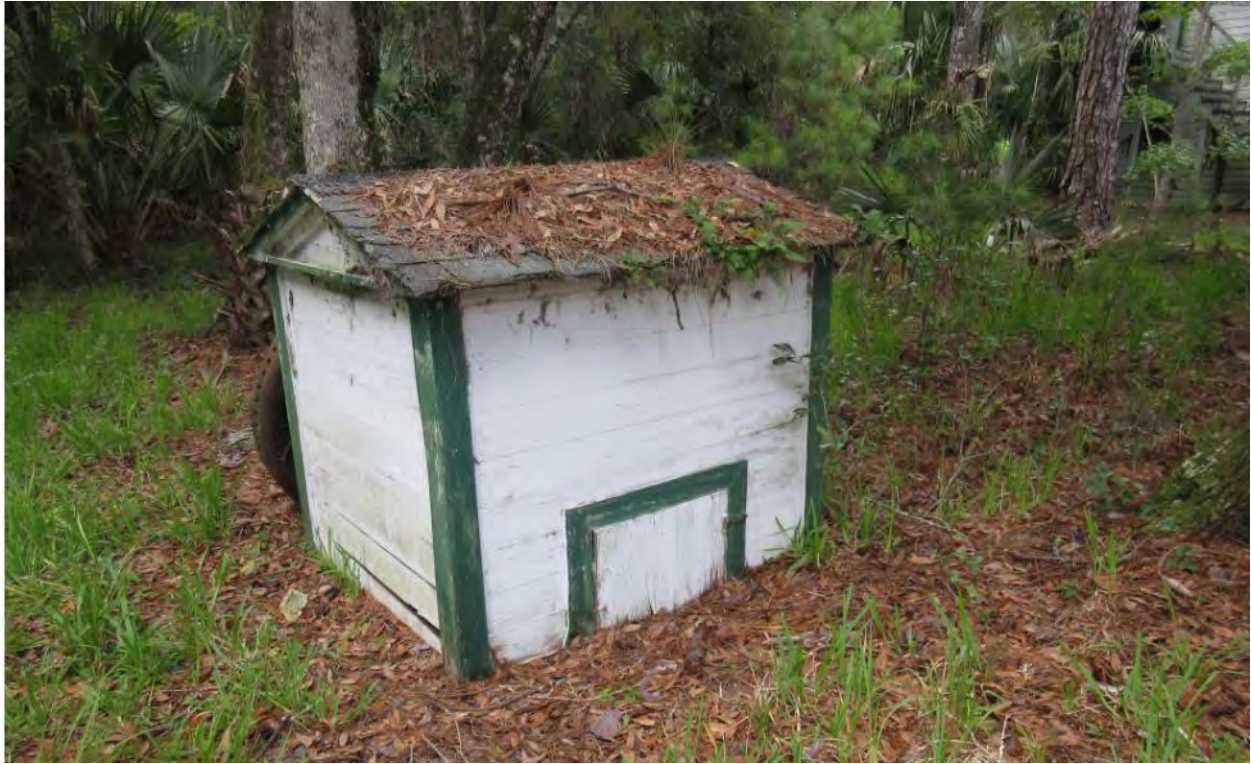
View toward the north and west sides of the smoker.

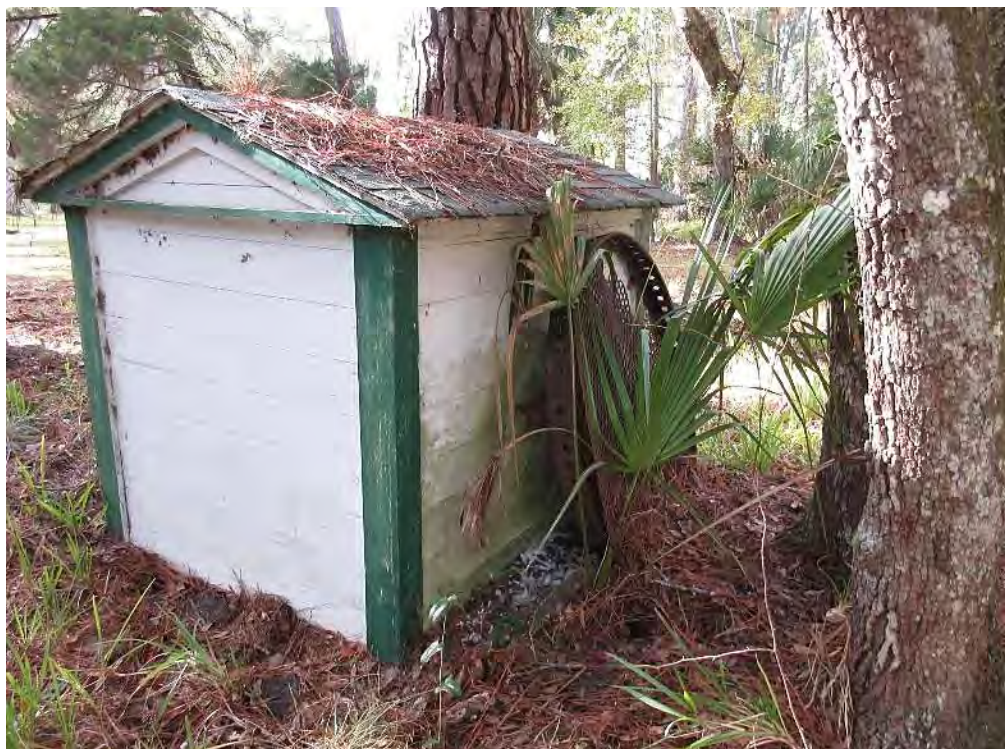
View toward the south and east sides of the smoker.

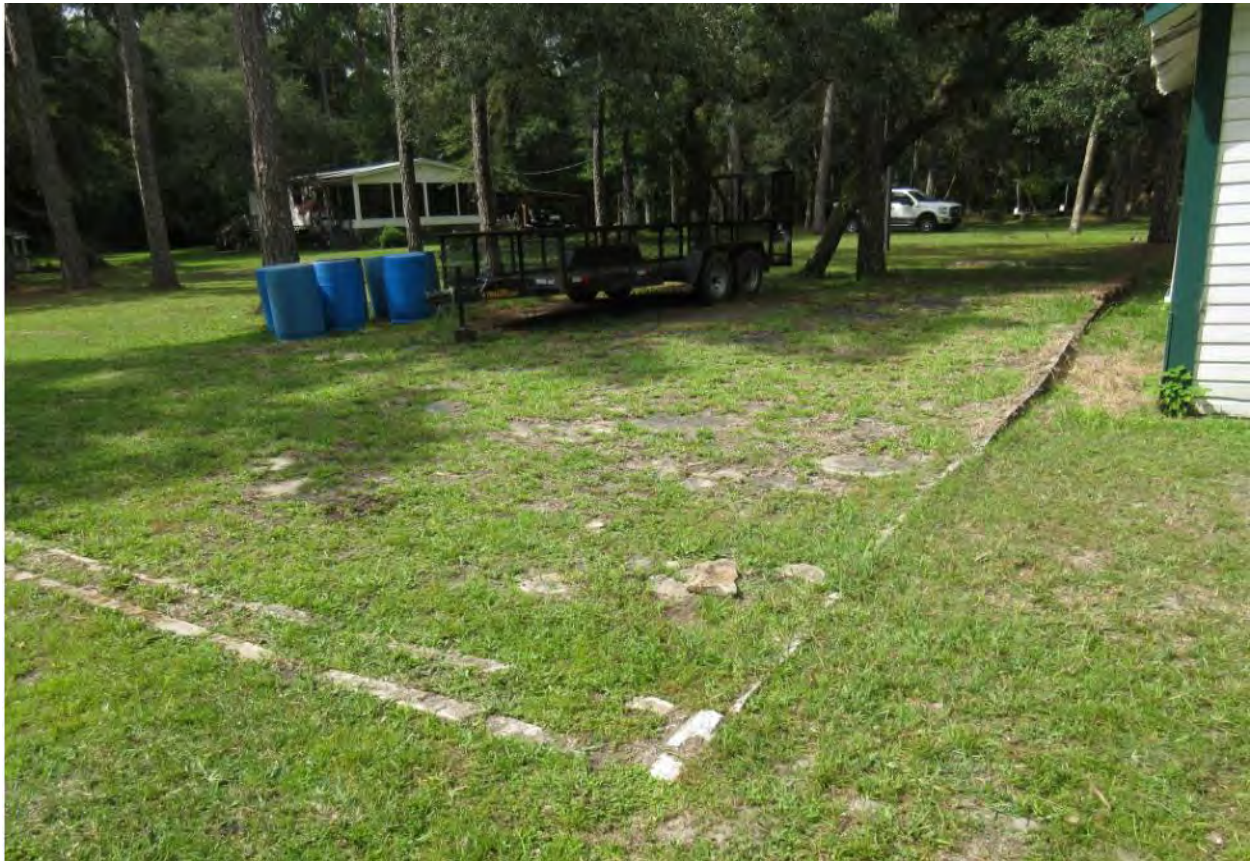
View southwest of the Dog Kennel Foundation.

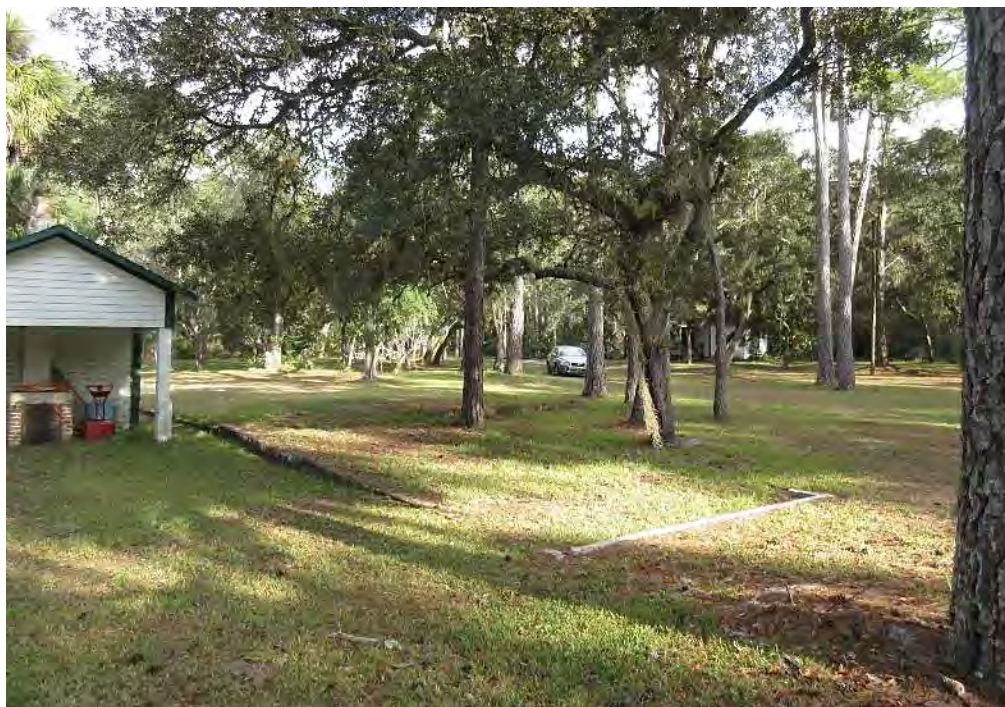
View southeast showing the sloped northwest corner of the Dog Kennel Foundation.

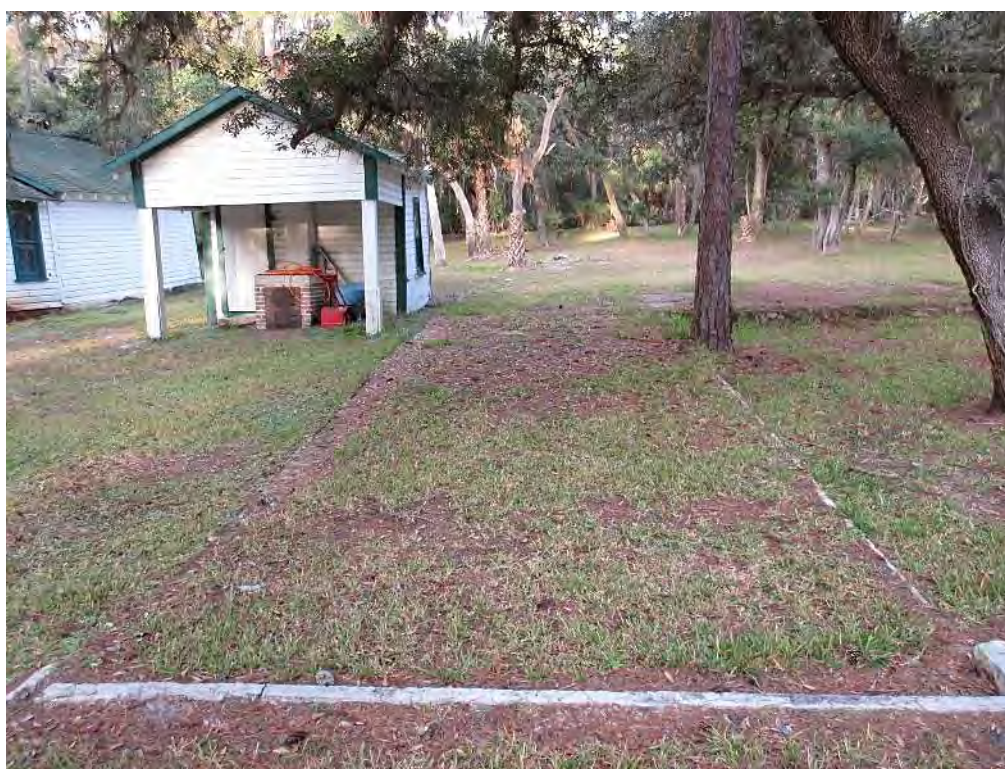
View east of the Dog Kennel Foundation.

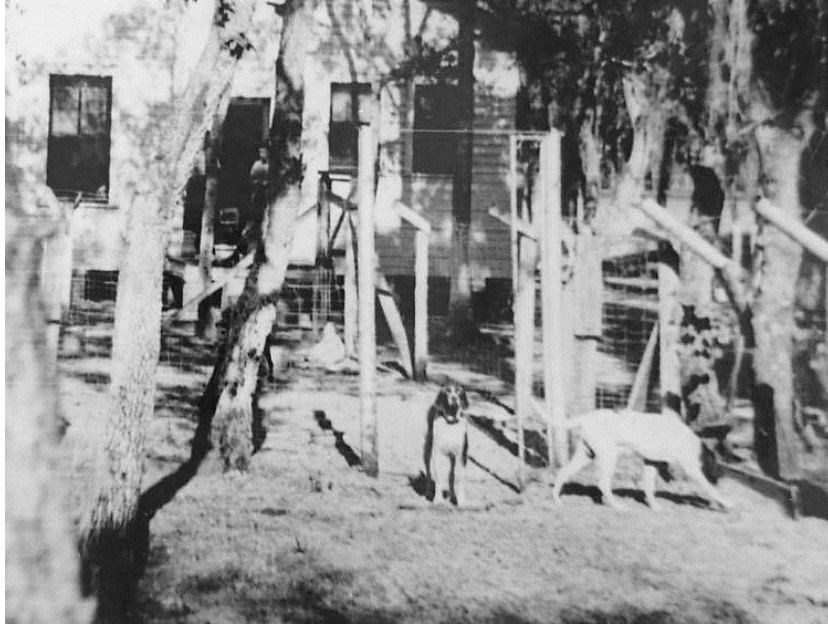
Detail of a December 1939 photo looking north toward the rear of the main house with a portion of the kennel visible at right. (Photo courtesy Bob McKinstry)

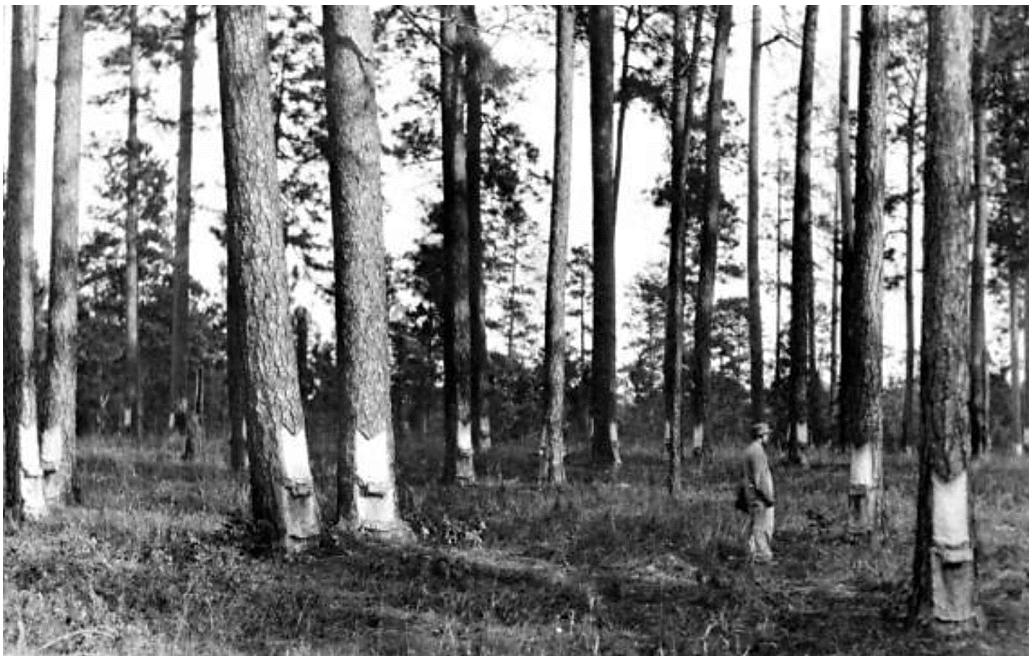
Pine trees with Herty style boxes to catch the sap flow, circa 1910s.  
(Florida Memory, Image No. NO43977)

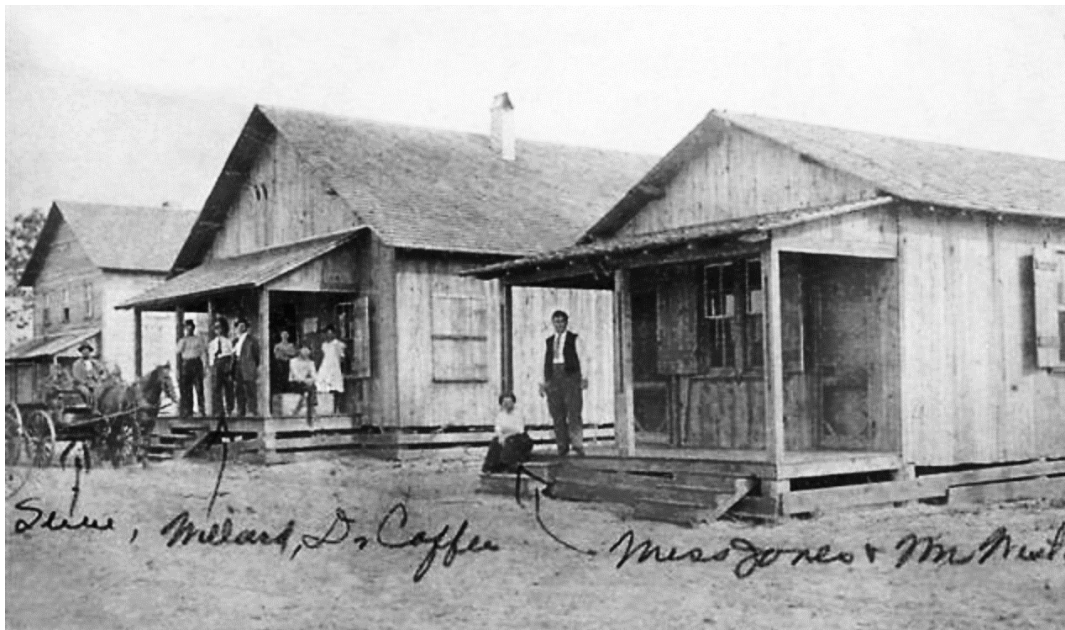
The Cummer Sons Cypress Company hotel, commissary and office at Sumner, circa 1915.  
(Photo provided by Nancy Towns, accessed by fl-genweb.org)

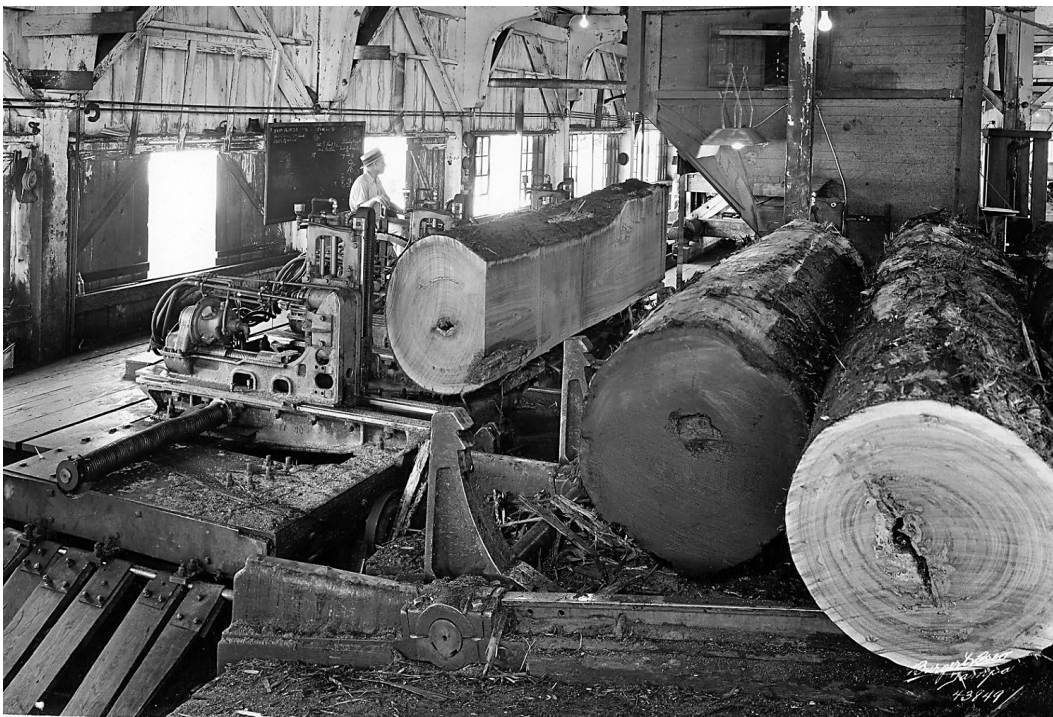
Cypress logs being milled at the Cummer Cypress Company sawmill at Lacoochee Florida. The mill at Sumner employed similar equipment for sawing cypress logs. (Scan provided by Louie Holt, courtesy the Pioneer Florida Museum).
