# **HISTORIC STRUCTURE ASSESSMENT REPORT**

## **VISTA HISTORIC SITE Lower Suwannee National Wildlife Refuge**

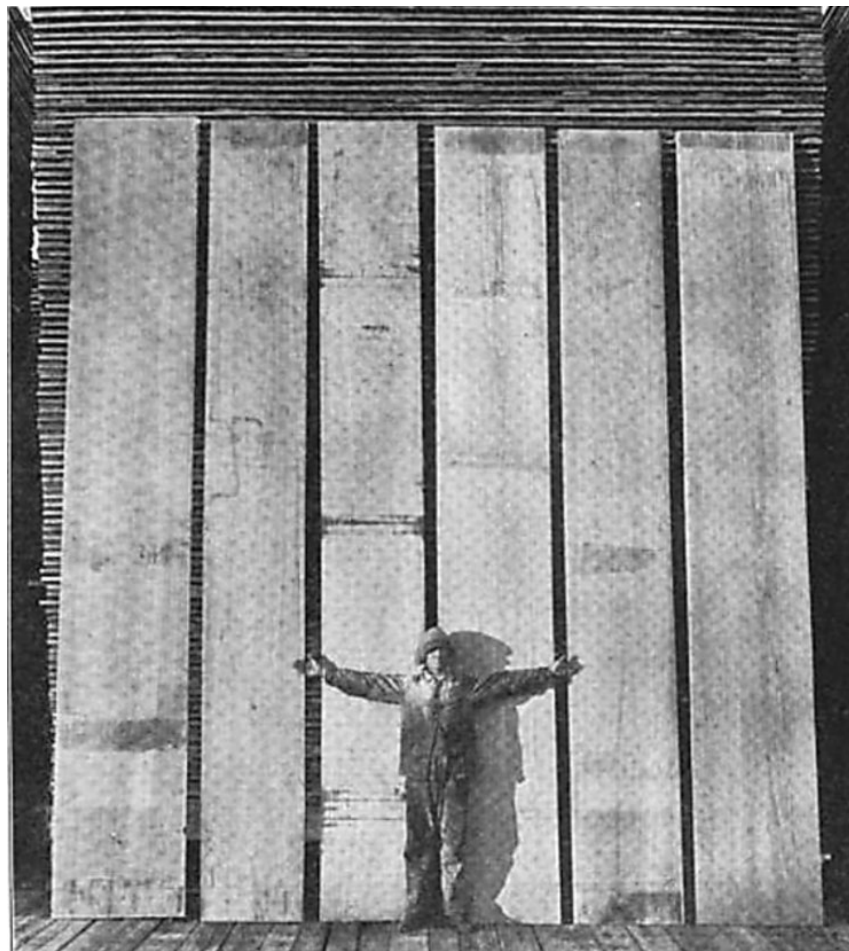
Cypress boards cut at Sumner on display at the company wharves in Jacksonville prior to shipment.  
(*Lumber World Review*, February 10, 1922, p. 30.)

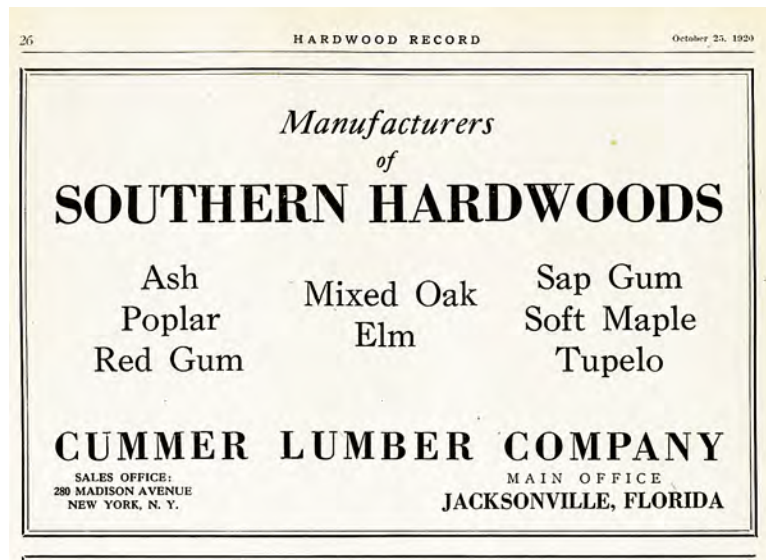
Advertisement in *Hardwood Record*, October 25, 1920.

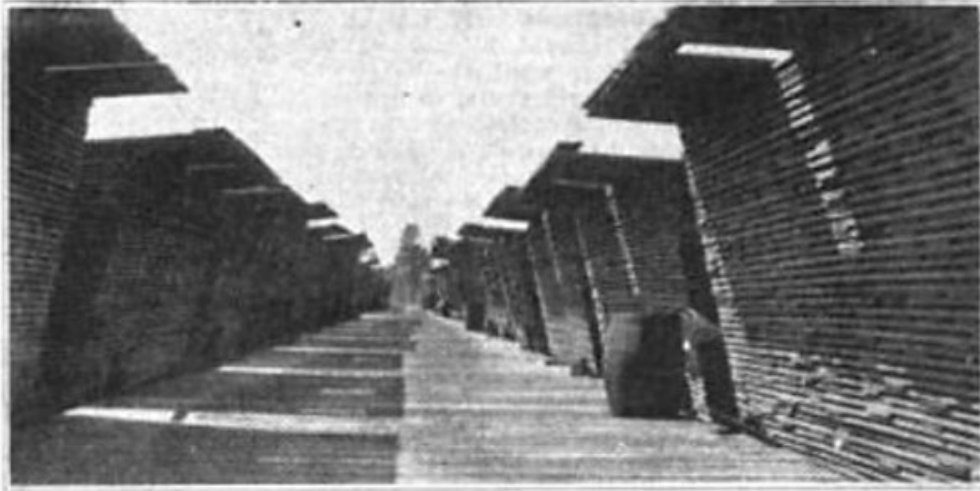
*Yards adjoining the mill of the Cummer Cypress Co. at Sumner, Fla., have a capacity of 23,000,000 feet. Photograph shows piles exclusively of cypress in the Sumner yard and is typical of the entire layout of the big Florida plant*

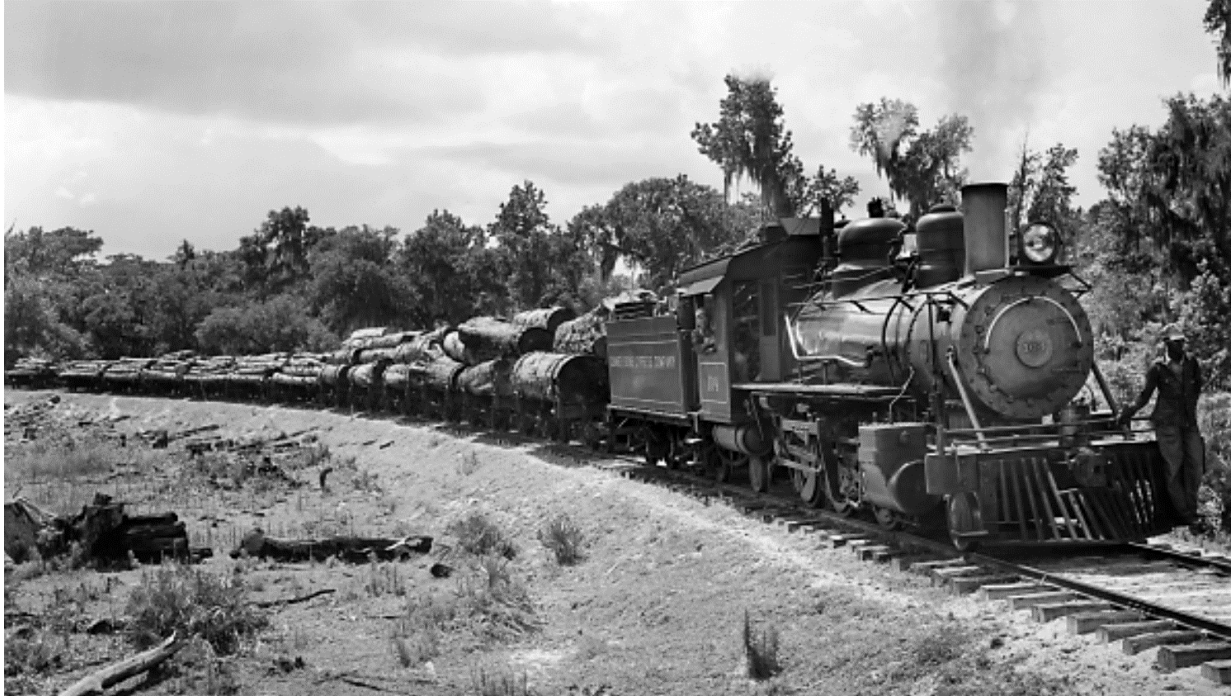
Cummer Engine No. 104 carrying logs to the Lacoochee sawmill in 1939.  
(Florida Memory, Image No. RC04629)

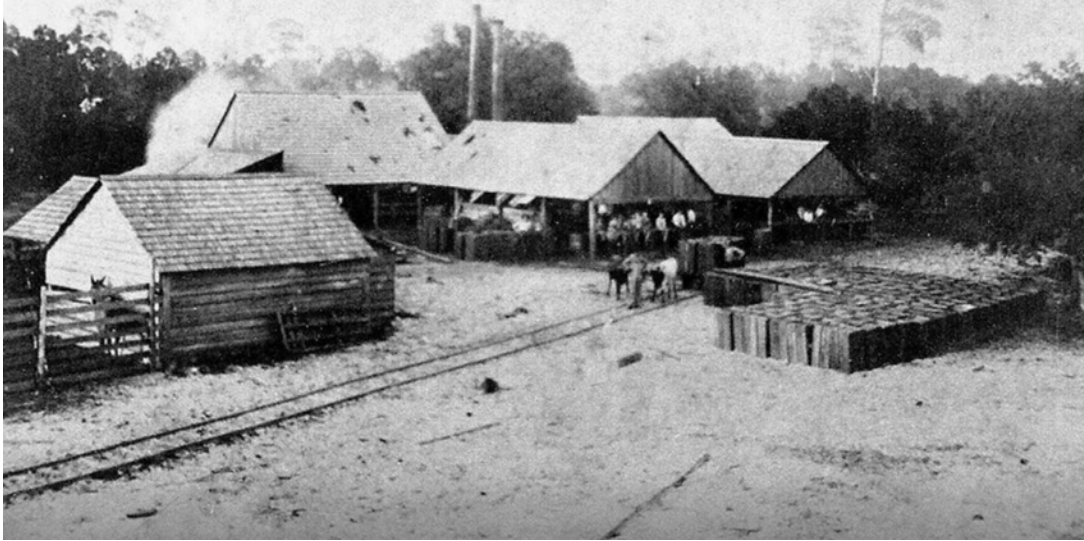
Undated photo purported to show the Yearty sawmill at Vista.  
This photo may have been taken from the upper deck of the *City of Hawkinsville*.  
(Evelyn Walrath Yearty / Facebook Group / Yearty's of Levy County, Florida)

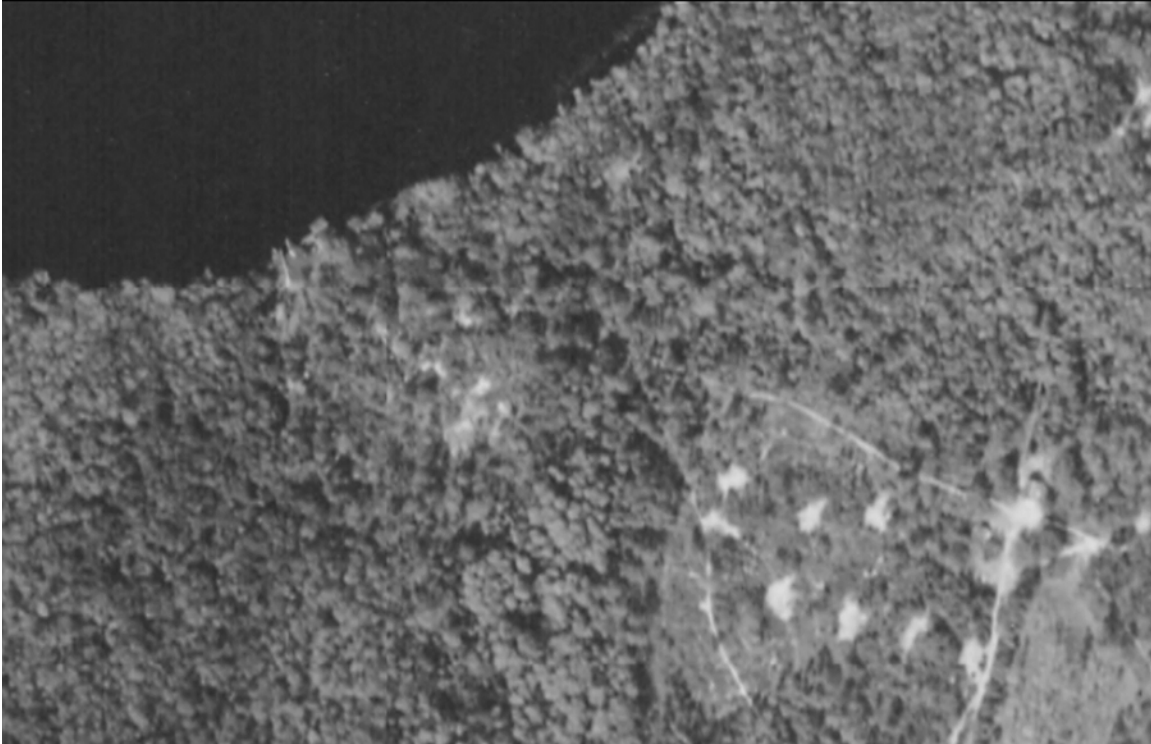
November 18, 1944 aerial photo of the Vista camp. Note that the Boathouse is not visible. It may have been reconstructed around this time. (University of Florida Digital Collections)

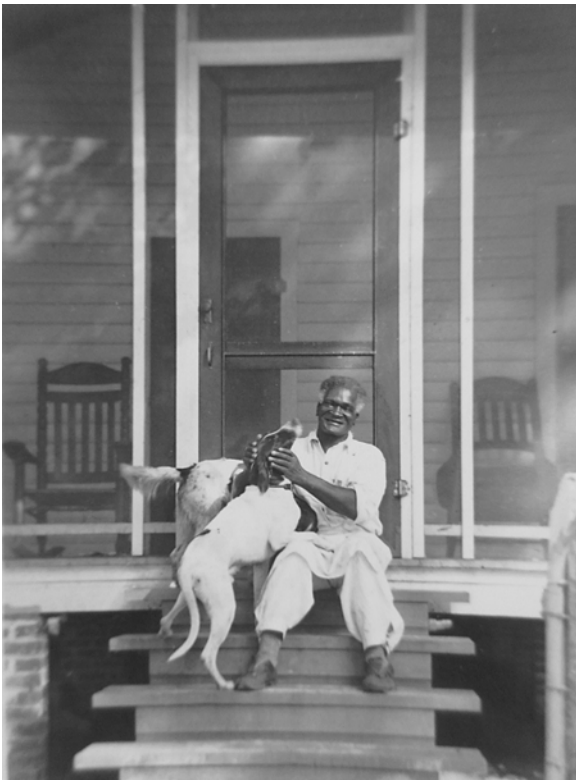
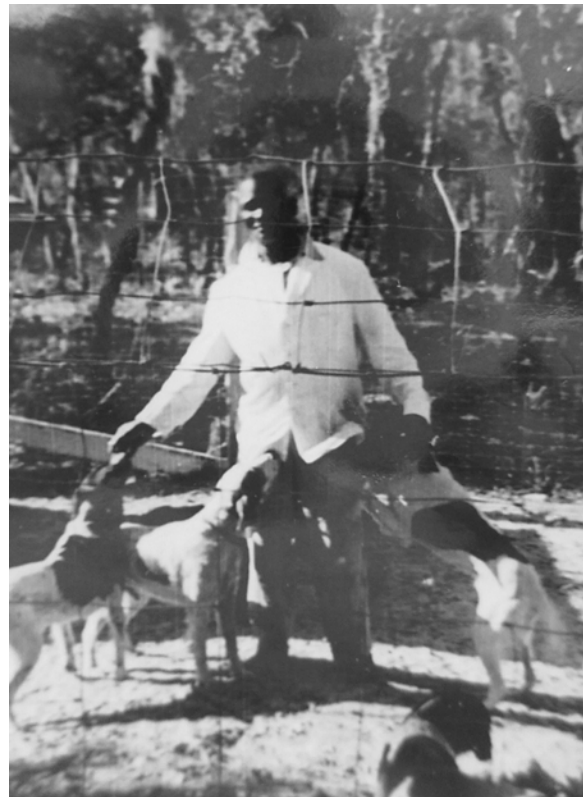
Circa 1940 photos of William Larry (“Uncle William”) at Vista.  
(Photo courtesy Bob McKinstry)

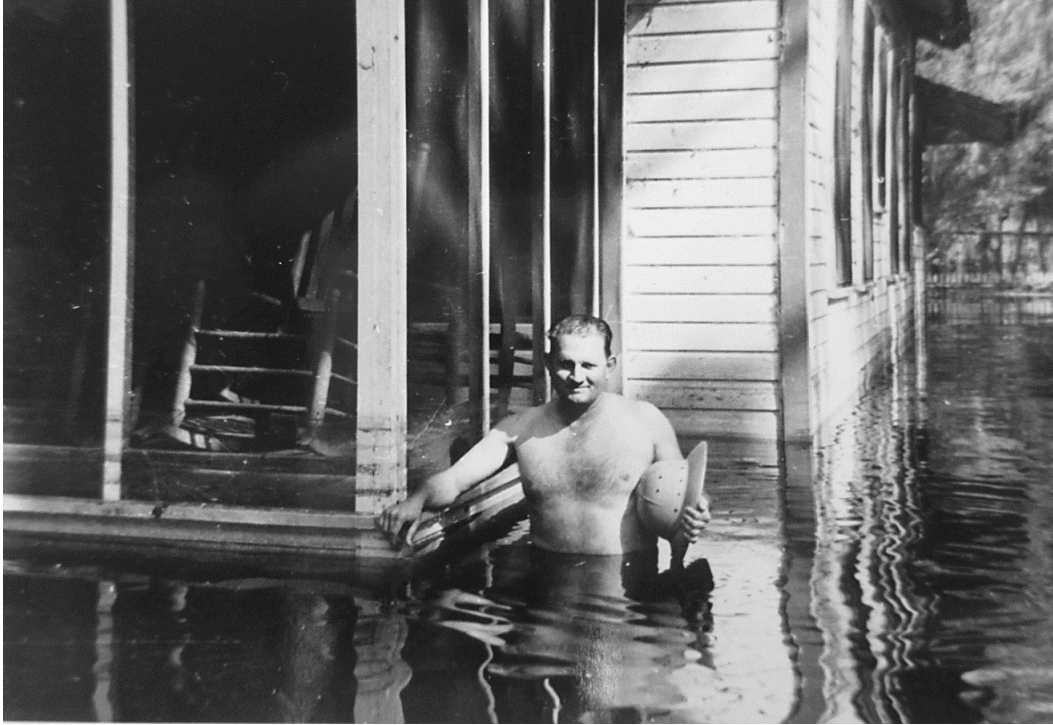
Bill McKinstry wading in the flood waters adjacent to the front porch of the Main House.  
(Photo courtesy Bob McKinstry)

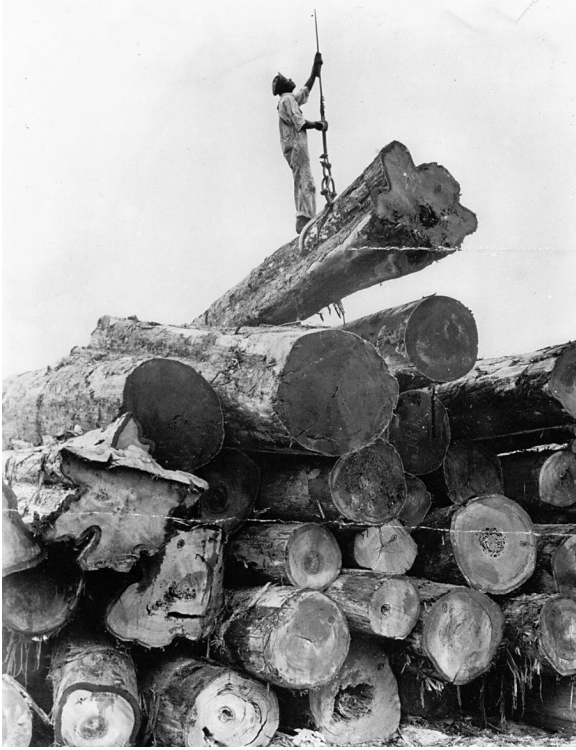
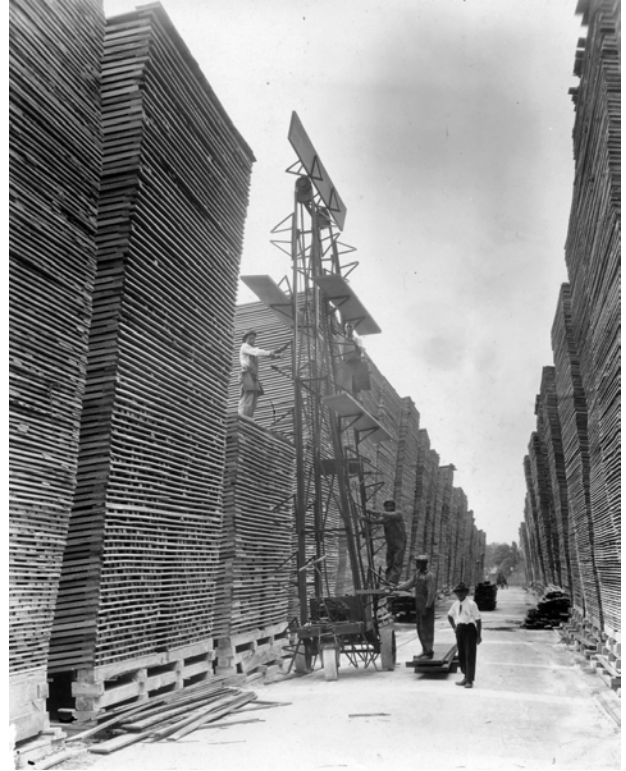
Circa 1930s images from the Lacoochee mill. At left, a worker attaches a hook to a log for transport to the sawmill. At right, stacks of lumber in the Lacoochee yard.  
(Jeff Miller, via Flickr)

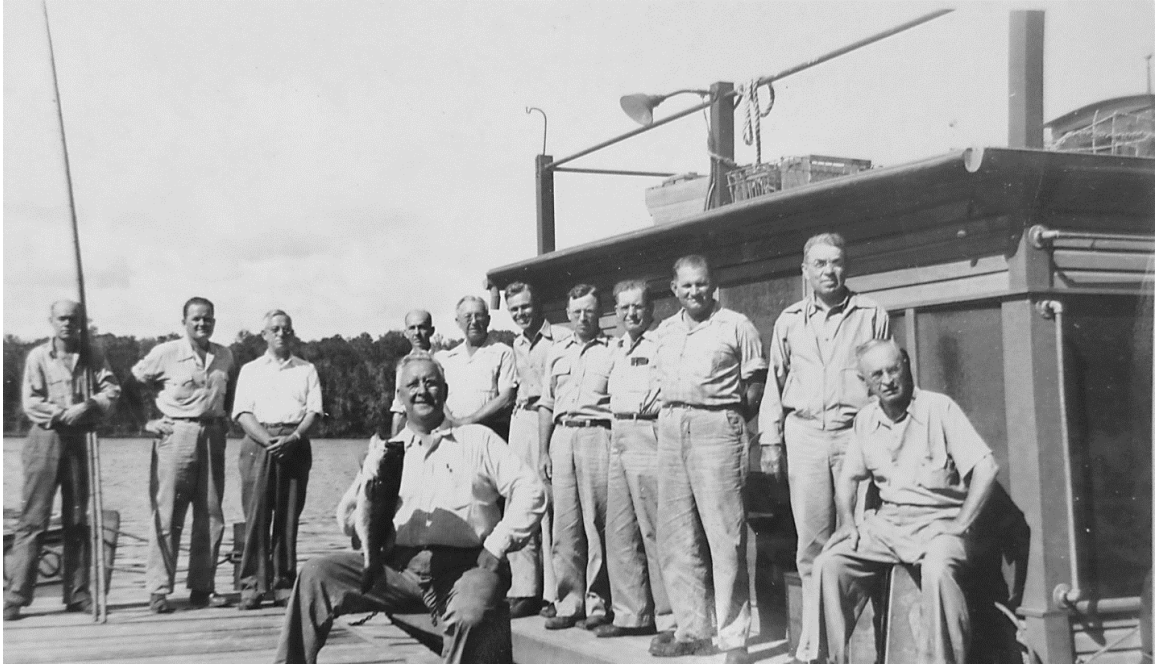
1958 photo of Cummer company officials with the houseboat moored at the Vista dock. The Lacochee sawmill would close the following year. From far left standing: Dr. William Walters (1<sup>st</sup>), Edward Roe (2<sup>nd</sup>), Brantley Thomas (6<sup>th</sup>), Bill McKinstry (9<sup>th</sup>). (Photo courtesy Bob McKinstry)

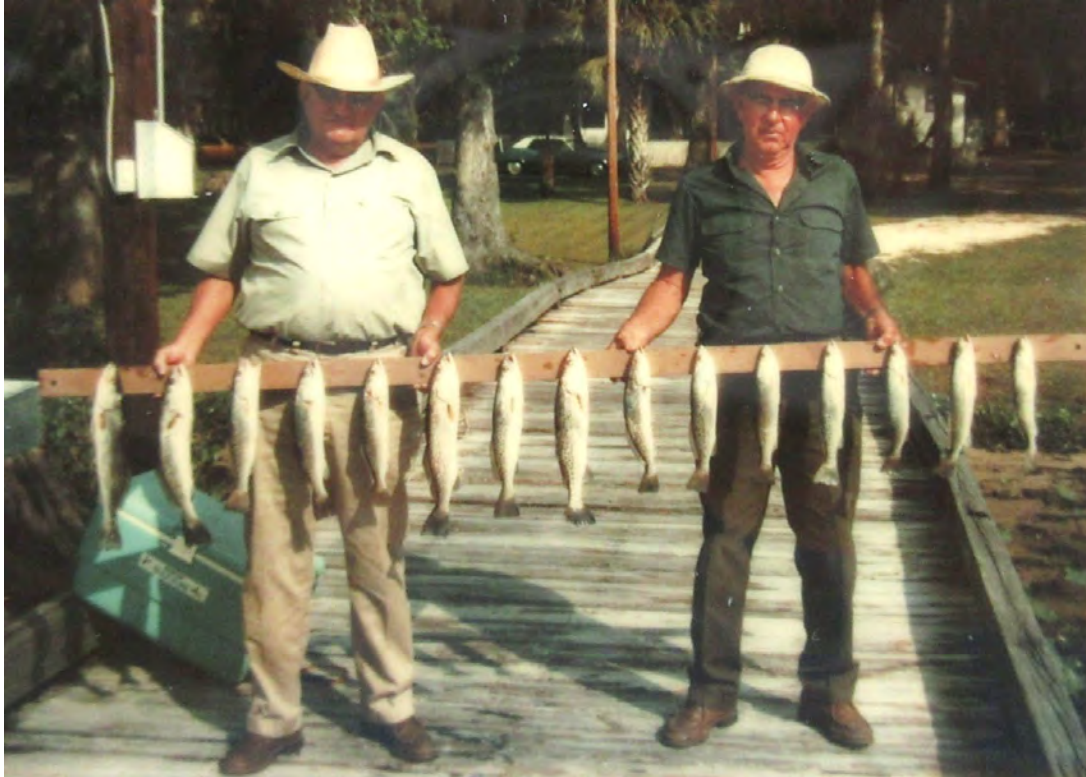
1974 photo of Bill McKinstry and Alton Marsh on the dock at Vista.  
(Photo courtesy Bob McKinstry)

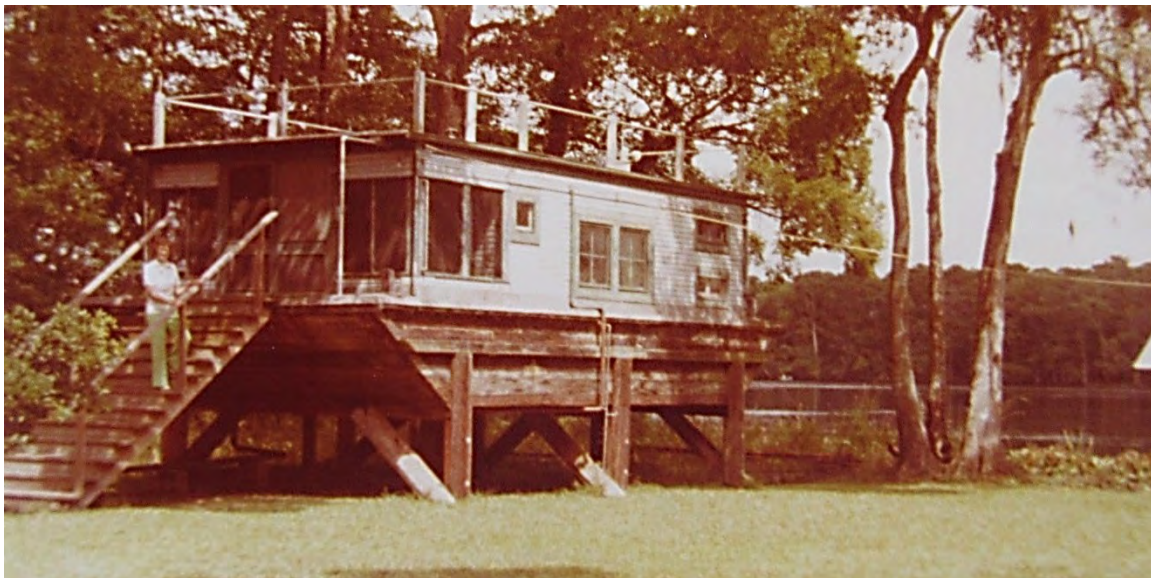
Circa 1980 photo of the Houseboat. (Photo courtesy Bob McKinstry)

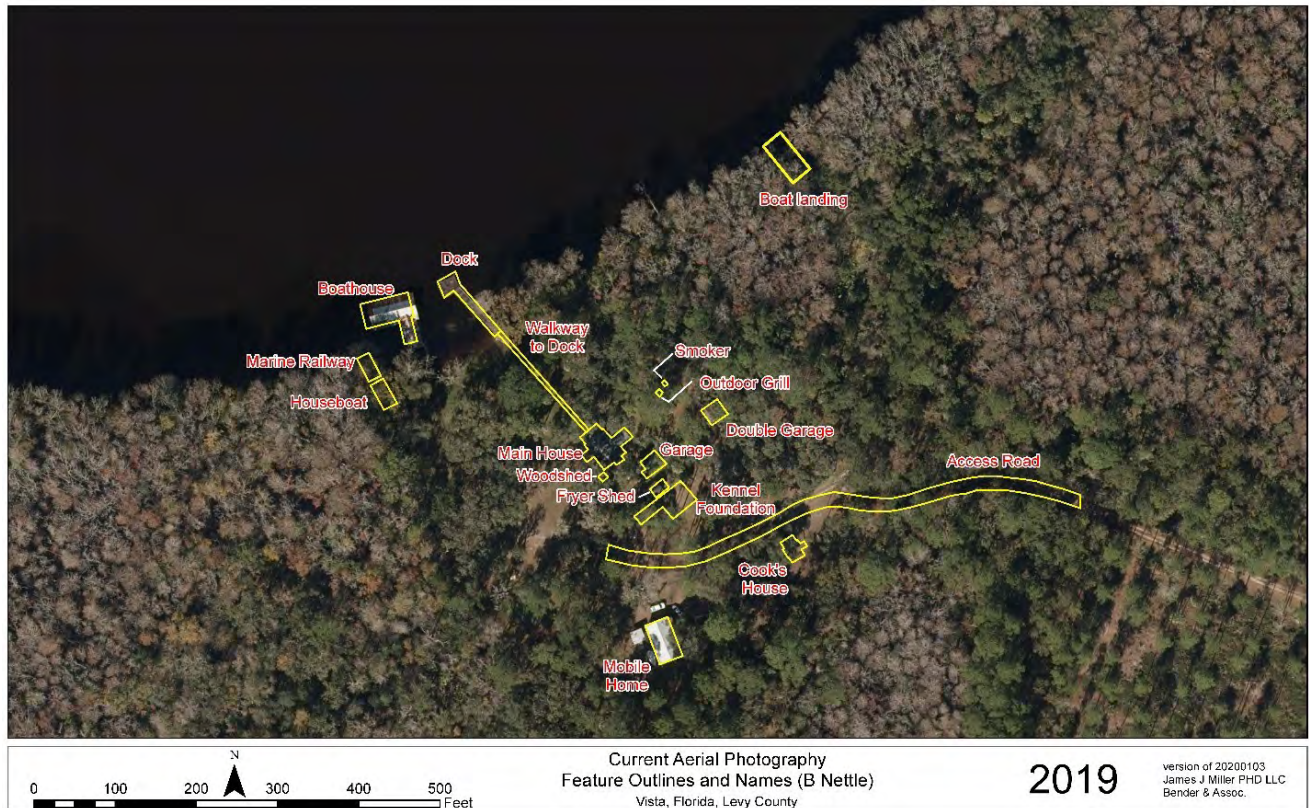
**PROJECT:** Vista Sites  
**ELEMENT:** Main House  
**ITEM:** General Description  
**EVALUATION:** Historic, Good Condition

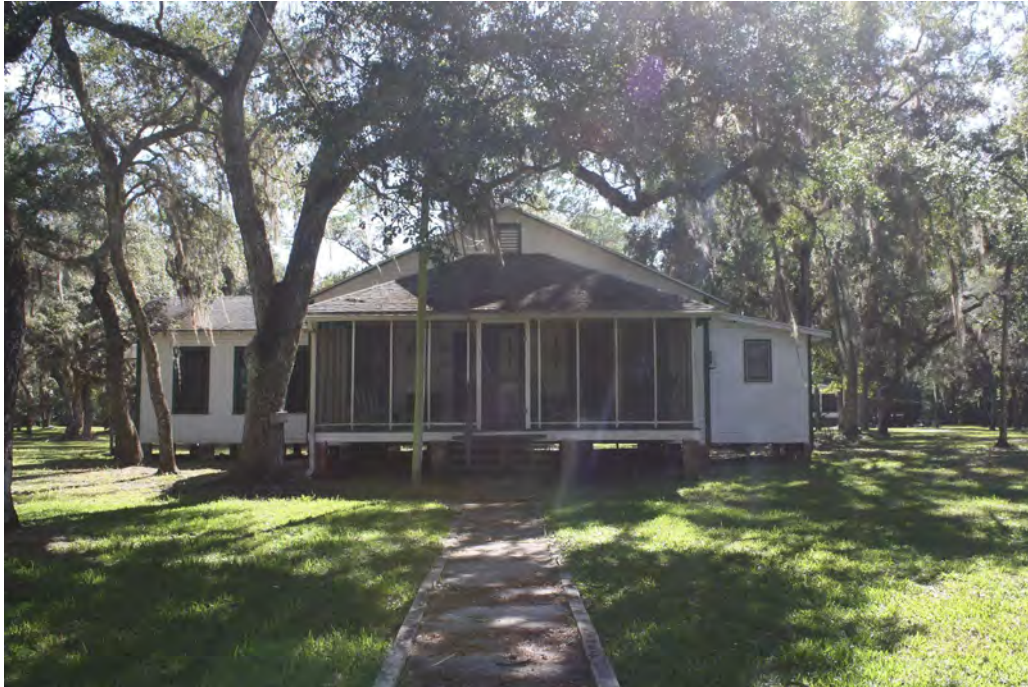
North elevation of the Main House in November 2019

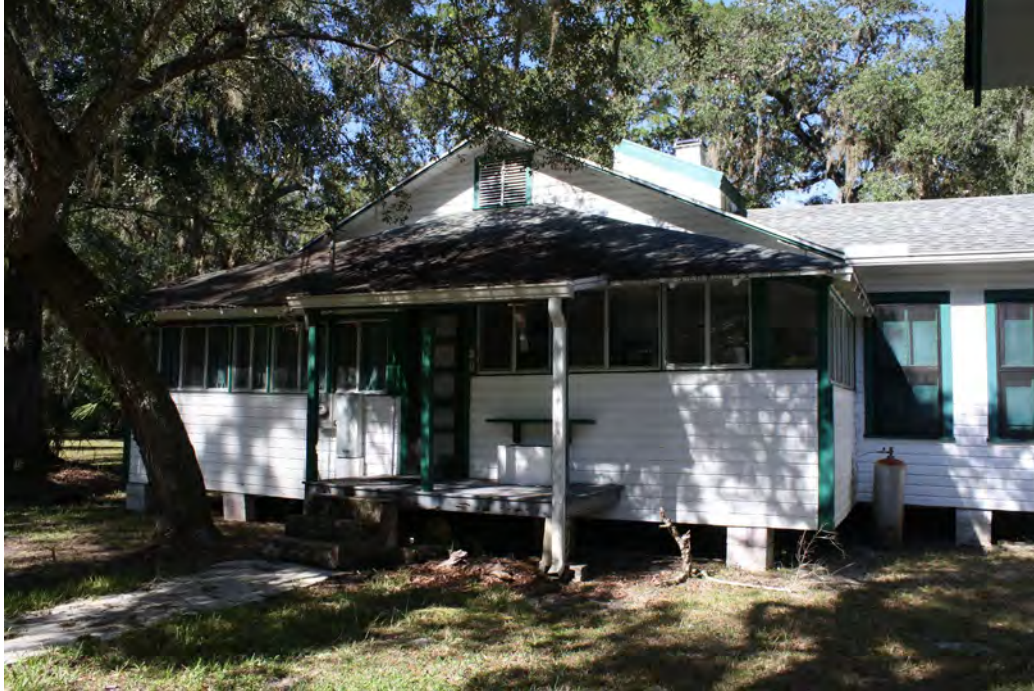
South elevation of the Main House. This elevation shows later additions, including the south porch, it's enclosure with glass windows, extension to the east, and dining room addition.

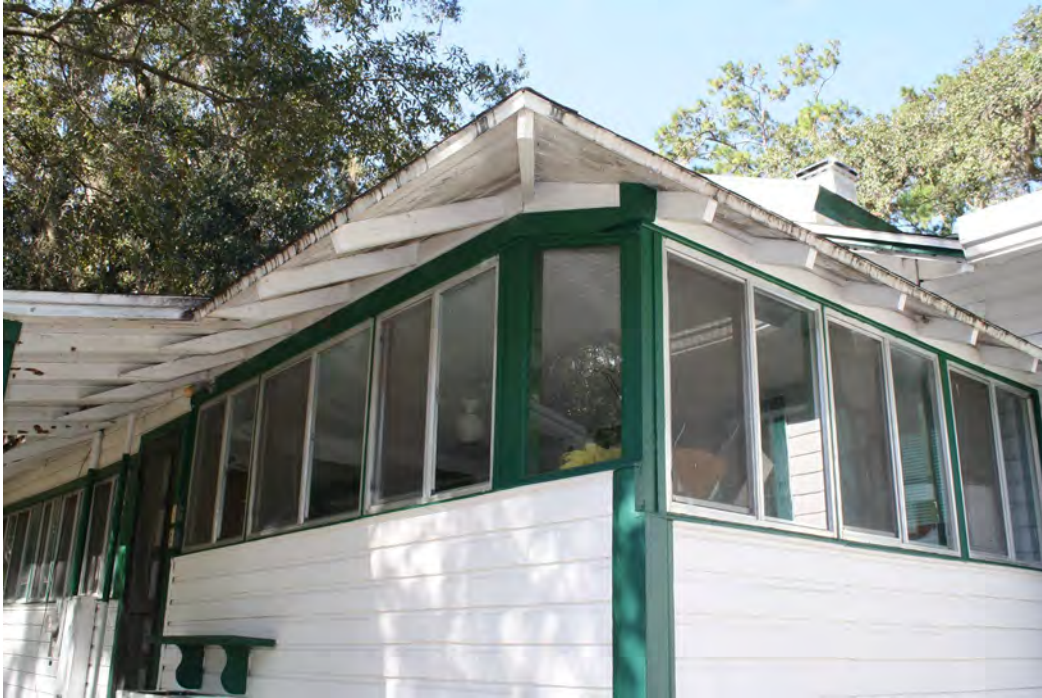
Detail of the south porch addition showing the east side extension.

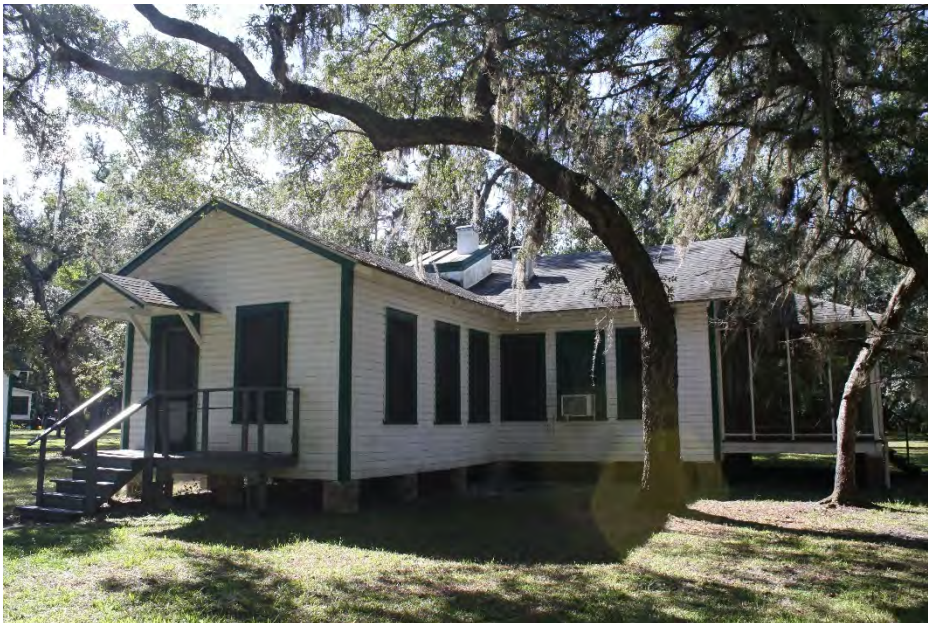
**PROJECT:** Vista Sites  
**ELEMENT:** Main House  
**ITEM:** Exterior Openings / Doors & Windows  
**EVALUATION:** Historic, Good Condition.

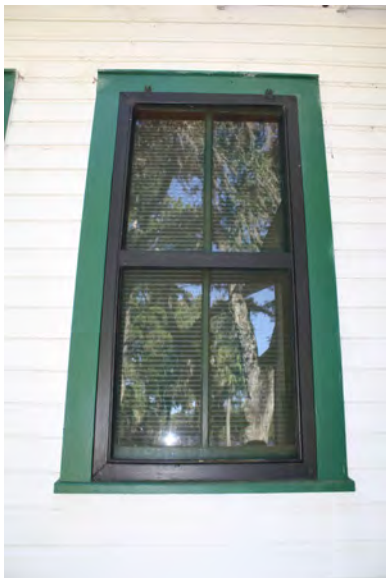
This window is on the Main House and is in good condition as are other elements on the Main House due to ongoing maintenance.

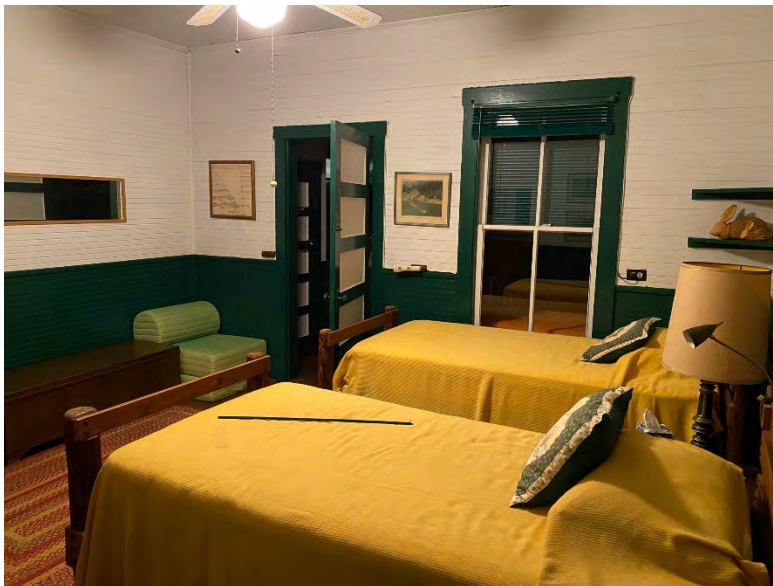
The northeast corner of the room includes an original five-panel wood door that offers a pass-through to the Living Room. There is a small wooden door above the closet door with flat board trim. It is presumably used for storage. The northwest corner of the room includes a small niche which accesses a bathroom. That room was probably constructed after the Master Bedroom Bath.

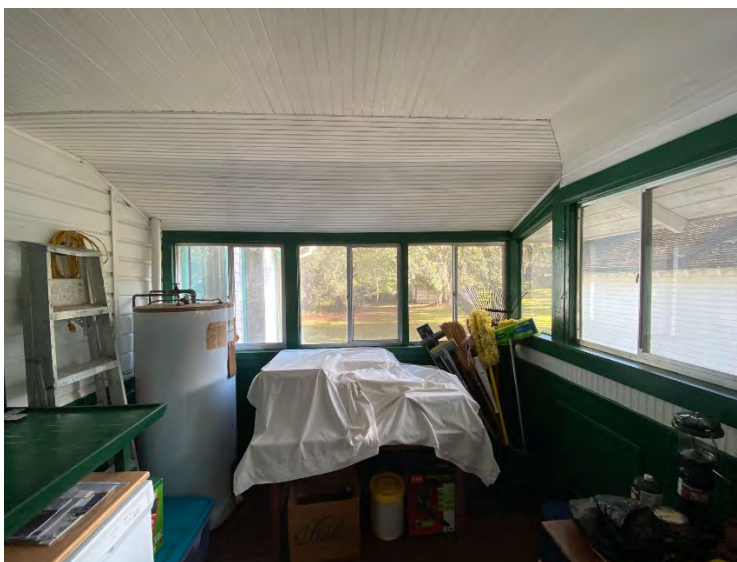
### **RECOMMENDATIONS:**

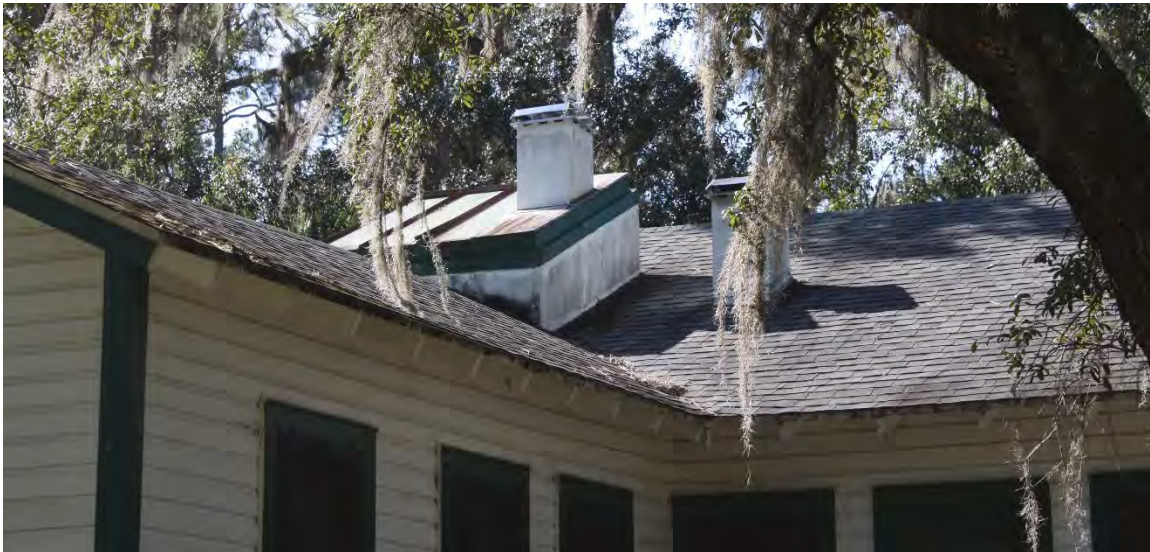
**RECOMMENDATIONS:**

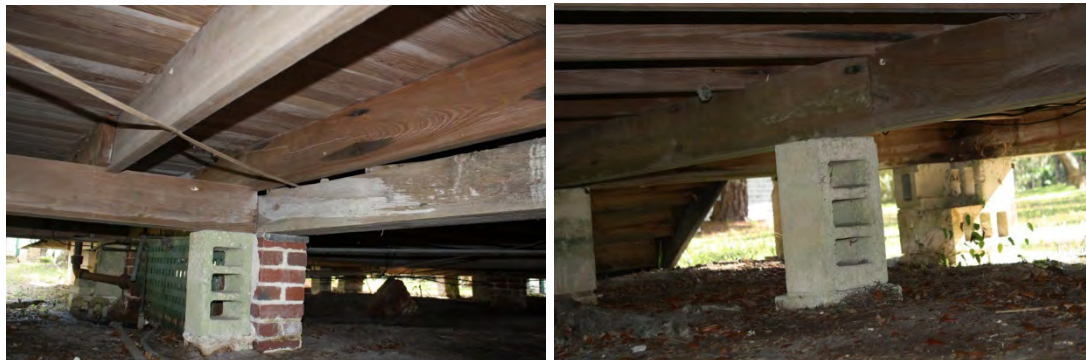
**RECOMMENDATIONS:**

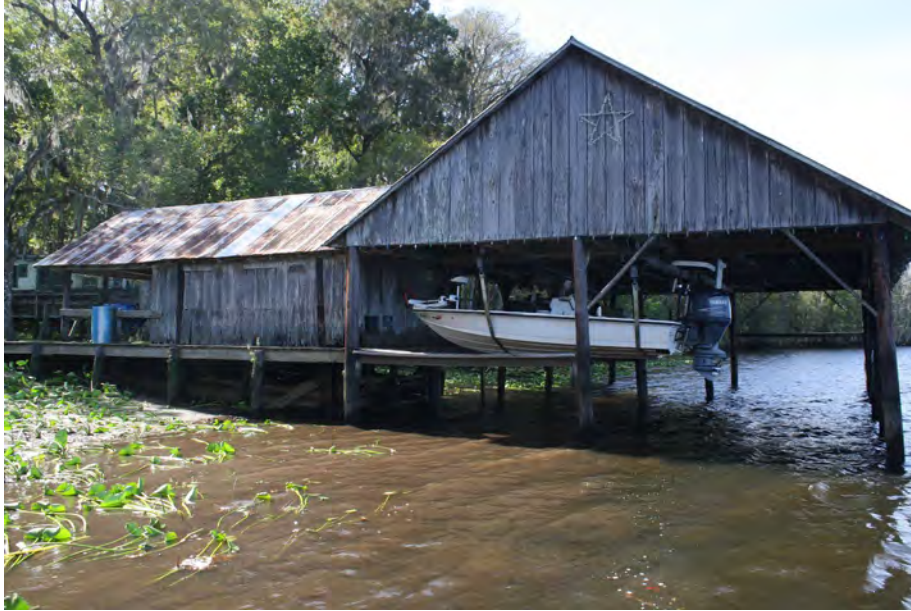
The Boathouse and shed components.

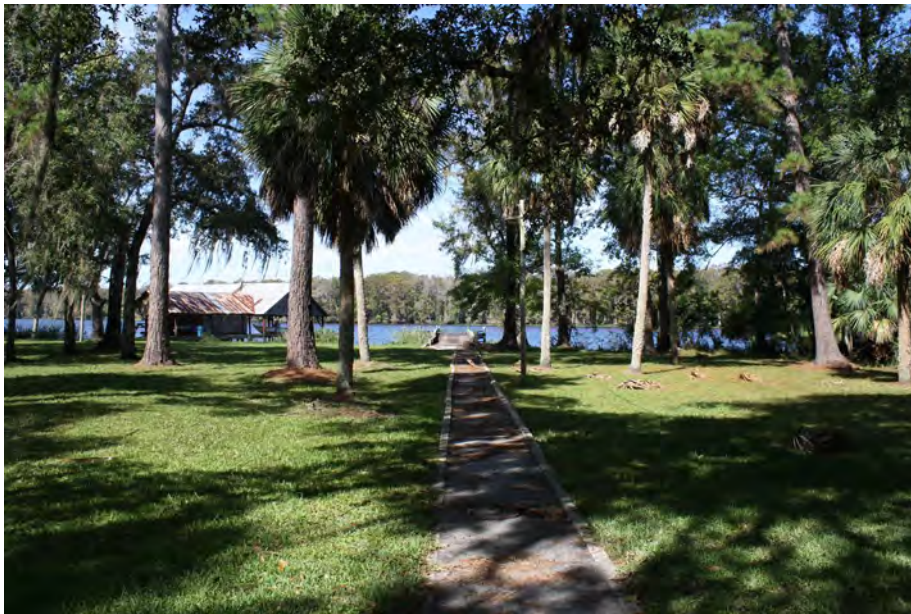
View of the Boathouse and dock areas from the Main House.

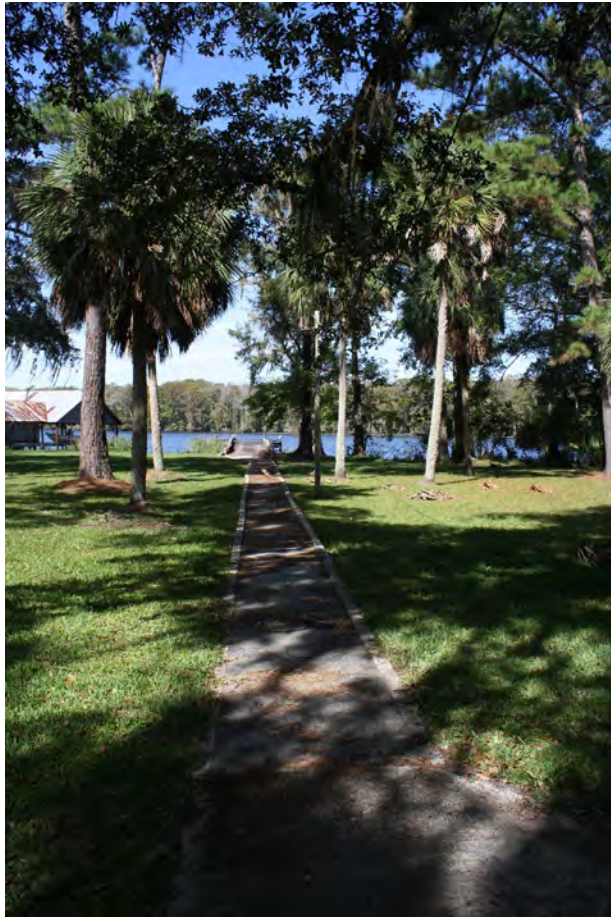
Concrete walk to the Dock area.

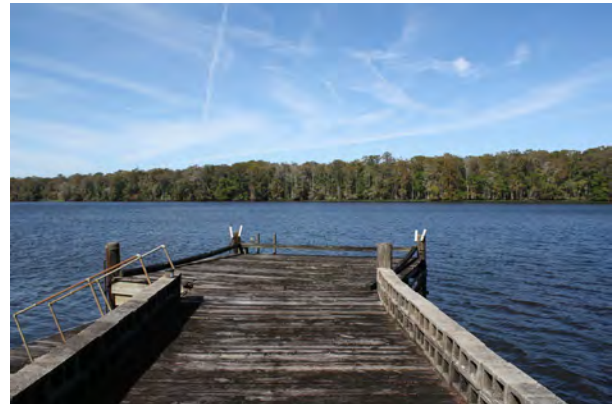
Upper and Lower Docks.

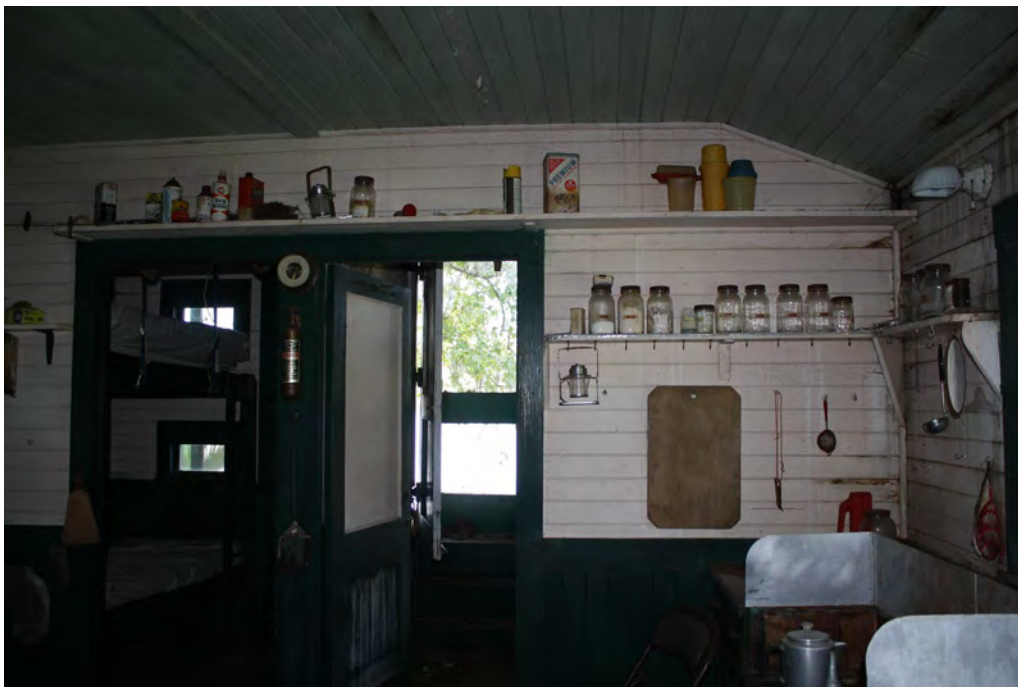
Looking toward the stern.

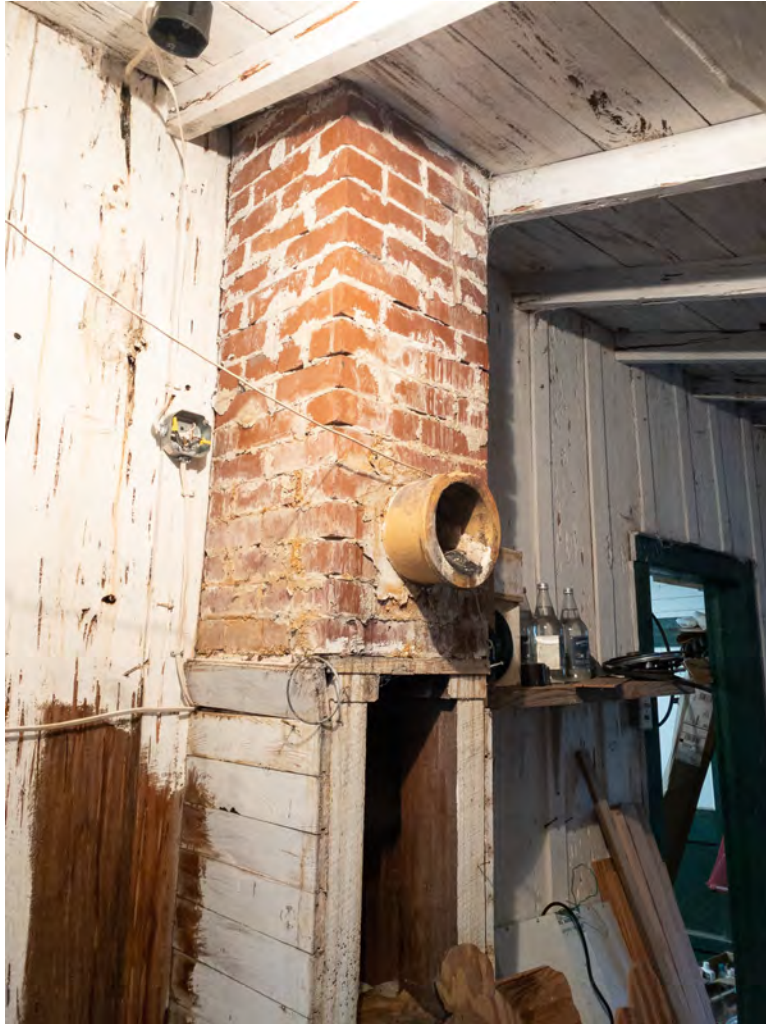
This is the chimney in the south side addition with opening for the stove and wood base.

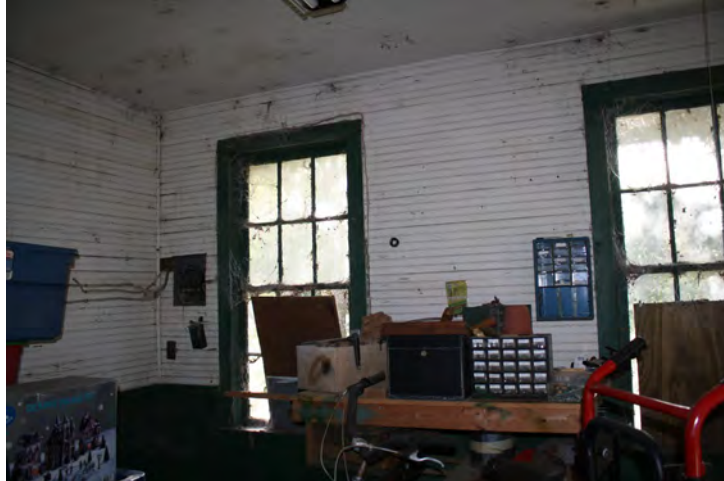
Northwest room of the Cook's House looking west.

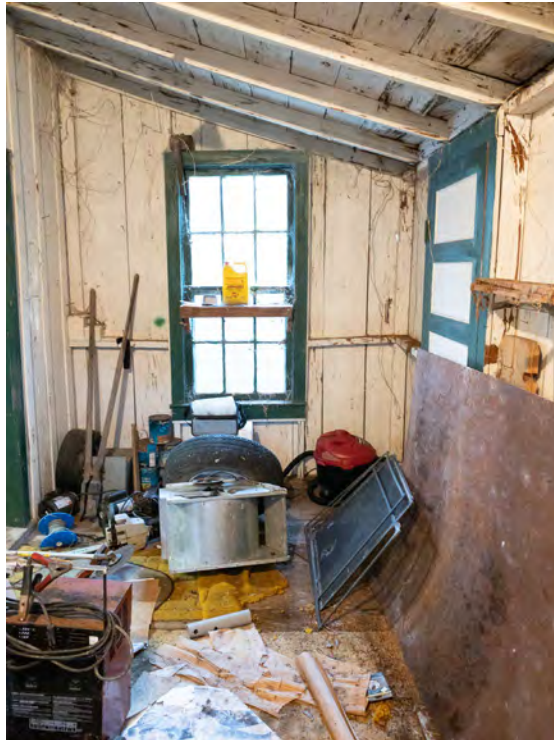
## **RECOMMENDATIONS:**

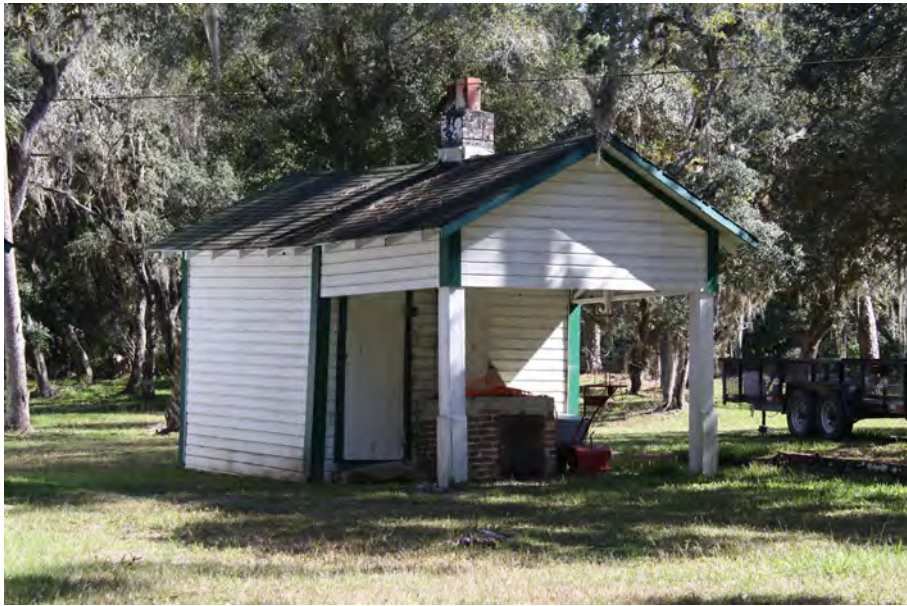
Fryer Shed from the west side.

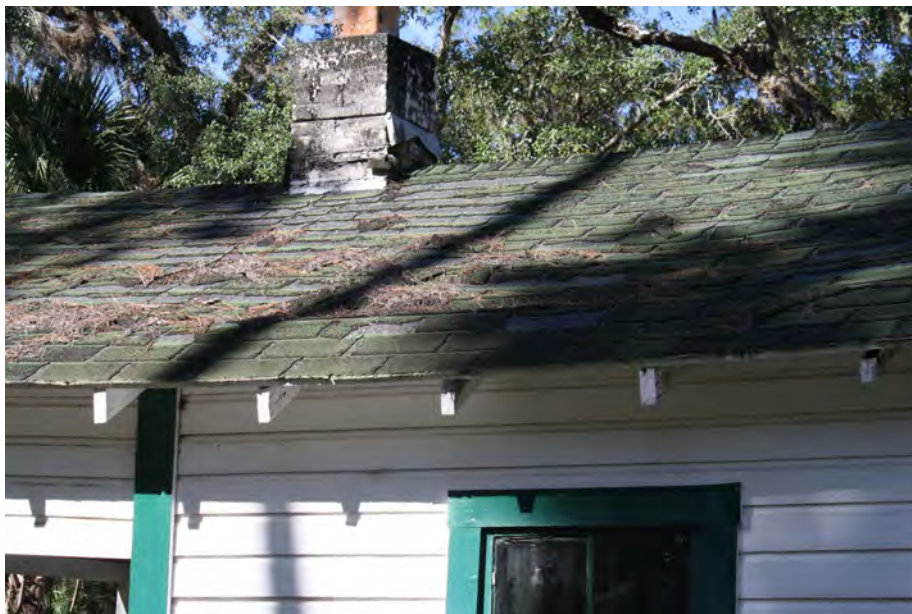
Fryer Shed chimney. Deteriorated and needs restoration.

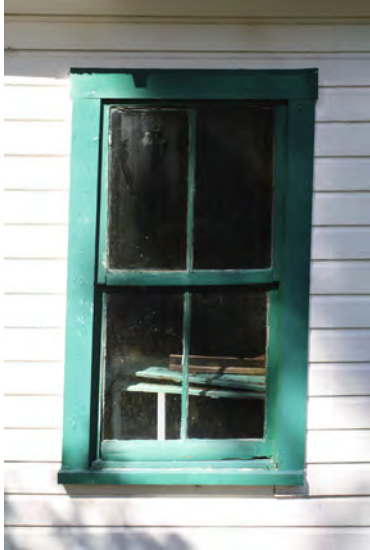
Fryer Shed window with deterioration.

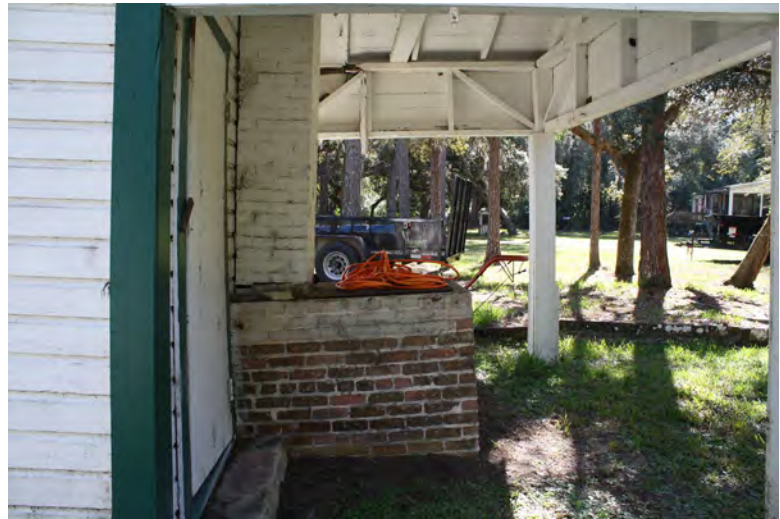
Fryer Shed base has dropped at the building.

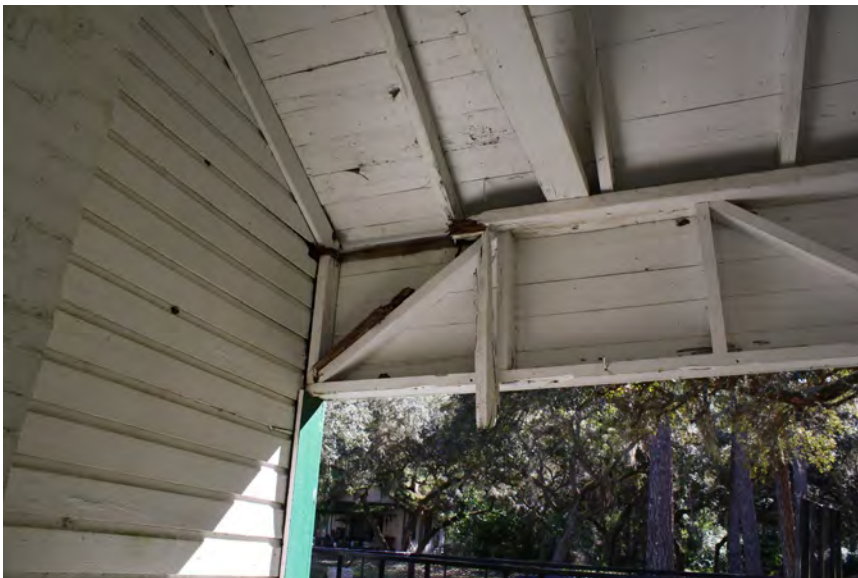
Fryer Shed plate deterioration.

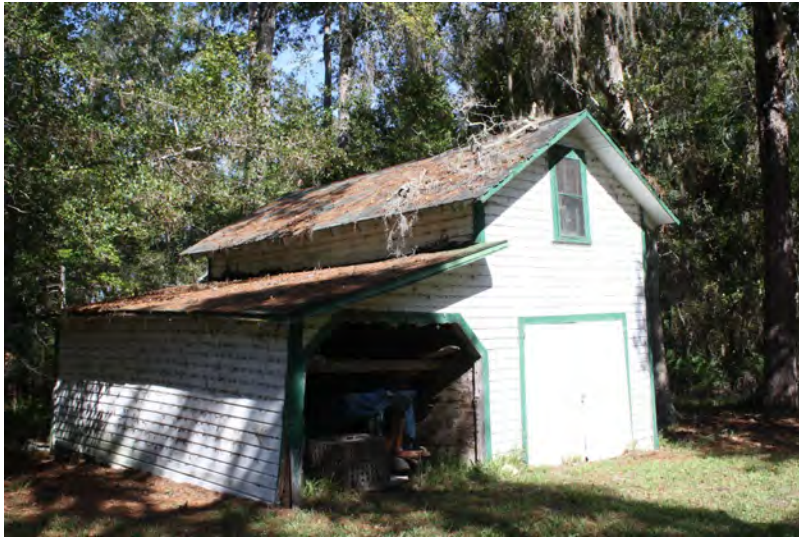
Front of Attic Garage.

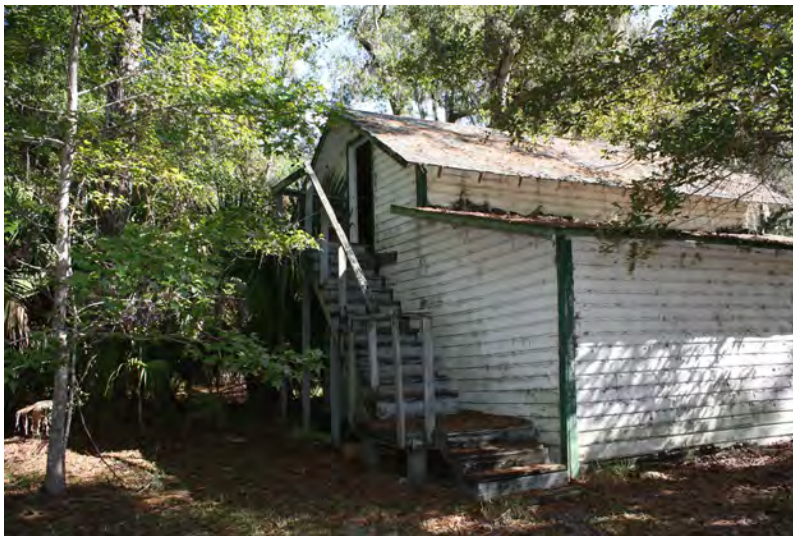
Rear of Attic Garage.
