# **HISTORIC STRUCTURE ASSESSMENT REPORT**

## **VISTA HISTORIC SITE Lower Suwannee National Wildlife Refuge**

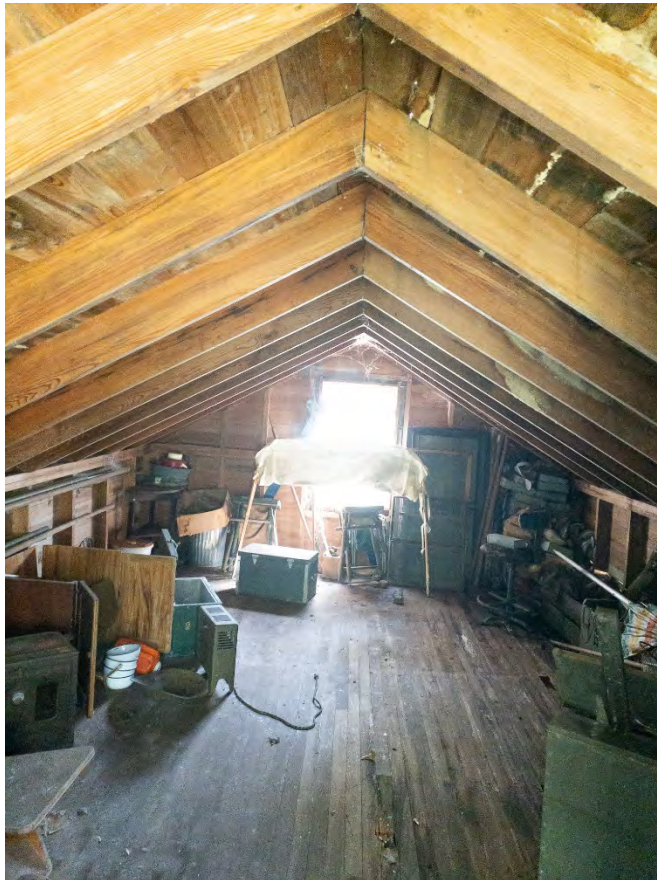
Attic of Attic Garage.

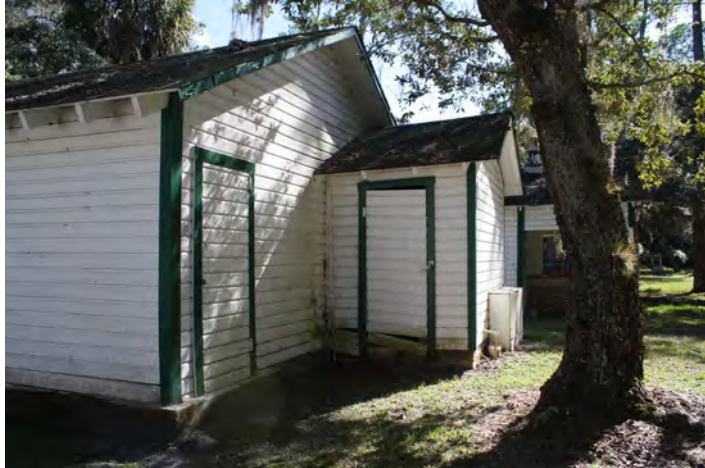
Rear of the Double Garage with deterioration on the rear addition.

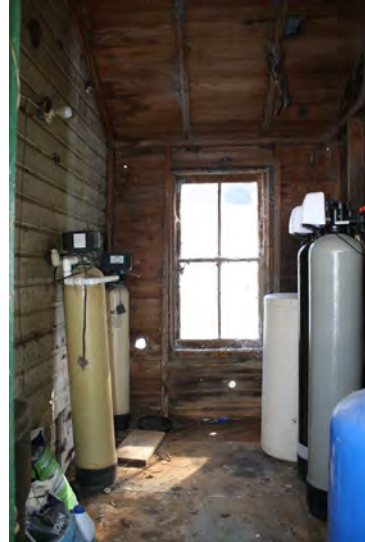
Rear storage room at Double Garage.

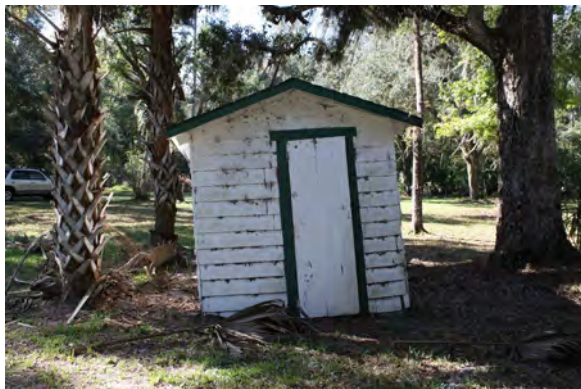
The north façade includes a hinged access panel constructed of shingle slats. Several shingles have fallen from the building toward the base of this façade. There is a large section of termite damage that has opened a hole in the rear (west) side of the structure and caused a number of shingles to fall away from the building.

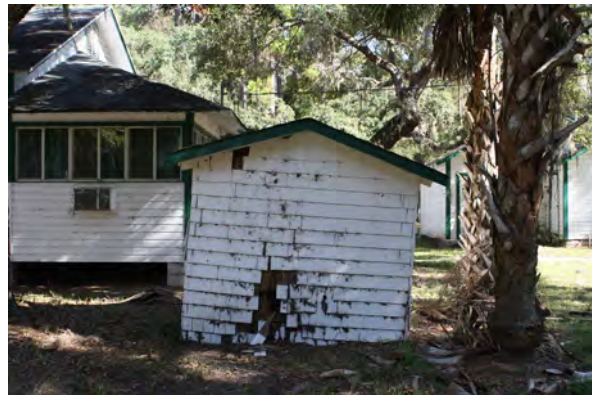
Woodshed for the Main House has lost shingles and is falling into the ground due to no foundation.

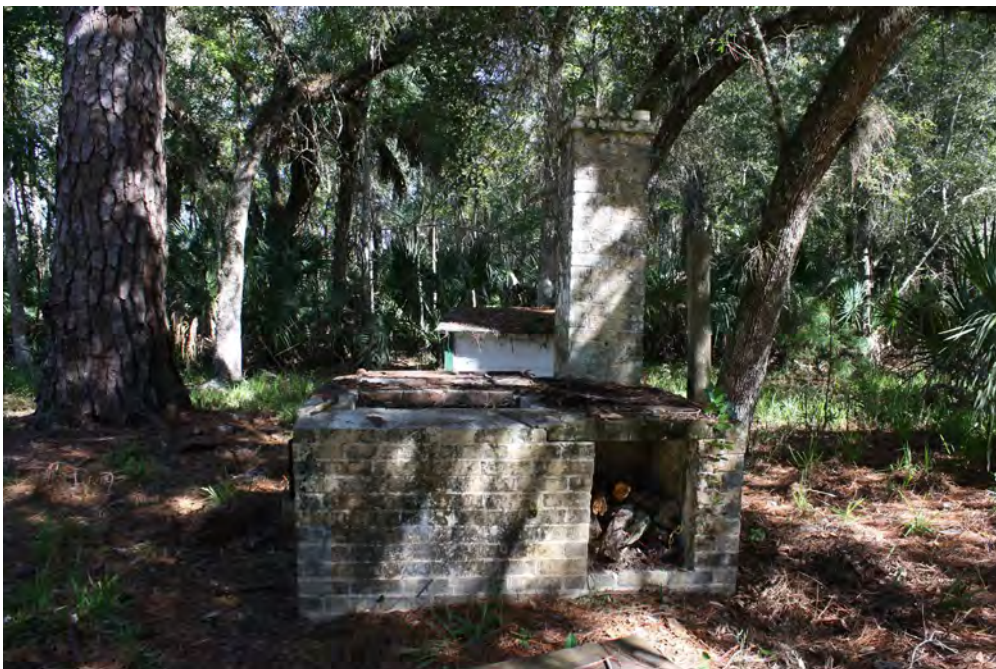
West side elevation of the grill.

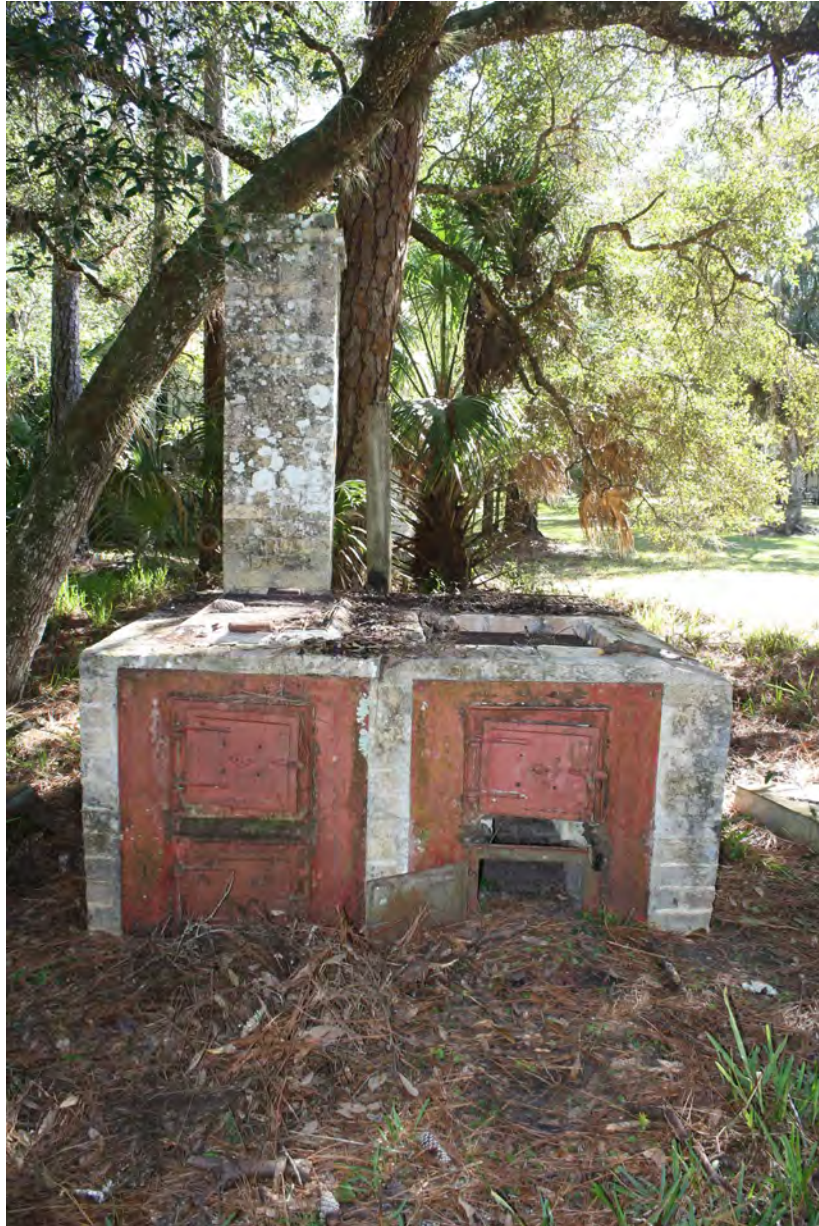
North side elevation of the grill. Note that some components will need restoration, including the concrete top.

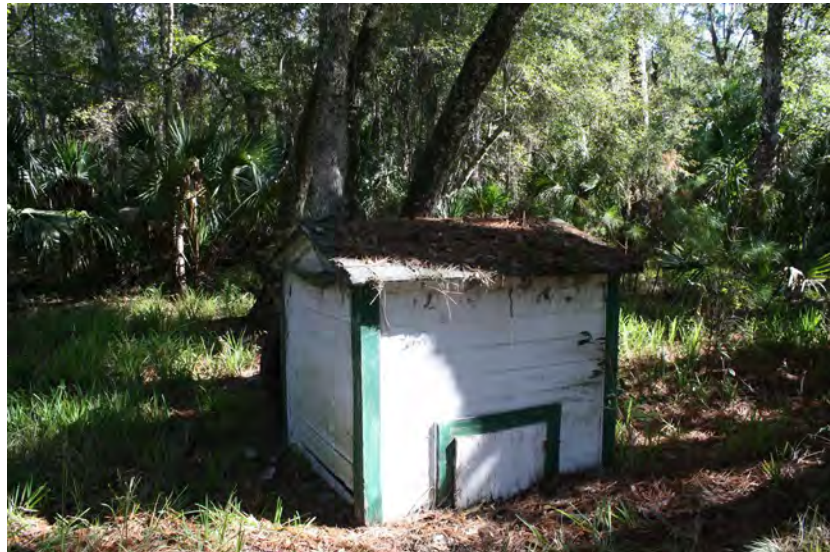
The smoker needs some repairs, most notably at the ground level.

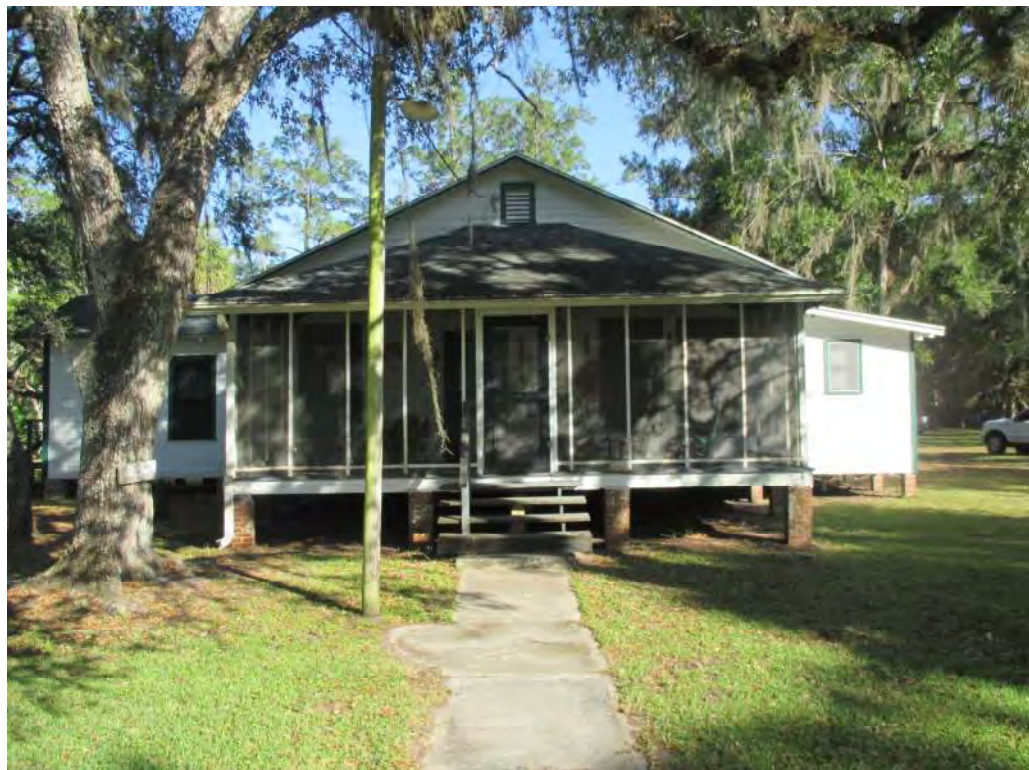
**Photograph 1**  
**Primary Facade of Main House**

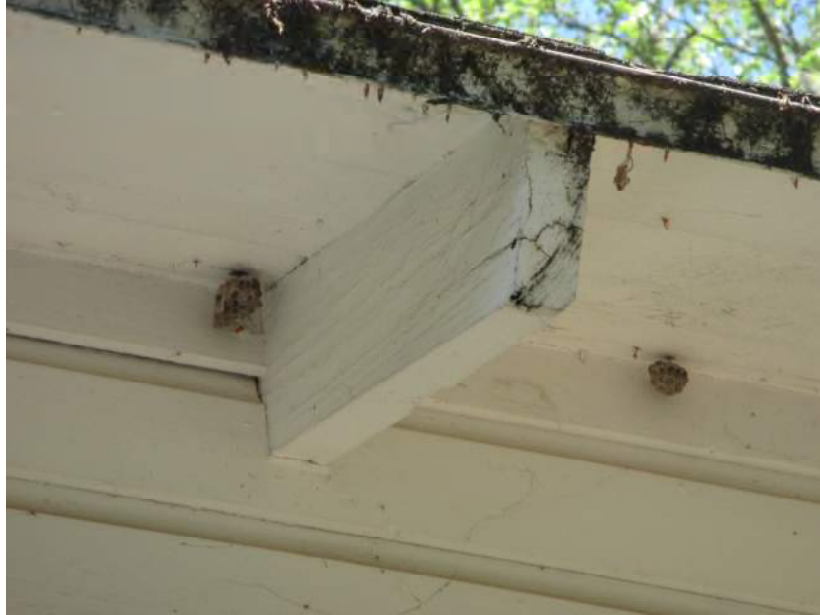
**Photograph 4**  
**Deteriorated Rafter Tail**

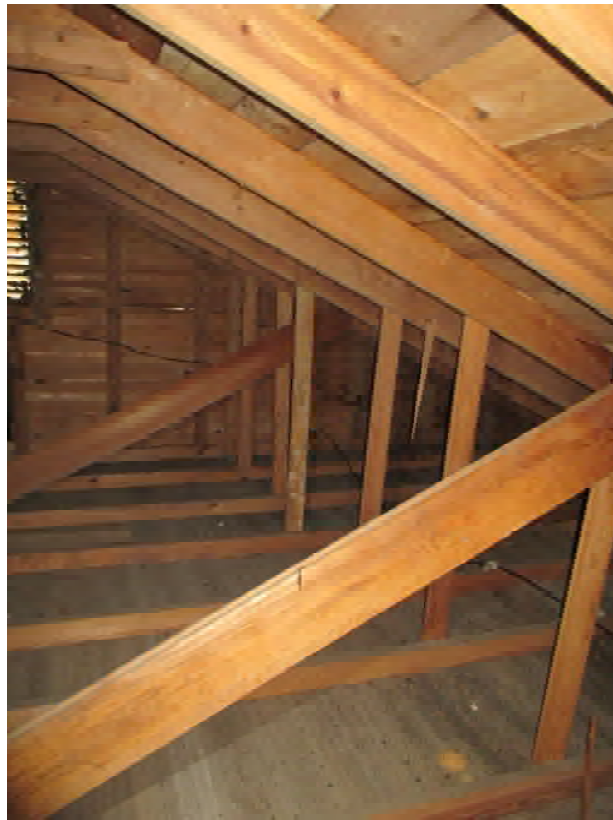
**Photograph 5**  
**Missing Diagonals within Attic**

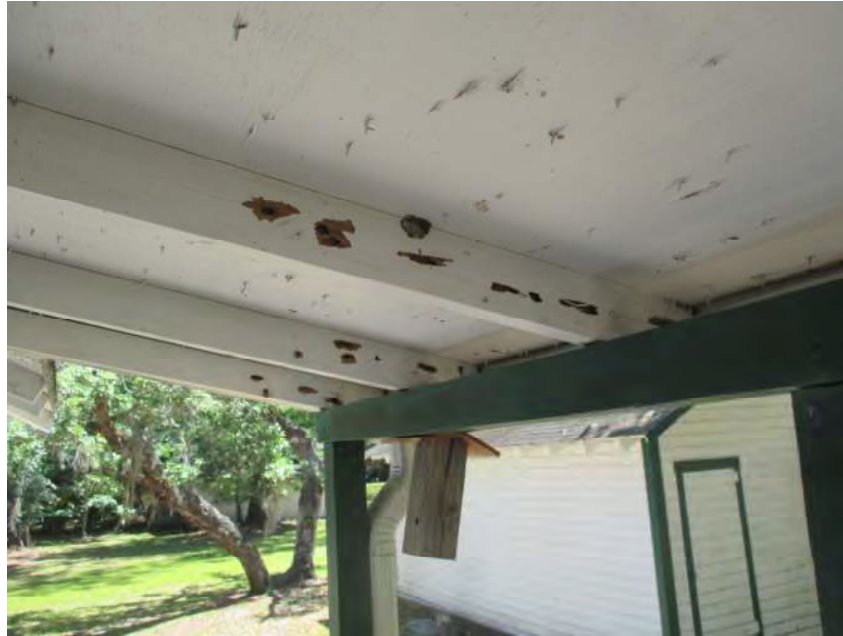
**Photograph 6**  
**Termite Damaged Rafter Tail at Rear Porch**

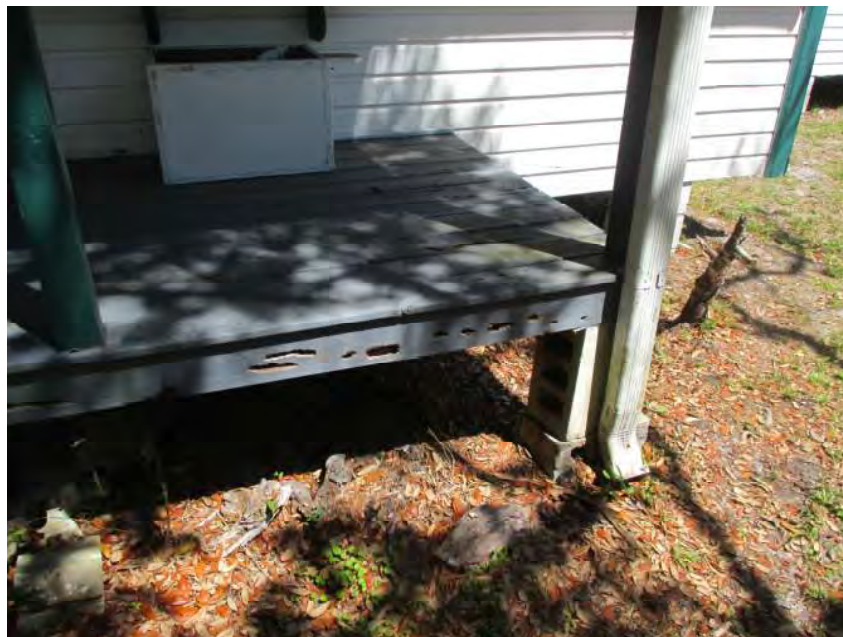
**Photograph 7**  
**Termite Damaged Rear Porch Entry Framing**

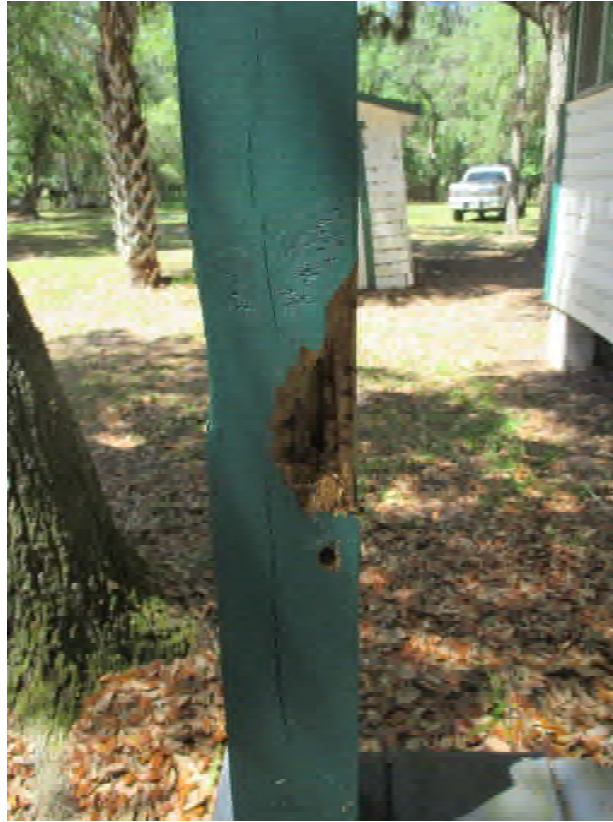
**Photograph 8**  
**Termite Damaged Porch Column**

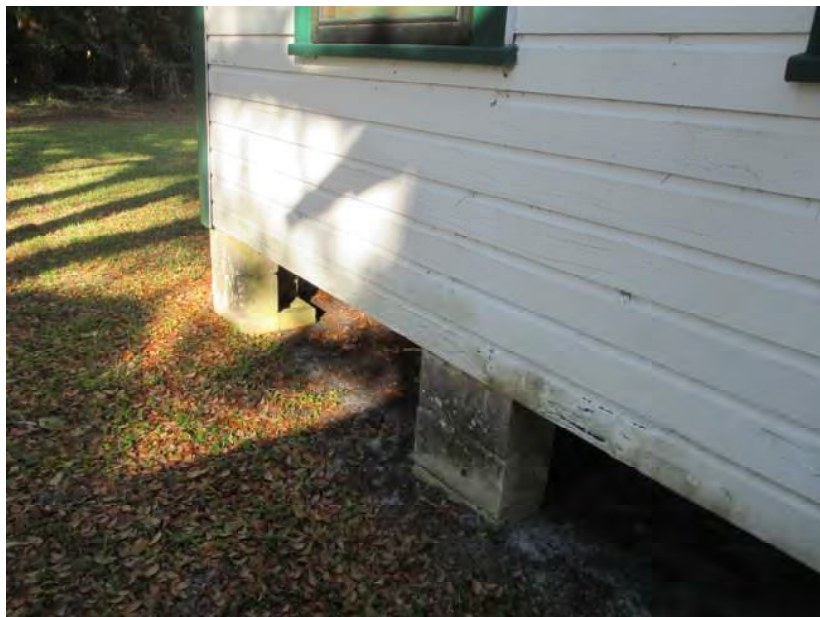
**Photograph 9**  
**Weathered Siding and Trim**

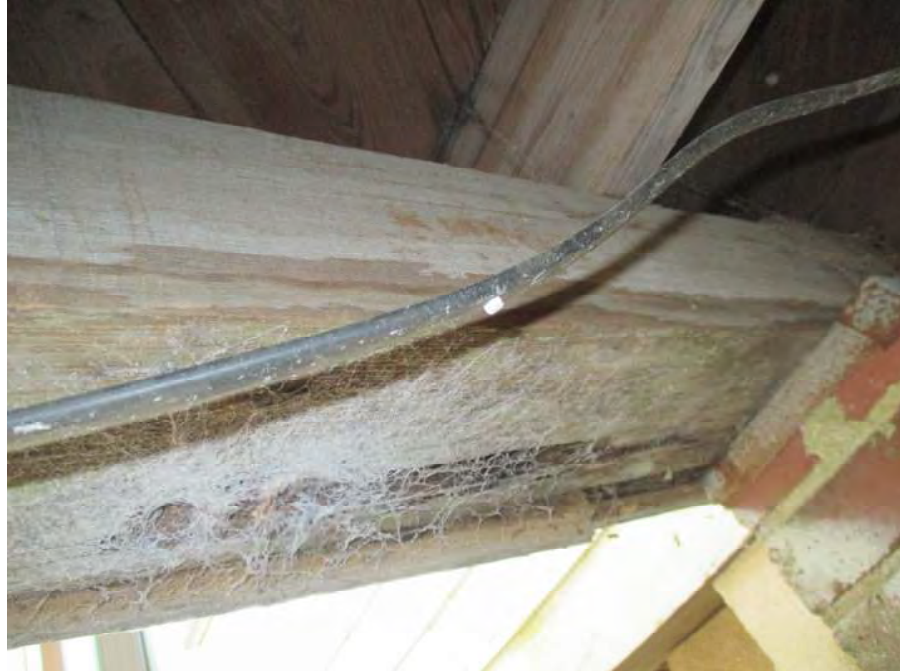
**Photograph 10**  
**Termite Damaged Floor Framing**

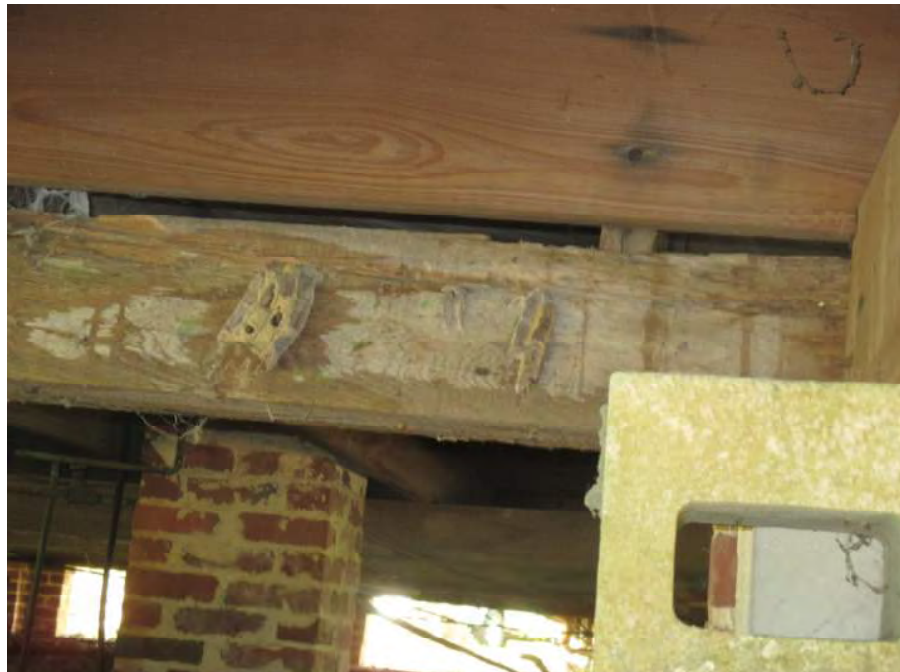
**Photograph 11**  
**Weathered Floor Framing**

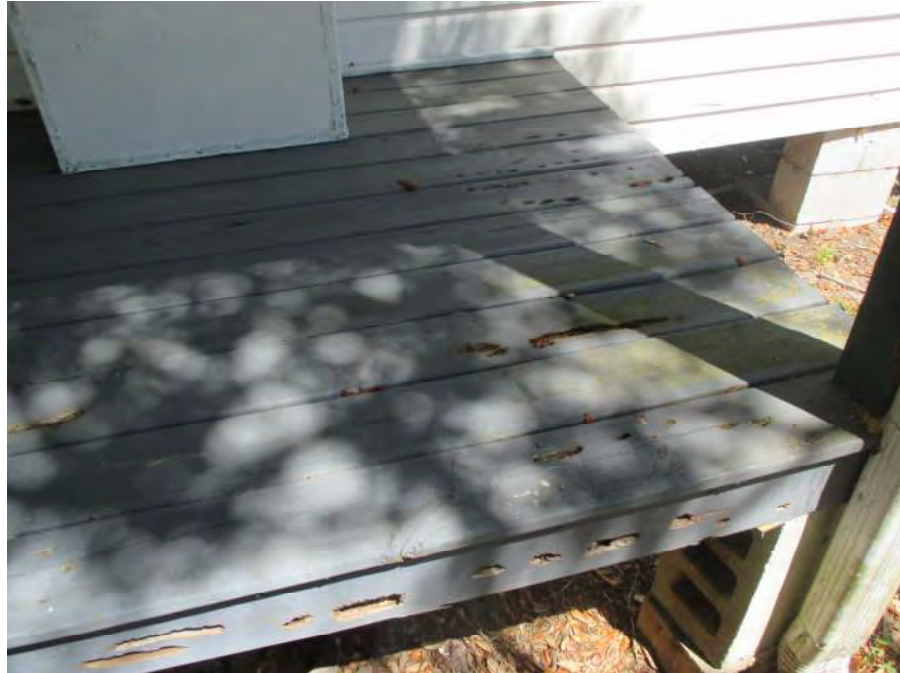
**Photograph 12**  
**Termite Damaged Floor Decking of Rear Porch Entry**

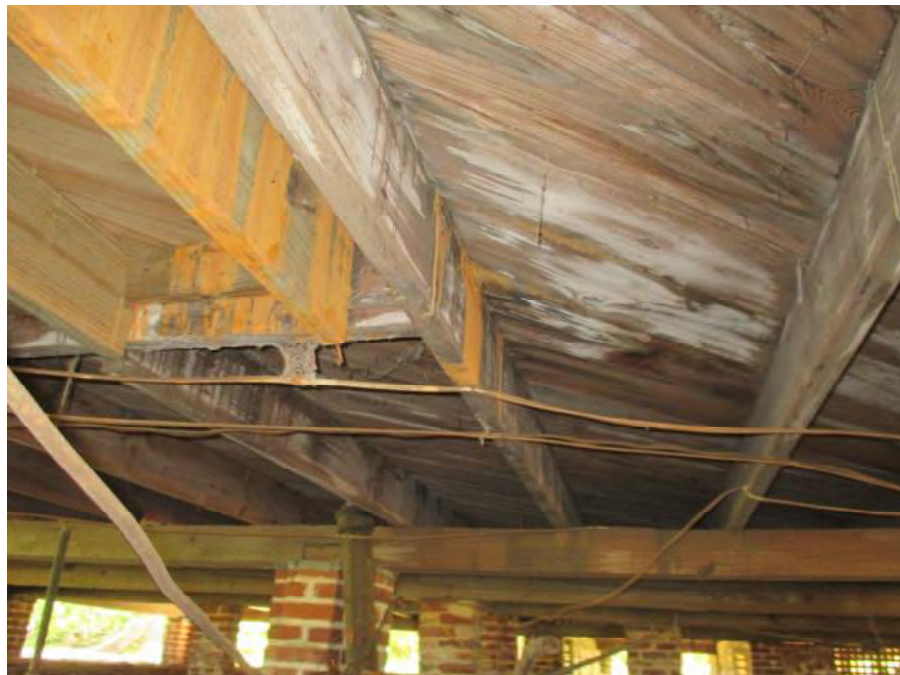
**Photograph 13**  
**Water Damaged Floor Decking**

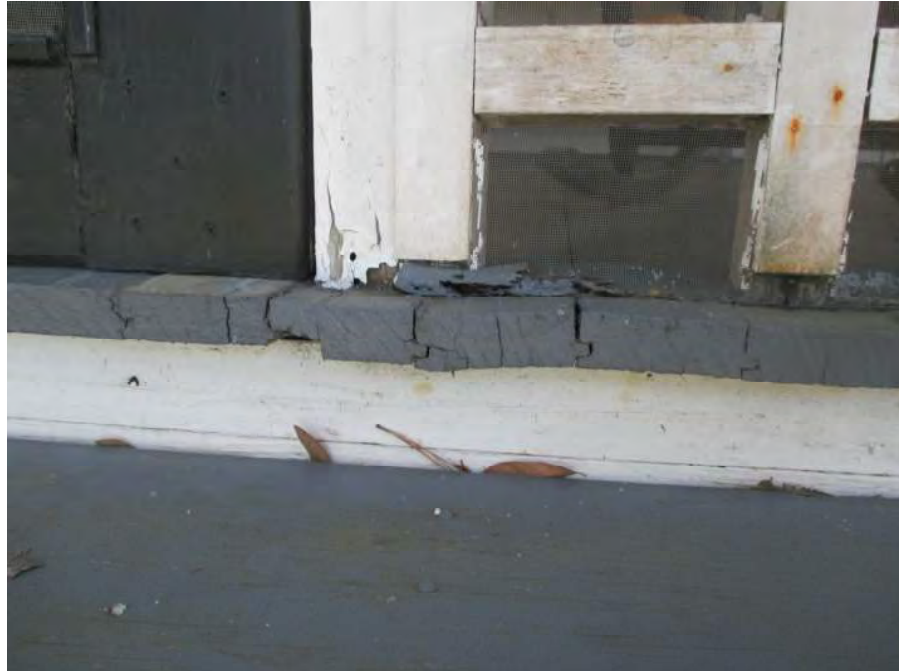
**Photograph 14**  
**Water Damaged Decking at Main Entry Porch**

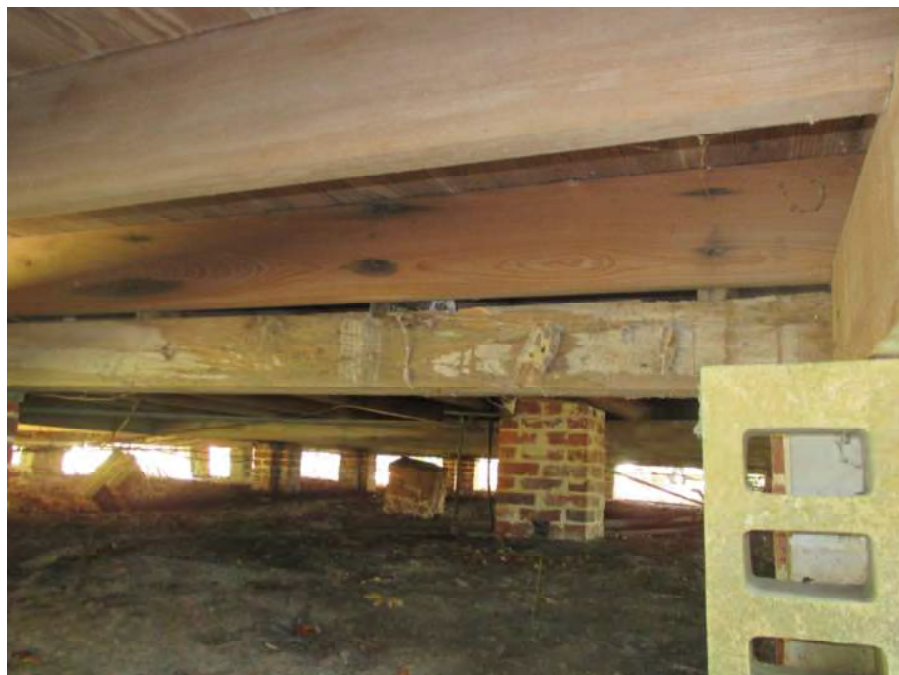
**Photograph 15**  
**Rotated and Settled Foundation Piers**

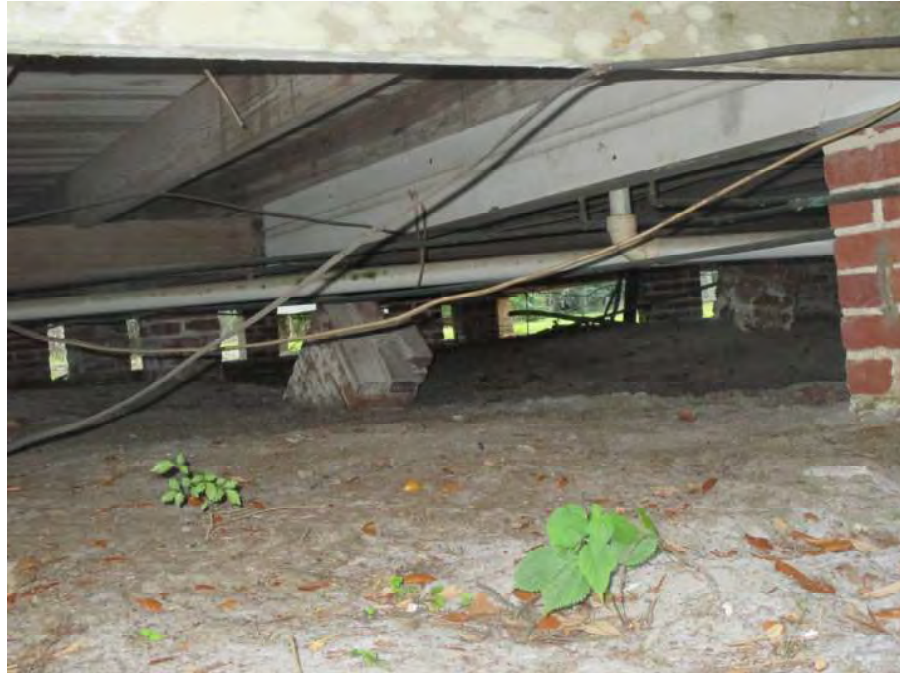
**Photograph 16**  
**Rotated and Settled Foundation Piers**

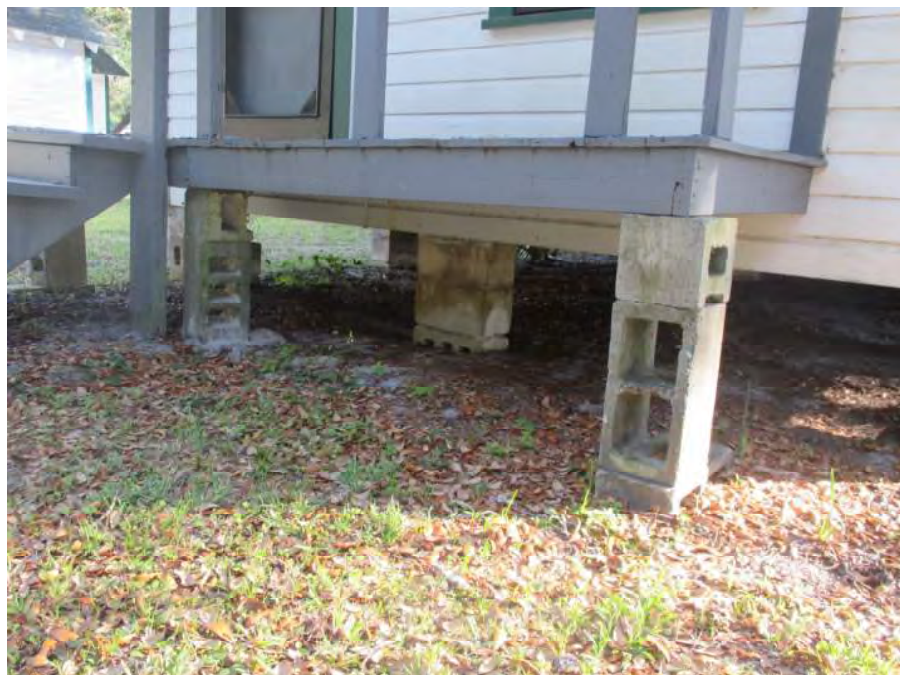
**Photograph 17**  
**Dry-Stacked and Unstable CMU Piers**

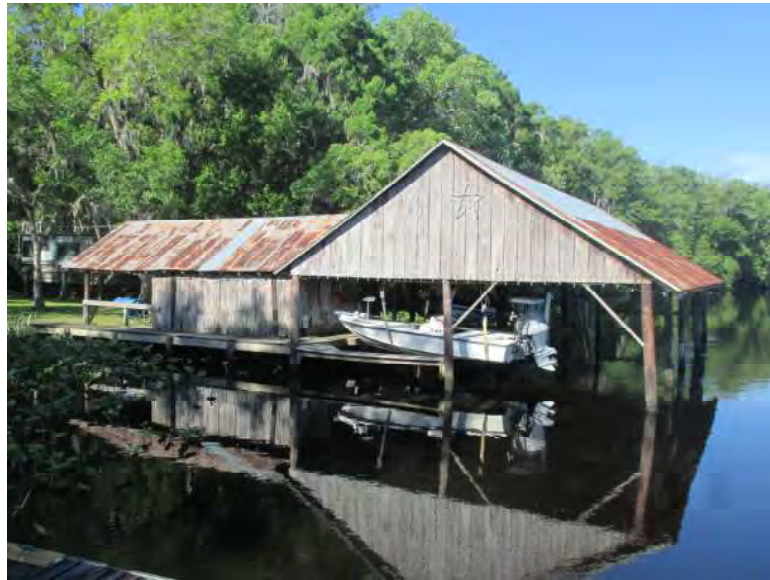
**Photograph 1**  
**East Facade of Boathouse**

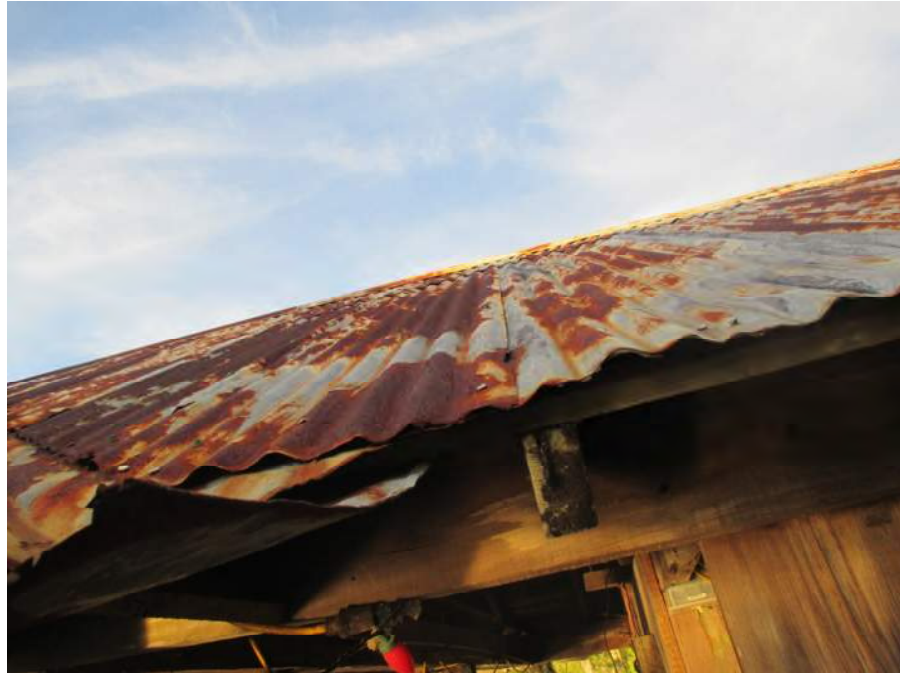
**Photograph 3**  
**Surfacial Rust on Metal V-Crimp Roofing**

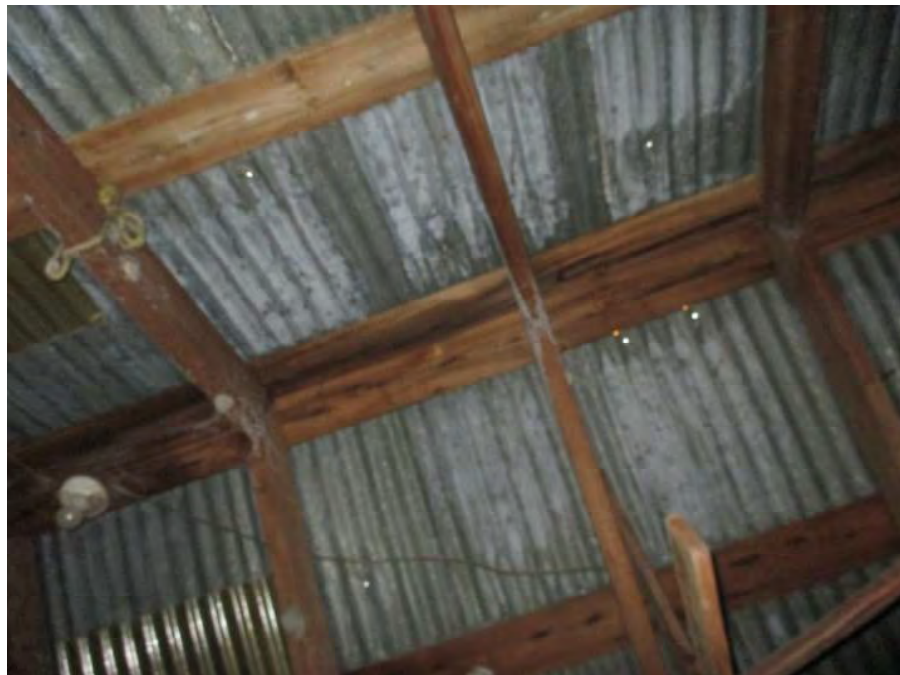
**Photograph 4**  
**Underside of Metal Roofing**

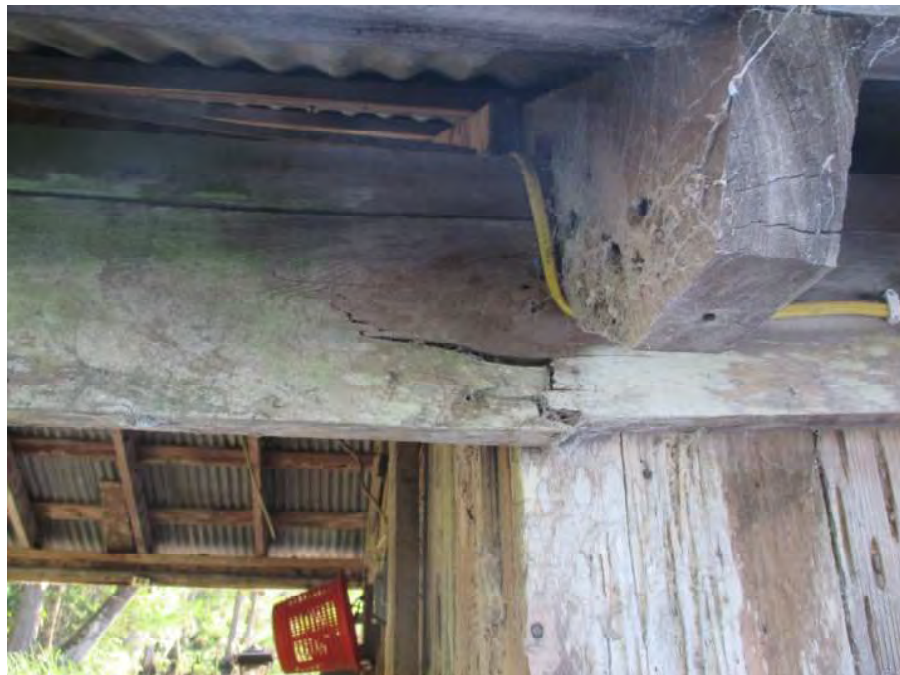
**Photograph 6**  
**Cracked Perimeter Beam**

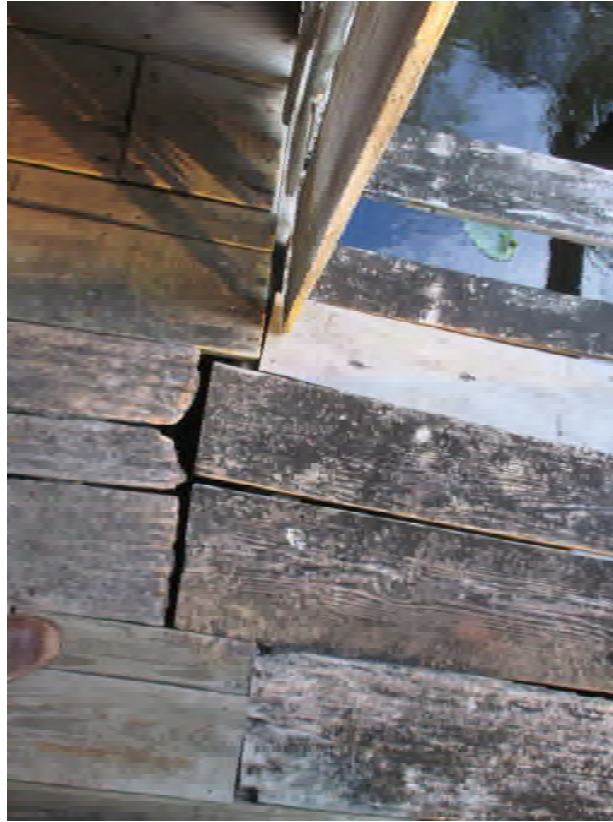
**Photograph 7**  
**Decking Deteriorated and Not Fastened**

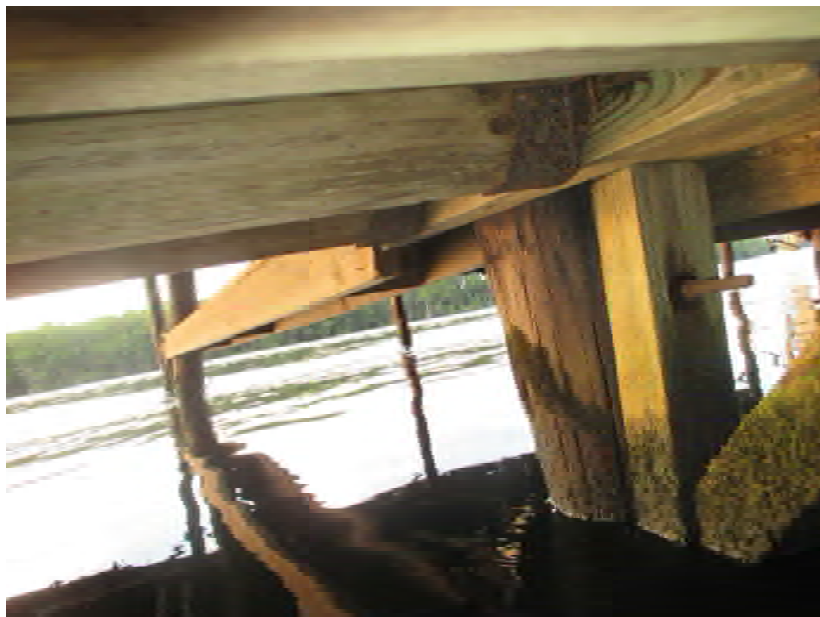
**Photograph 8**  
**Joist Hangers Deteriorated**

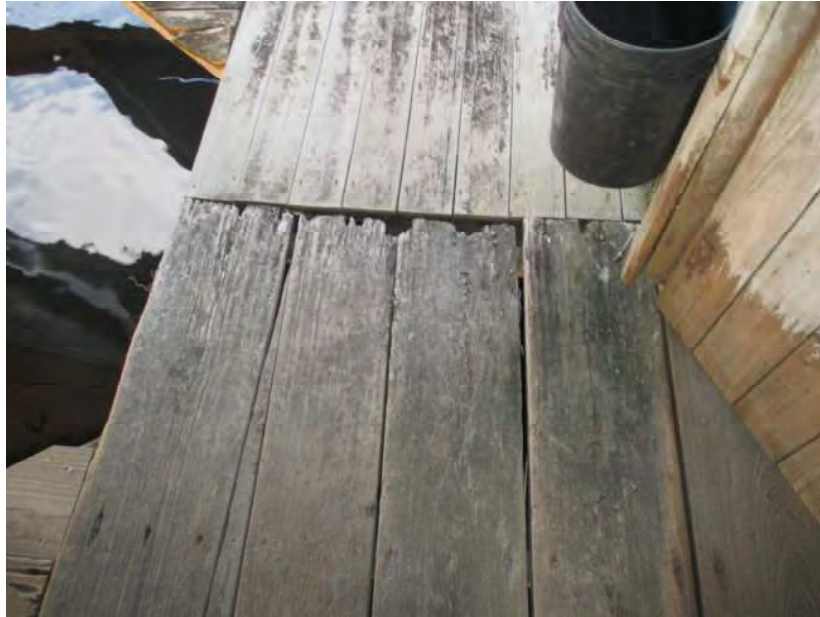
**Photograph 9**  
**Decking Deteriorated and Not Fastened**

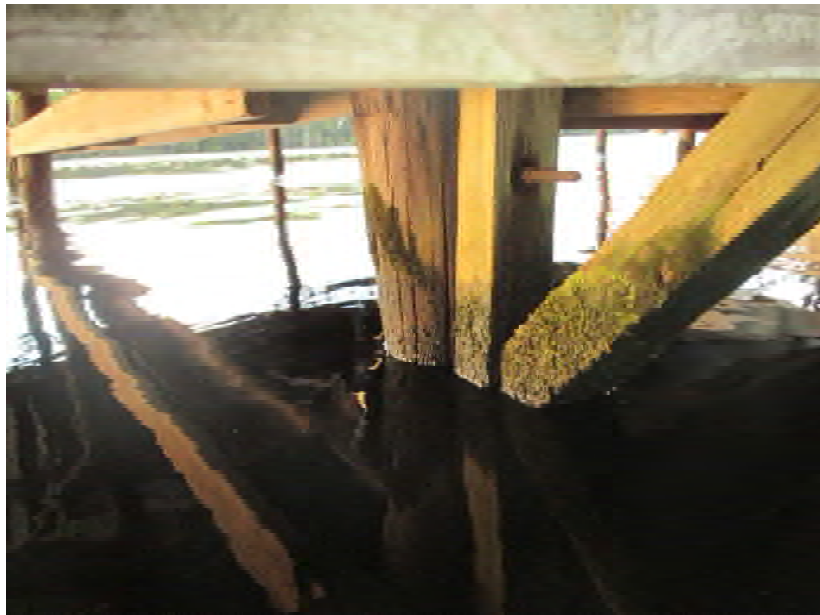
**Photograph 10**  
**Biological Growth at Waterline and Weather Checking**

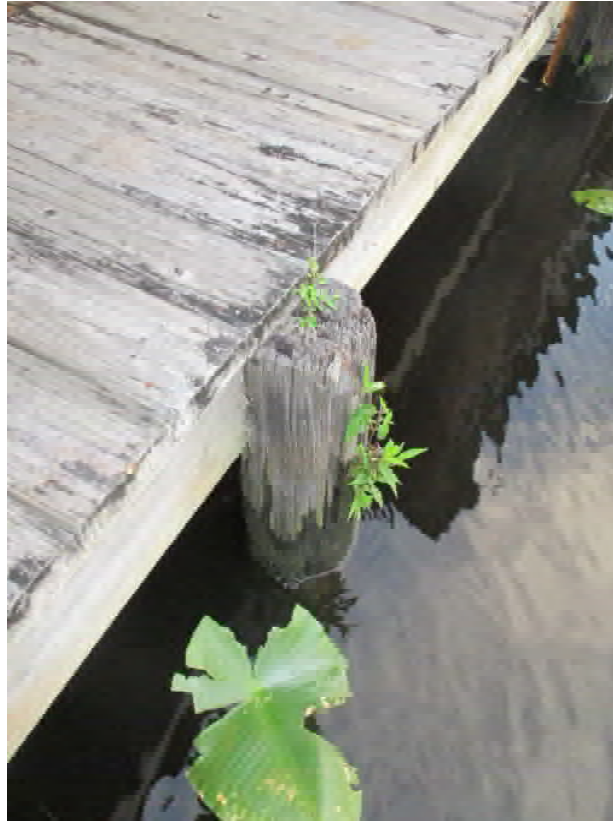
**Photograph 11**  
**Deterioration at Top of Timber Pile**

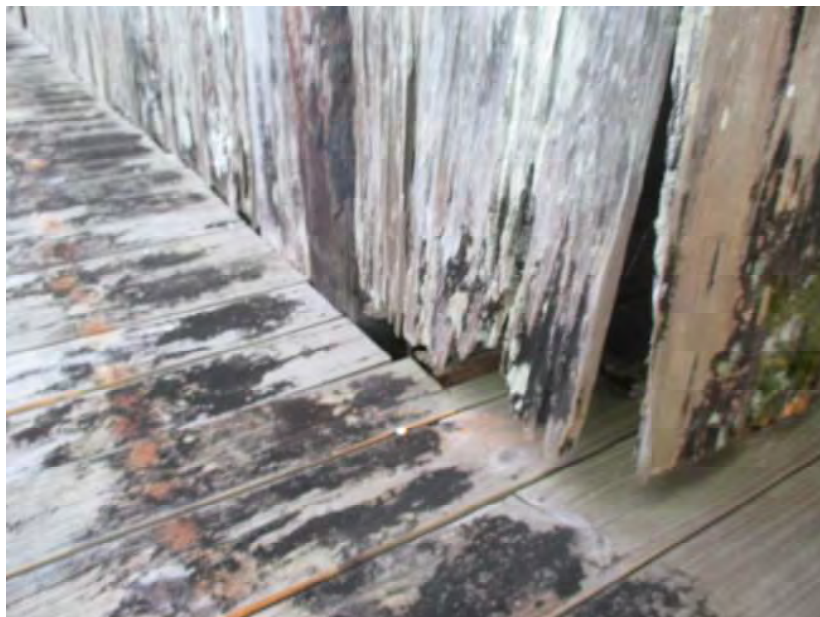
**Photograph 12**  
**Deterioration at Base of Siding**

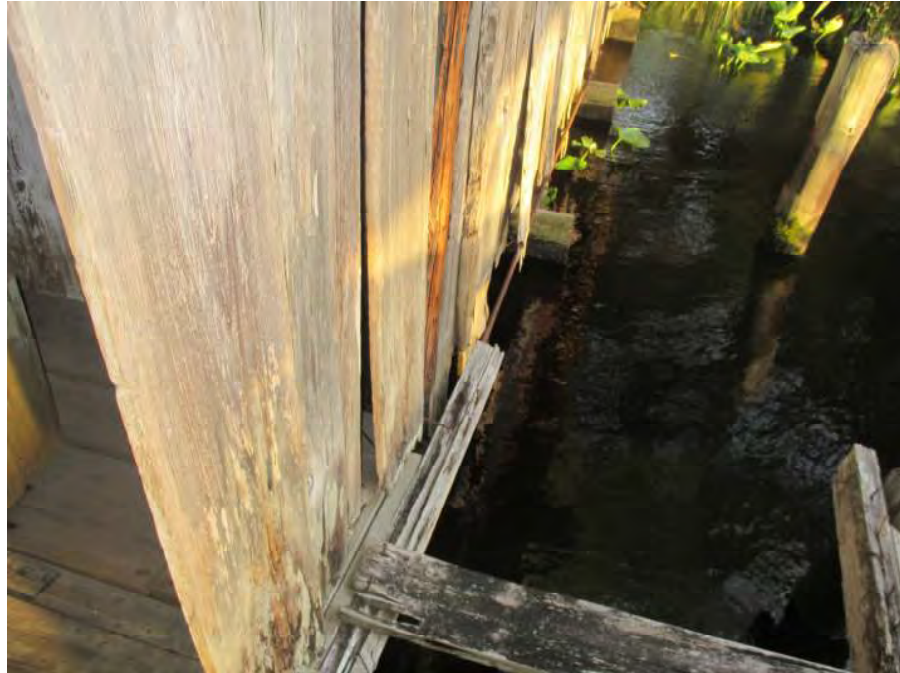
**Photograph 13**  
**Deterioration at Base of Siding and Missing Deteriorated Framing**

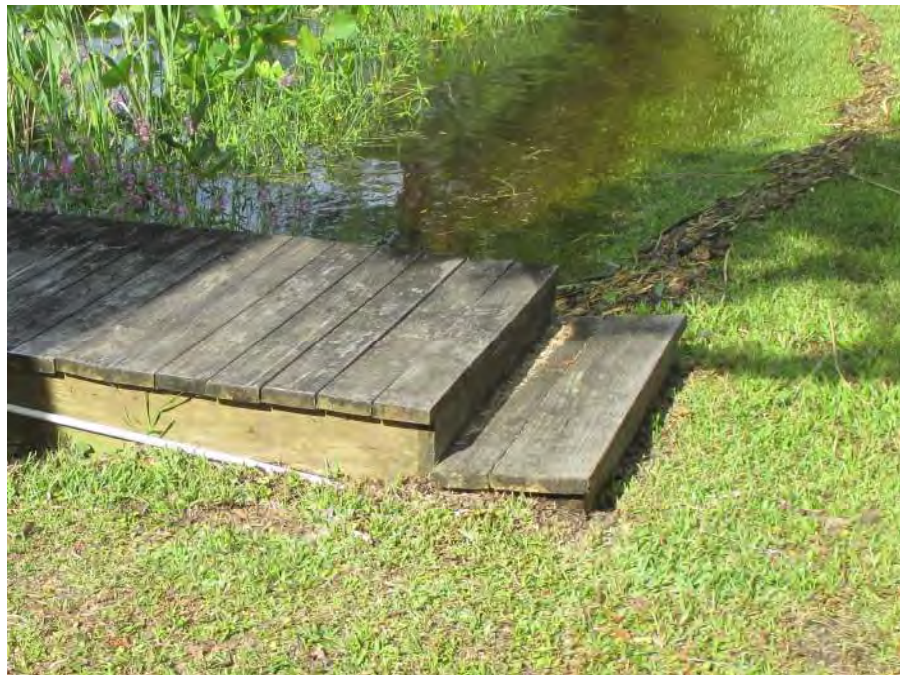
**Photograph 14**  
**Settled Entry Step**

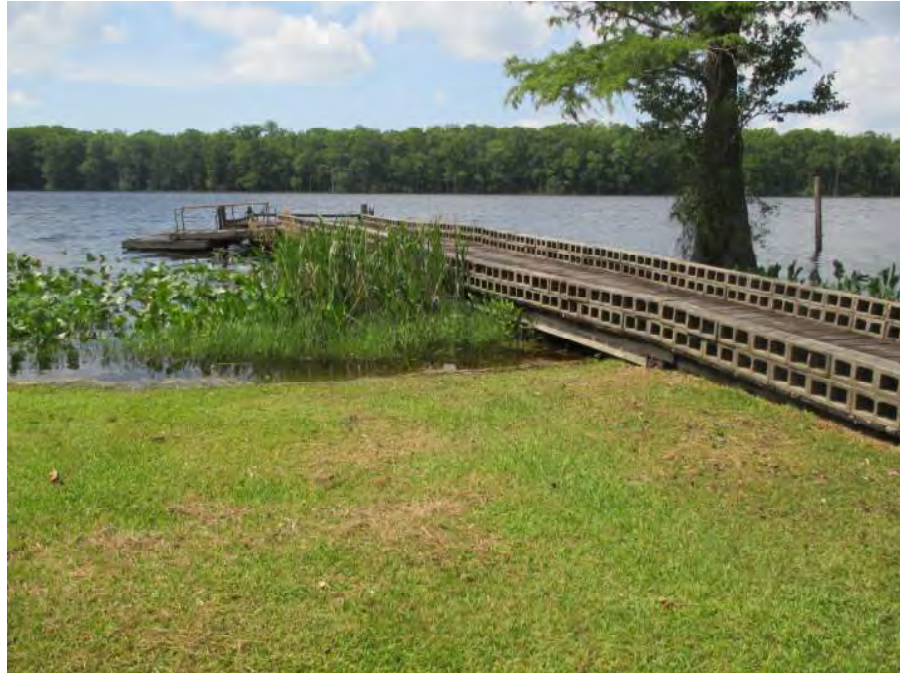
**Photograph 1**  
**Overall of Dock**

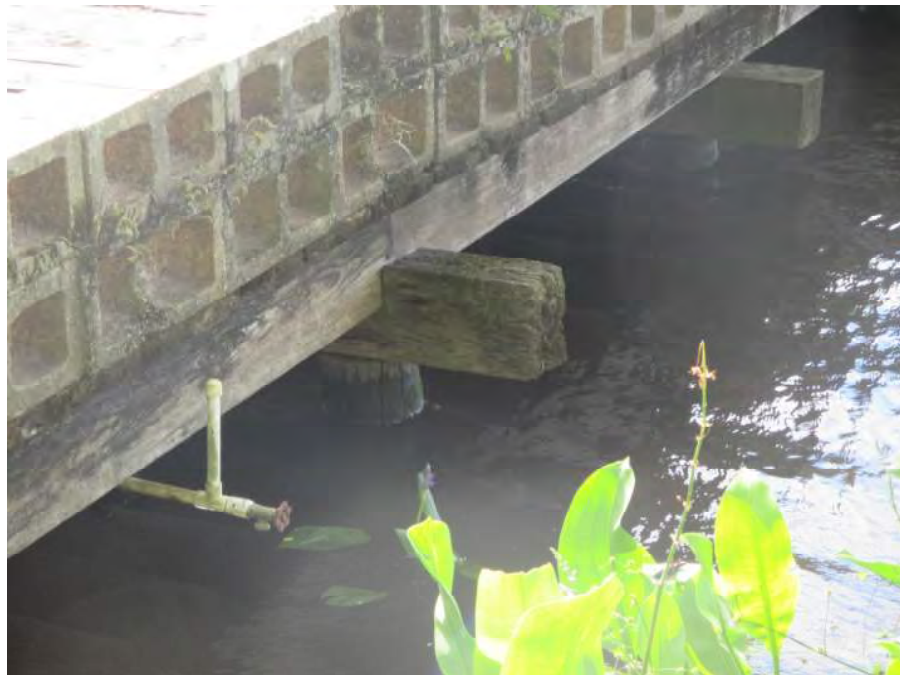
**Photograph 2**  
**Deteriorated Beam End Cantilevered Over Timber Pile**

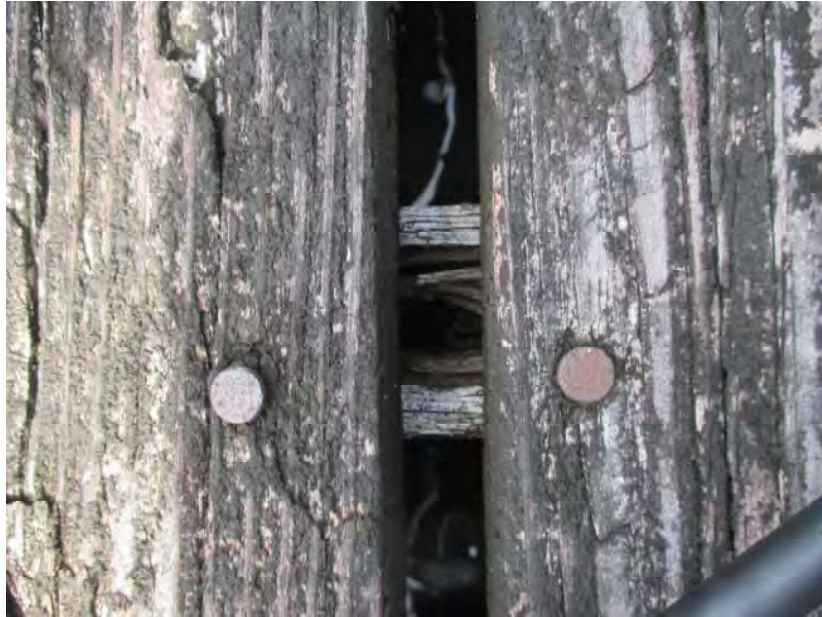
**Photograph 3**  
**Deteriorated 2x Stringer**

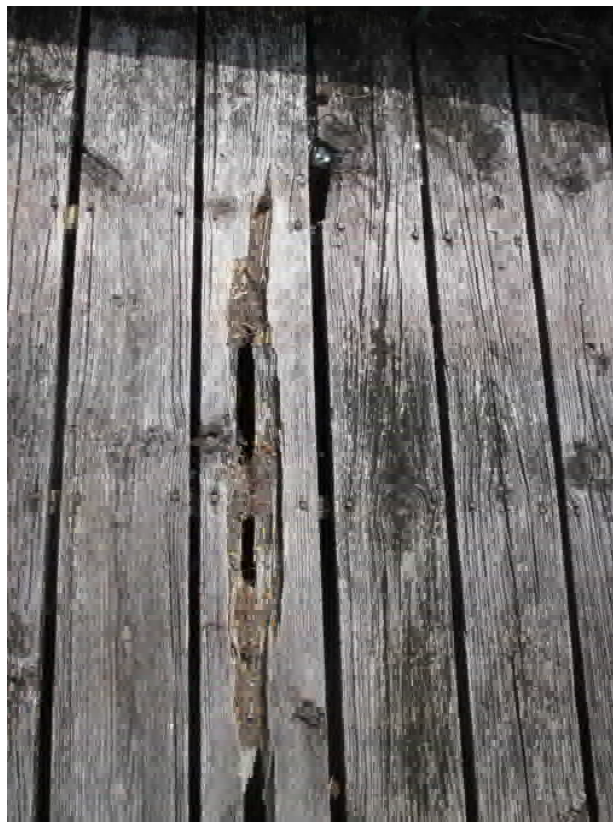
**Photograph 4**  
**Deteriorated Decking**

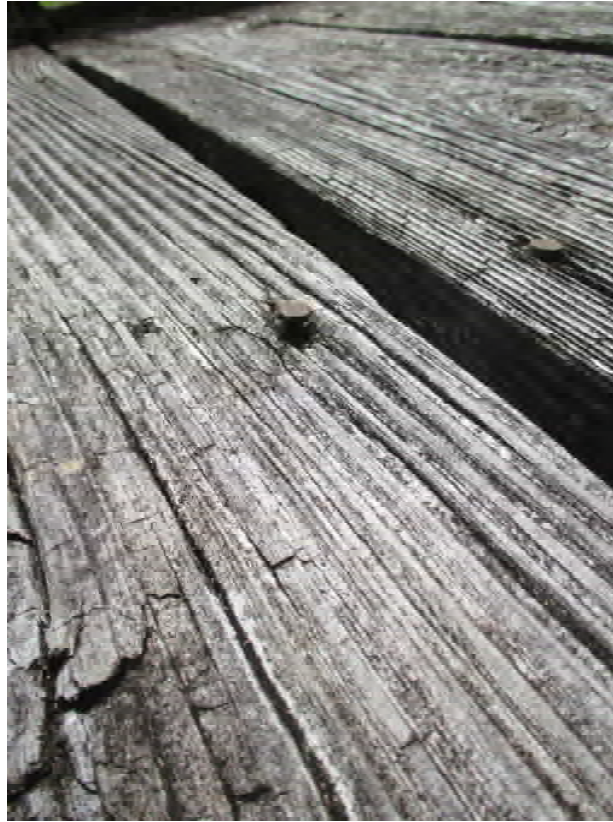
**Photograph 5**  
**Raised Nail Heads**

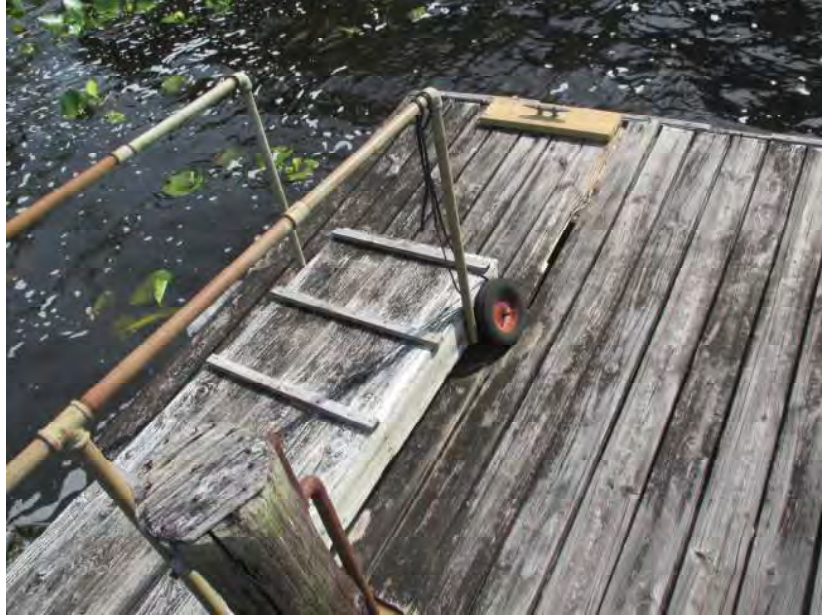
**Photograph 9**  
**Deteriorated Decking at Pivot Ramp**

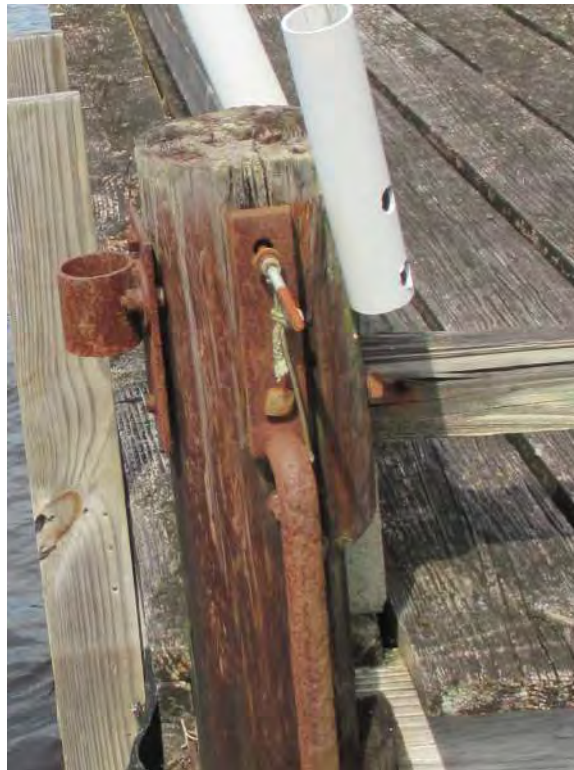
**Photograph 10**  
**Corroded and Missing Hardware**
