# **HISTORIC STRUCTURE ASSESSMENT REPORT**

## **VISTA HISTORIC SITE Lower Suwannee National Wildlife Refuge**

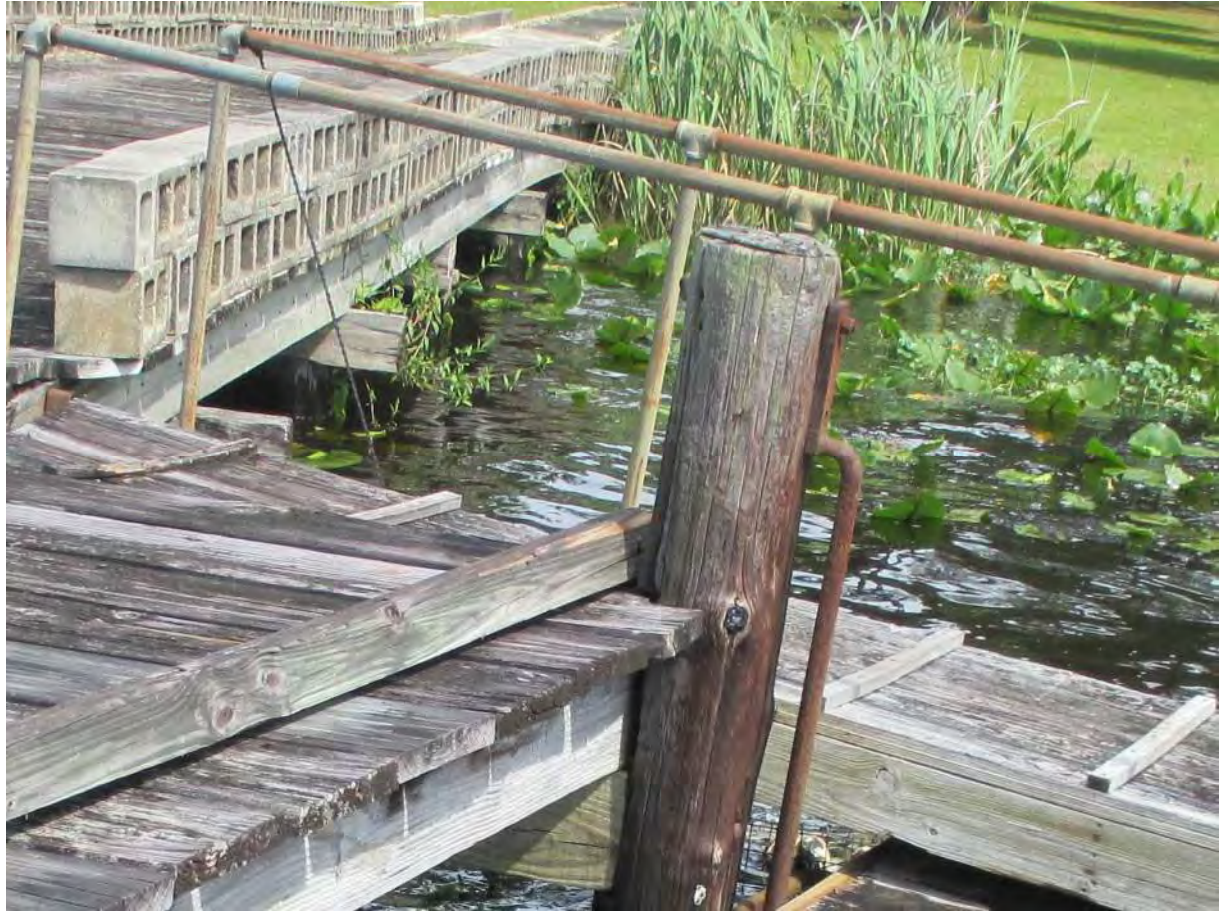
**Photograph 11**  
**Perimeter Timber Unattached**

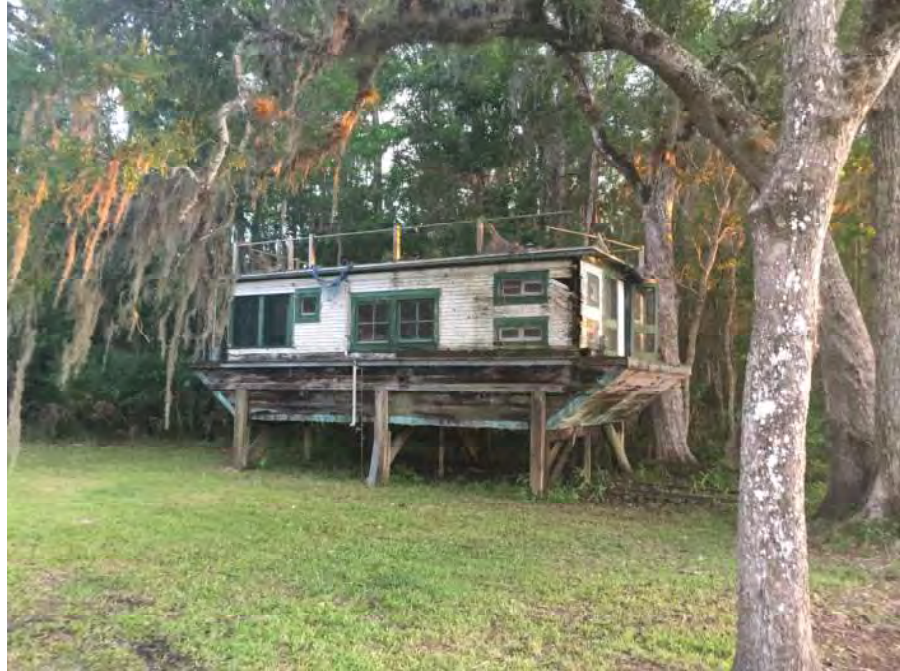
**Photograph 1**  
**West Wall (Starboard) Overall**

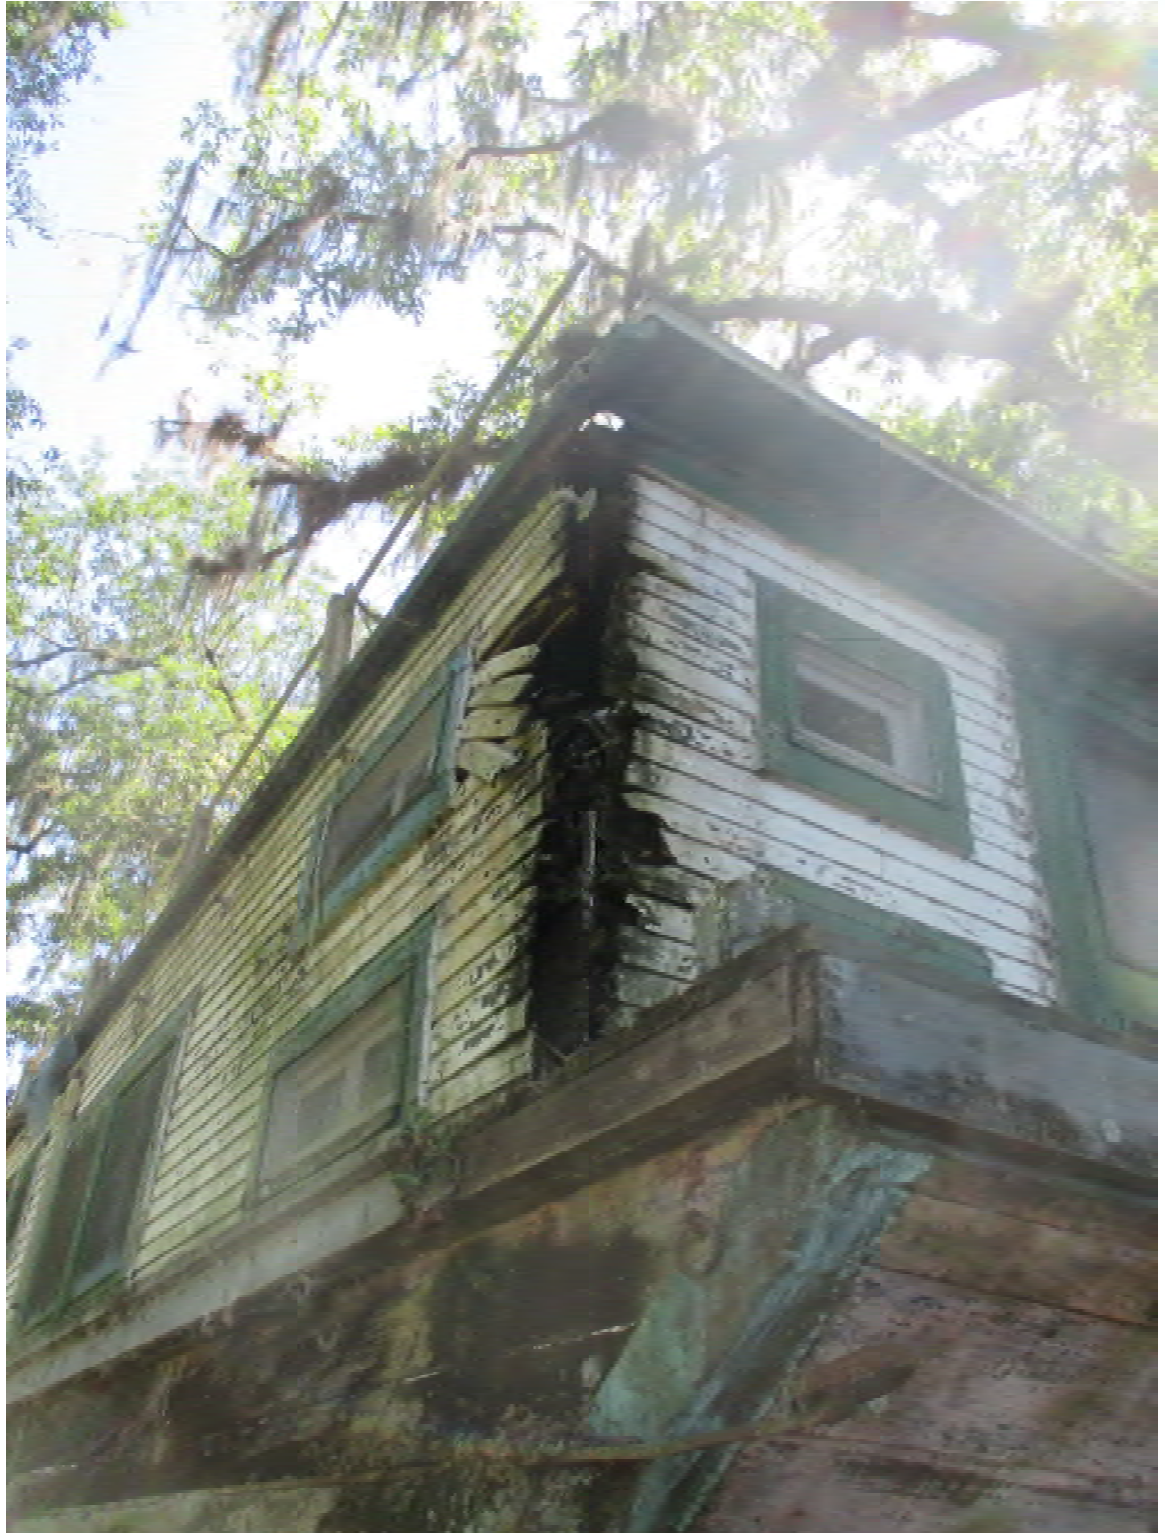
**Photograph 3**  
**Northwest Corner Severely Deteriorated**

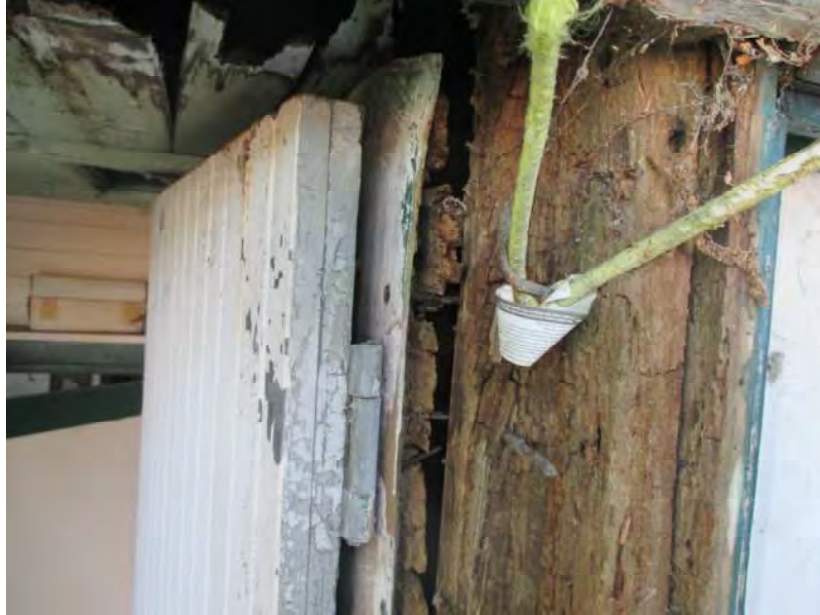
**Photograph 4**  
**North Wall and Roof Joists Severely Deteriorated**

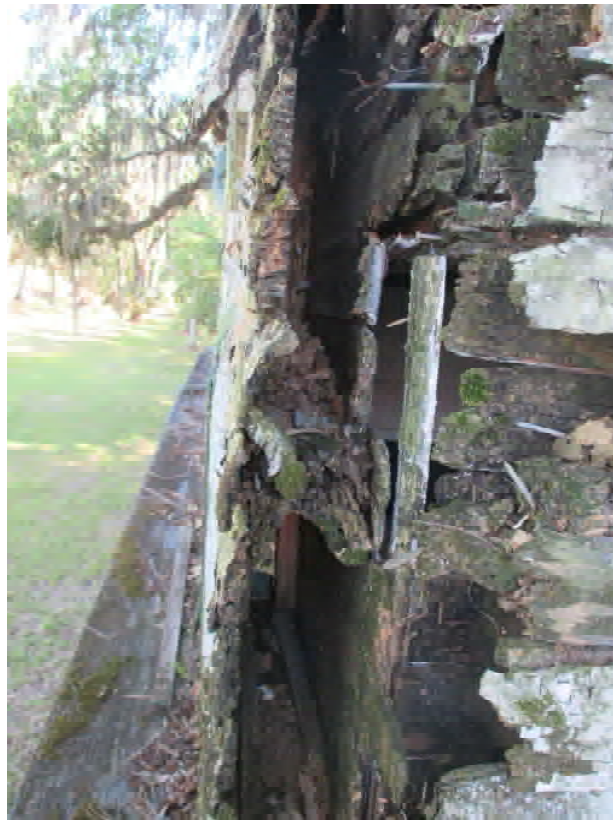
**Photograph 5**  
**Wall Studs, Siding, Blocking, and Decking Severely Deteriorated**

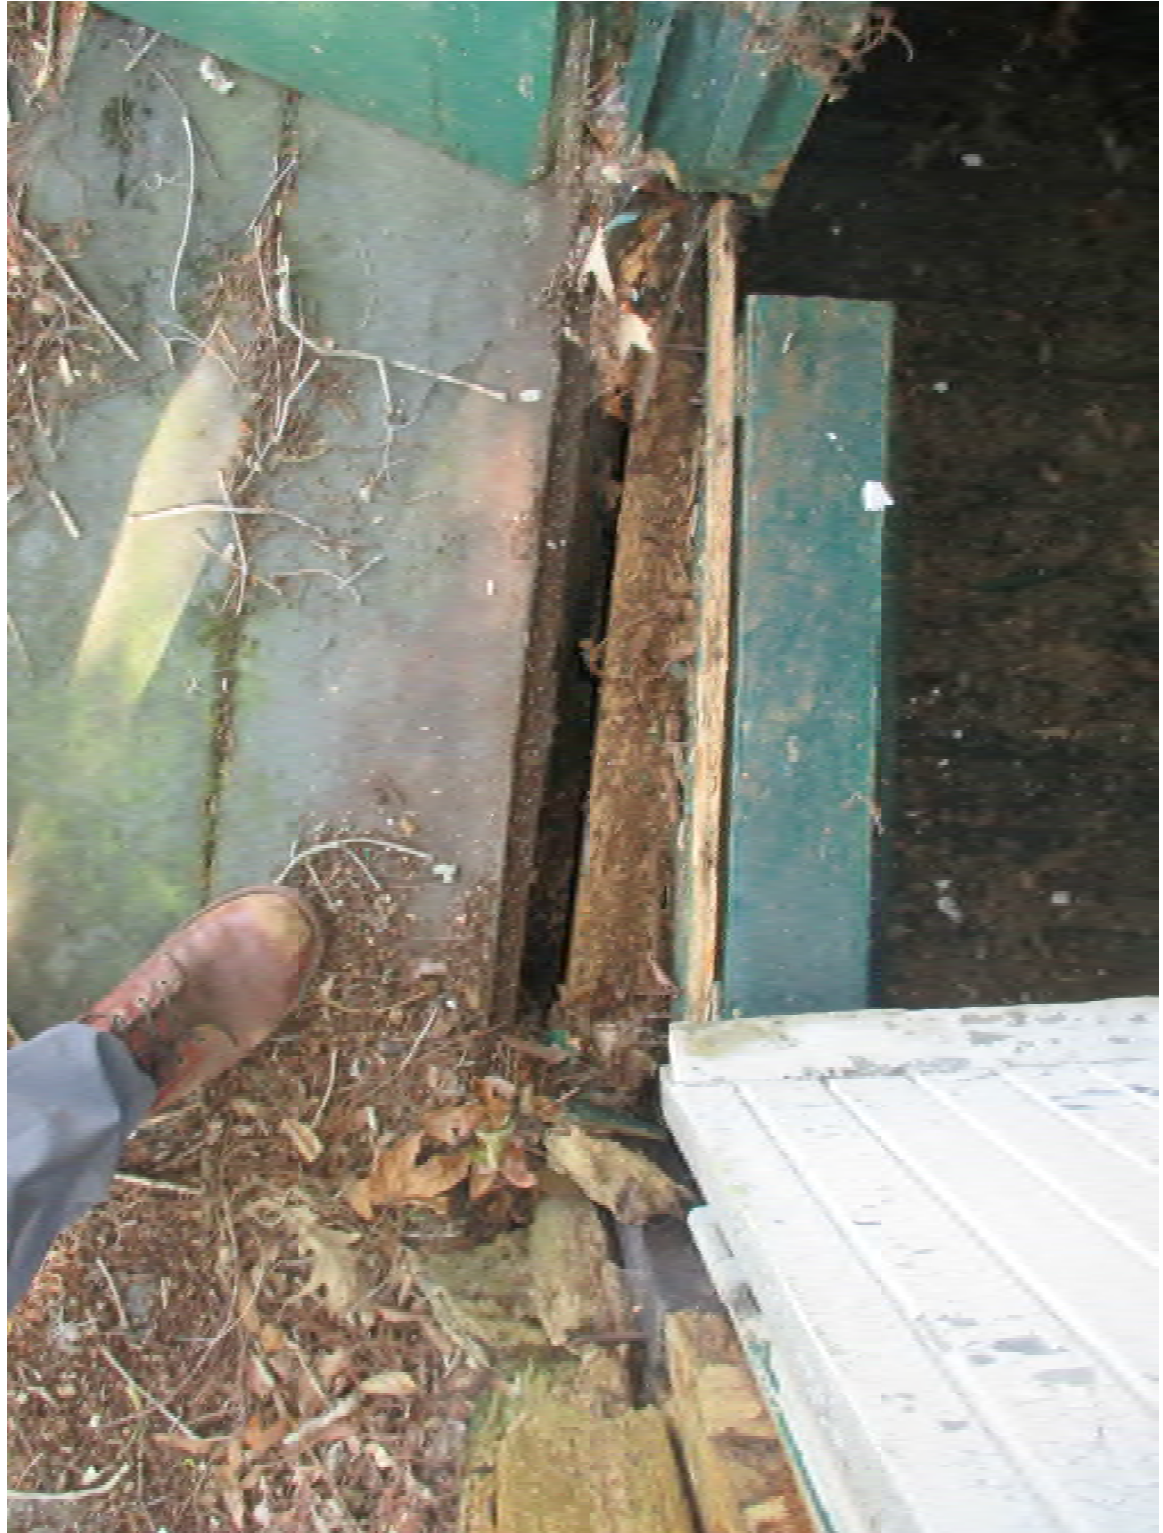
**Photograph 6**  
**Decking, Entry Step, and Wall Framing Severely Deteriorated**

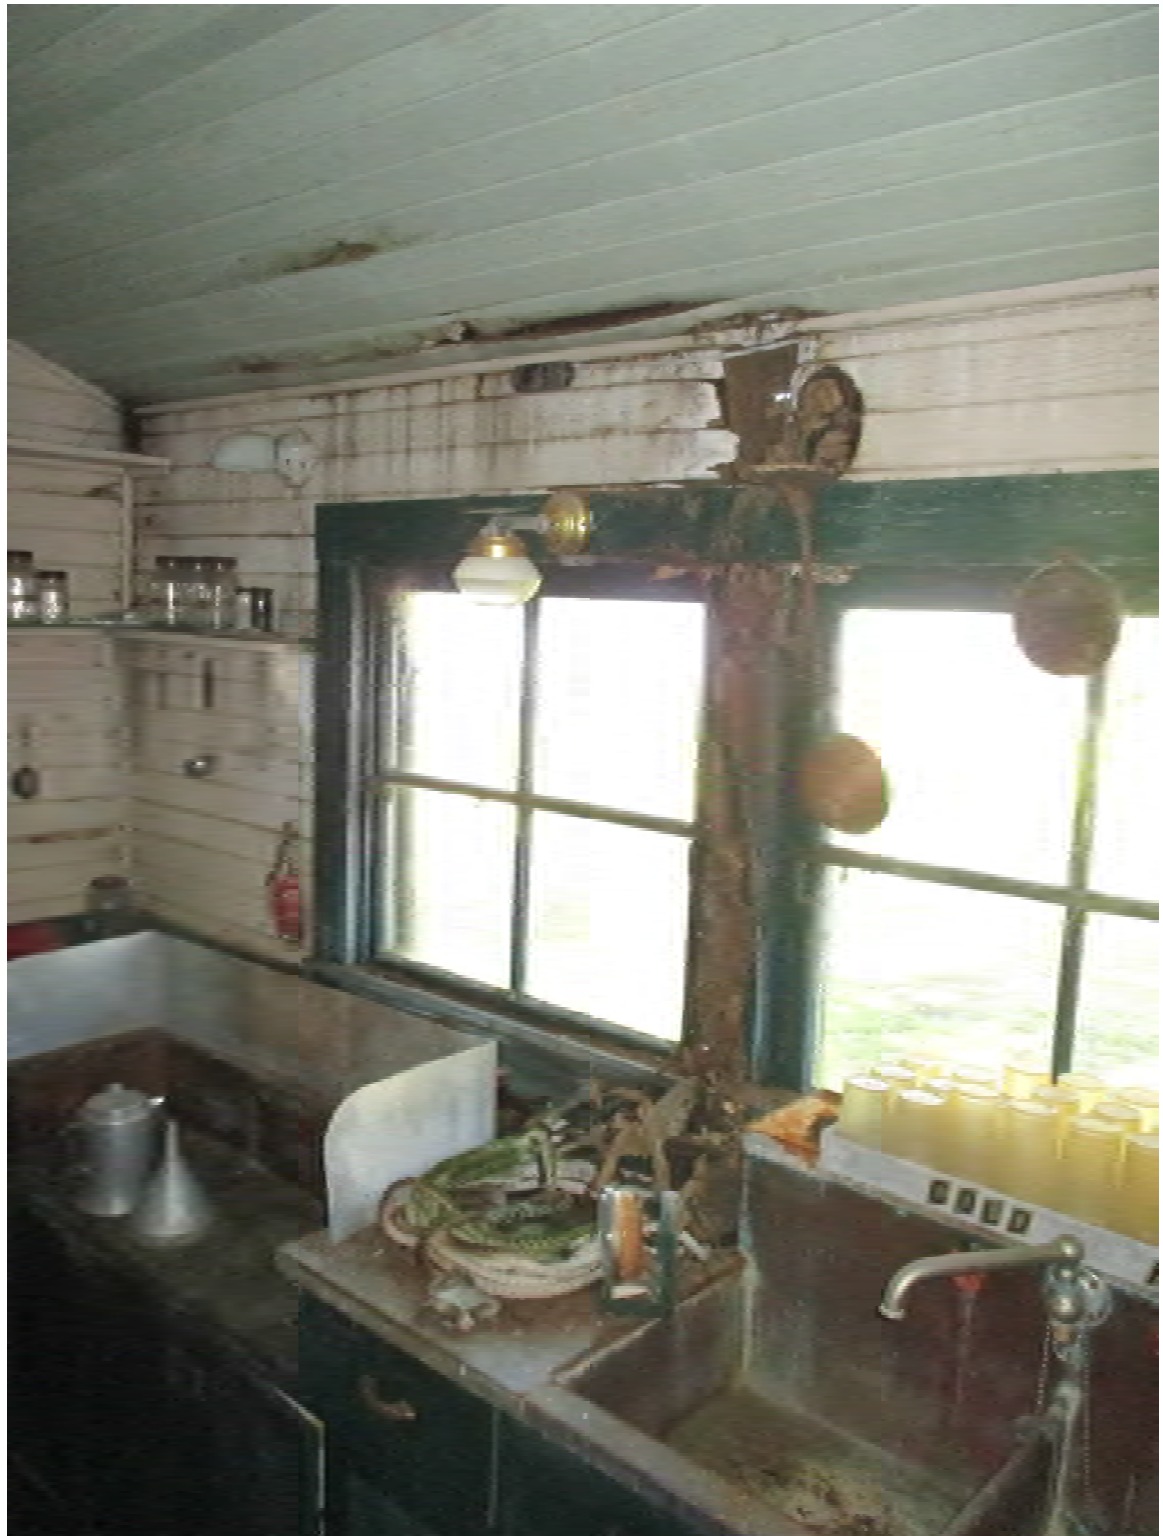
**Photograph 7**  
**Wall Framing and Siding Severely Deteriorated**

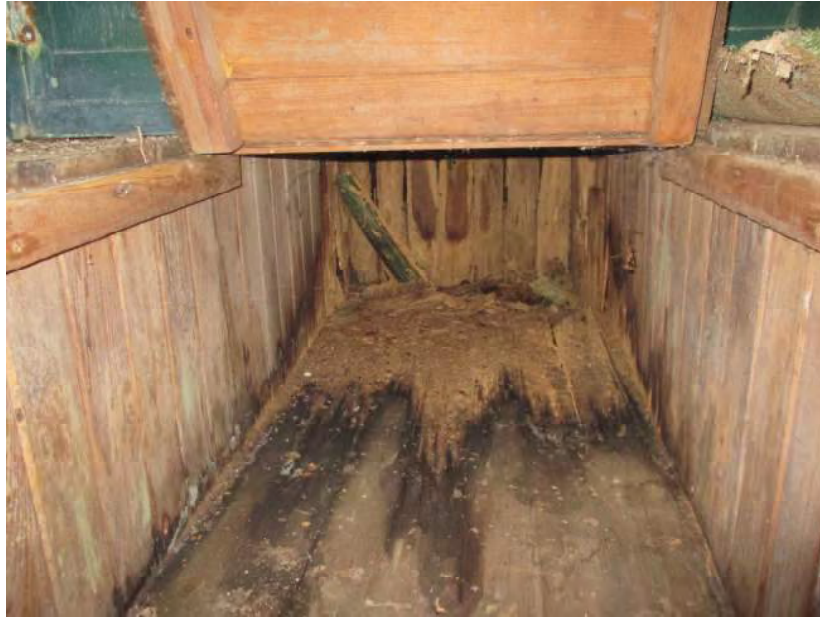
**Photograph 8**  
**Kitchen Floor Storage Well Moisture Damage**

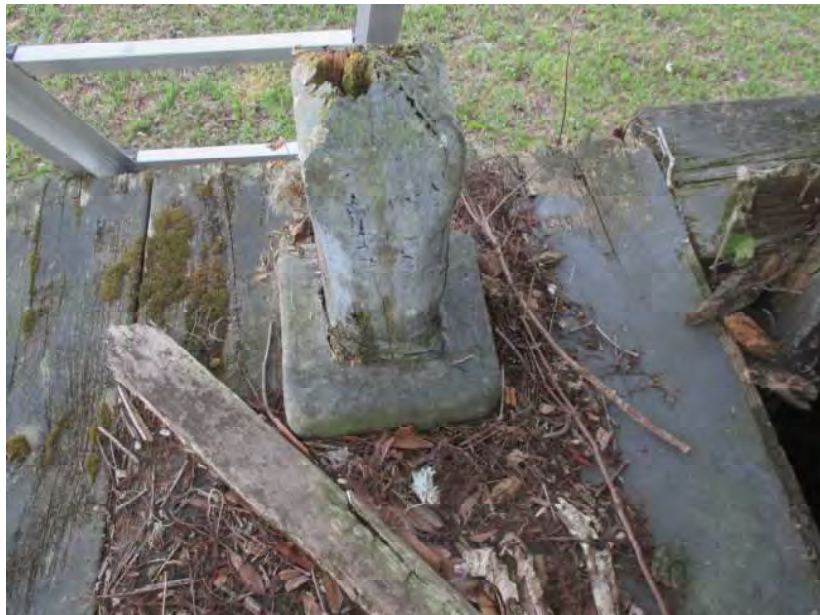
**Photograph 9**  
**Mooring Davit Deteriorated**

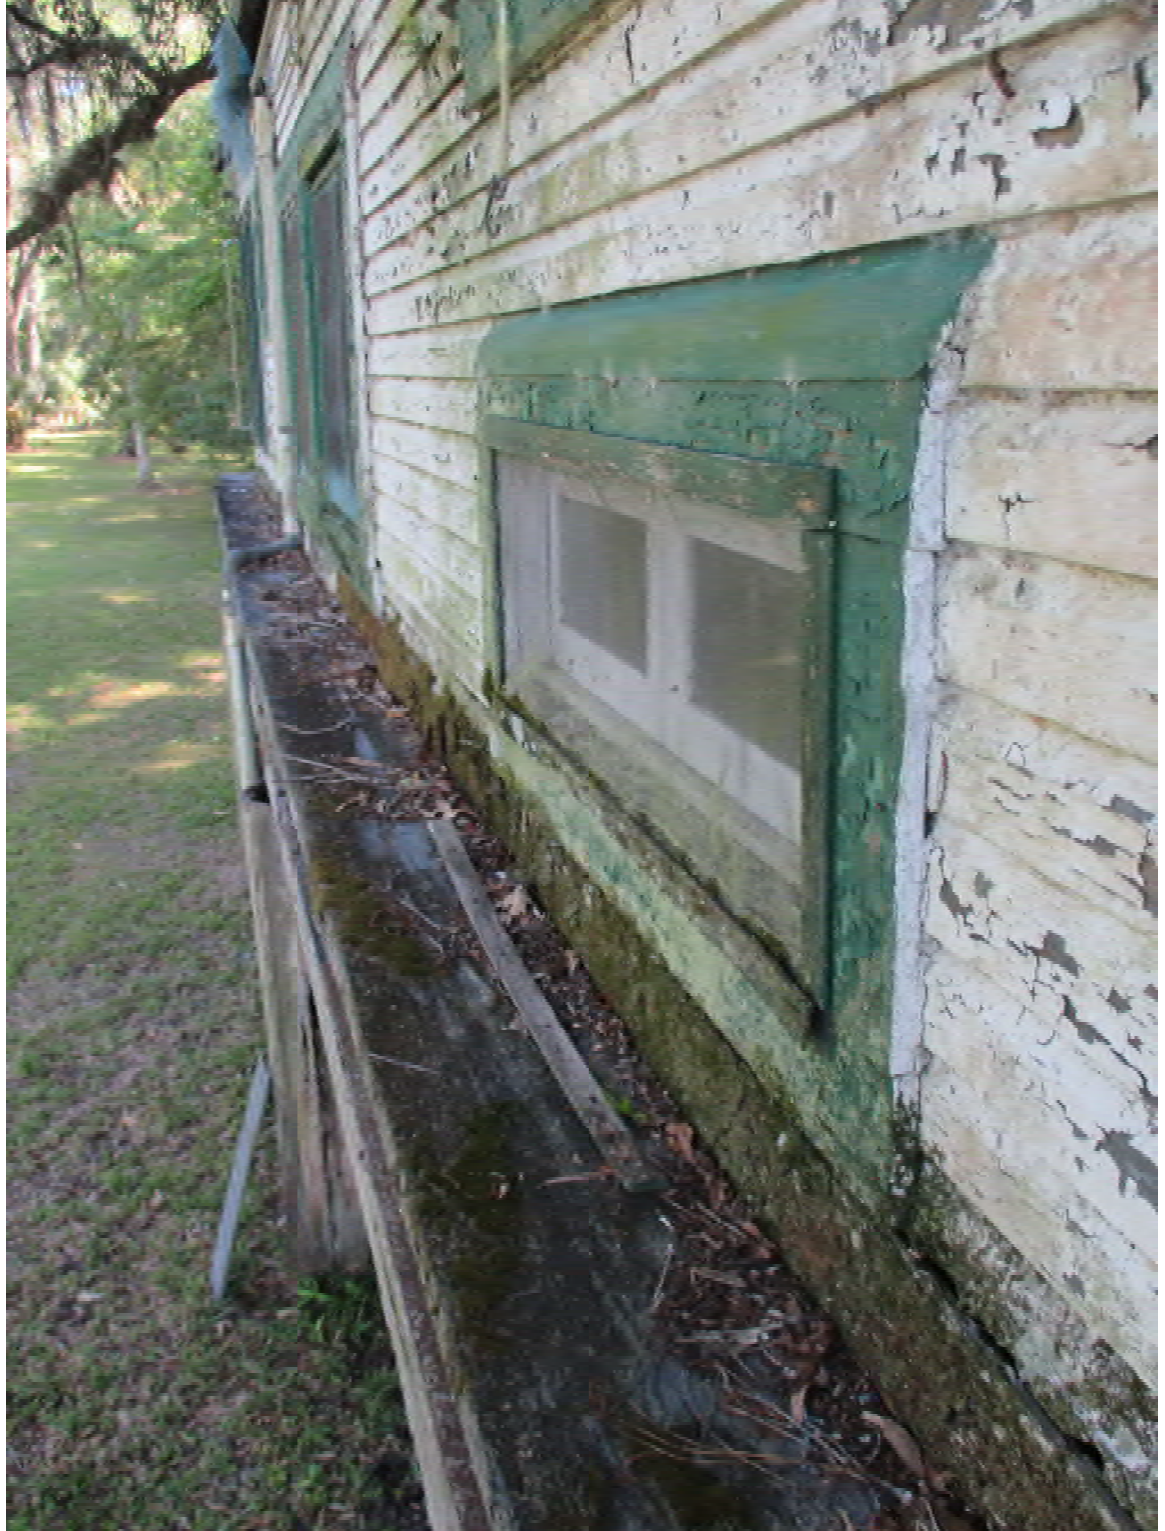
**Photograph 10**  
**Siding, Trim, Decking, and Wall Framing Severely Deteriorated**

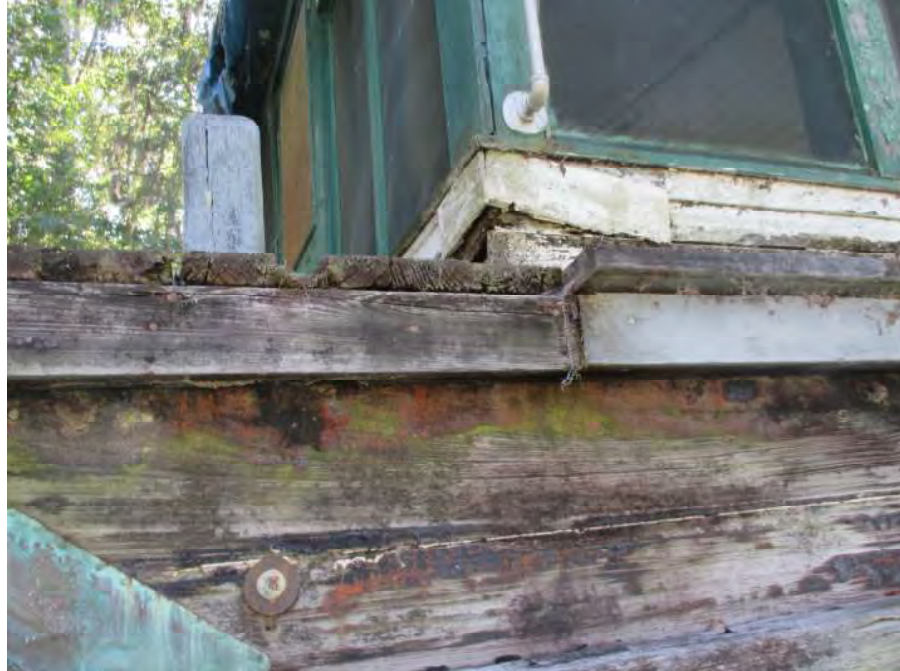
**Photograph 11**  
**Decking and Trim Deteriorated with Corroded Fasteners**

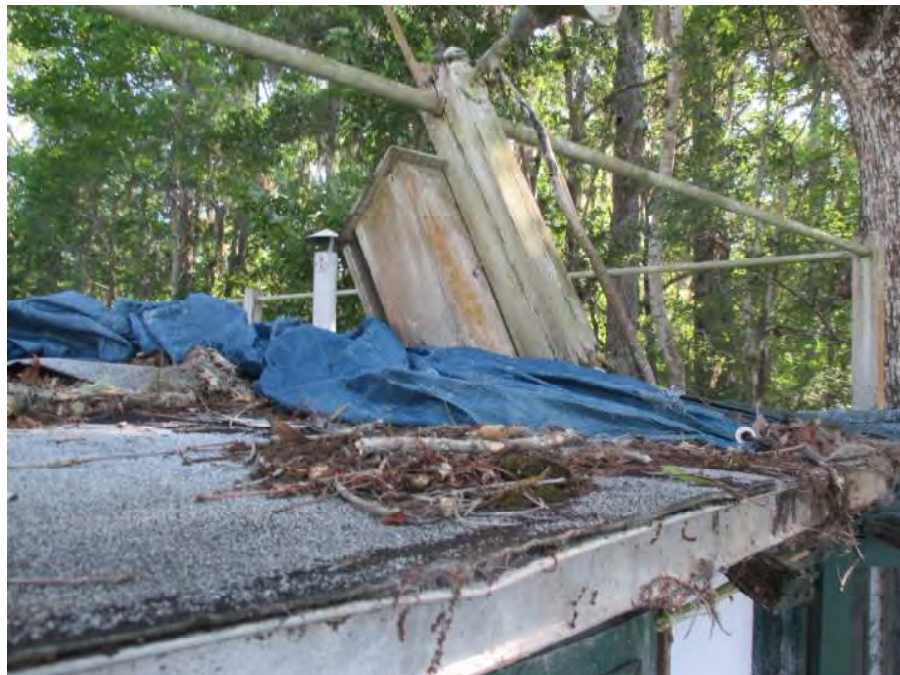
**Photograph 12**  
**Handrail Post Failed with Broken Handrail**

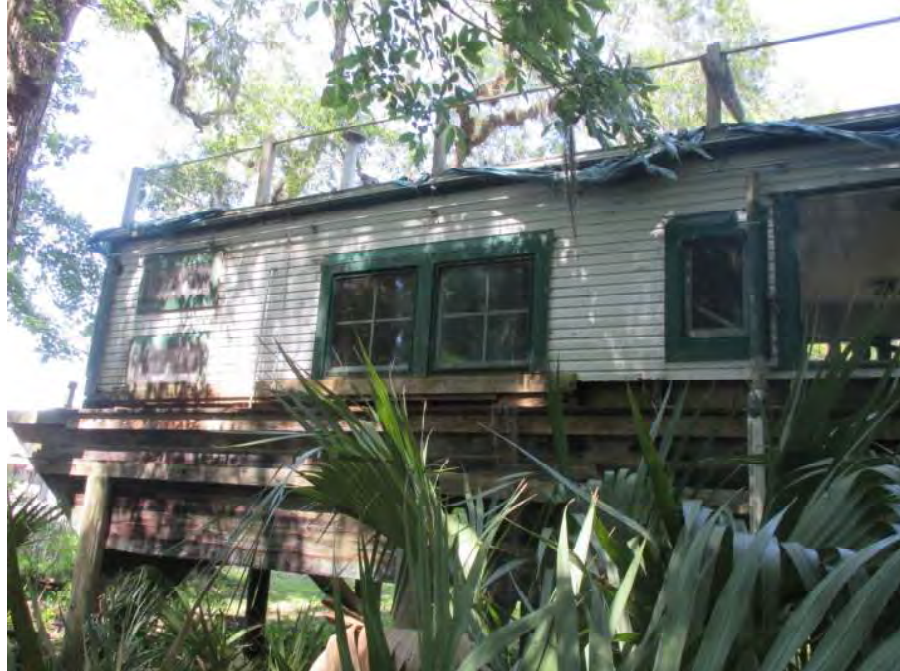
**Photograph 13**  
**Missing and Severely Deteriorated Siding**

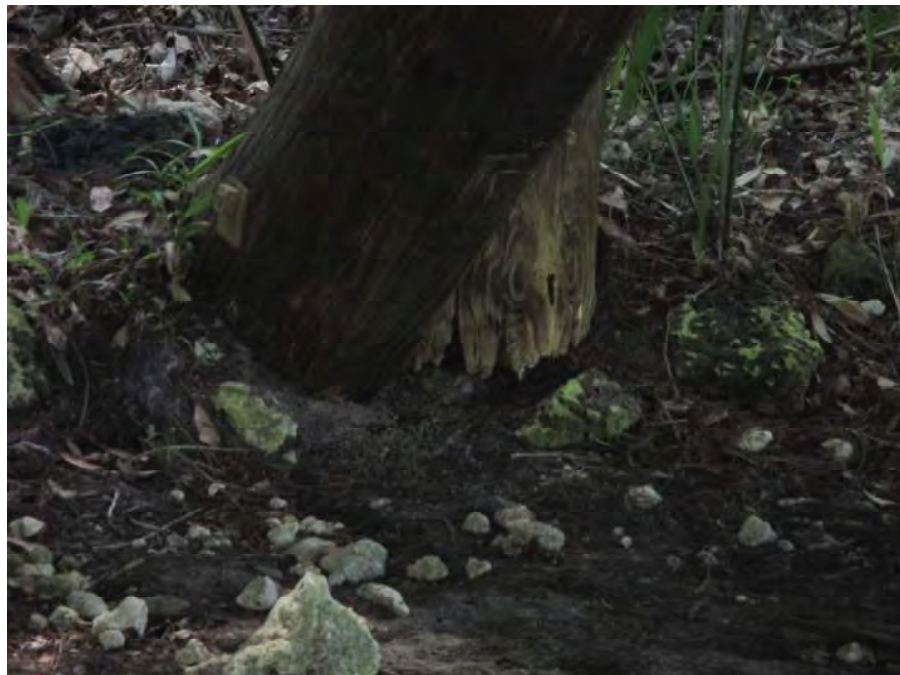
**Photograph 14**  
**Base of Houseboat Supports Deteriorated**

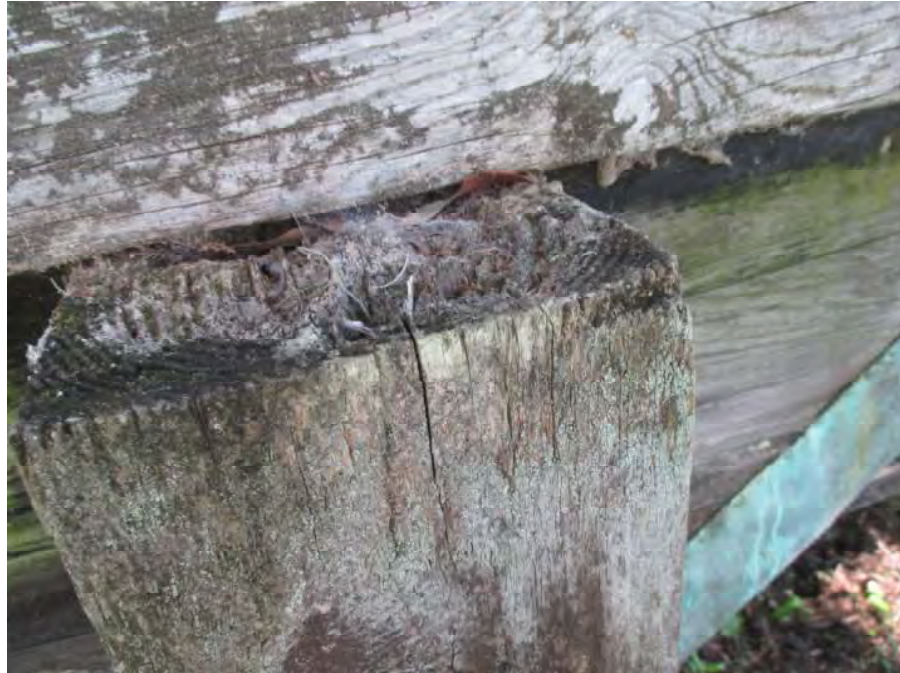
**Photograph 15**  
**Top of Houseboat Support Pile Deteriorated**

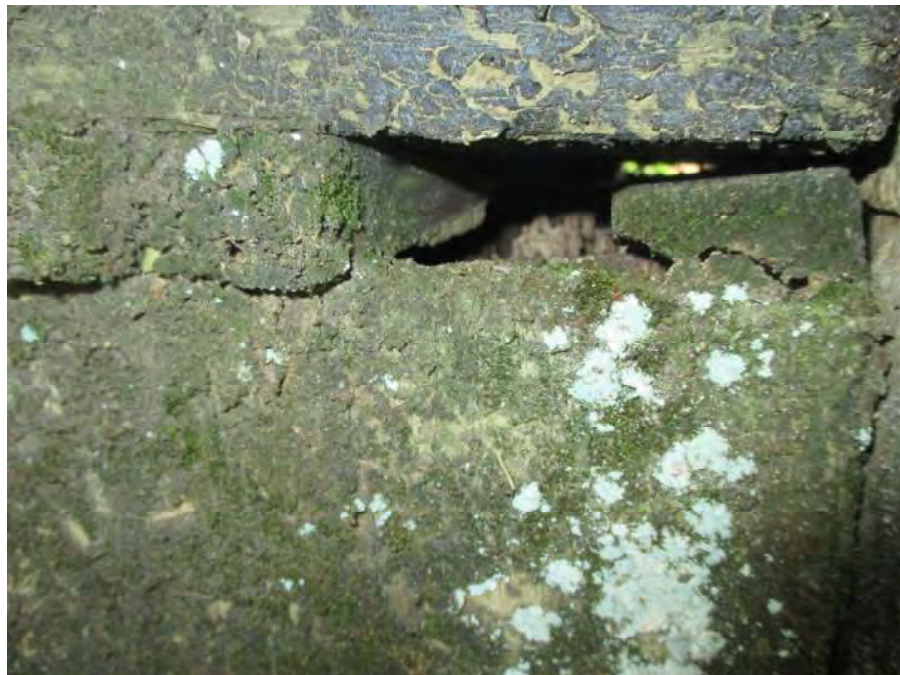
**Photograph 16**  
**Top of Houseboat Support Pile Deteriorated**

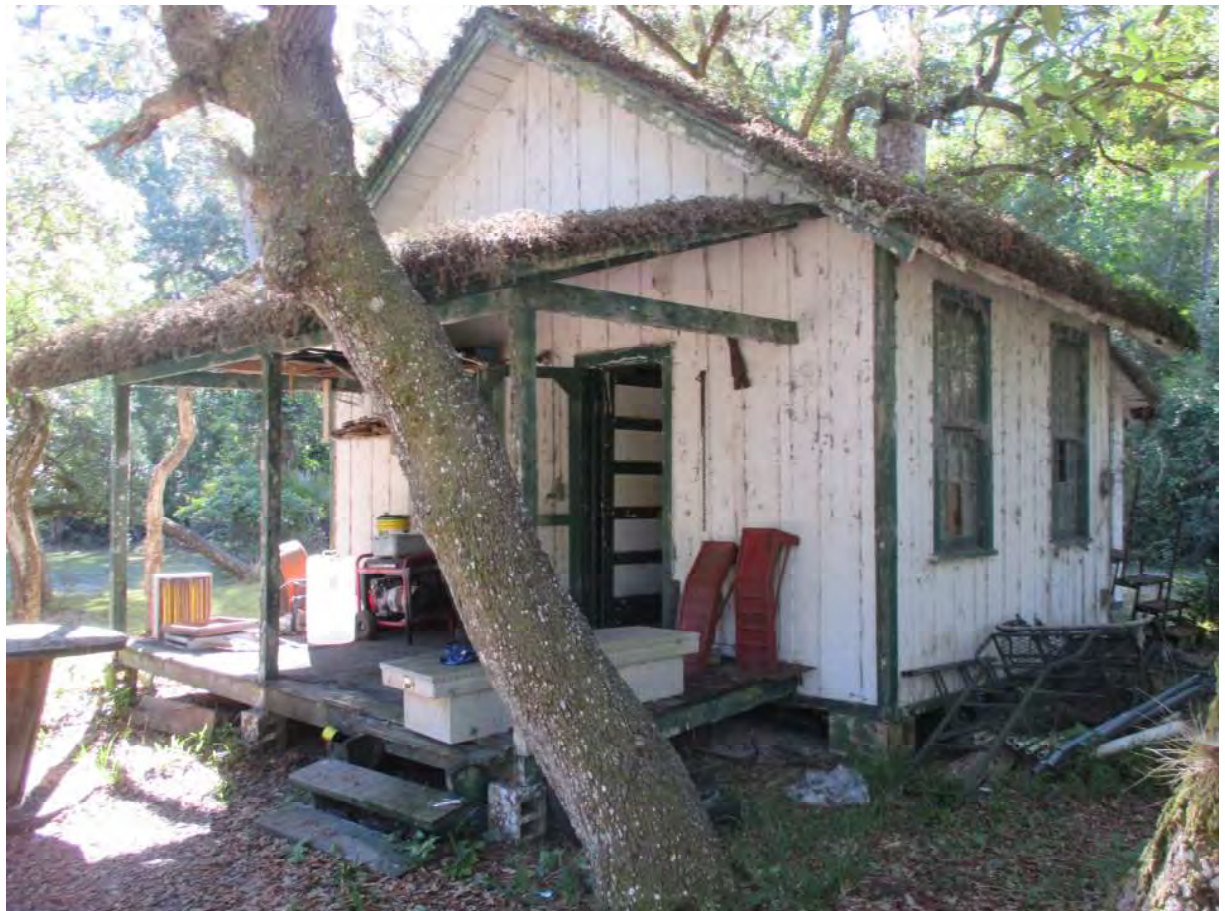
**Photograph 1**  
**Cook's House Main Entry Porch**

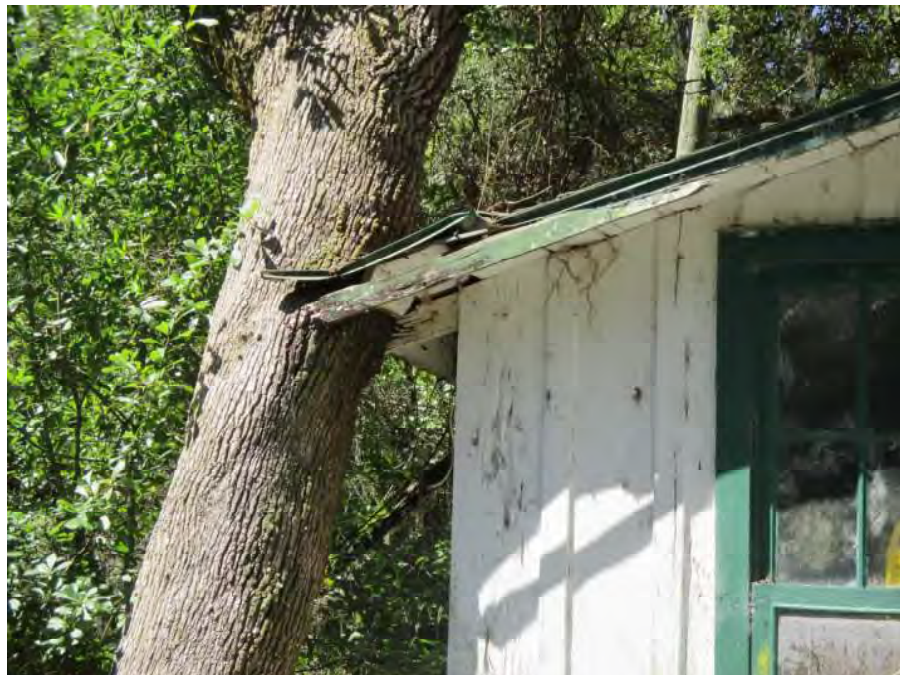
**Photograph 3**  
**Damaged Rear Corner Due to Tree**

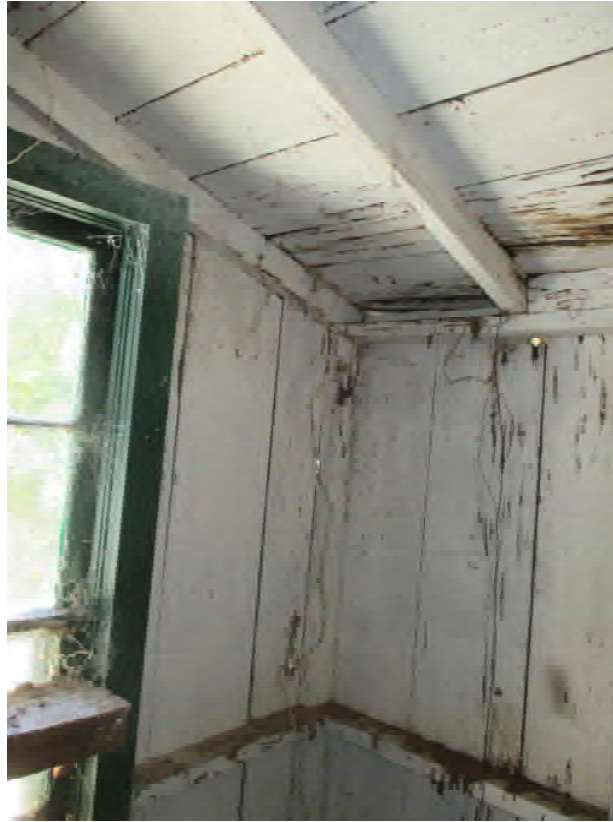
**Photograph 4**  
**Moisture Damaged Framing**

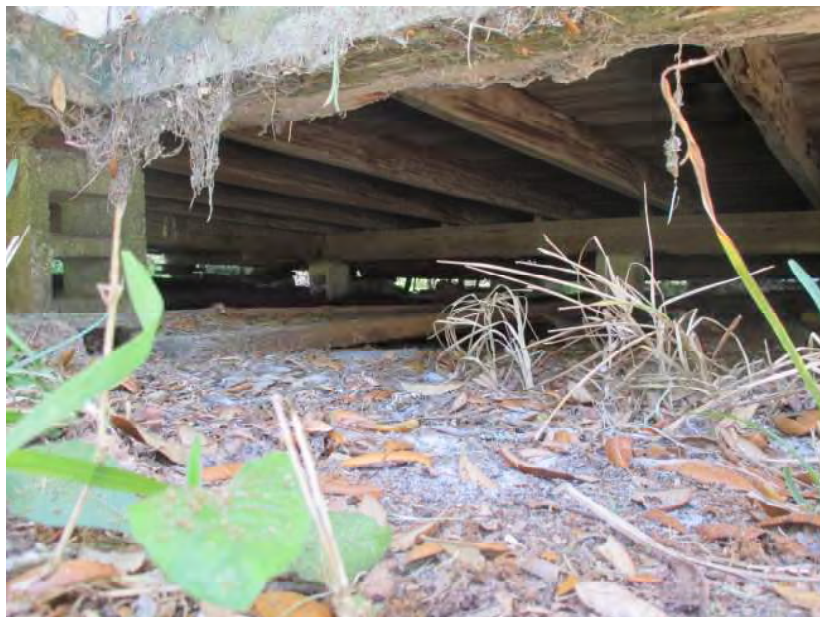
**Photograph 5**  
**Moisture or Termite Floor Framing Deteriorated**

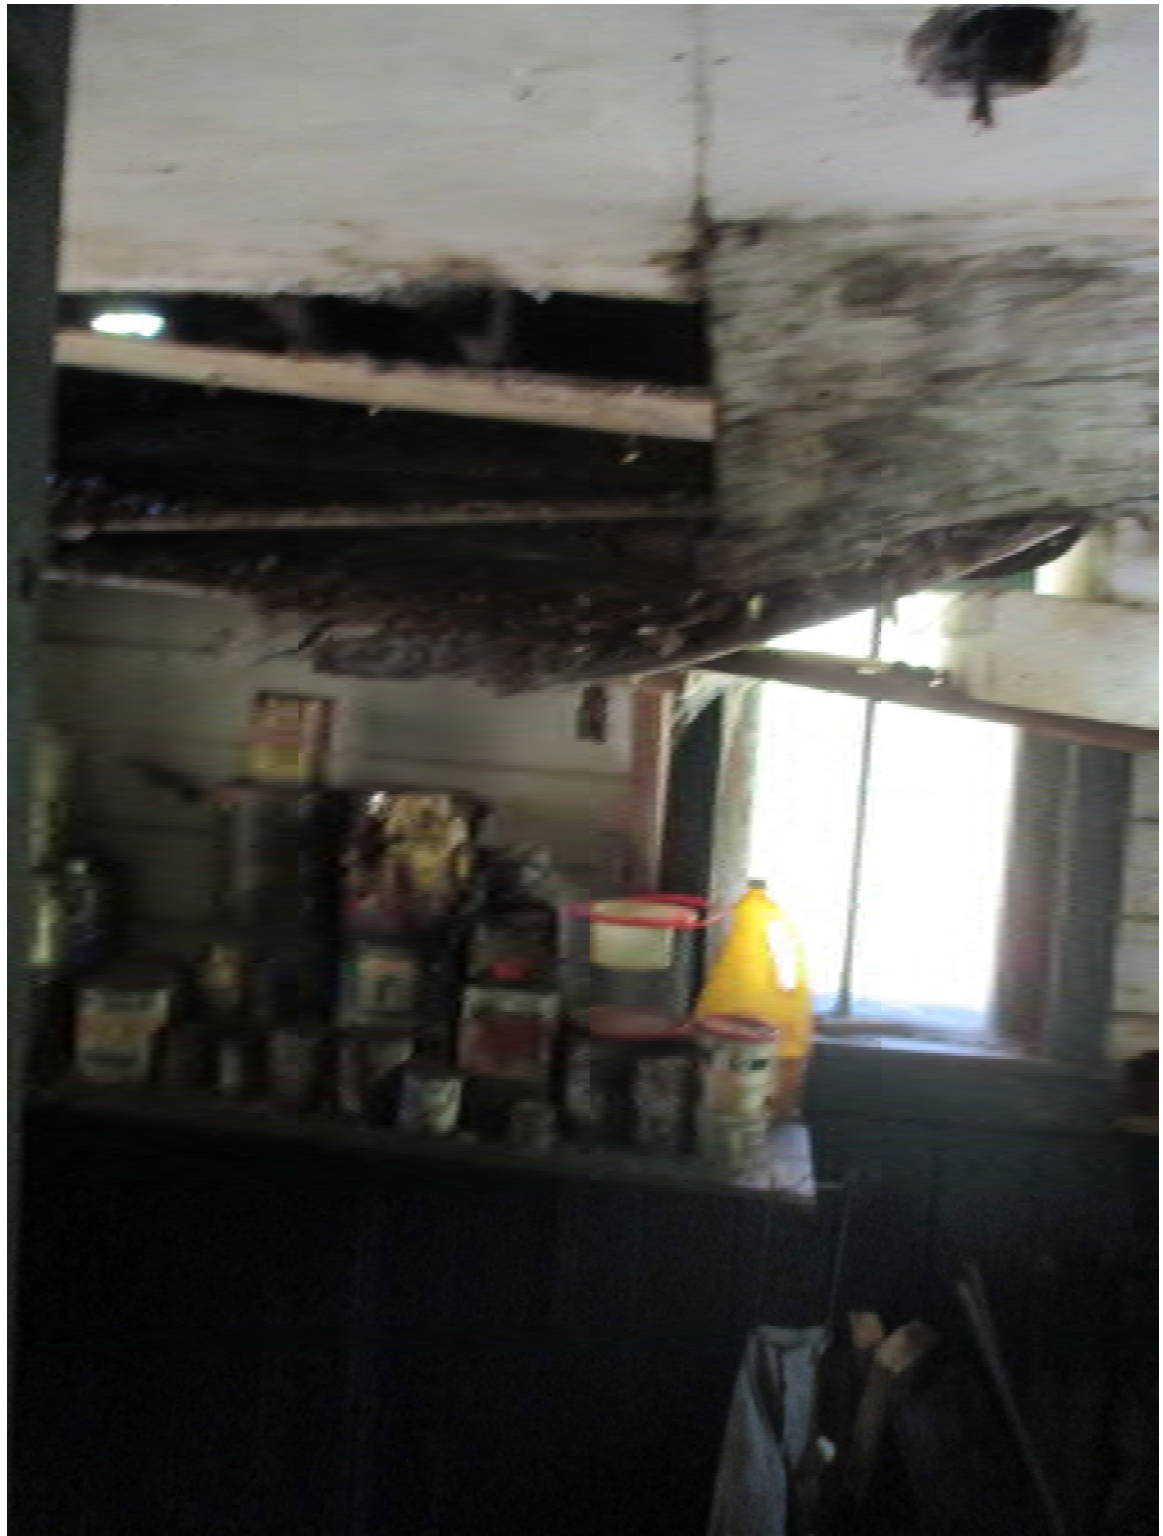
**Photograph 6**  
**Collapsed Roof Framing and Ceiling Due to Moisture**

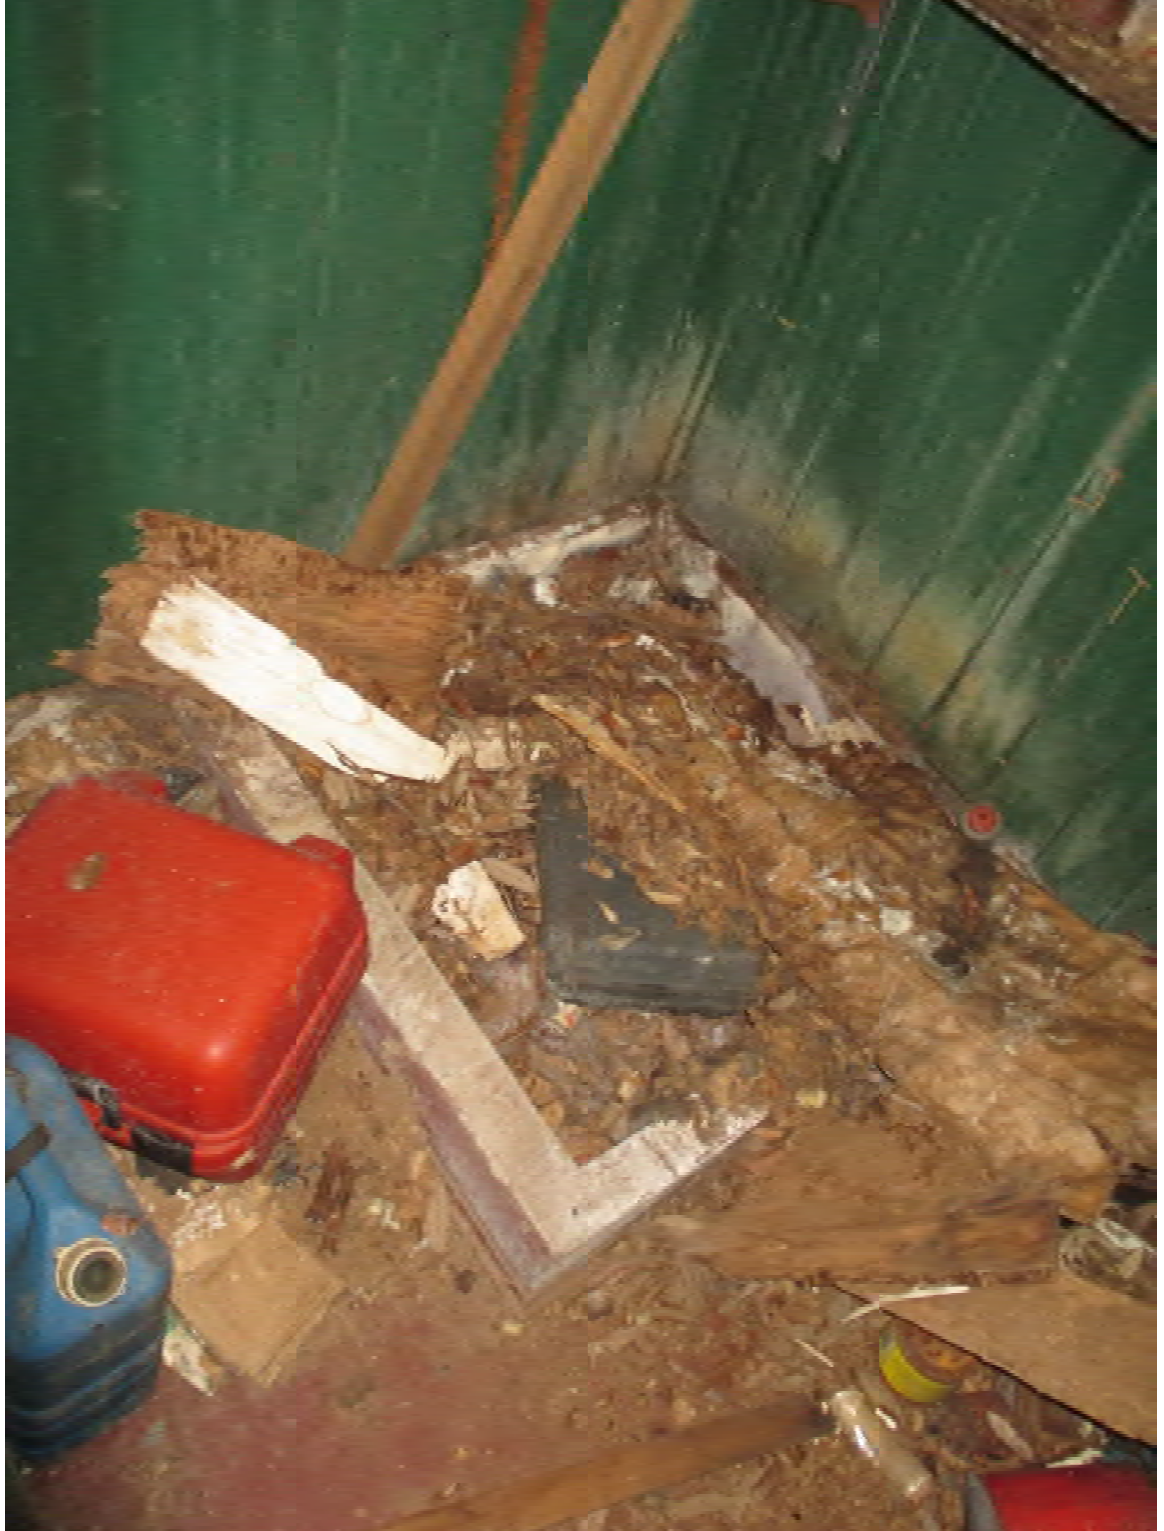
**Photograph 7**  
**Deteriorated Floor Decking at Addition**

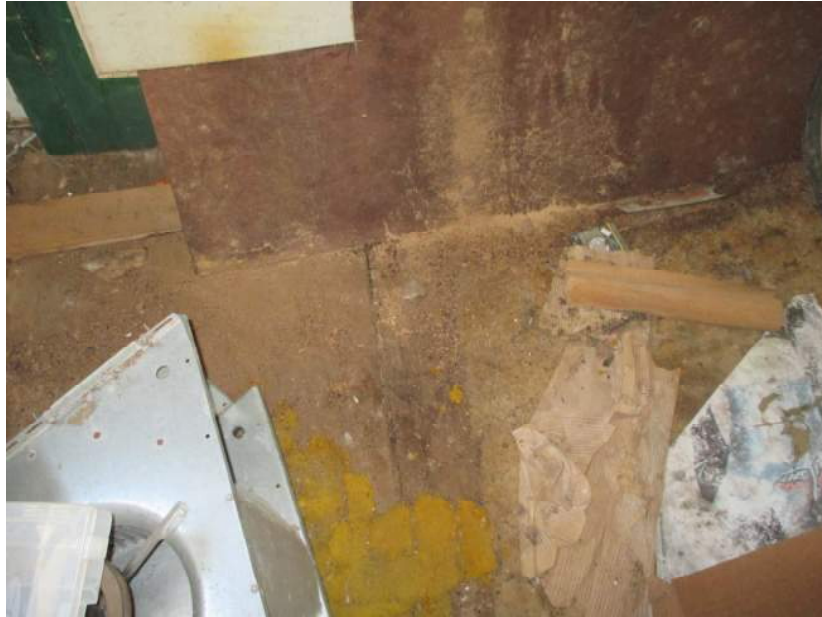
**Photograph 8**  
**Deteriorated Floor Decking at Rear Porch**

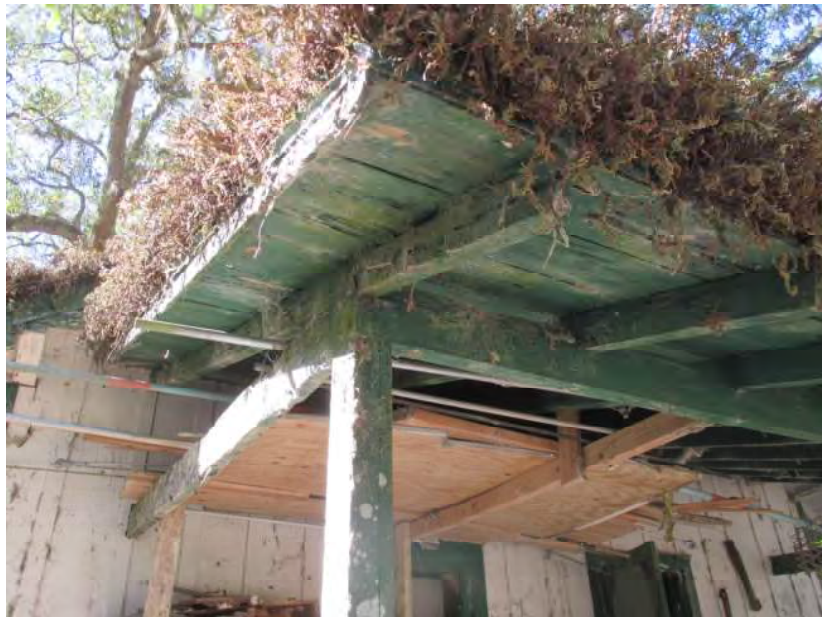
**Photograph 9**  
**Termite Deterioration**

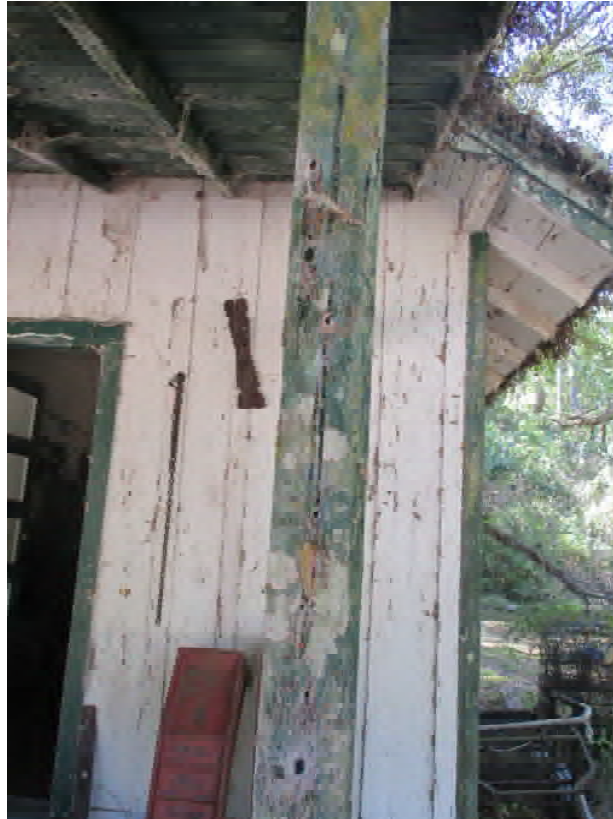
**Photograph 10**  
**Termite Deterioration**

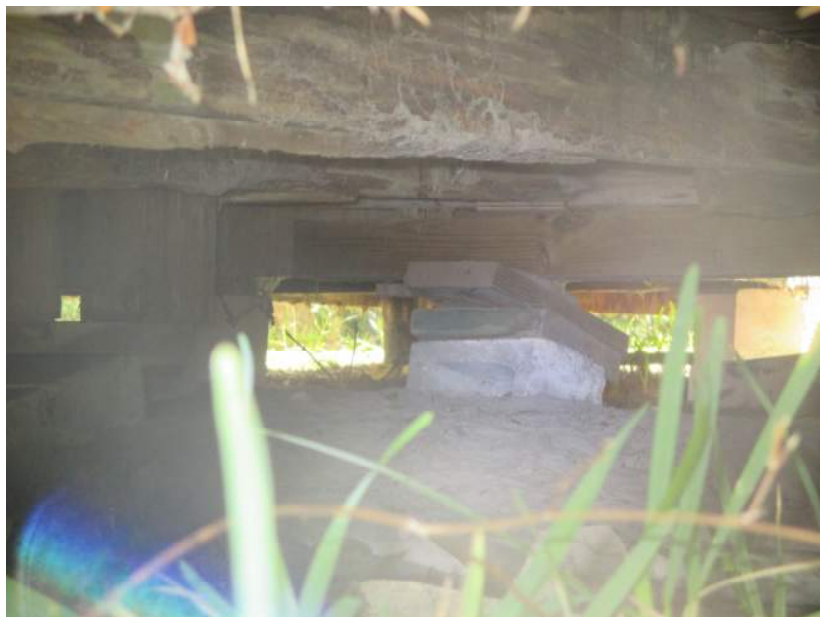
**Photograph 11**  
**Rotated and Loose Foundation**
