# **HISTORIC STRUCTURE ASSESSMENT REPORT**

## **VISTA HISTORIC SITE Lower Suwannee National Wildlife Refuge**

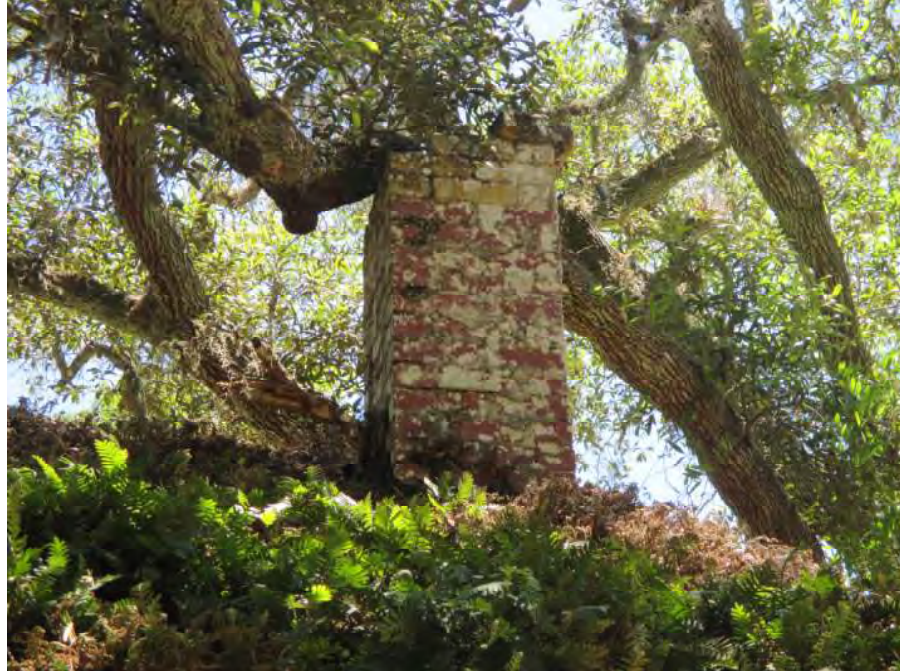
**Photograph 12**  
**Tree Bearing on Brick Chimney with Loose Debris**

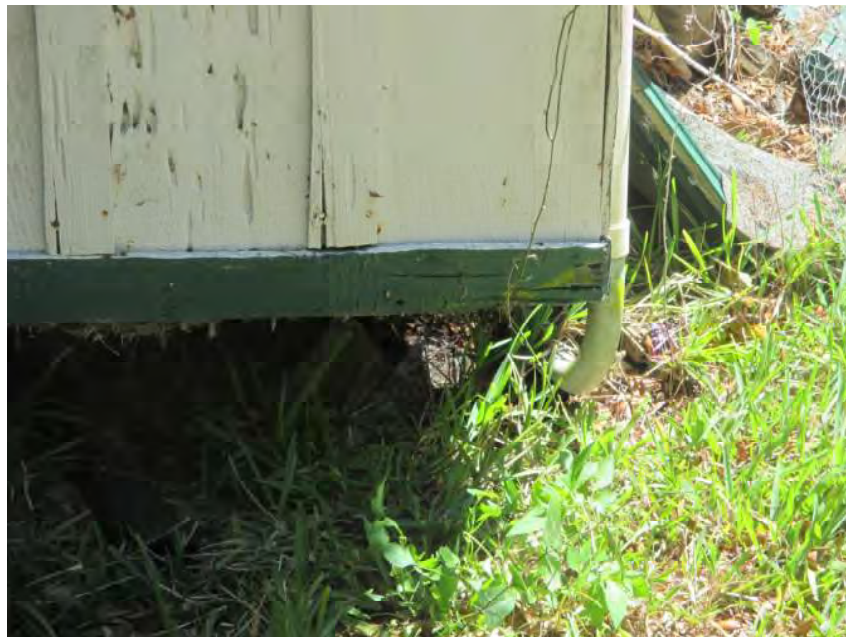
**Photograph 13**  
**Failed Corner Foundation**

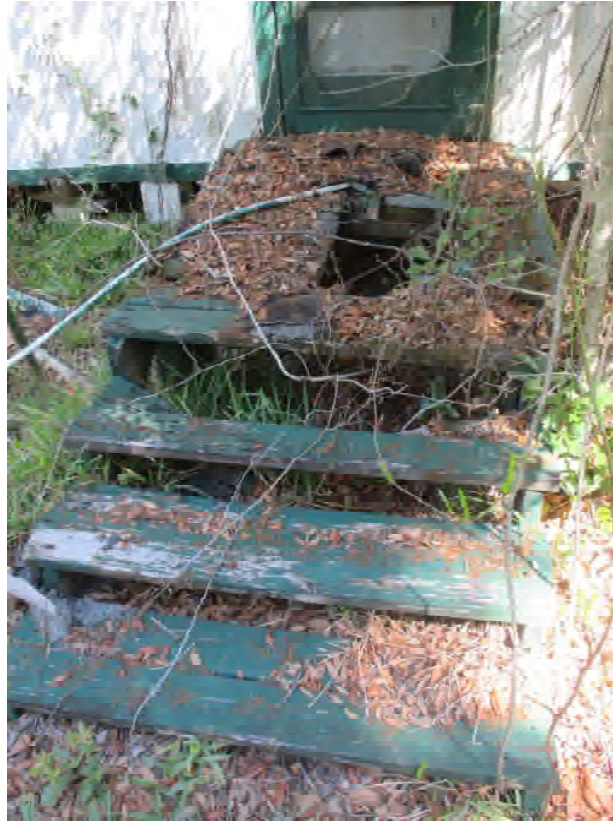
**Photograph 14**  
**Failed Rear Porch Entry Steps**

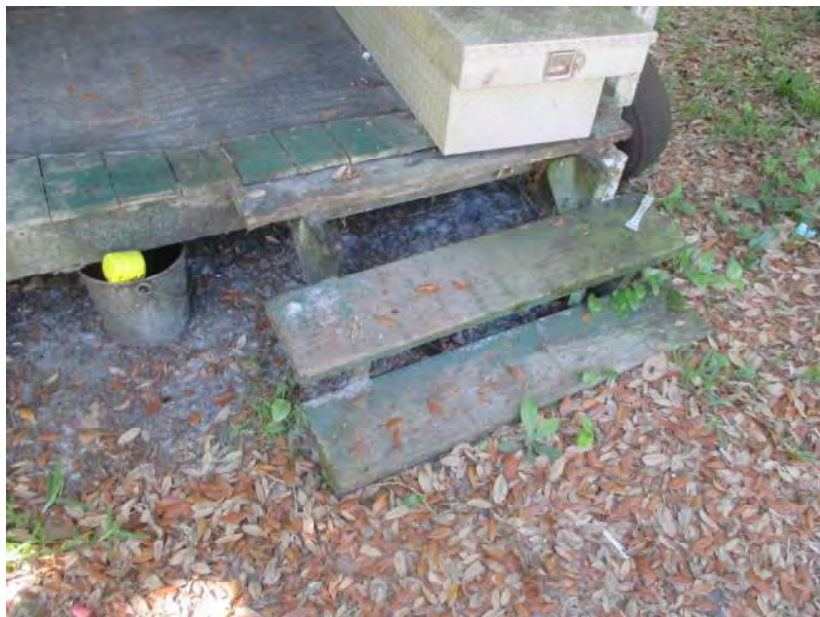
**Photograph 15**  
**Rotated and Deteriorated Main Entry Steps**

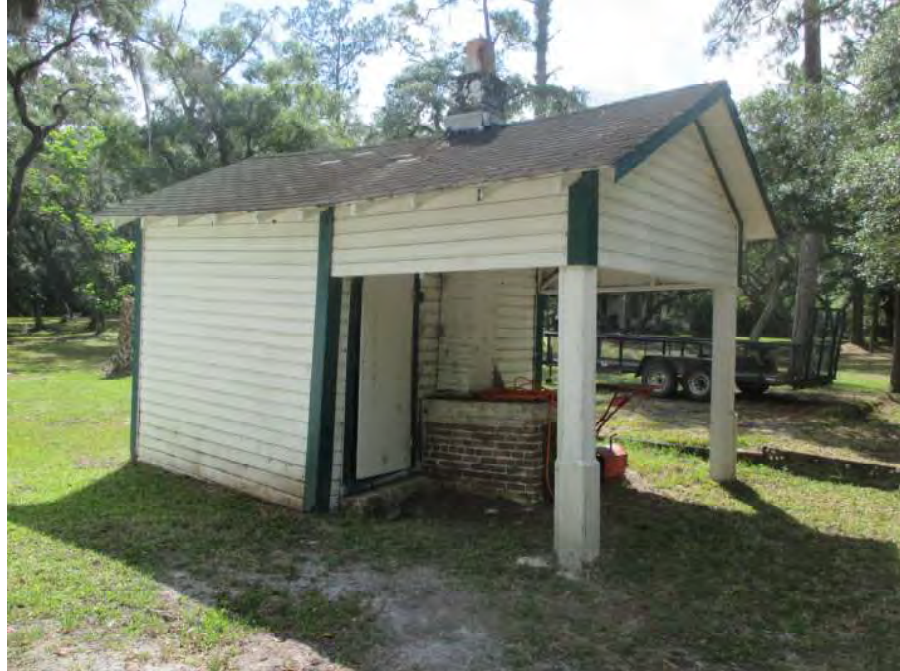
**Photograph 1**  
**Overall of Fryer Shed**

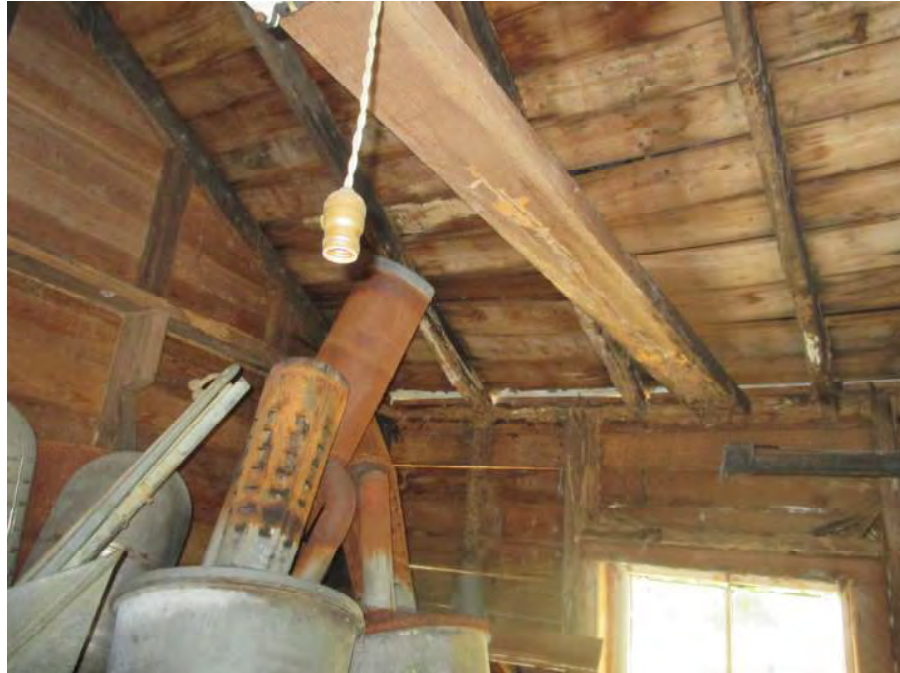
**Photograph 5**  
**Severely Deteriorated Wall and Roof Framing**

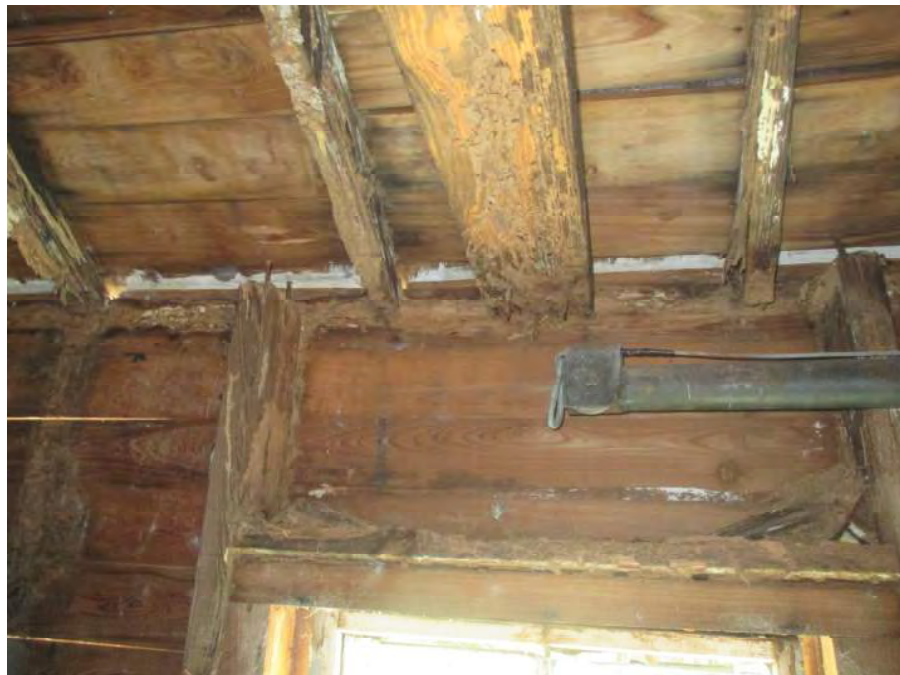
**Photograph 6**  
**Severely Deteriorated Wall and Roof Framing**

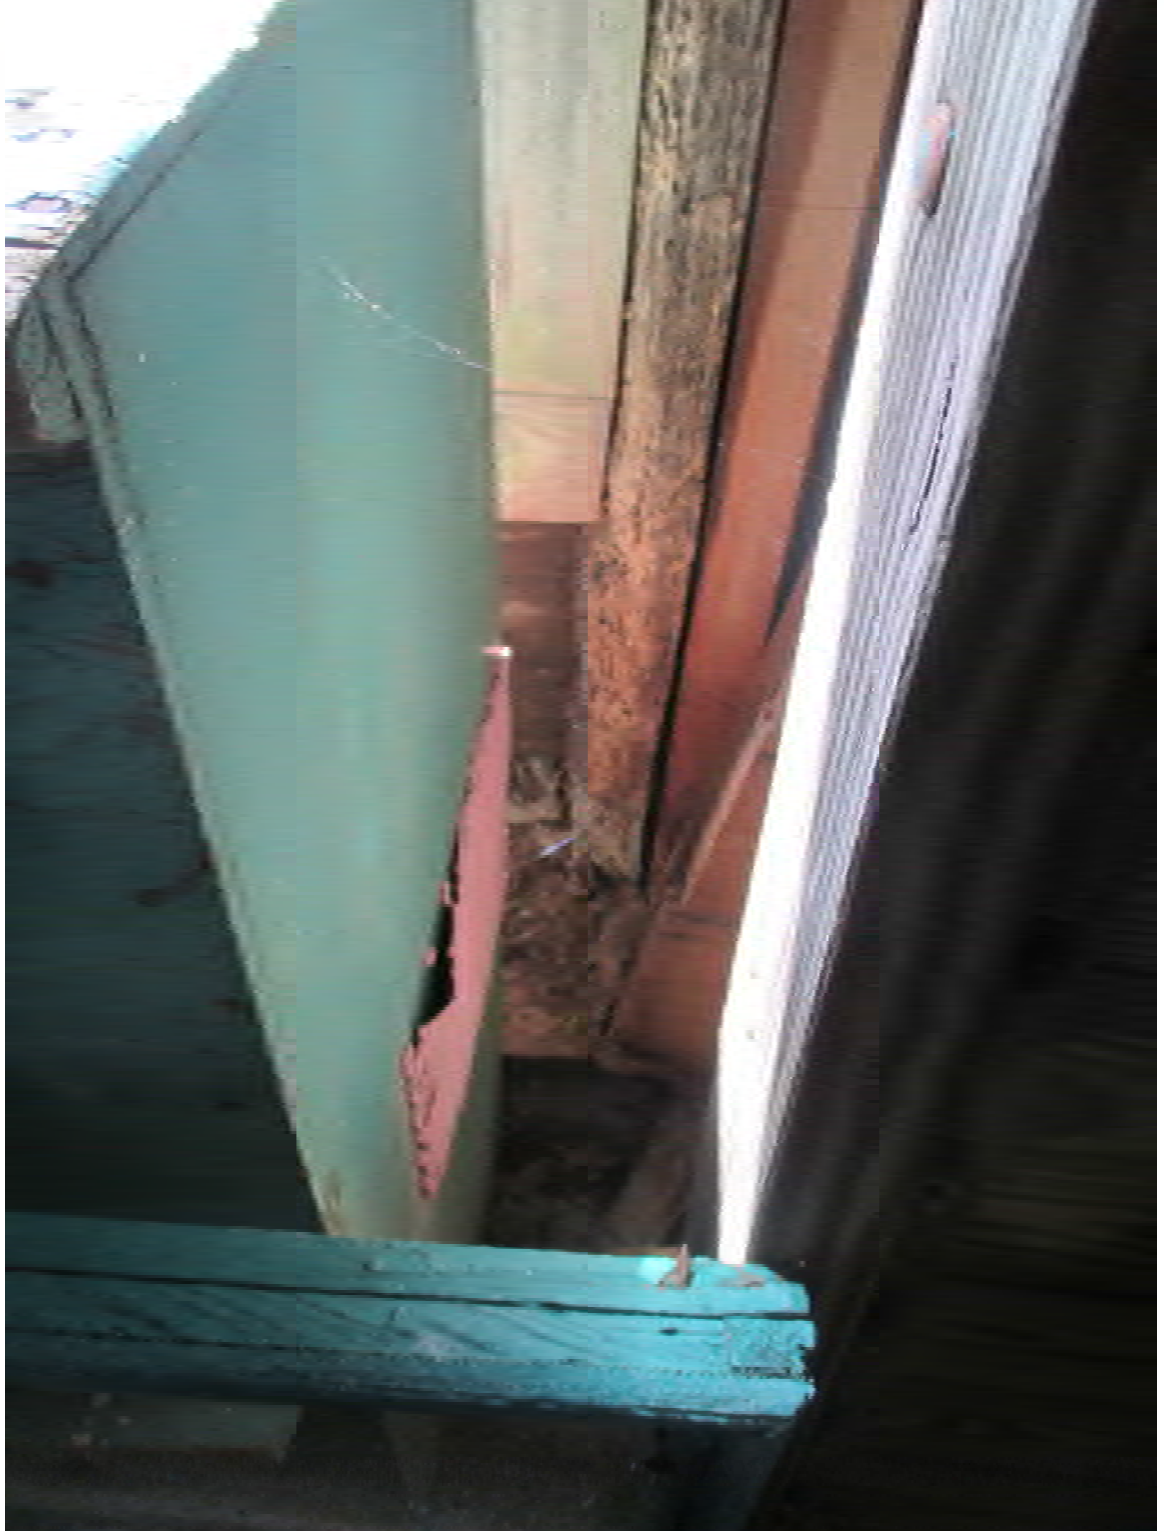
**Photograph 7**  
**Severely Deteriorated Wall Framing**

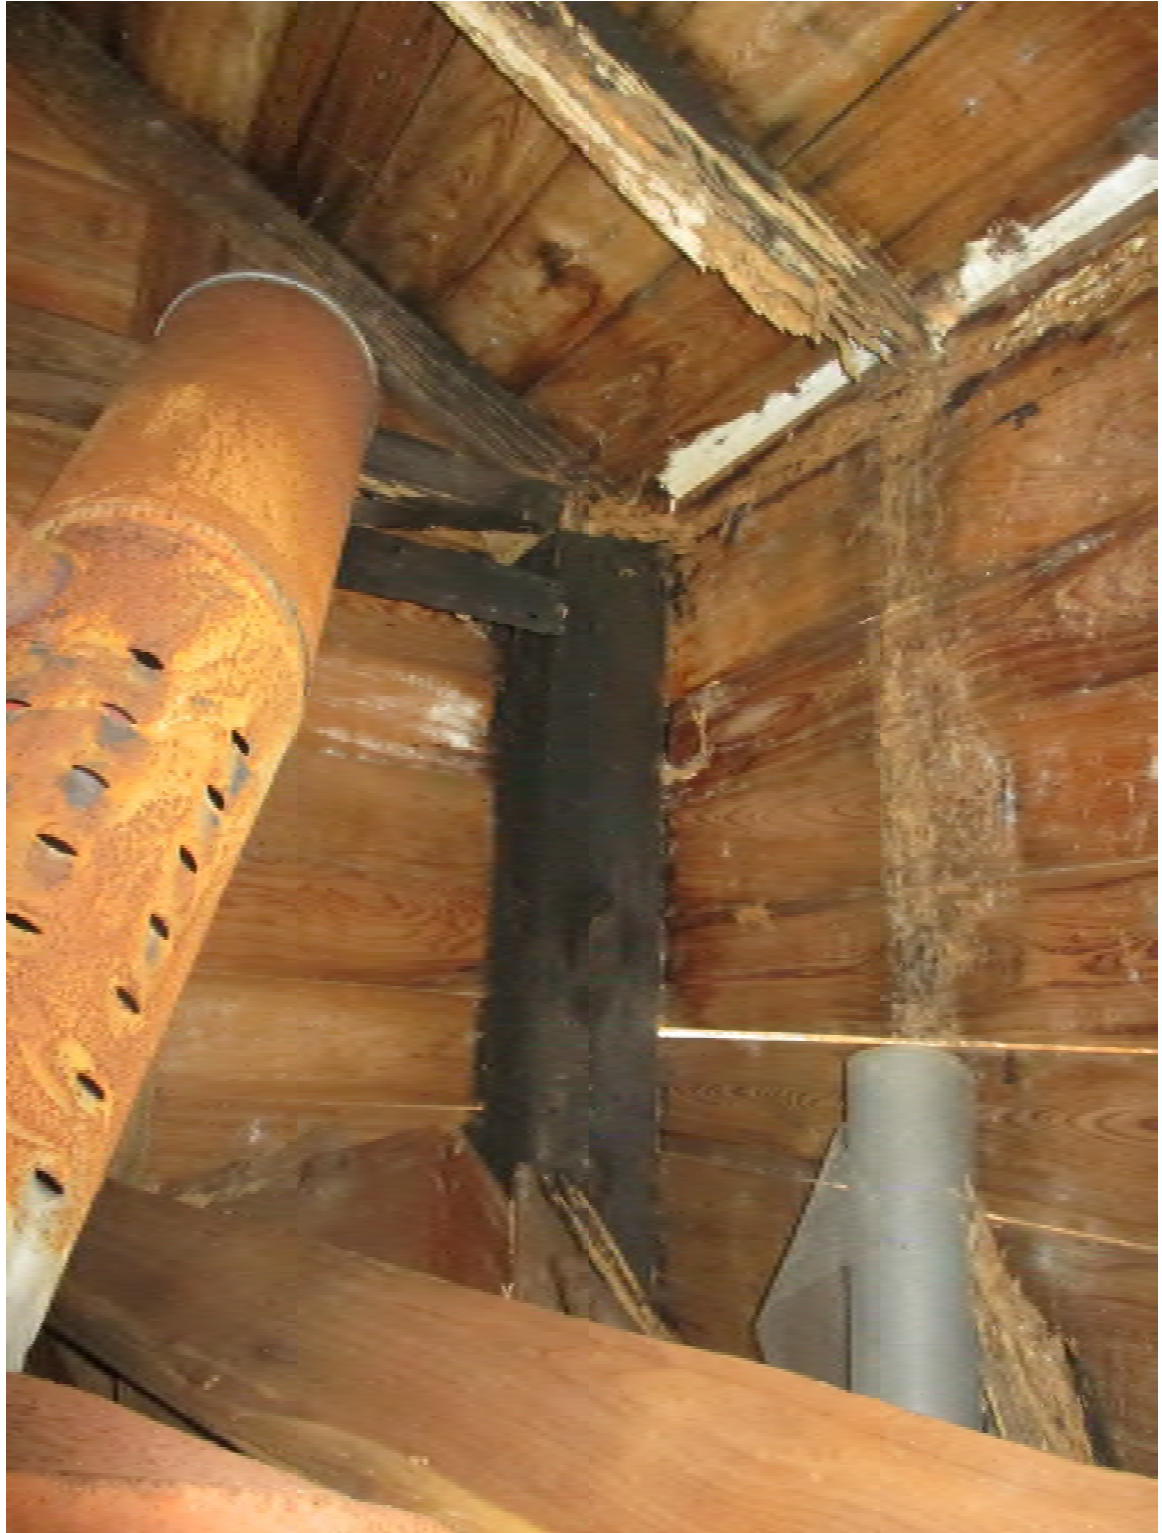
**Photograph 8**  
**Severely Deteriorated Wall and Roof Framing**

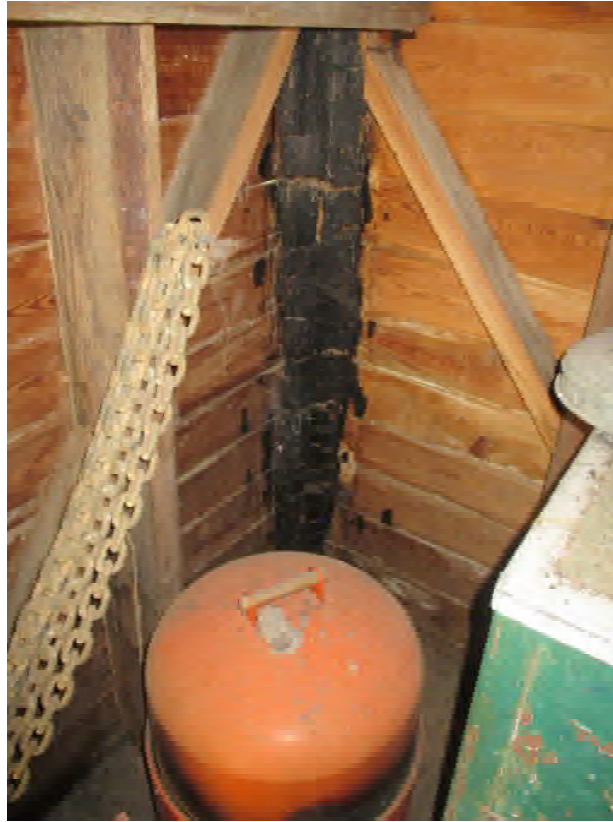
**Photograph 9**  
**Charred and Termite Damaged Column**

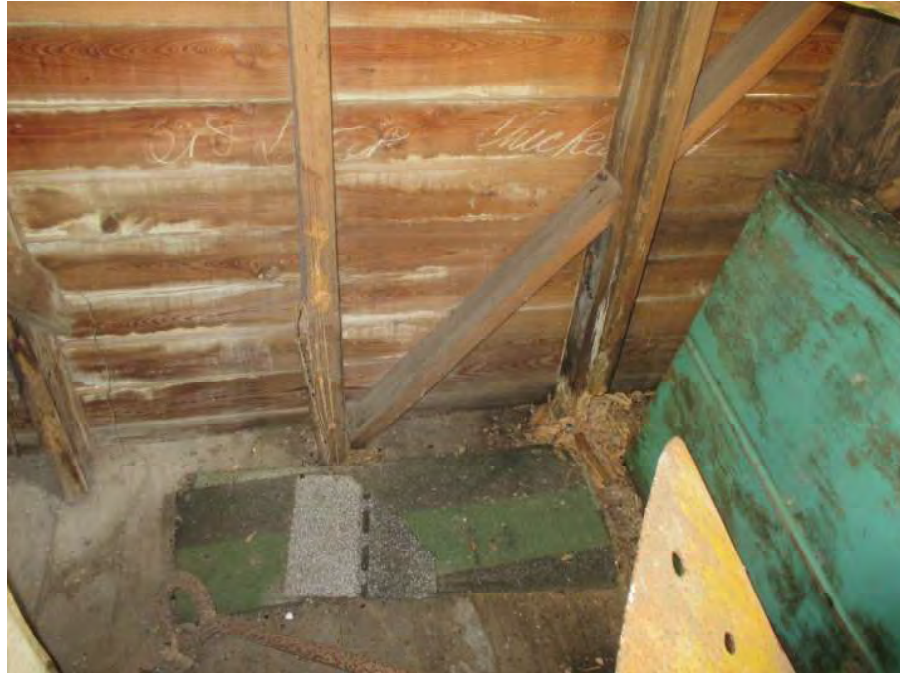
**Photograph 11**  
**Severely Deteriorated Wall Framing**

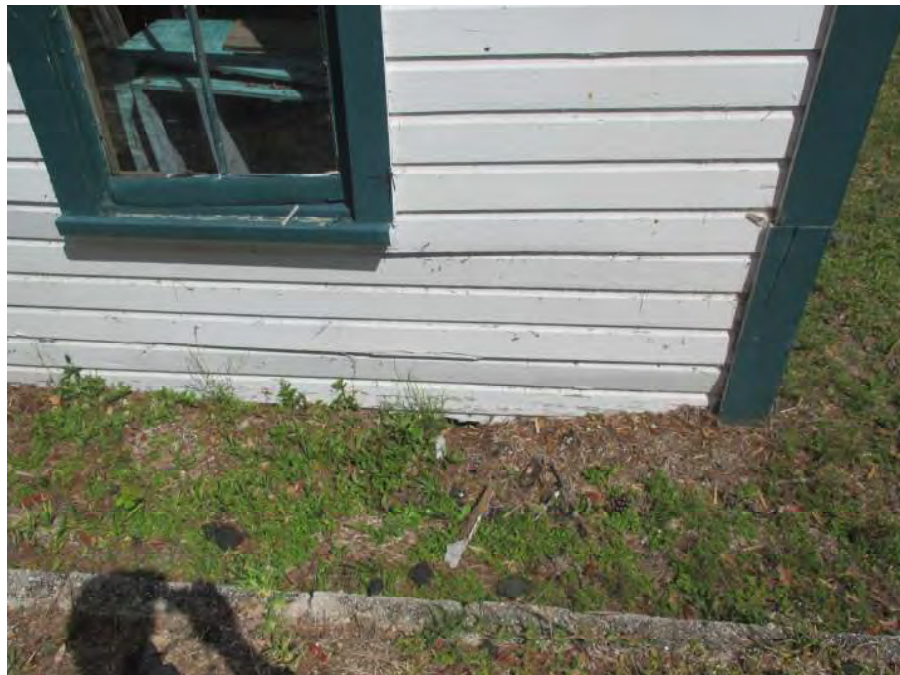
**Photograph 12**  
**Weathered Siding**

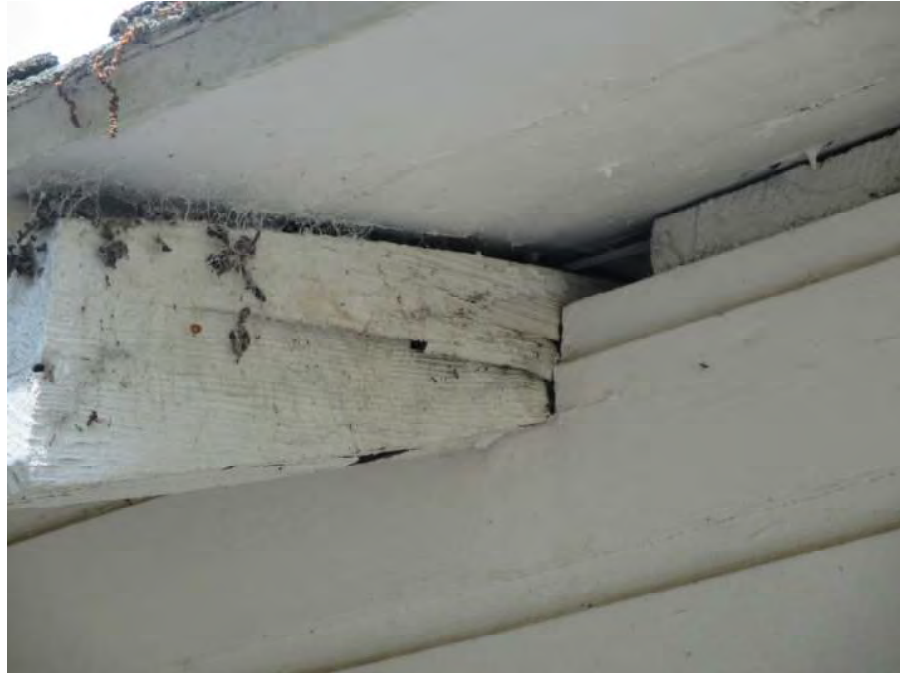
**Photograph 13**  
**Deteriorated Roof Joist**

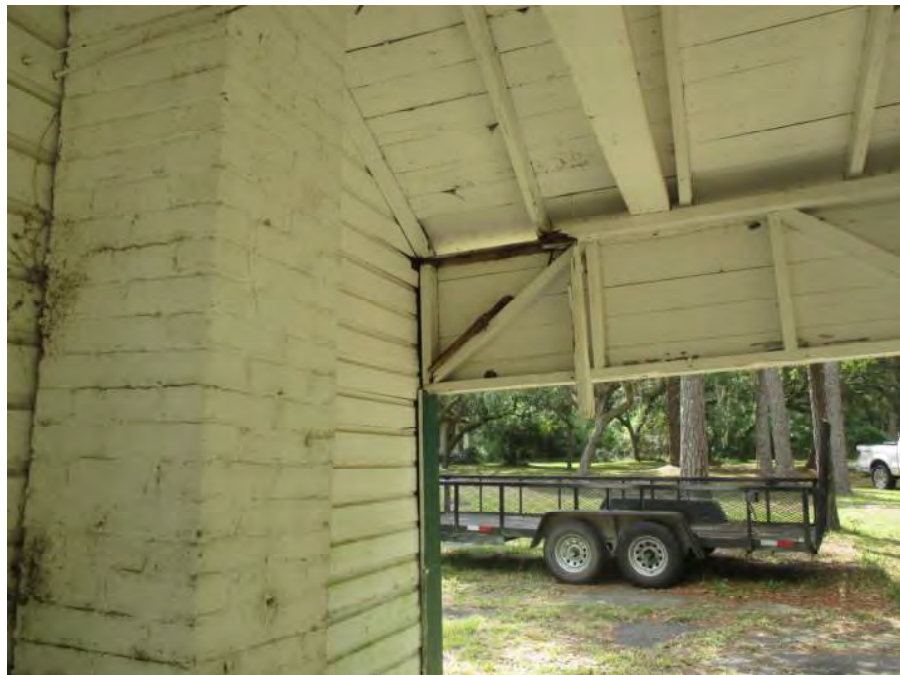
**Photograph 14**  
**Deteriorated Porch Framing**

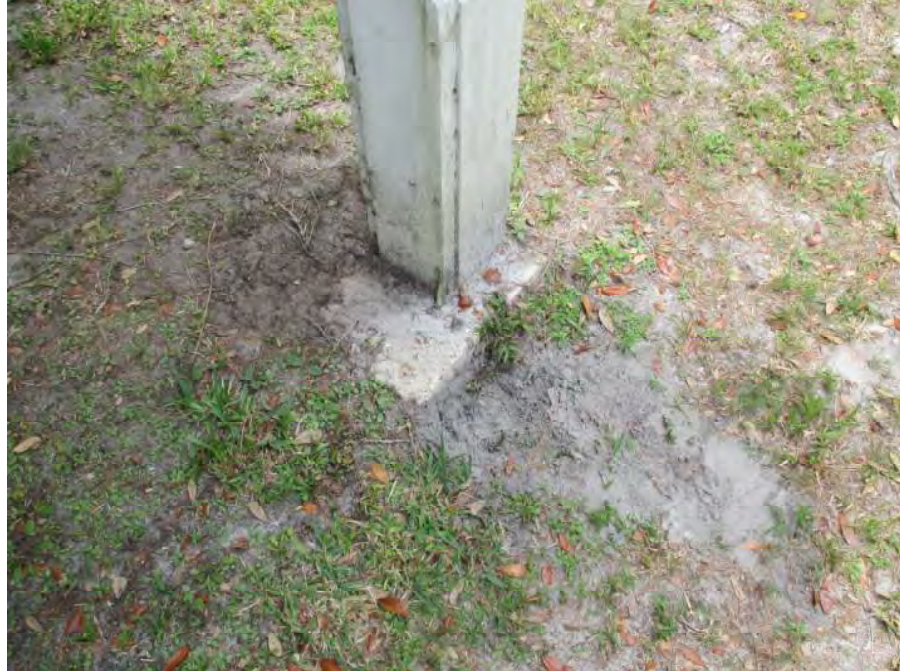
**Photograph 15**  
**Settled Column Foundation**

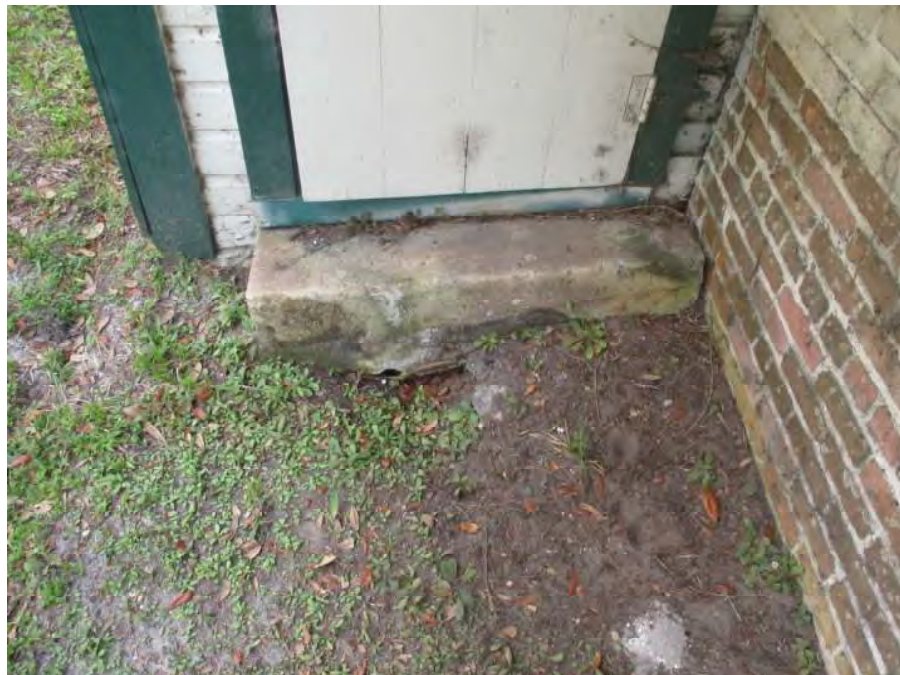
**Photograph 16**  
**Settled Entry Step**

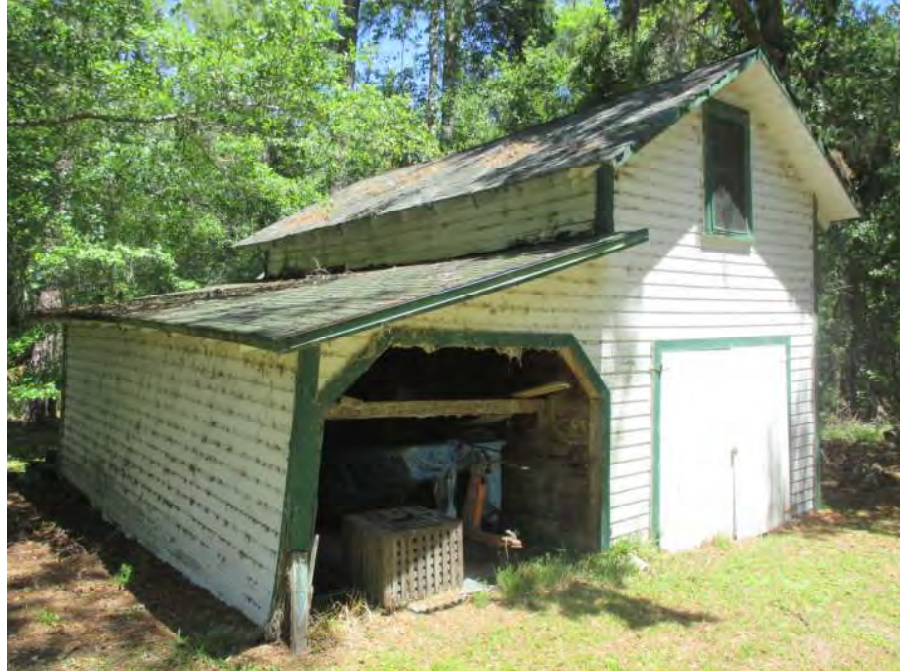
**Photograph 1**  
**Overall Attic Garage**

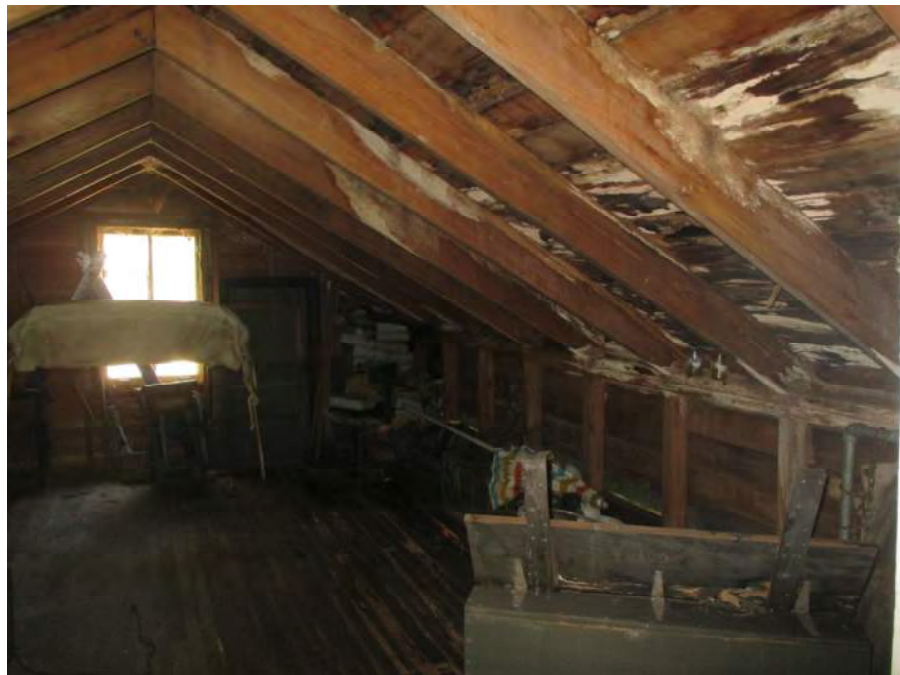
**Photograph 2**  
**Deteriorated Roof and Wall Framing**

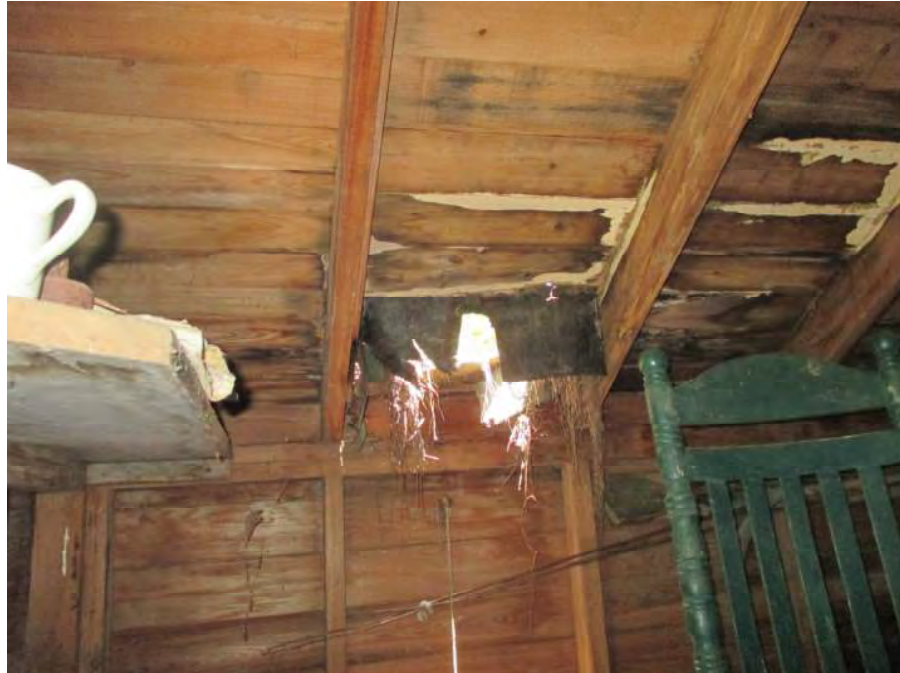
**Photograph 3**  
**Deteriorated Roof Framing and Sheathing**

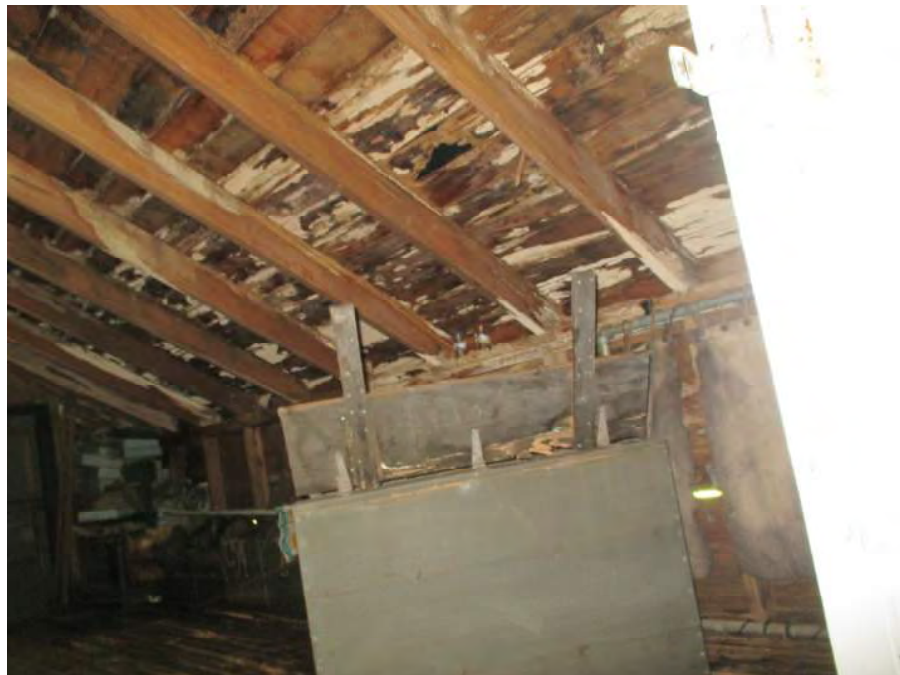
**Photograph 4**  
**Deteriorated Roof Sheathing and Framing**

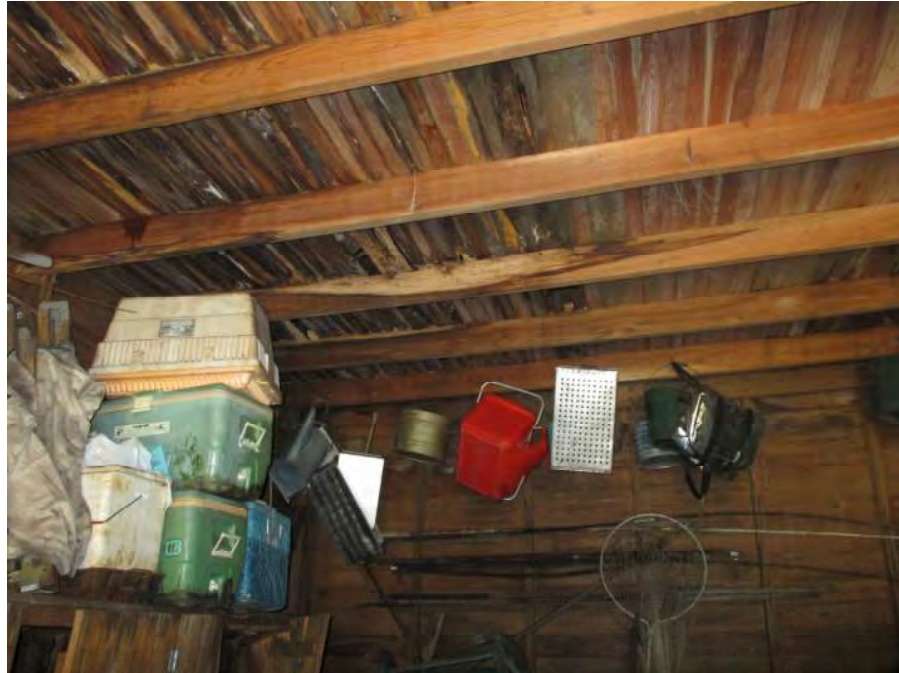
**Photograph 5**  
**Deteriorated Floor Framing and Decking**

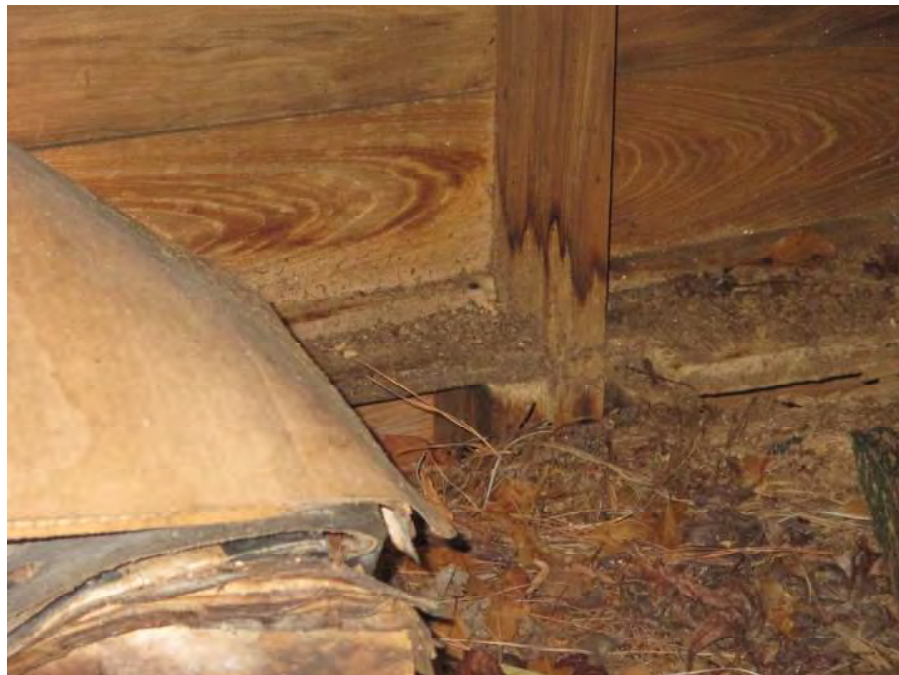
**Photograph 6**  
**Deteriorated Wall to Second-Floor Intersection**

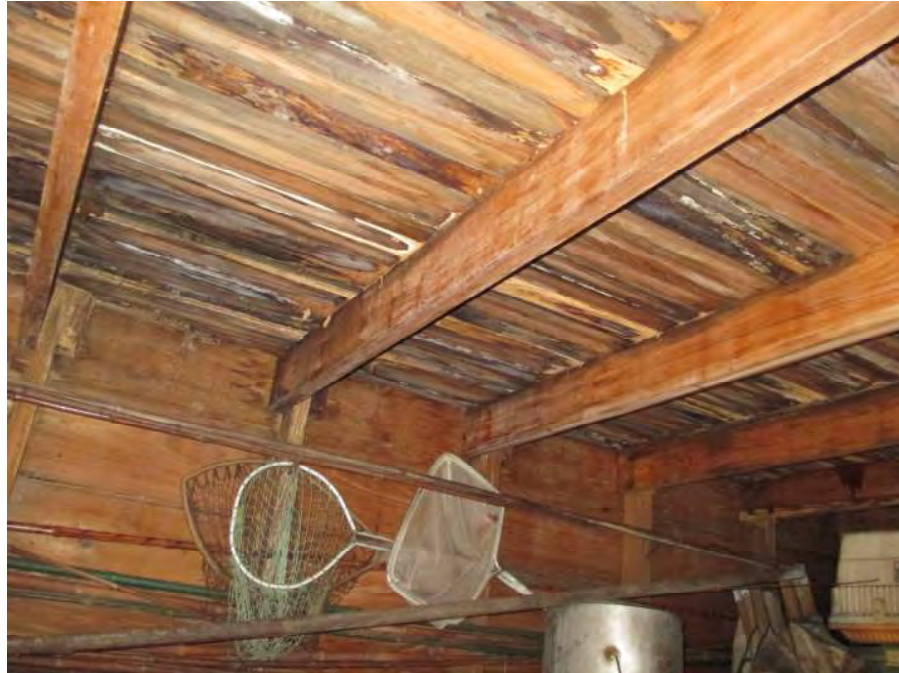
**Photograph 7**  
**Deteriorated Wall to Second-Floor Intersection**

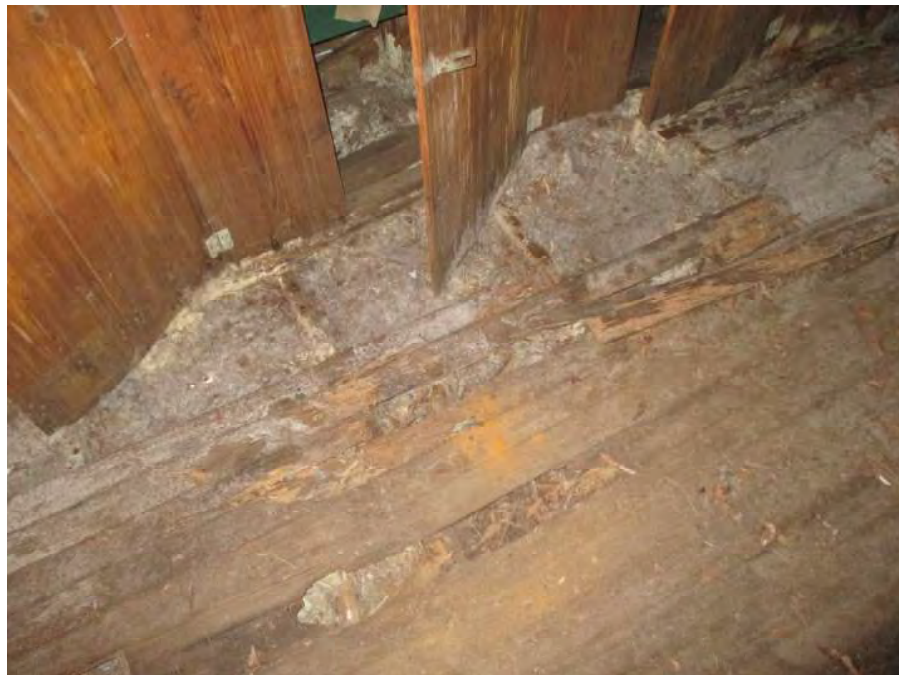
**Photograph 8**  
**Deteriorated Floor Decking and Framing Bearing on Grade**

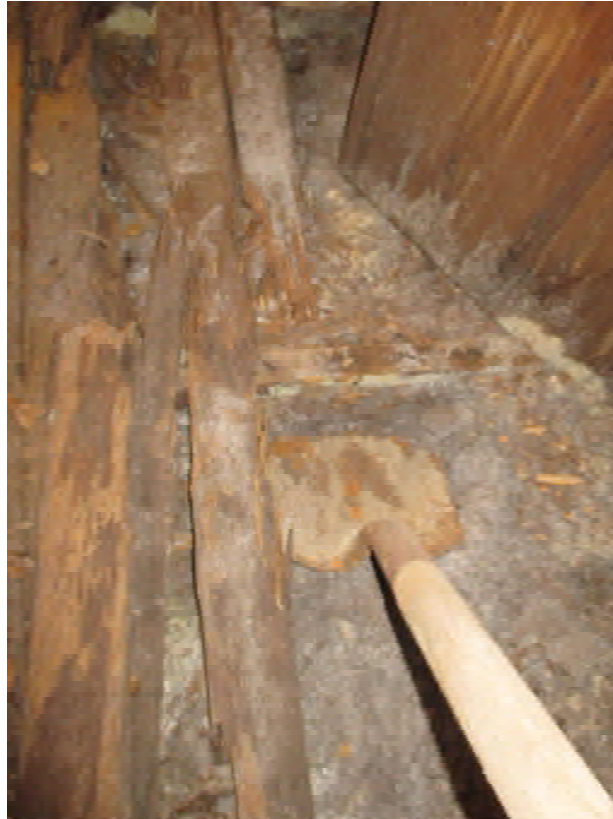
**Photograph 9**  
**Deteriorated Floor Decking and Framing Bearing on Grade**

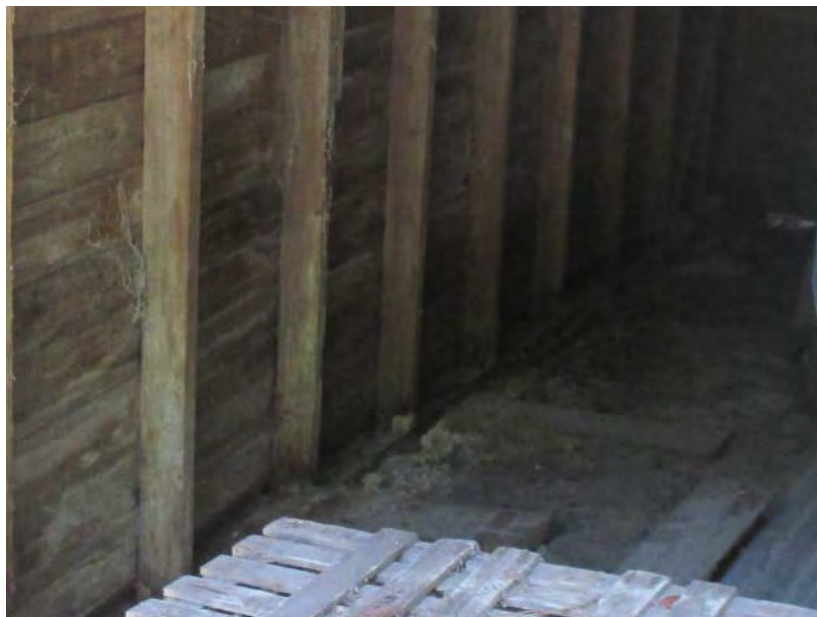
**Photograph 10**  
**Base of Wall Studs Deteriorated**

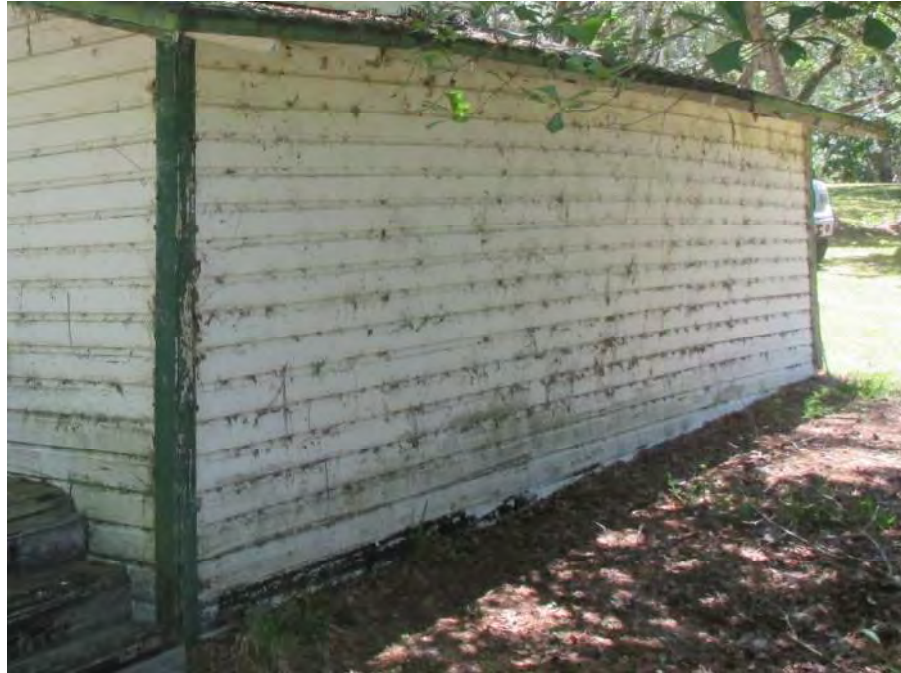
**Photograph 11**  
**Perimeter Vegetation Buildup**

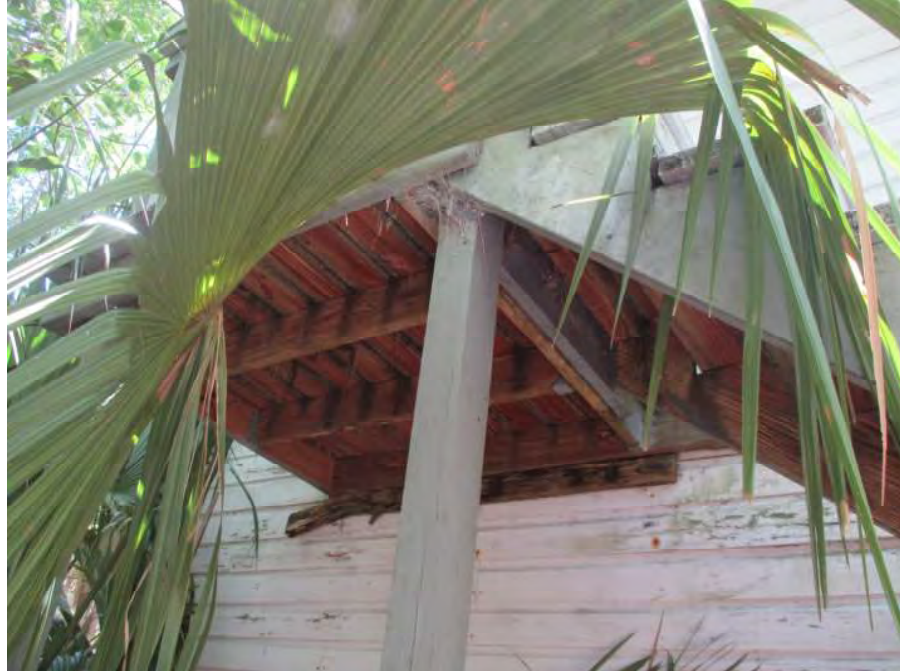
**Photograph 13**  
**Stair Ledger Severely Deteriorated**

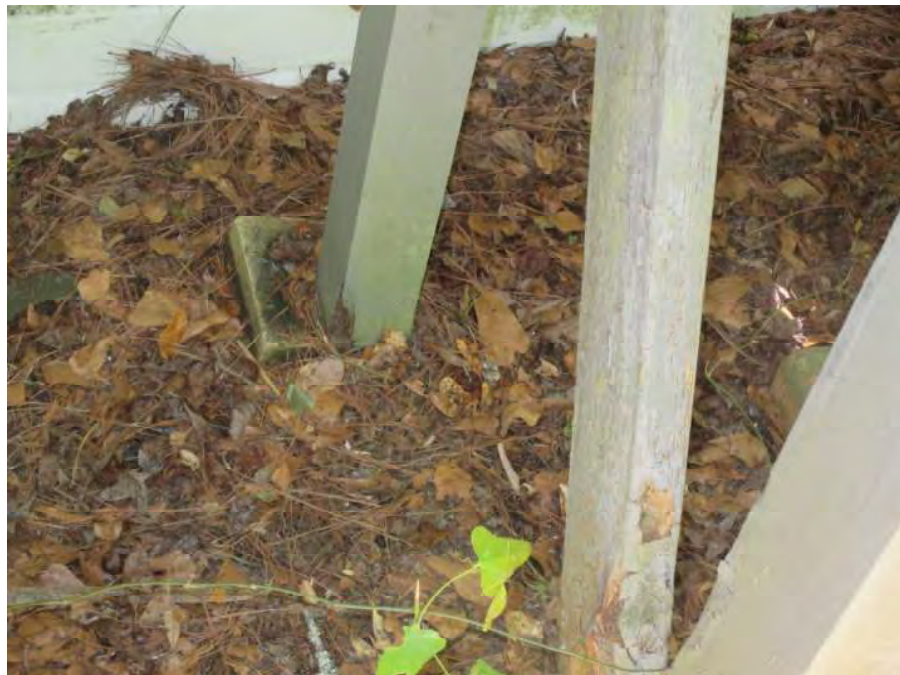
**Photograph 14**  
**Stair Column Not on Stable Foundation**

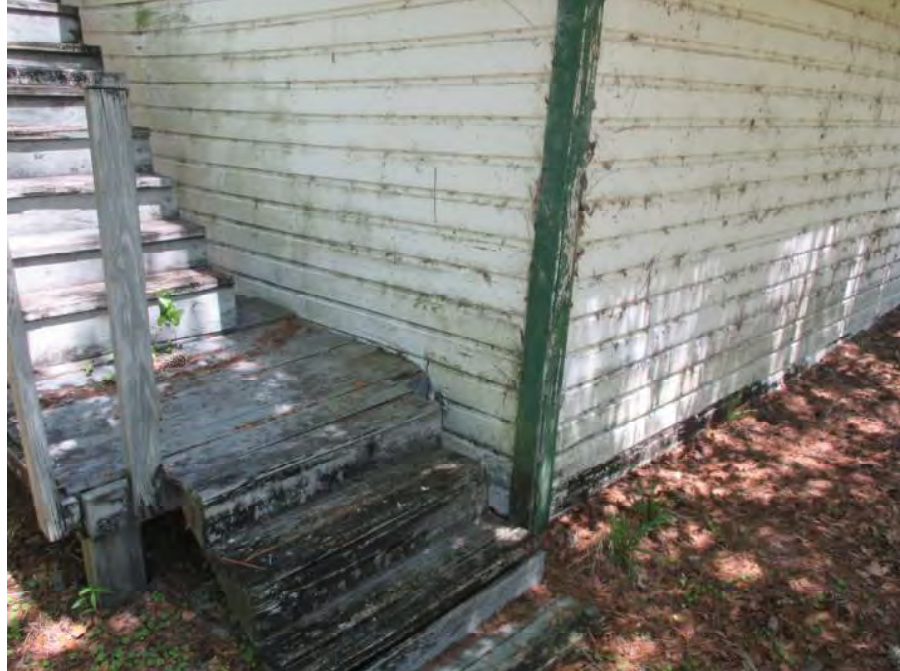
**Photograph 15**  
**Severely Deteriorated Attic Access Stair**

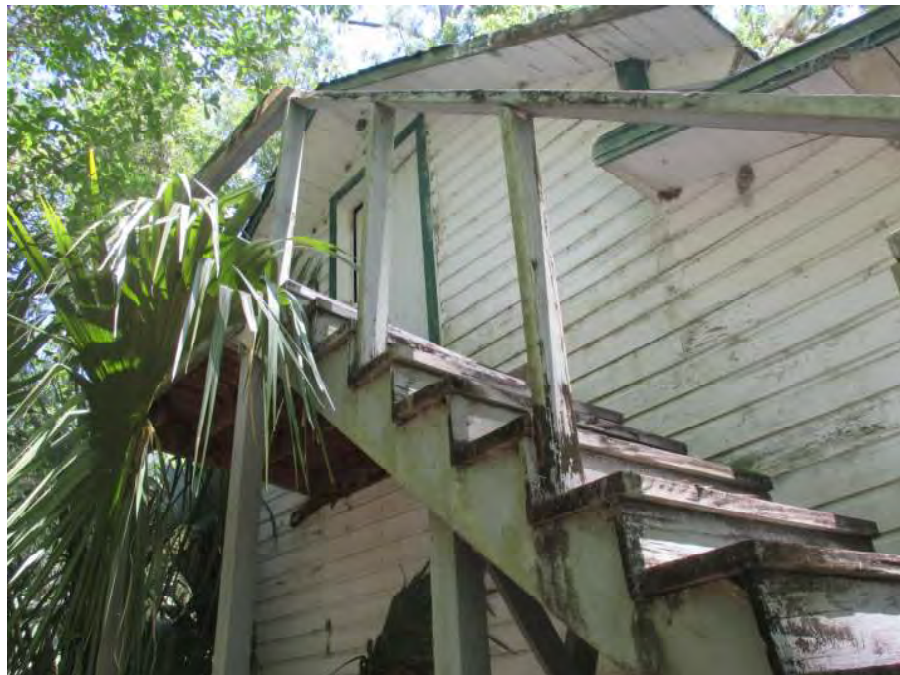
**Photograph 16**  
**Severely Deteriorated Attic Access Stair**

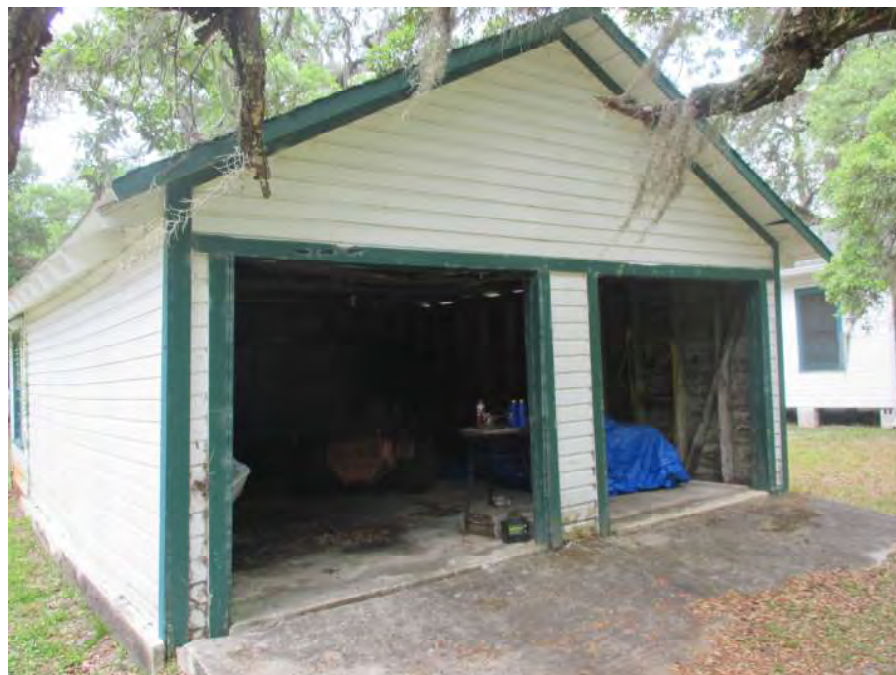
**Photograph 1**  
**Overall Double Garage Entry**

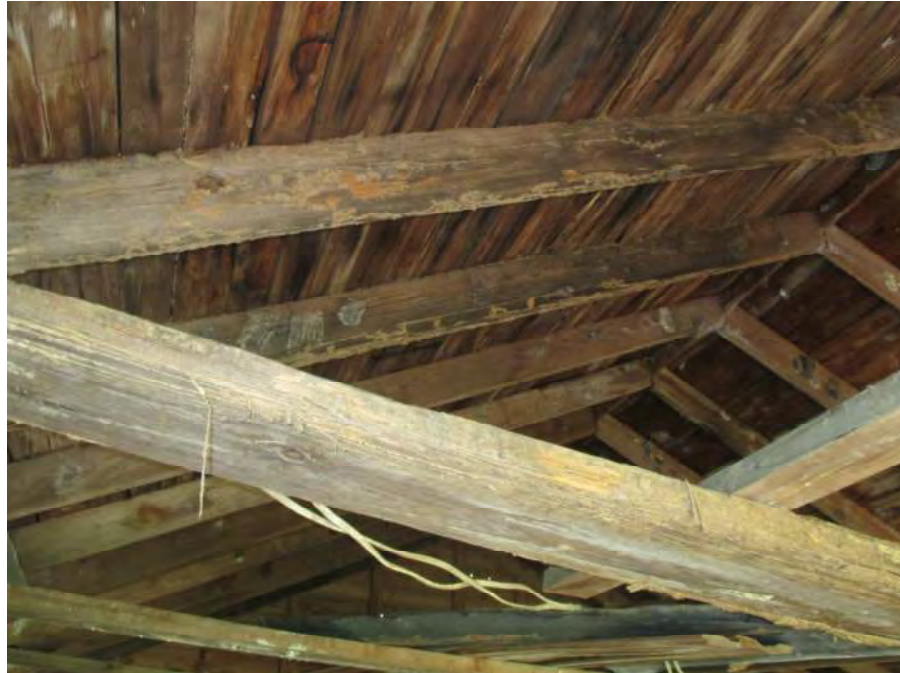
**Photograph 2**  
**Deteriorated Roof Rafters**

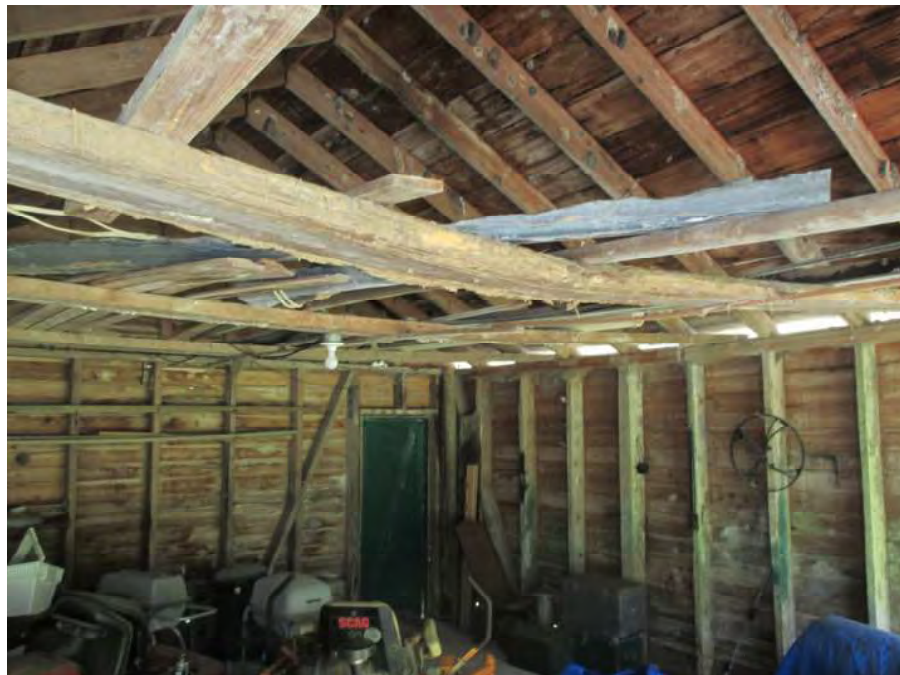
**Photograph 3**  
**Termite Damaged Framing**
