# **HISTORIC STRUCTURE ASSESSMENT REPORT**

## **VISTA HISTORIC SITE Lower Suwannee National Wildlife Refuge**

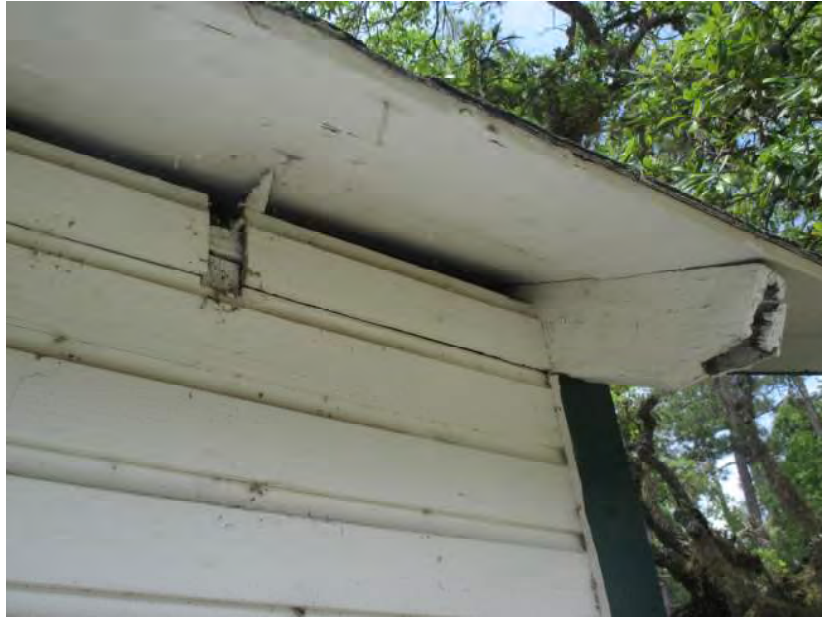
**Photograph 4**  
**Deteriorated Rafter Tails**

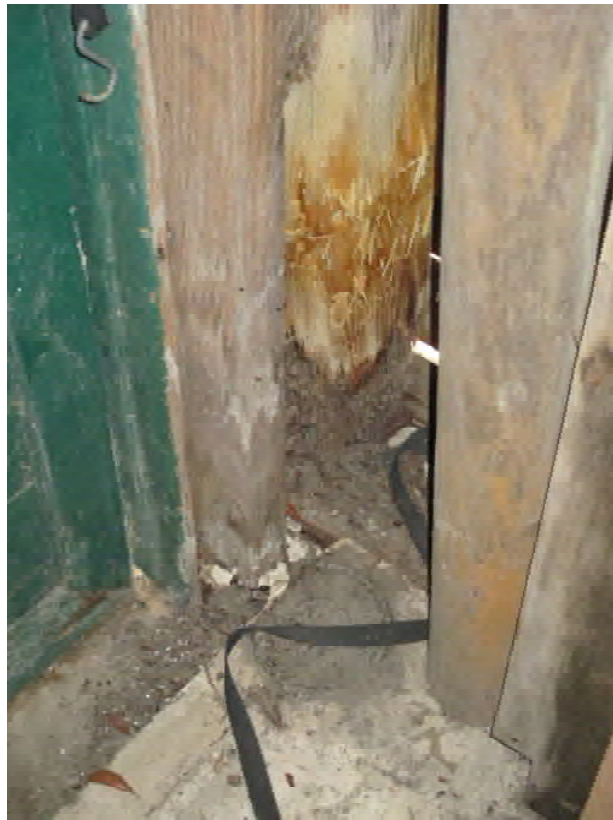
**Photograph 5**  
**Deteriorated Corner Column**

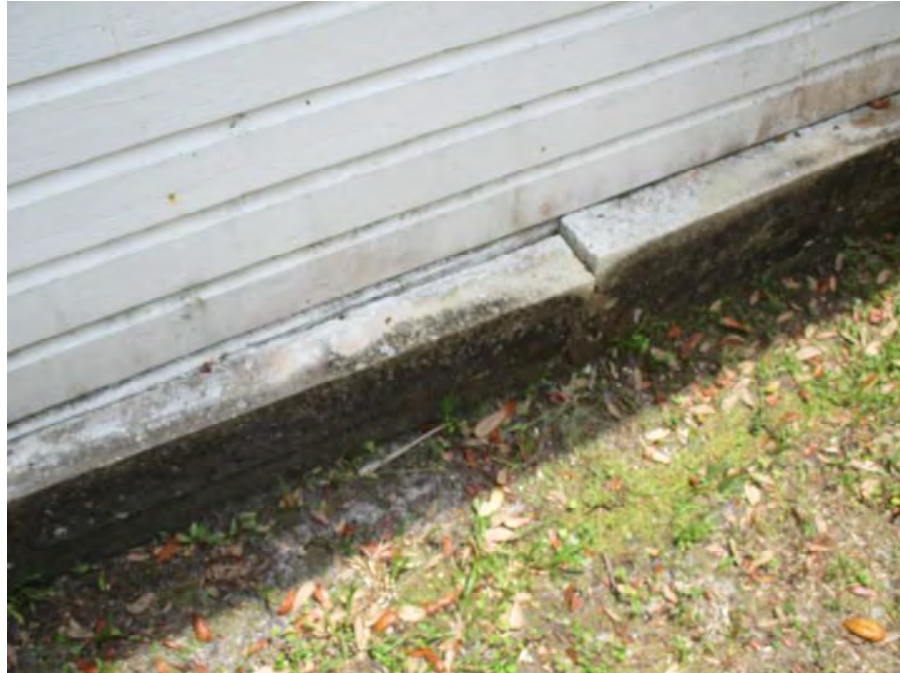
**Photograph 6**  
**Vertical and Horizontal Foundation Displacement**

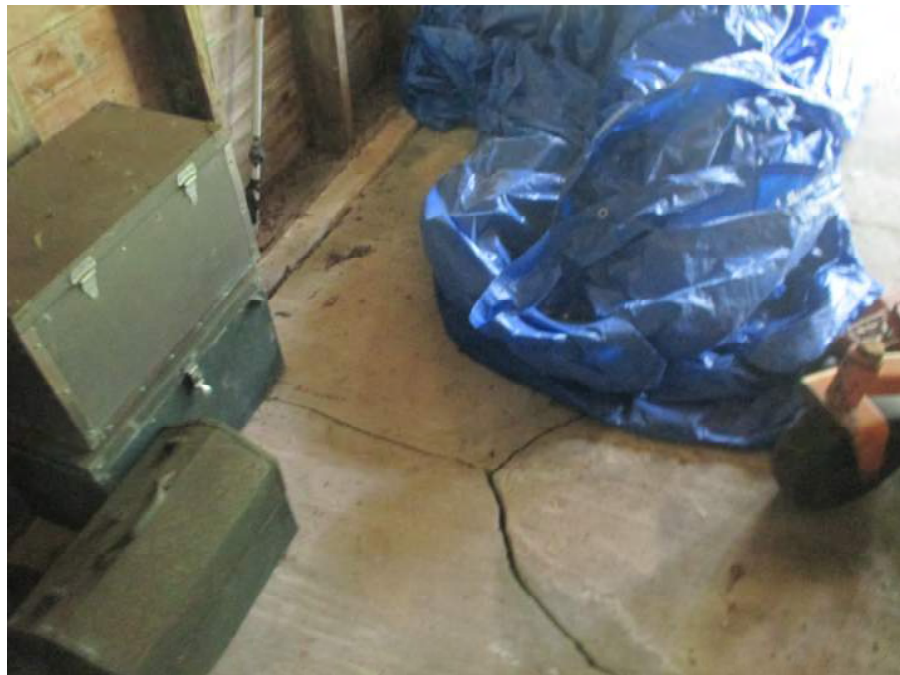
**Photograph 7**  
**Vertical and Horizontal Slab Displacement**

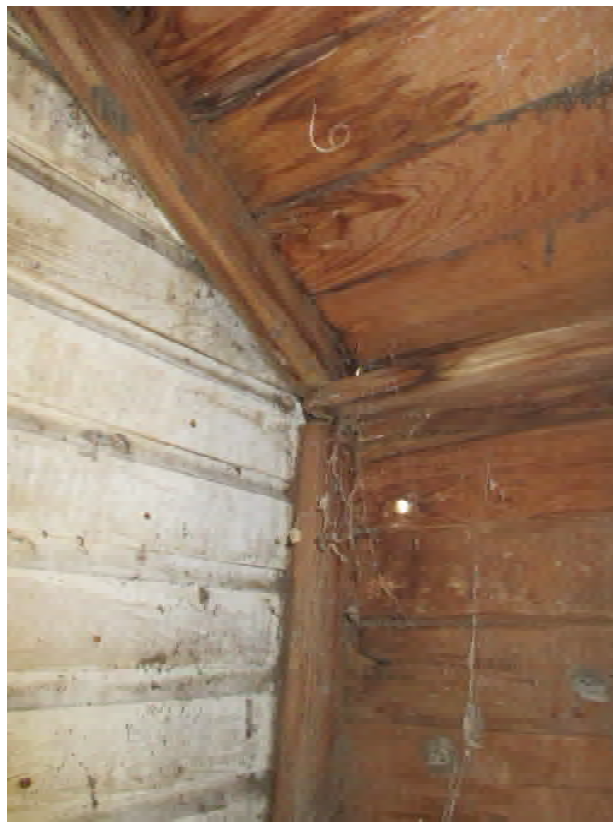
**Photograph 9**  
**Deteriorated Rear Shed Wall Framing**

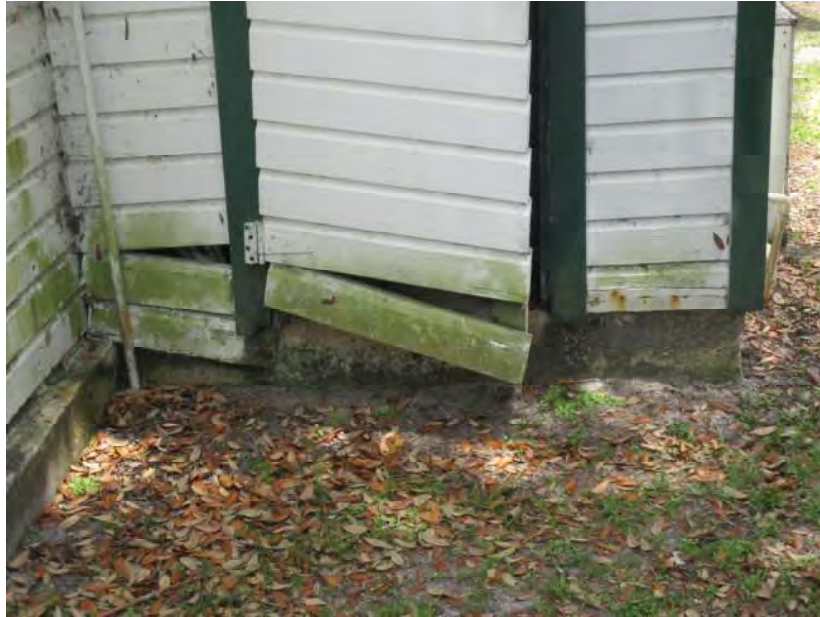
**Photograph 10**  
**Deteriorated Shed Siding**

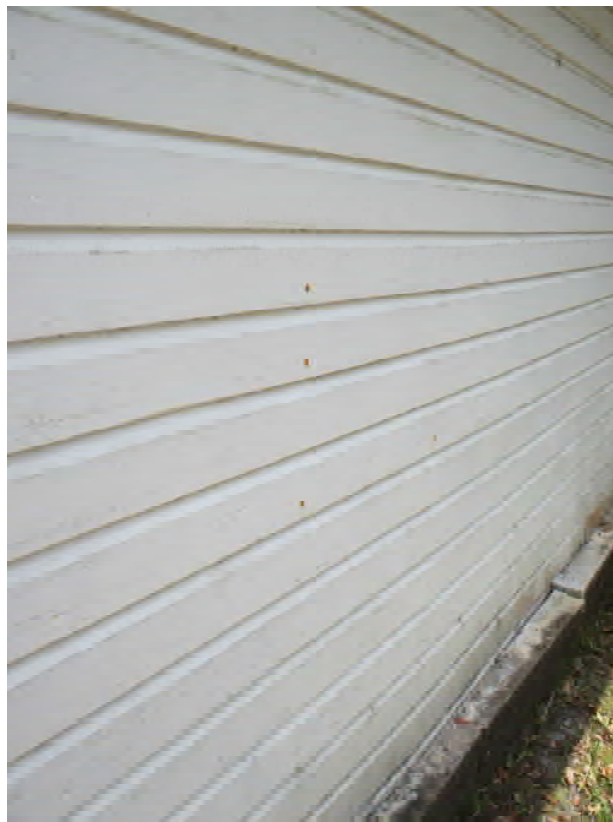
**Photograph 11**  
**Corroded Fasteners Throughout**

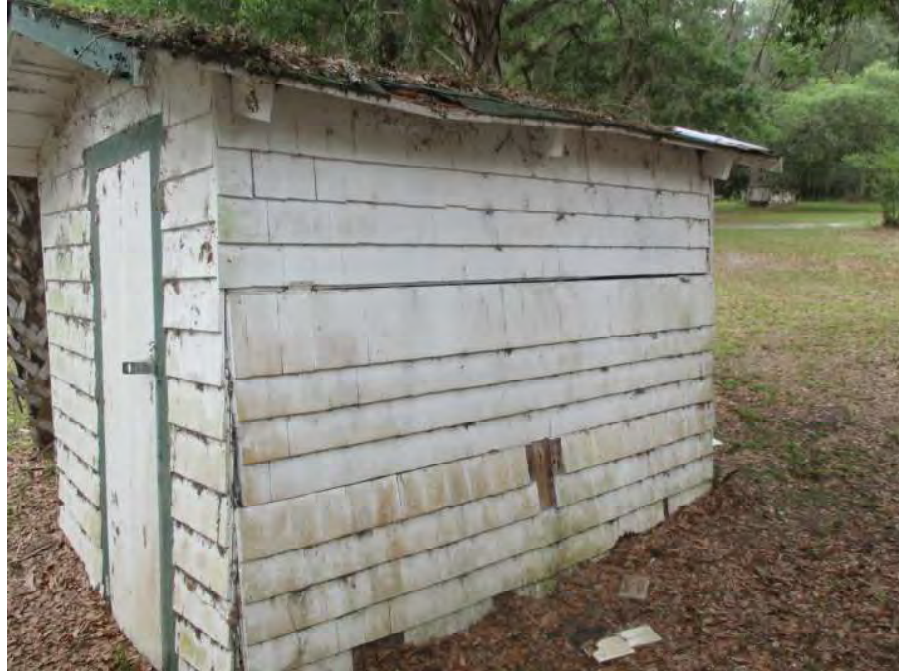
**Photograph 1**  
**Vertically Hinged Woodshed Access Door**

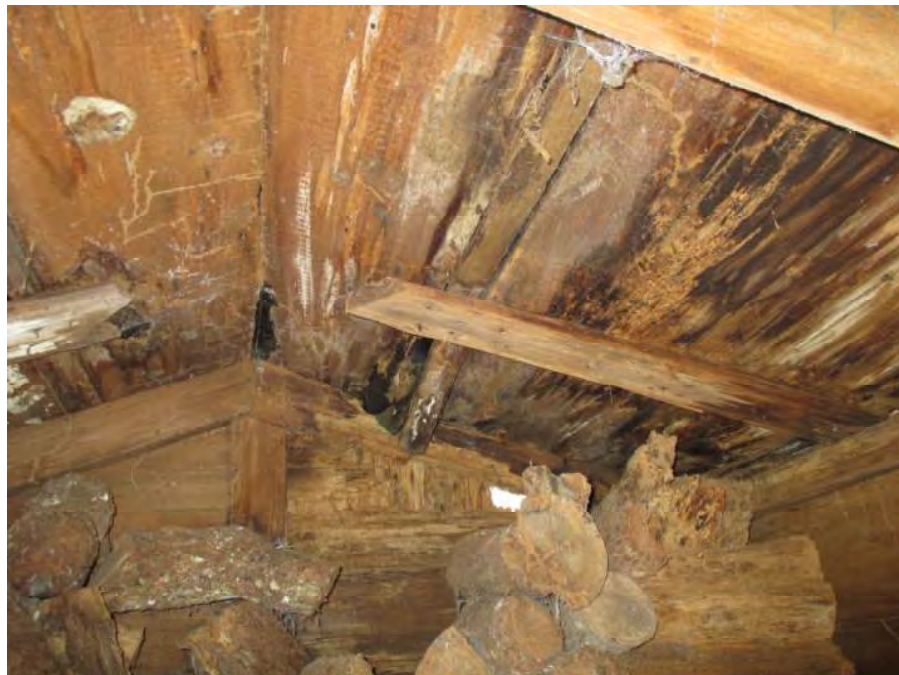
**Photograph 2**  
**Severely Deteriorated Roof Framing, Roof and Wall Sheathing**

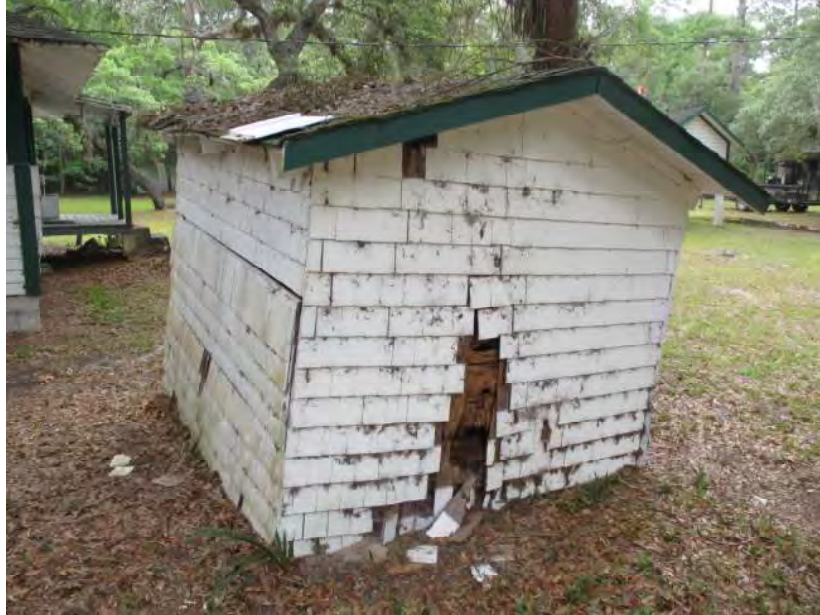
**Photograph 3**  
**Severely Deteriorated Wall Sheathing and Siding**

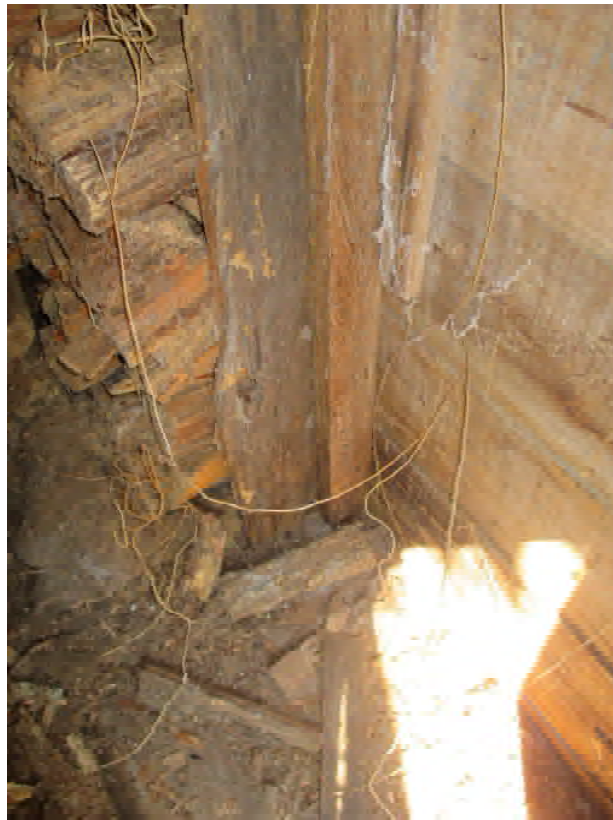
**Photograph 4**  
**Deteriorated Wall Framing and Sheathing**

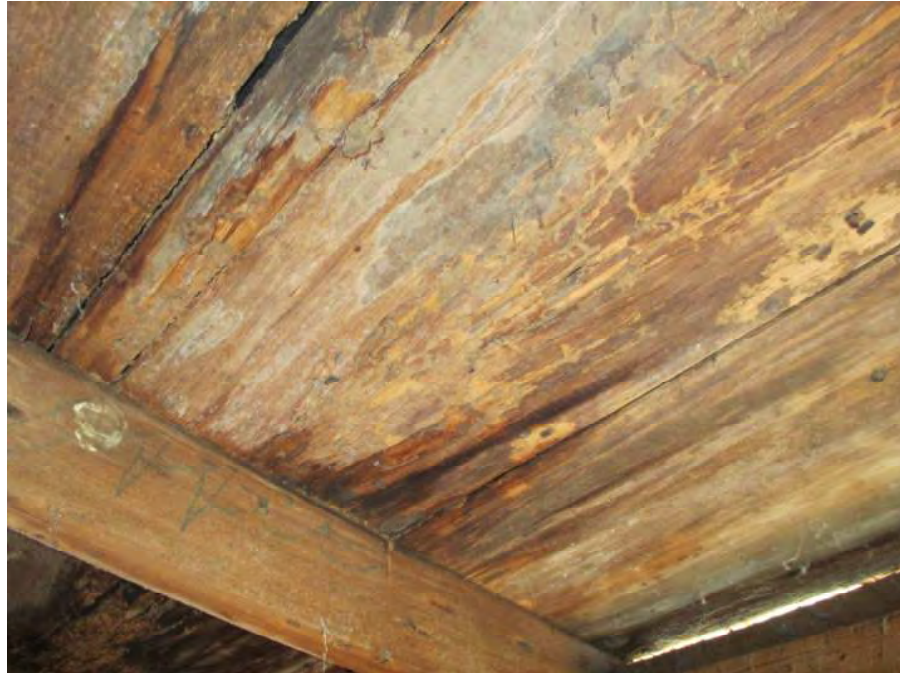
**Photograph 5**  
**Deteriorated Roof Sheathing**

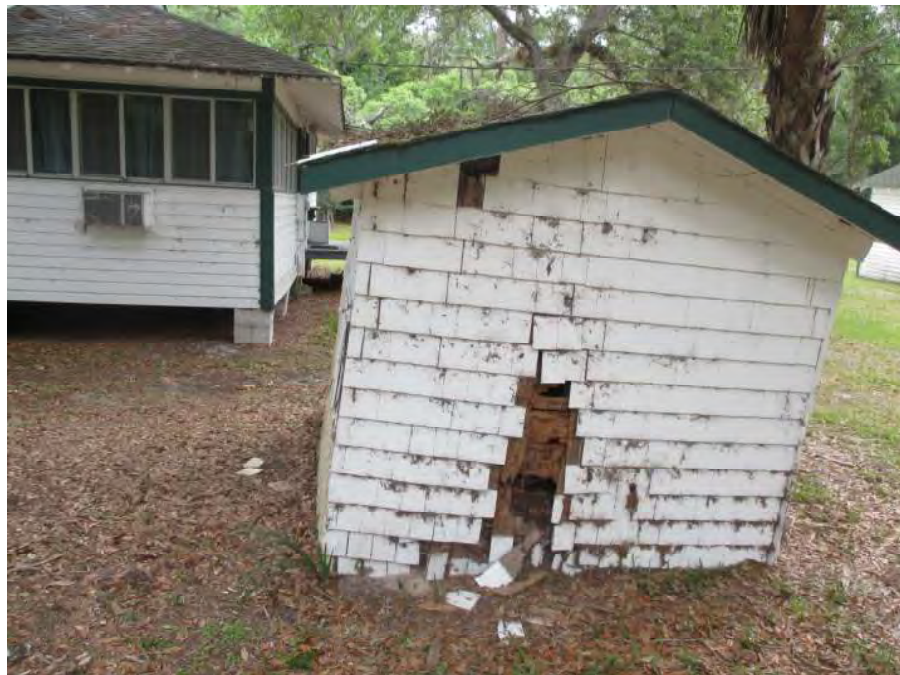
**Photograph 6**  
**Settled and Racked Structure**

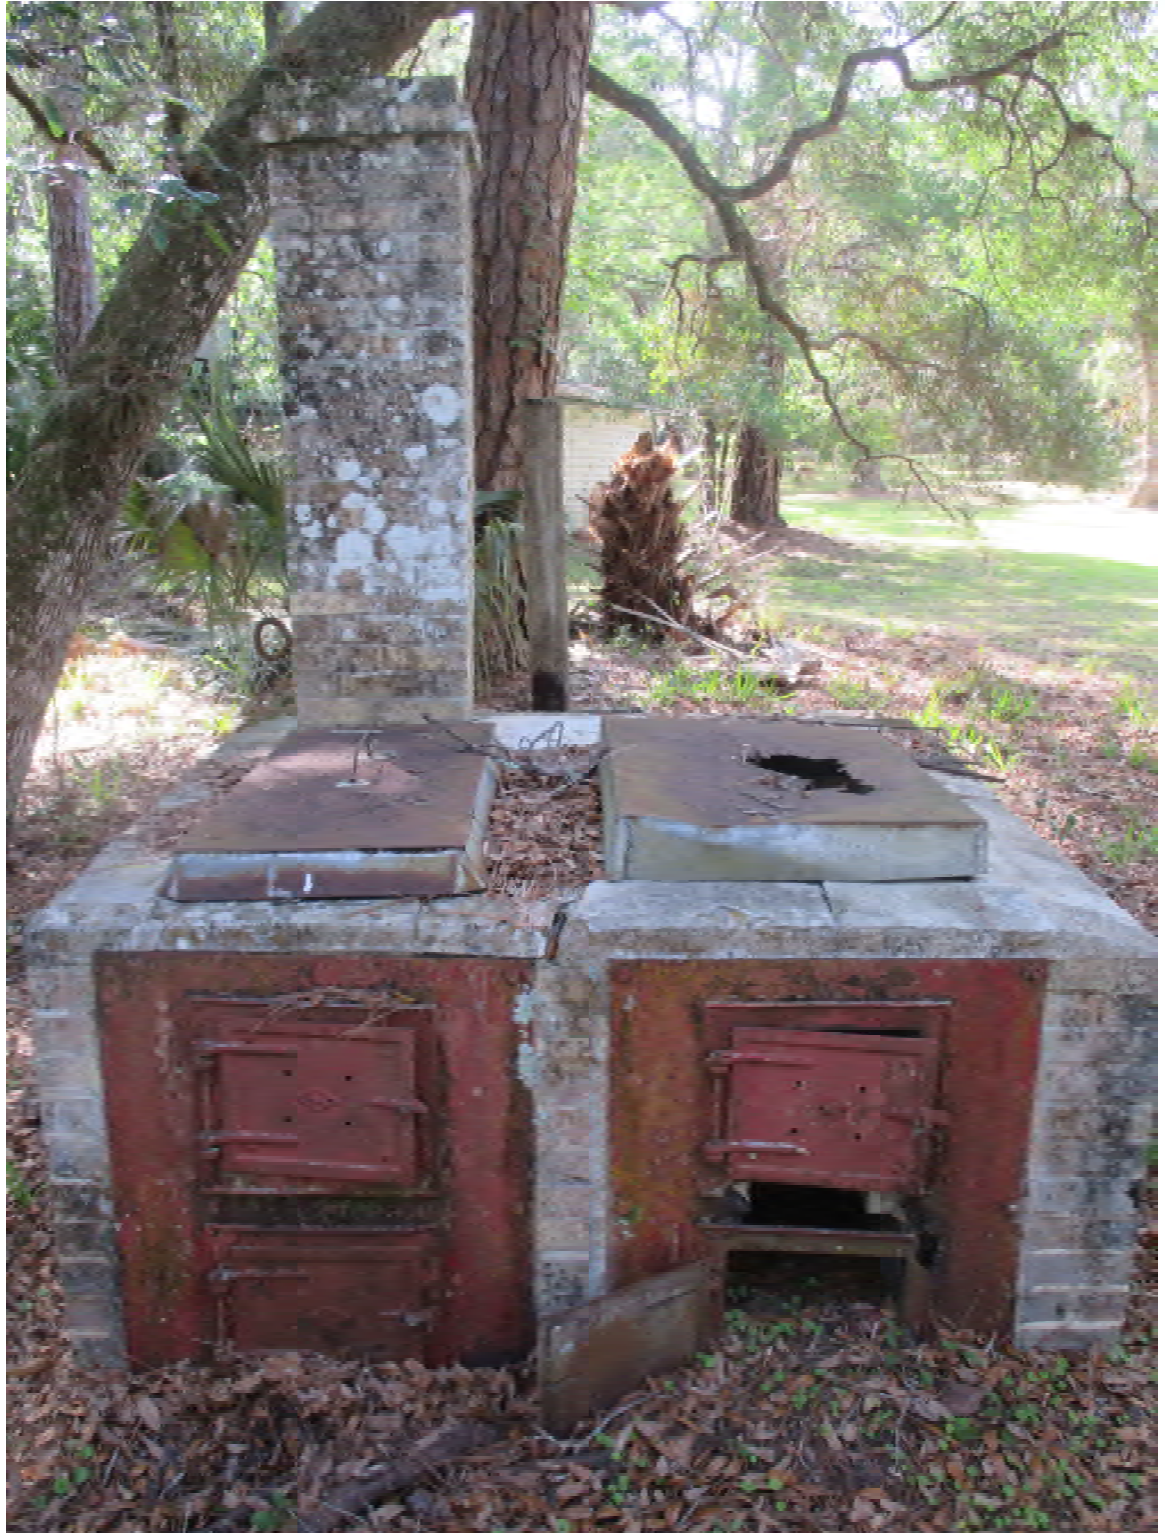
**Photograph 1**  
**Overall Outdoor Grill Front**

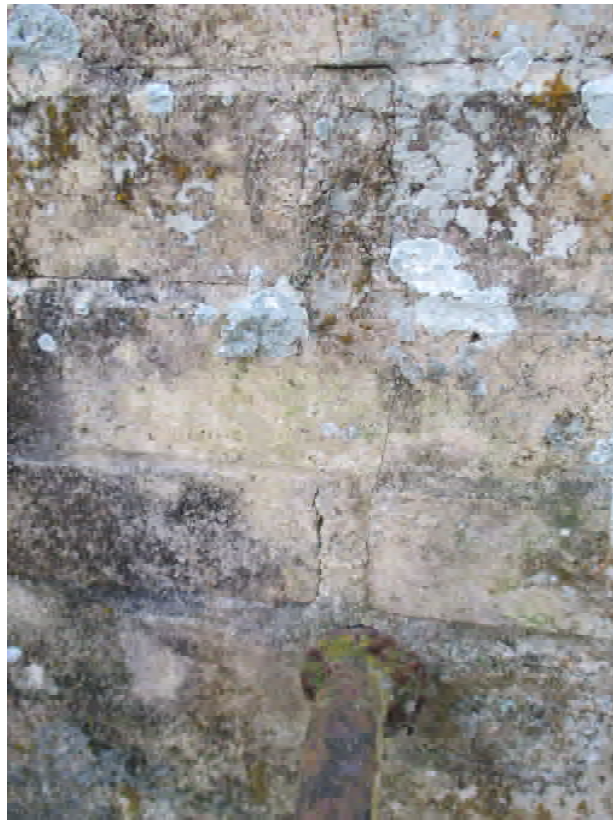
**Photograph 3**  
**Vertical Crack in Clay Brick**

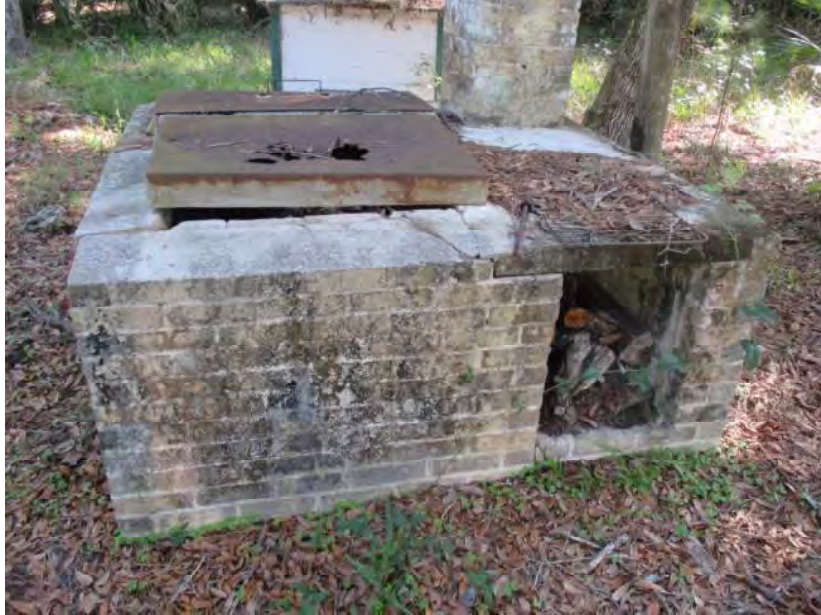
**Photograph 4**  
**Settling of Northwest Corner**

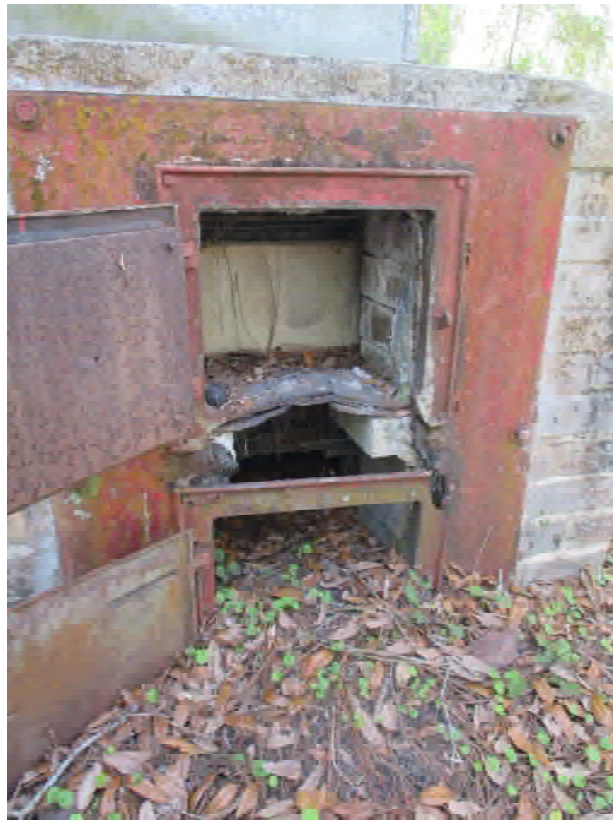
**Photograph 5**  
**Deteriorated Access Doors and Settled Corner**

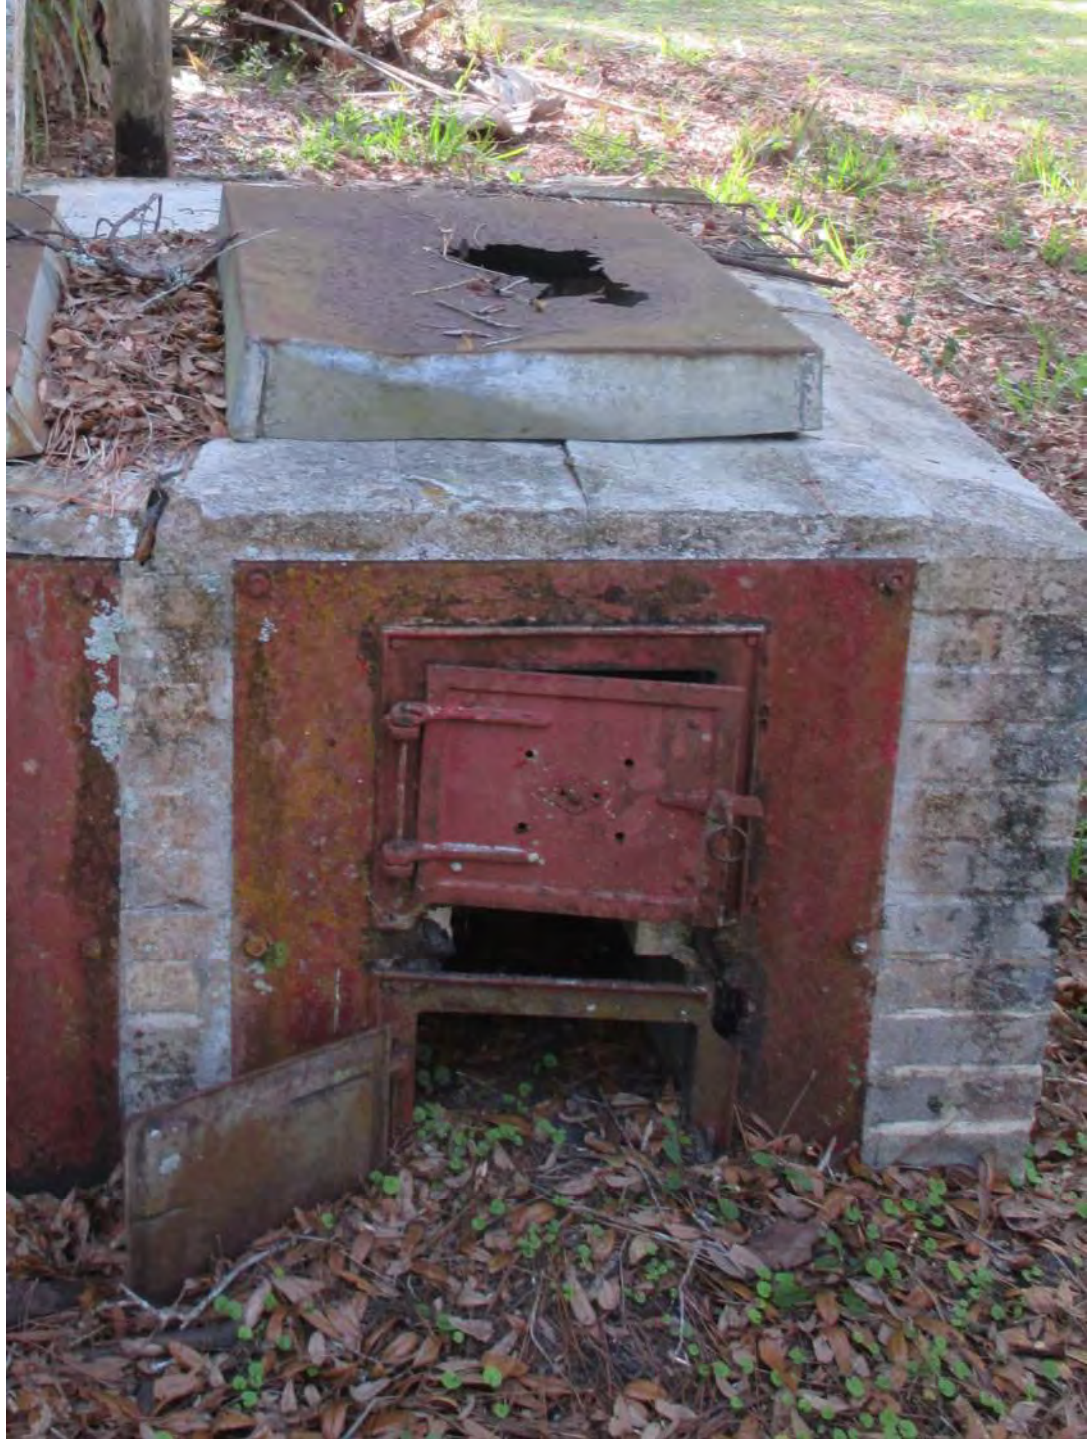
**Photograph 6**  
**Deteriorated Access Doors and Settled Corner**

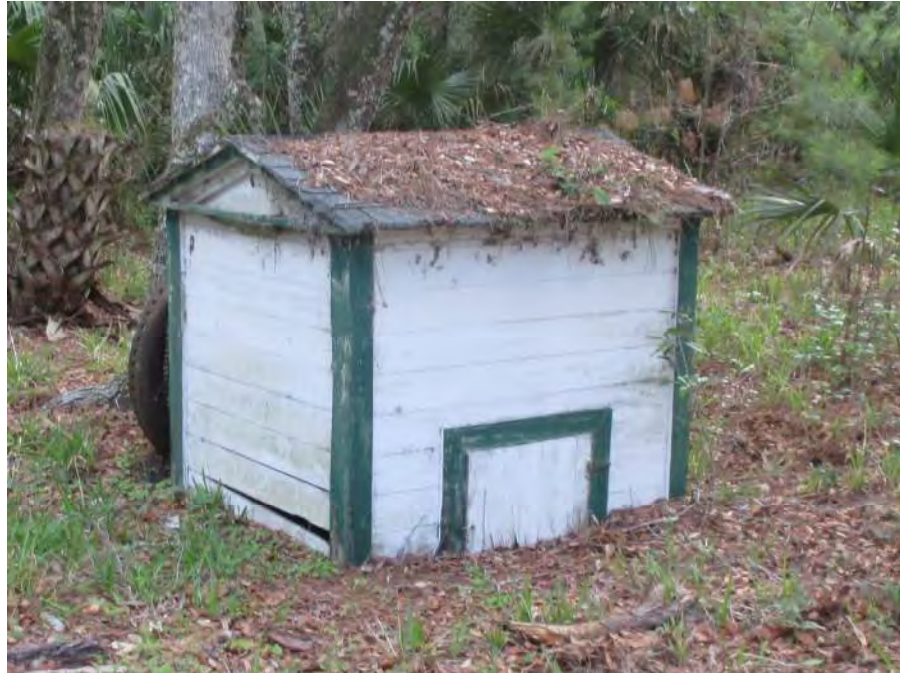
**Photograph 1**  
**Overall Smoker**

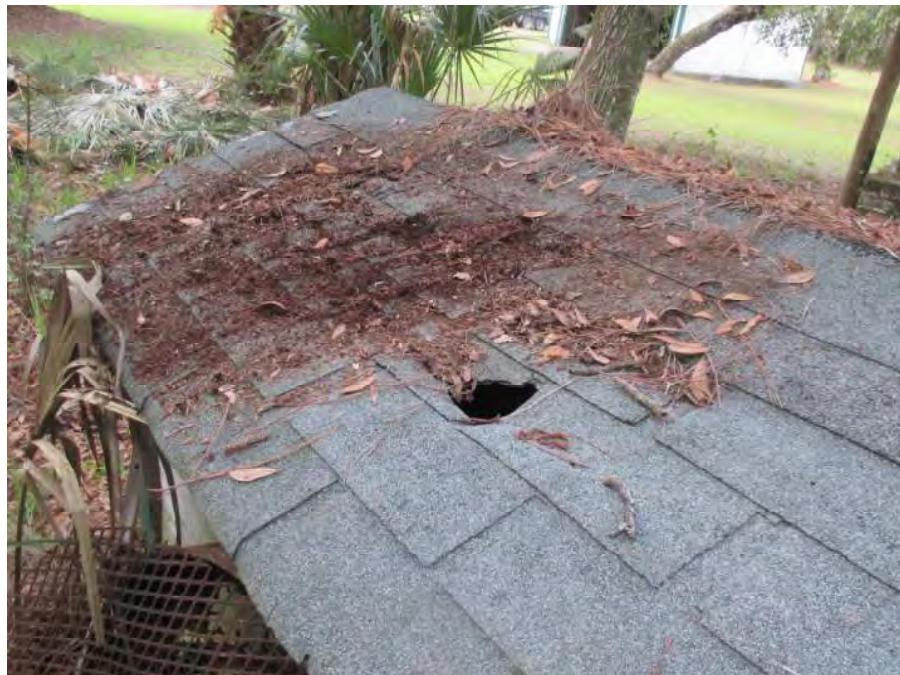
**Photograph 2**  
**Deteriorated Roof**

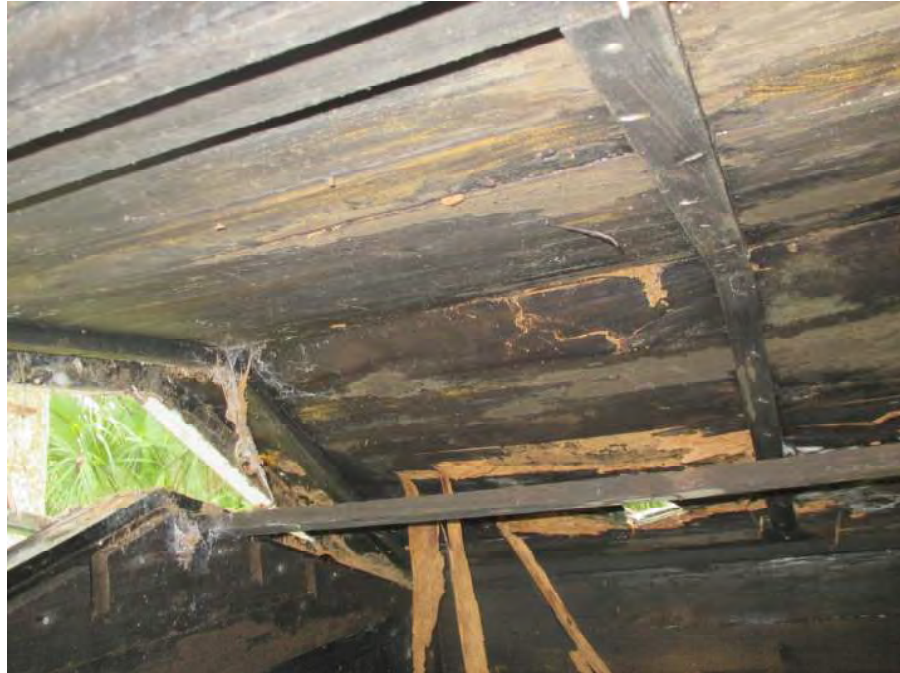
**Photograph 3**  
**Deteriorated Roof Sheathing and Framing**

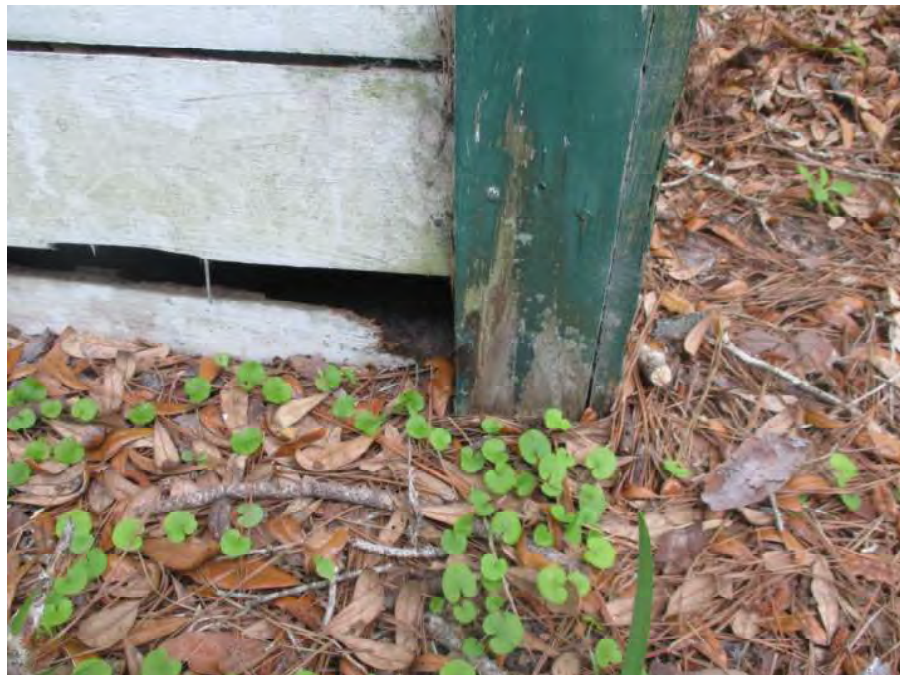
**Photograph 4**  
**Deteriorated Trim and Siding**

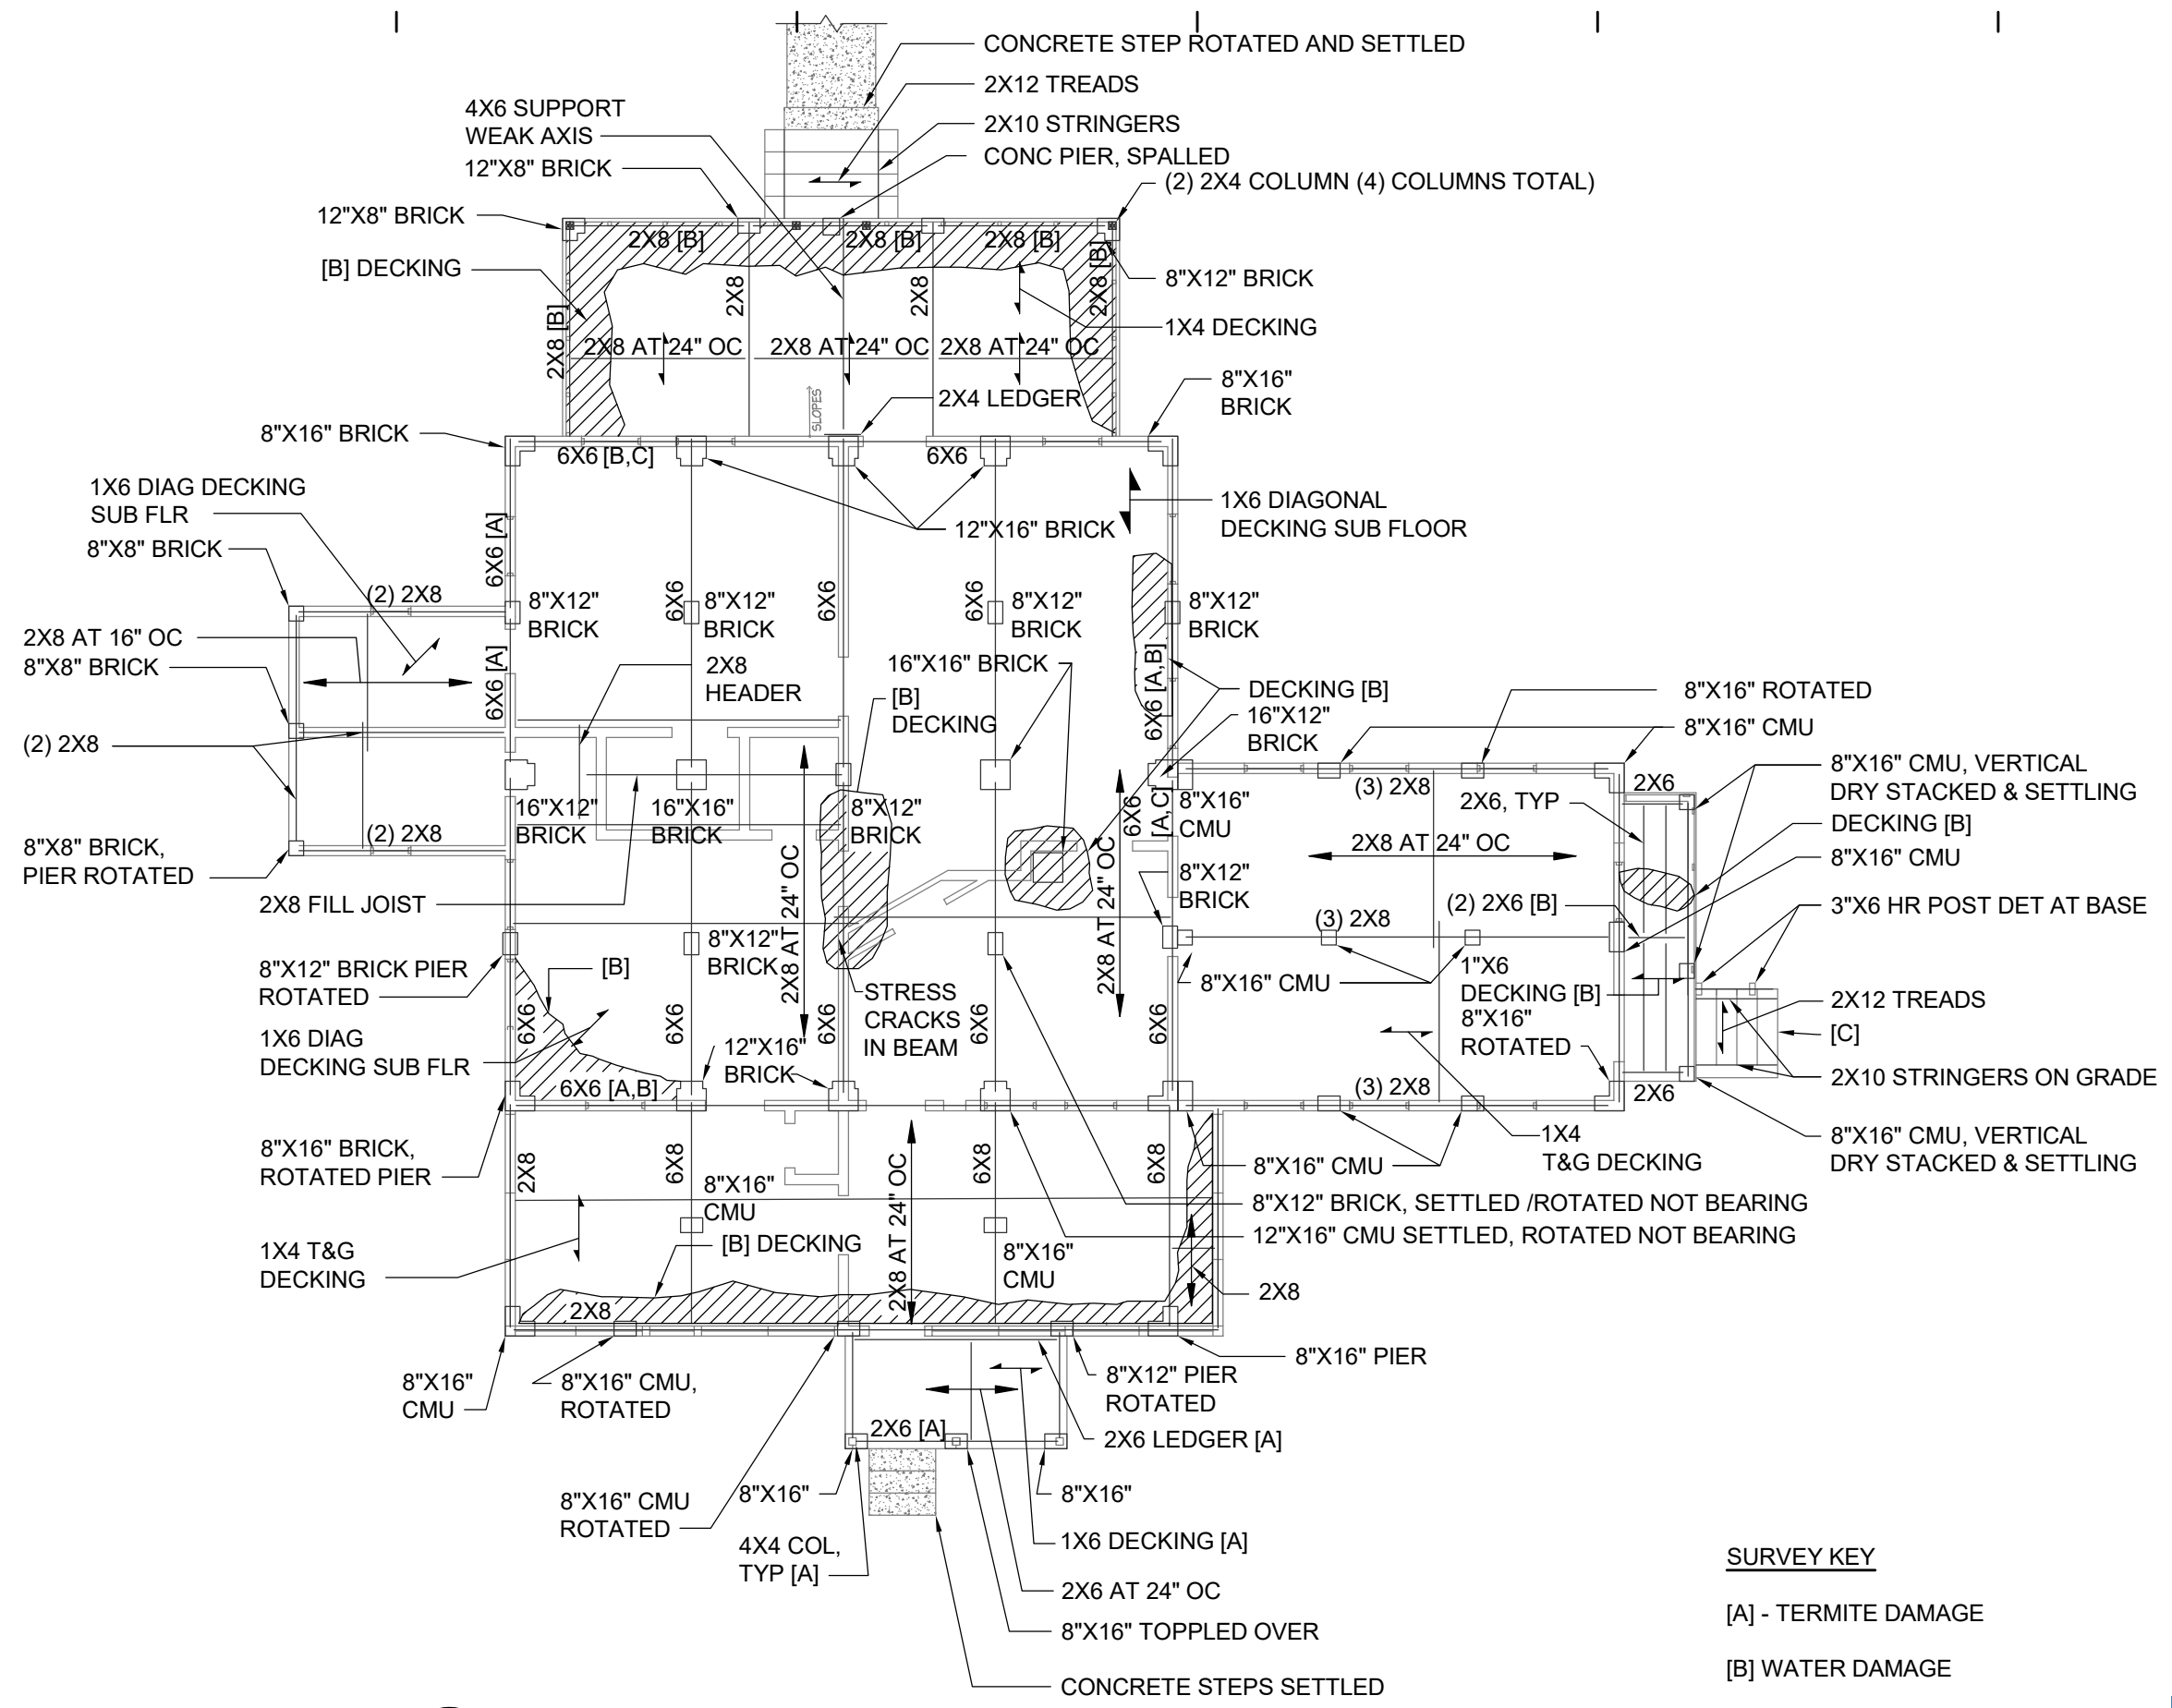
**MAIN HOUSE FOUNDATION AND FLOOR PLAN**

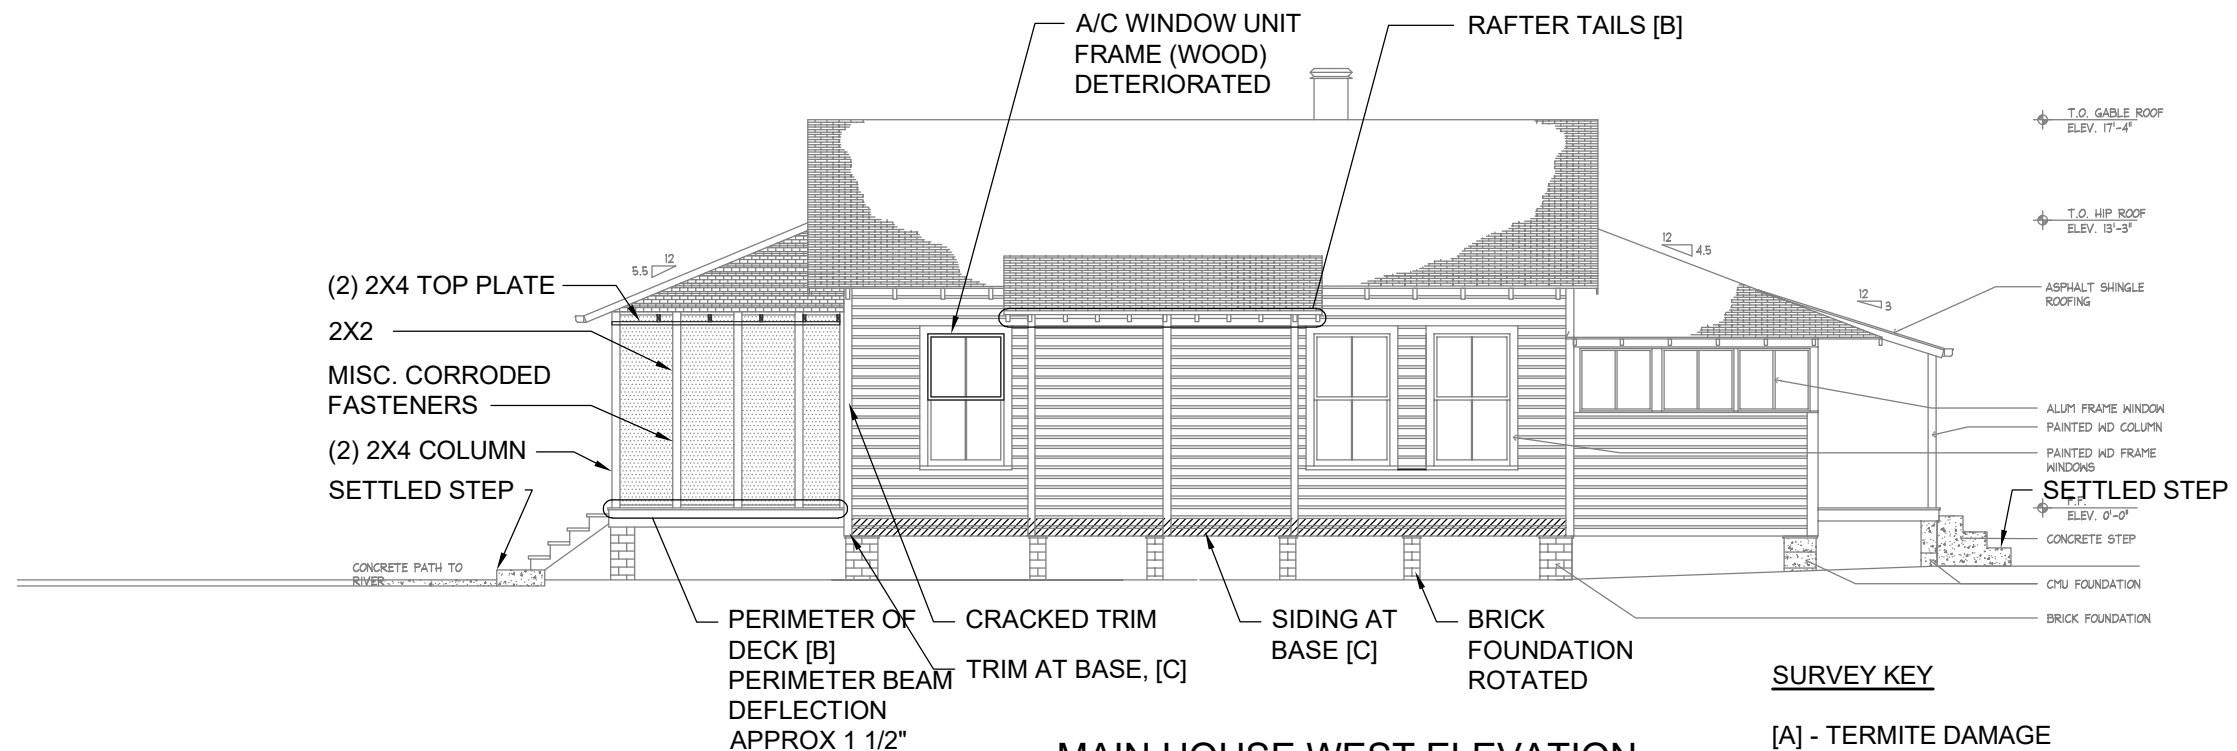
**MAIN HOUSE WEST ELEVATION**  
SCALE: 1/8" = 1'-0"

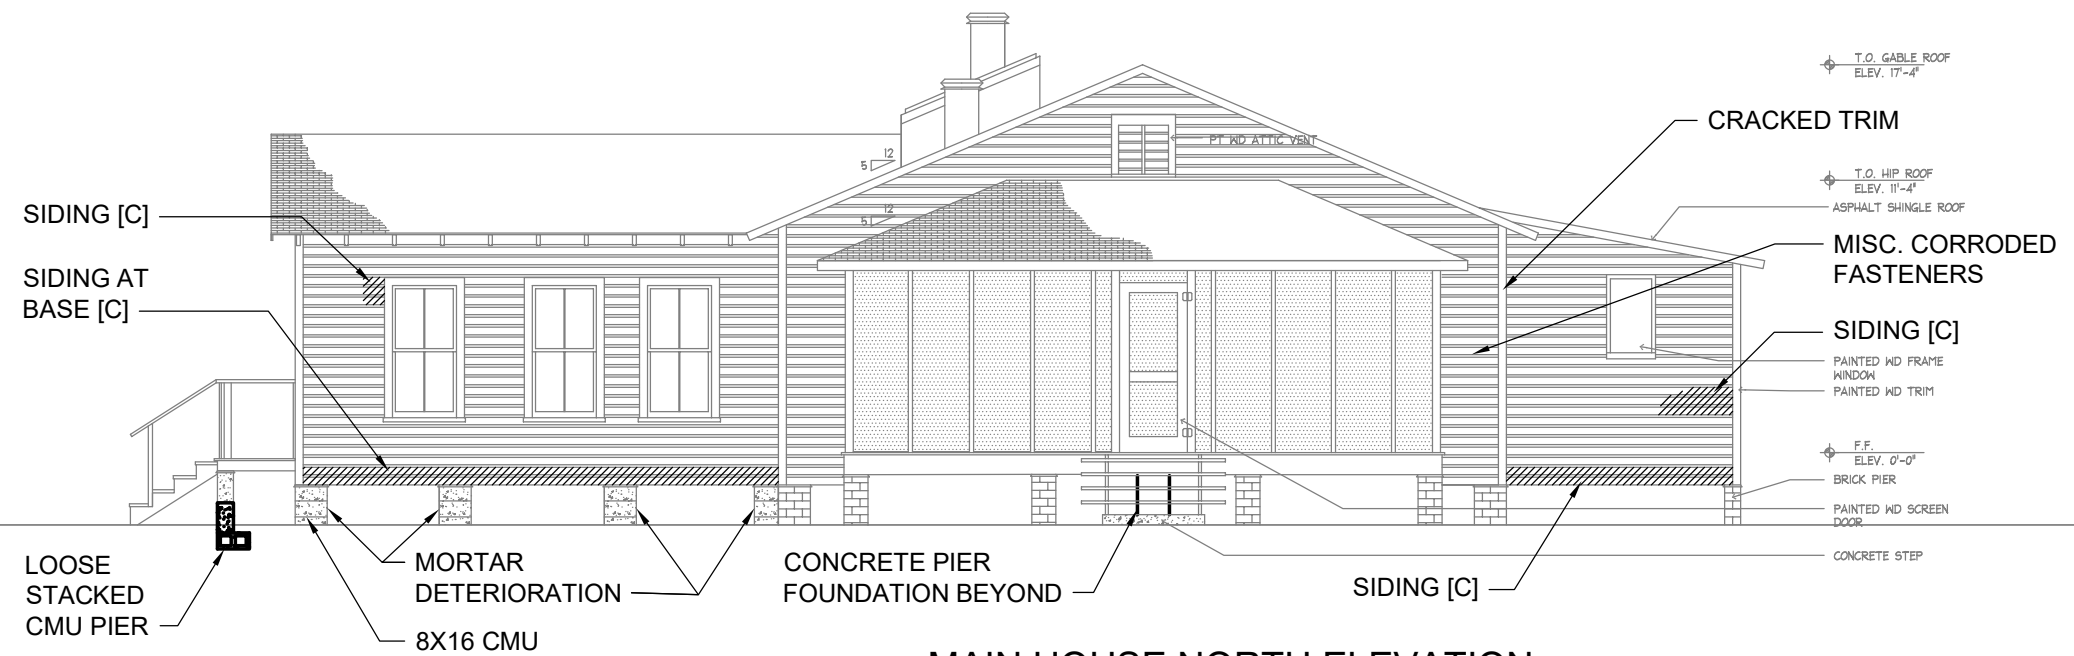
**MAIN HOUSE NORTH ELEVATION**  
SCALE: 1/8" = 1'-0"

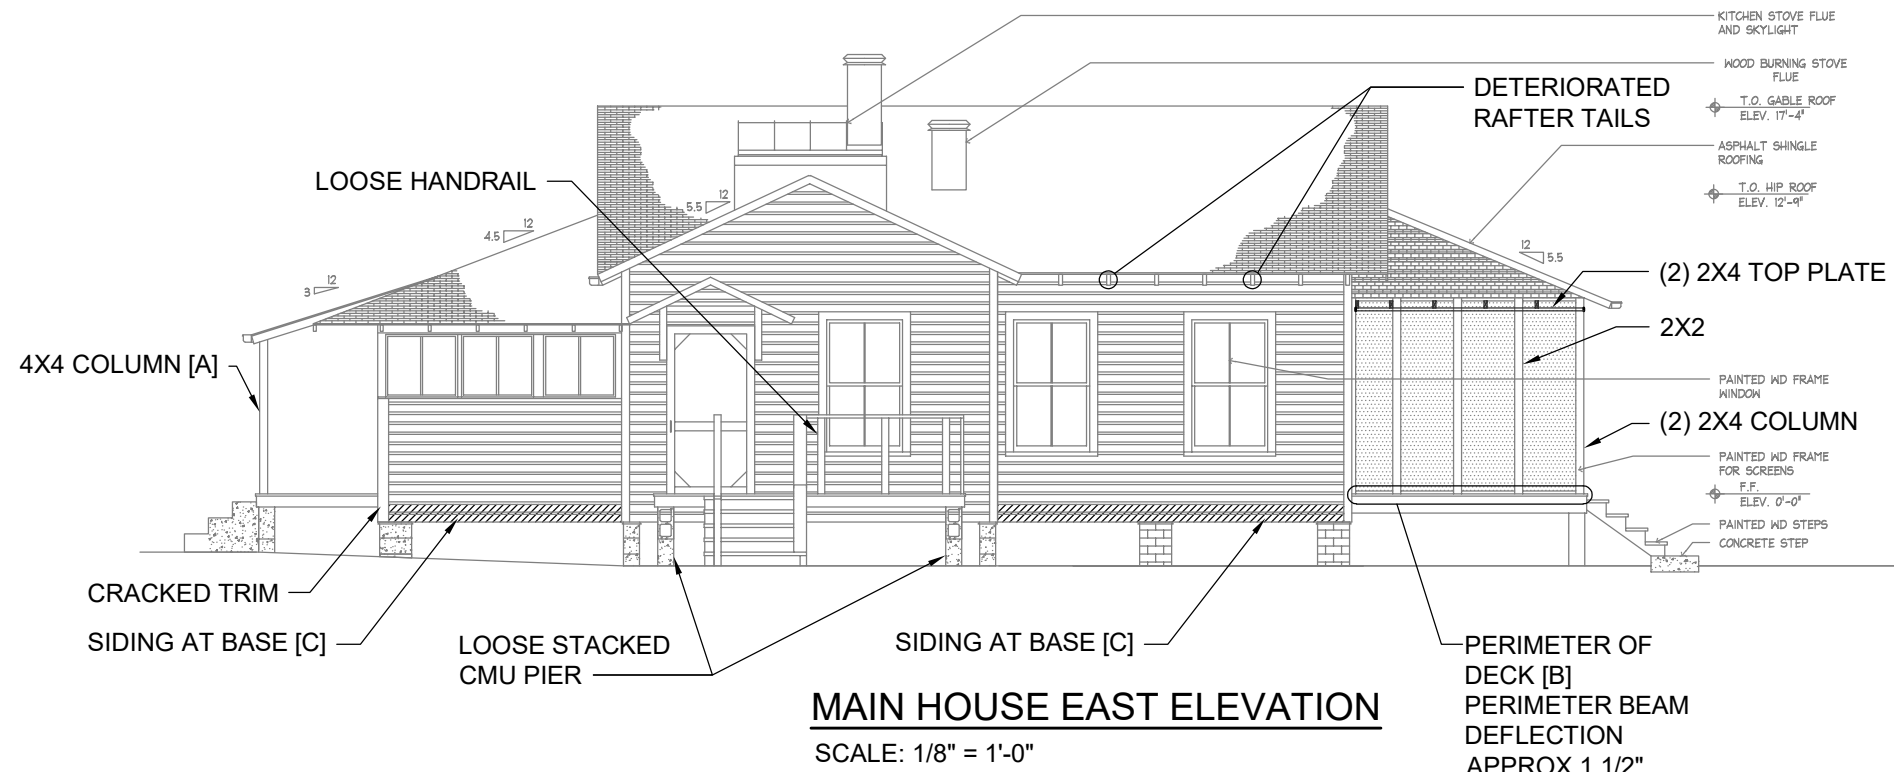
**MAIN HOUSE EAST ELEVATION**
