# **HISTORIC STRUCTURE ASSESSMENT REPORT**

## **VISTA HISTORIC SITE Lower Suwannee National Wildlife Refuge**

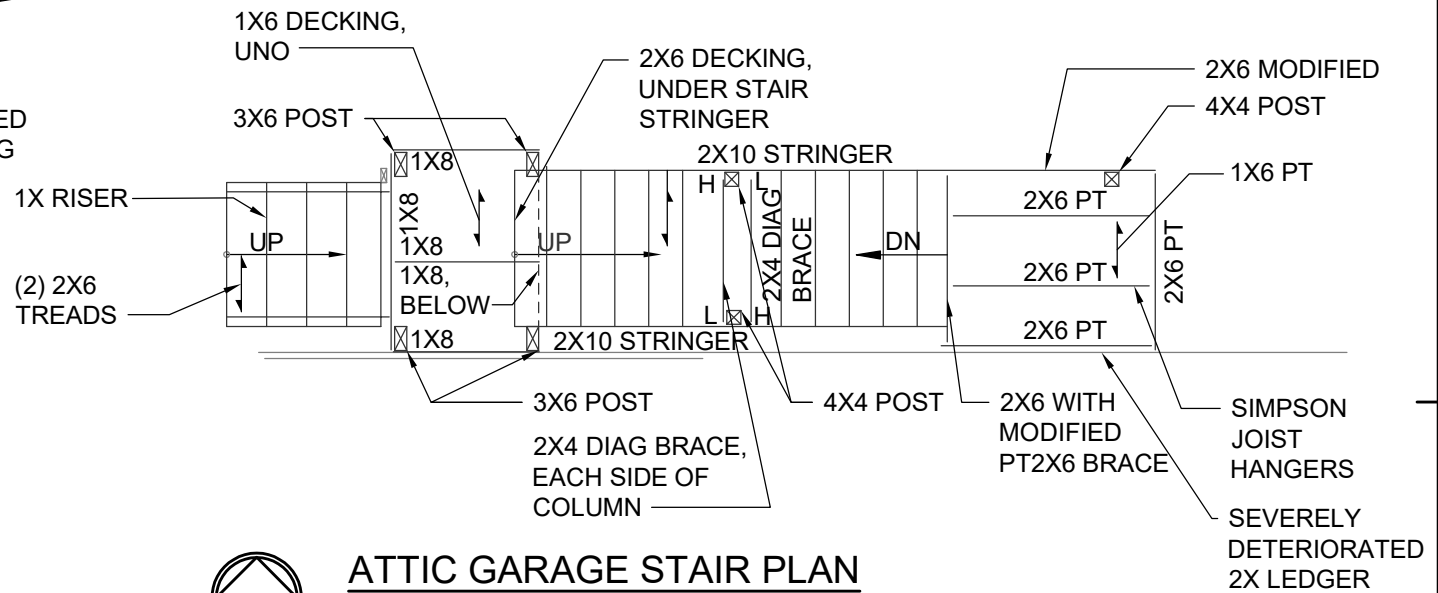
**ATTIC GARAGE STAIR PLAN**

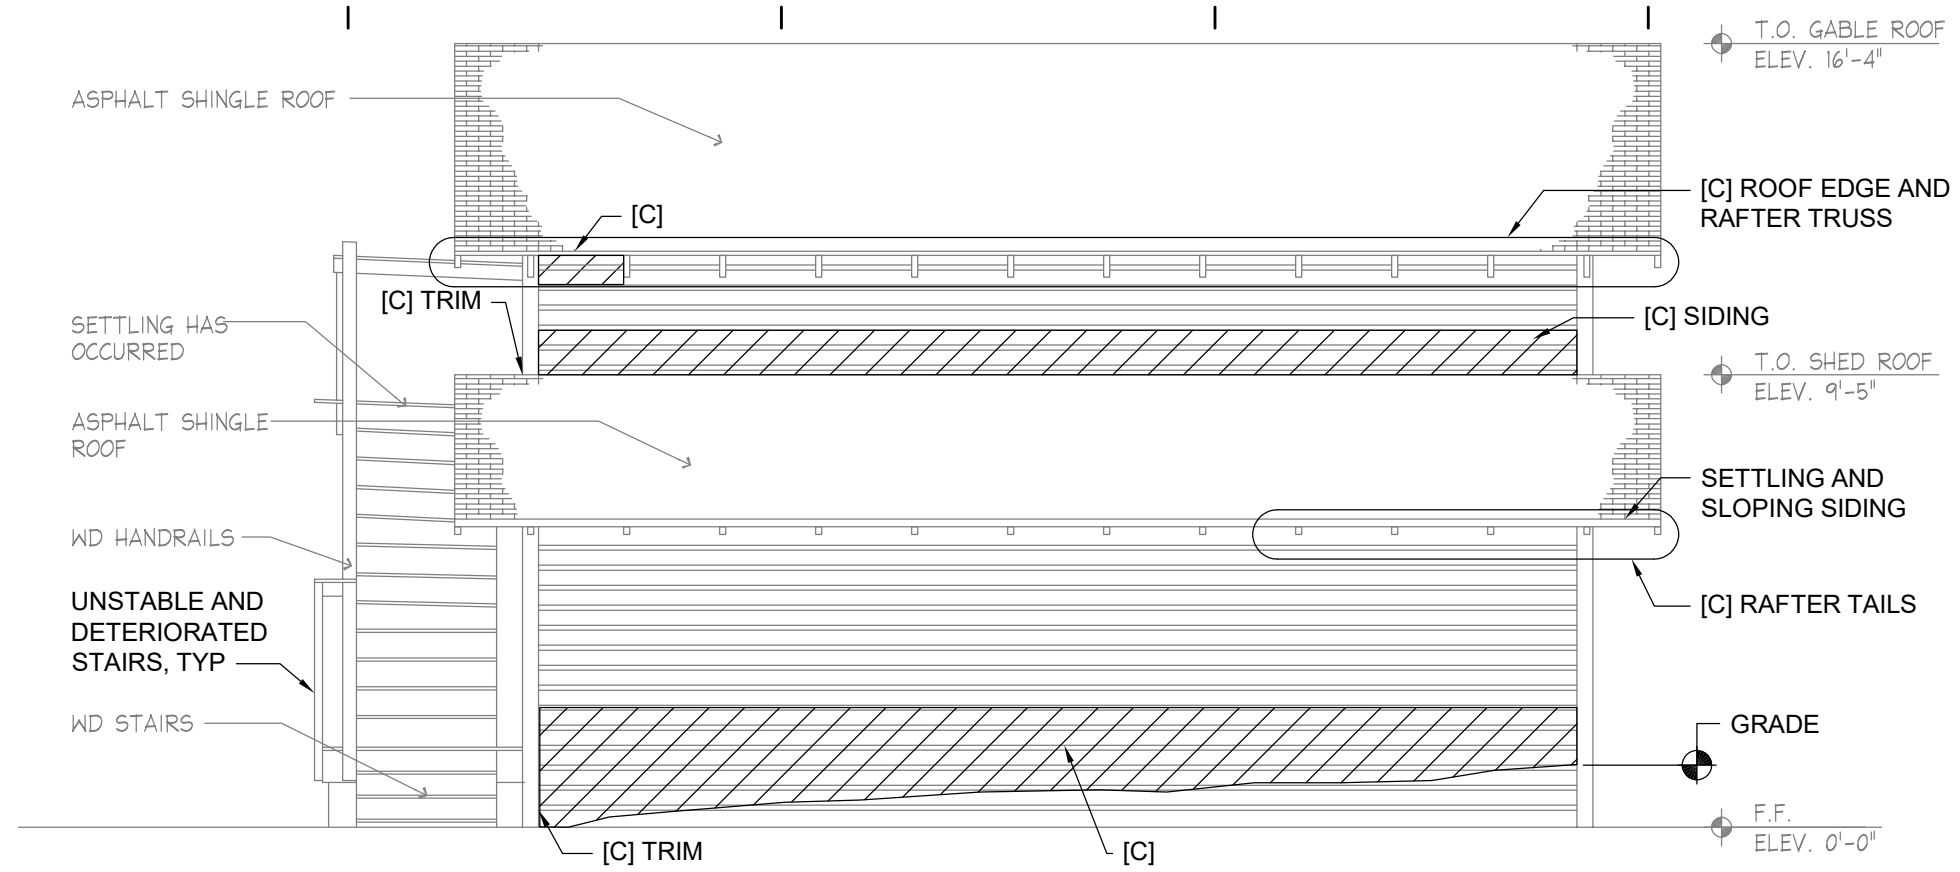
**ATTIC GARAGE WEST ELEVATION**  
SCALE: 1/4" = 1'-0"

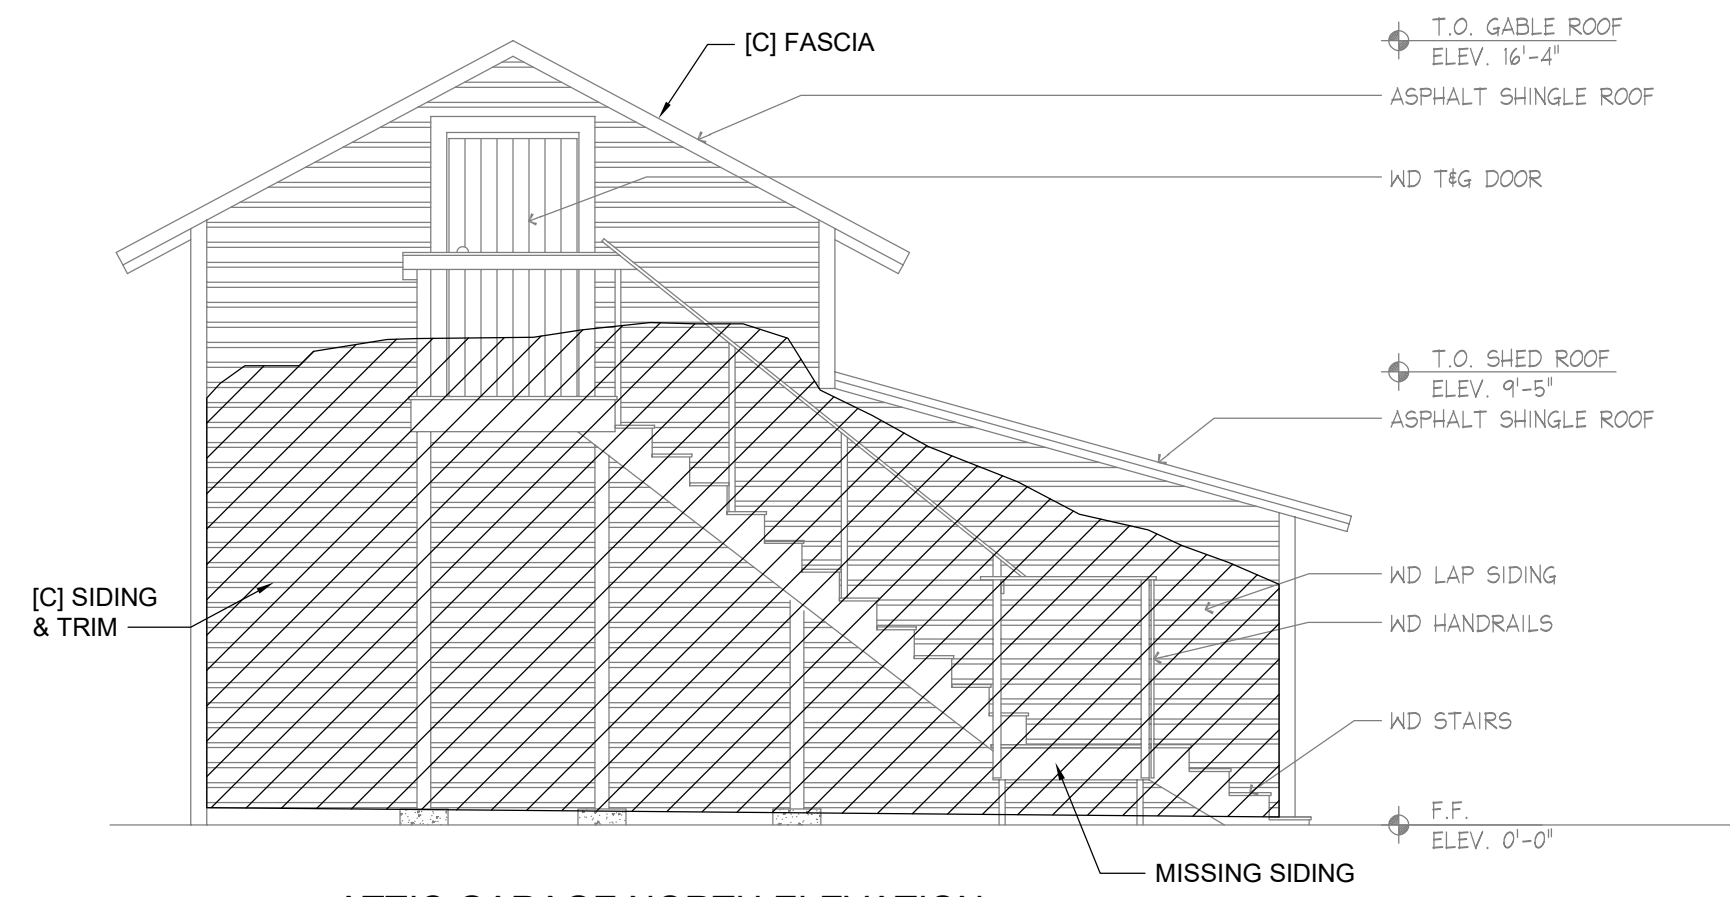
**ATTIC GARAGE NORTH ELEVATION**  
SCALE: 1/4" = 1'-0"

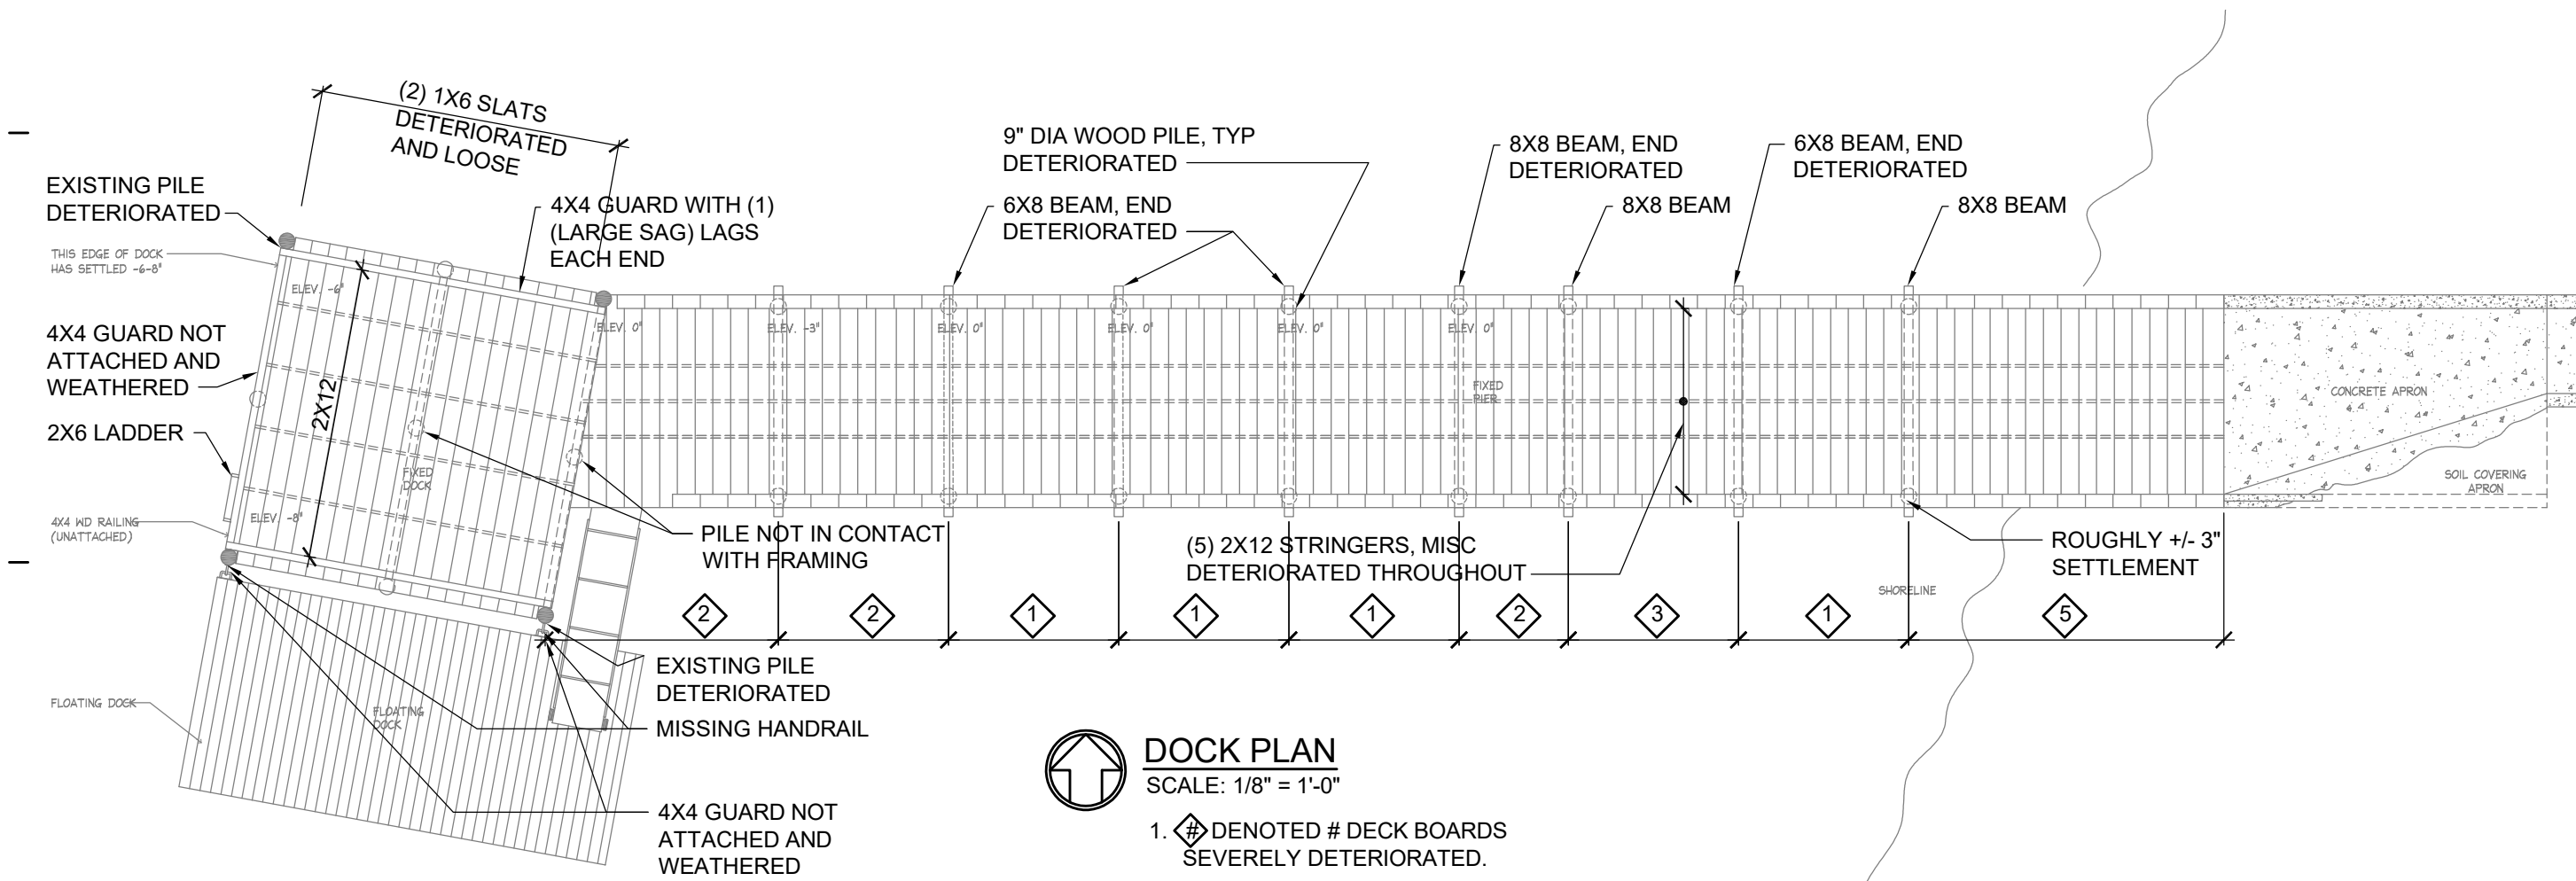
**DOCK PLAN**  
SCALE: 1/8" = 1'-0"

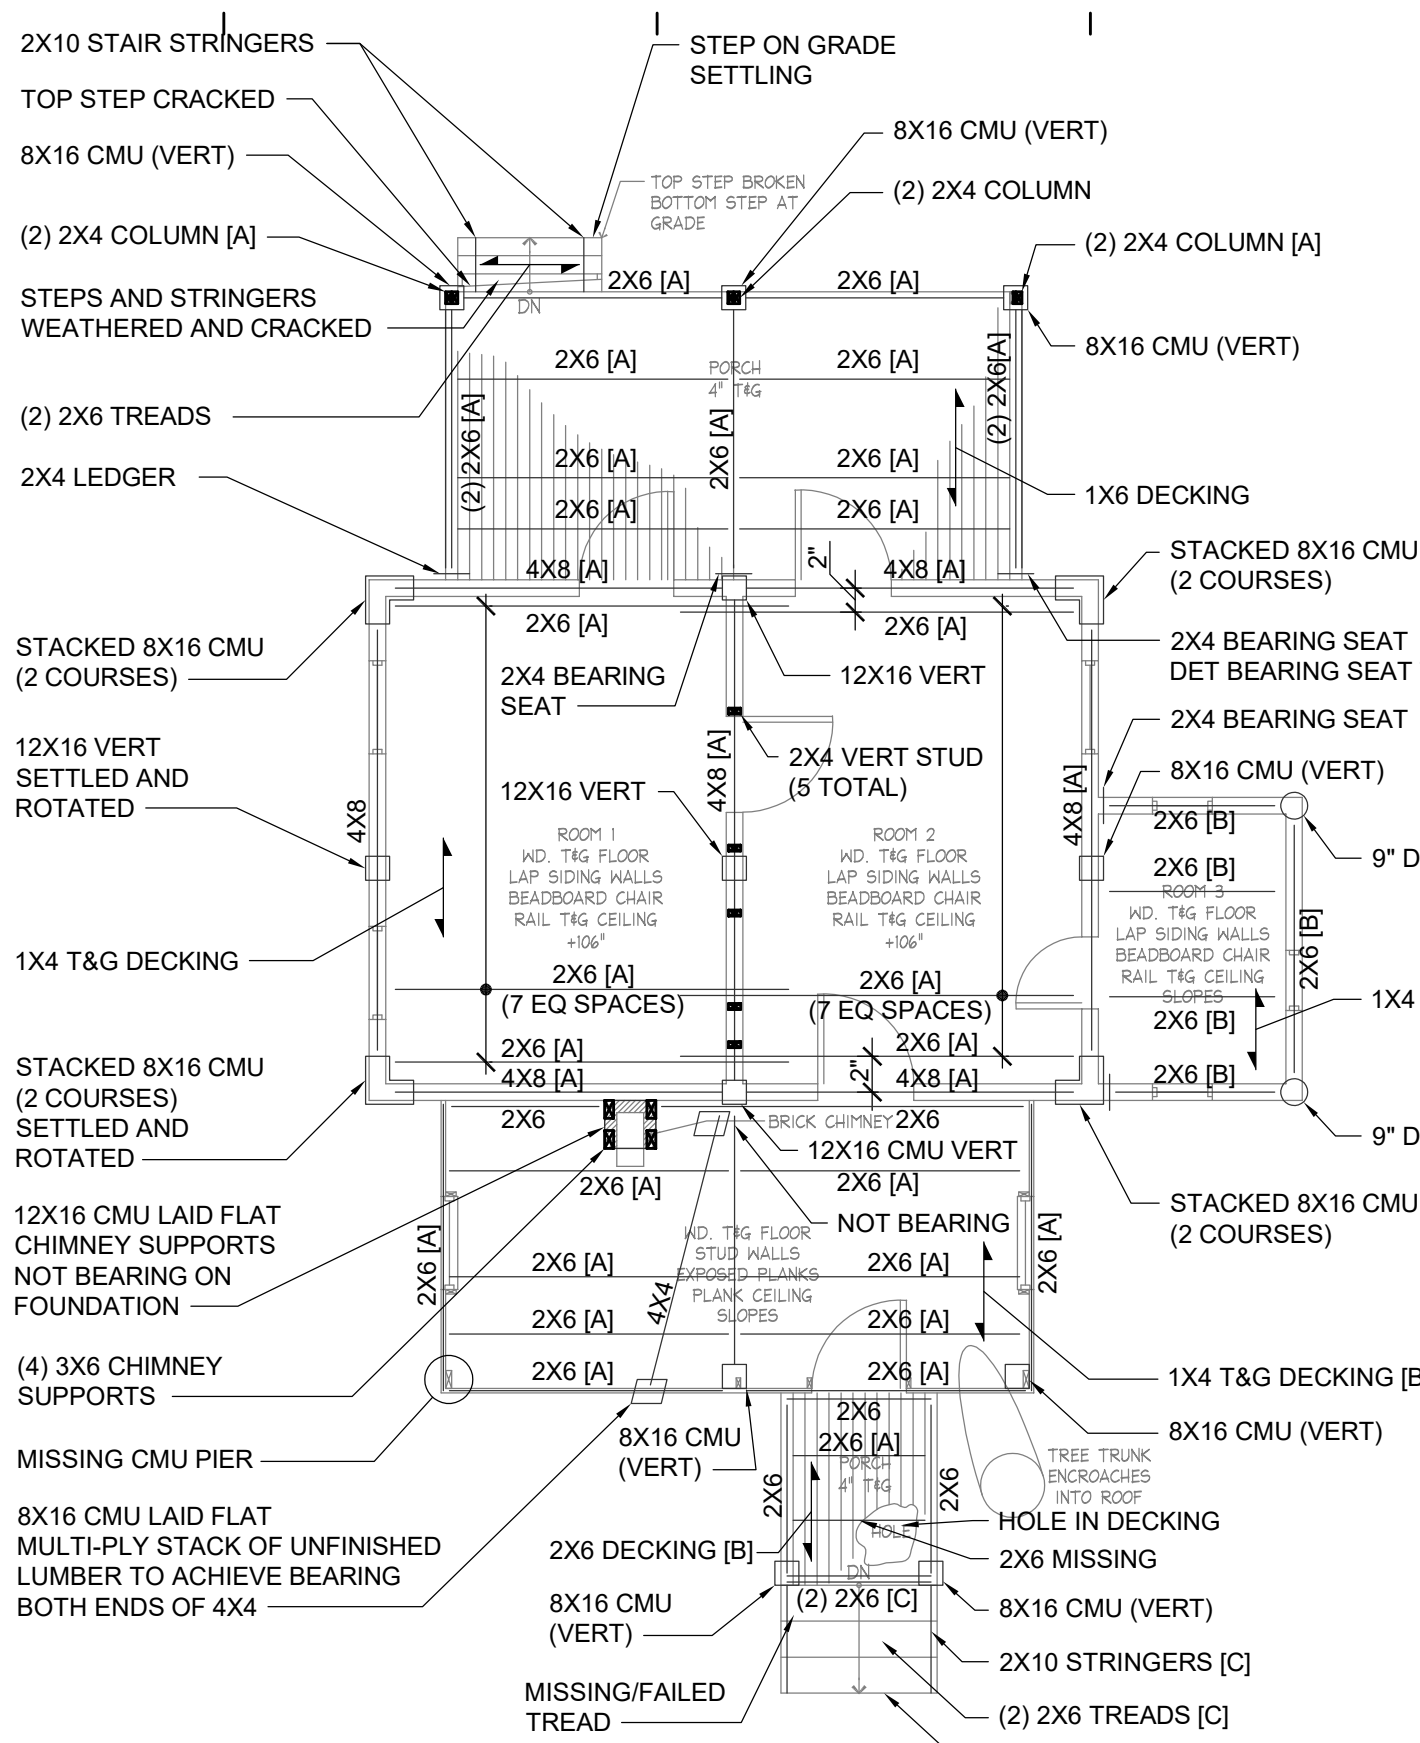
**COOKS HOUSE FOUNDATION FLOOR PLAN**  
SCALE: 3/16" = 1'-0"

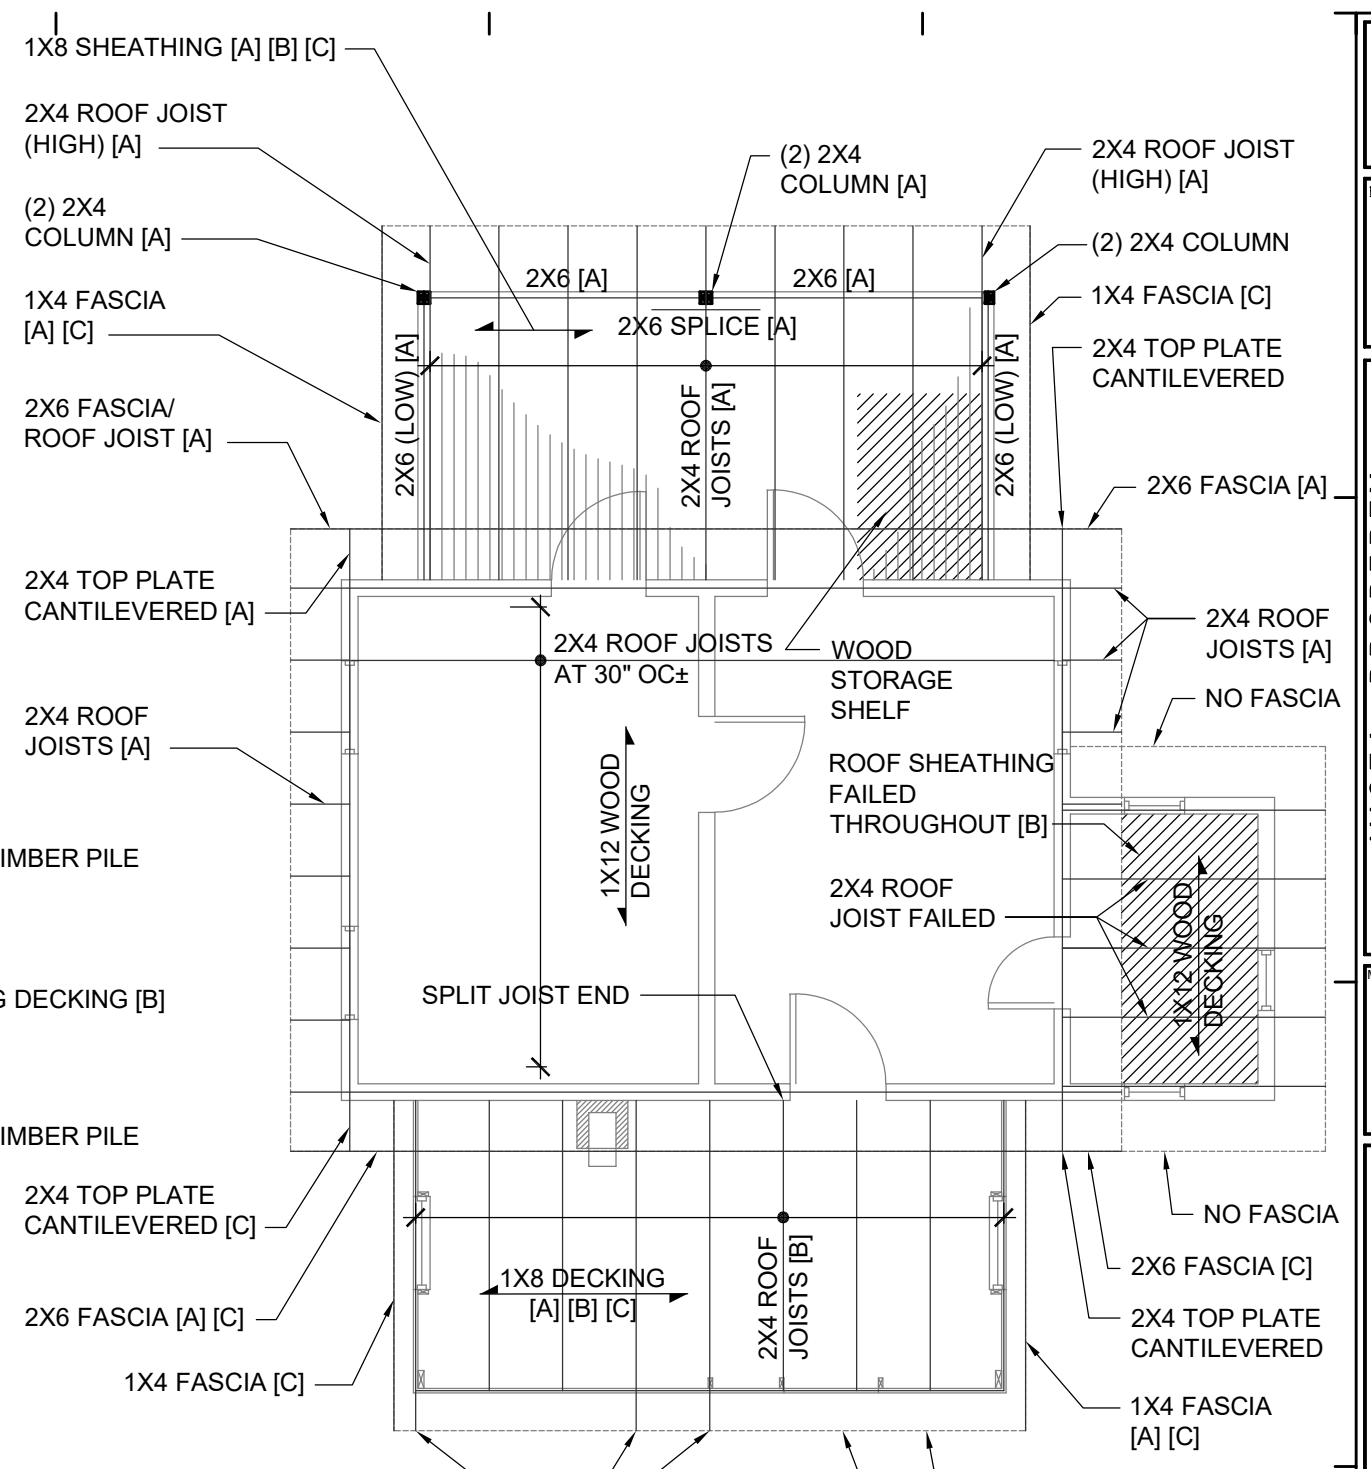
**COOKS HOUSE ROOF PLAN**  
SCALE: 3/16" = 1'-0"

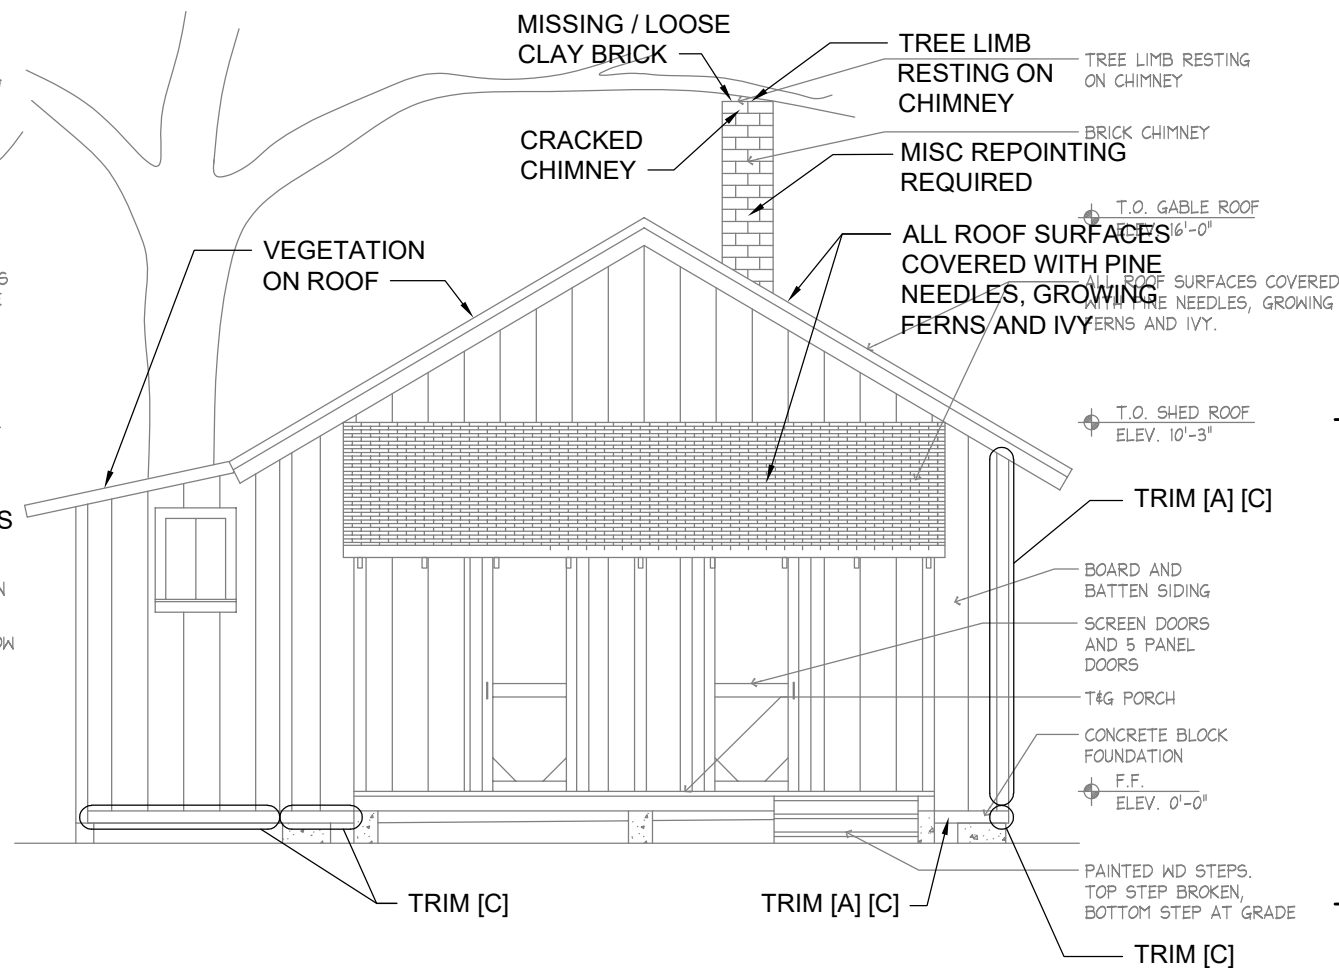
**COOKS HOUSE NORTH ELEVATION**

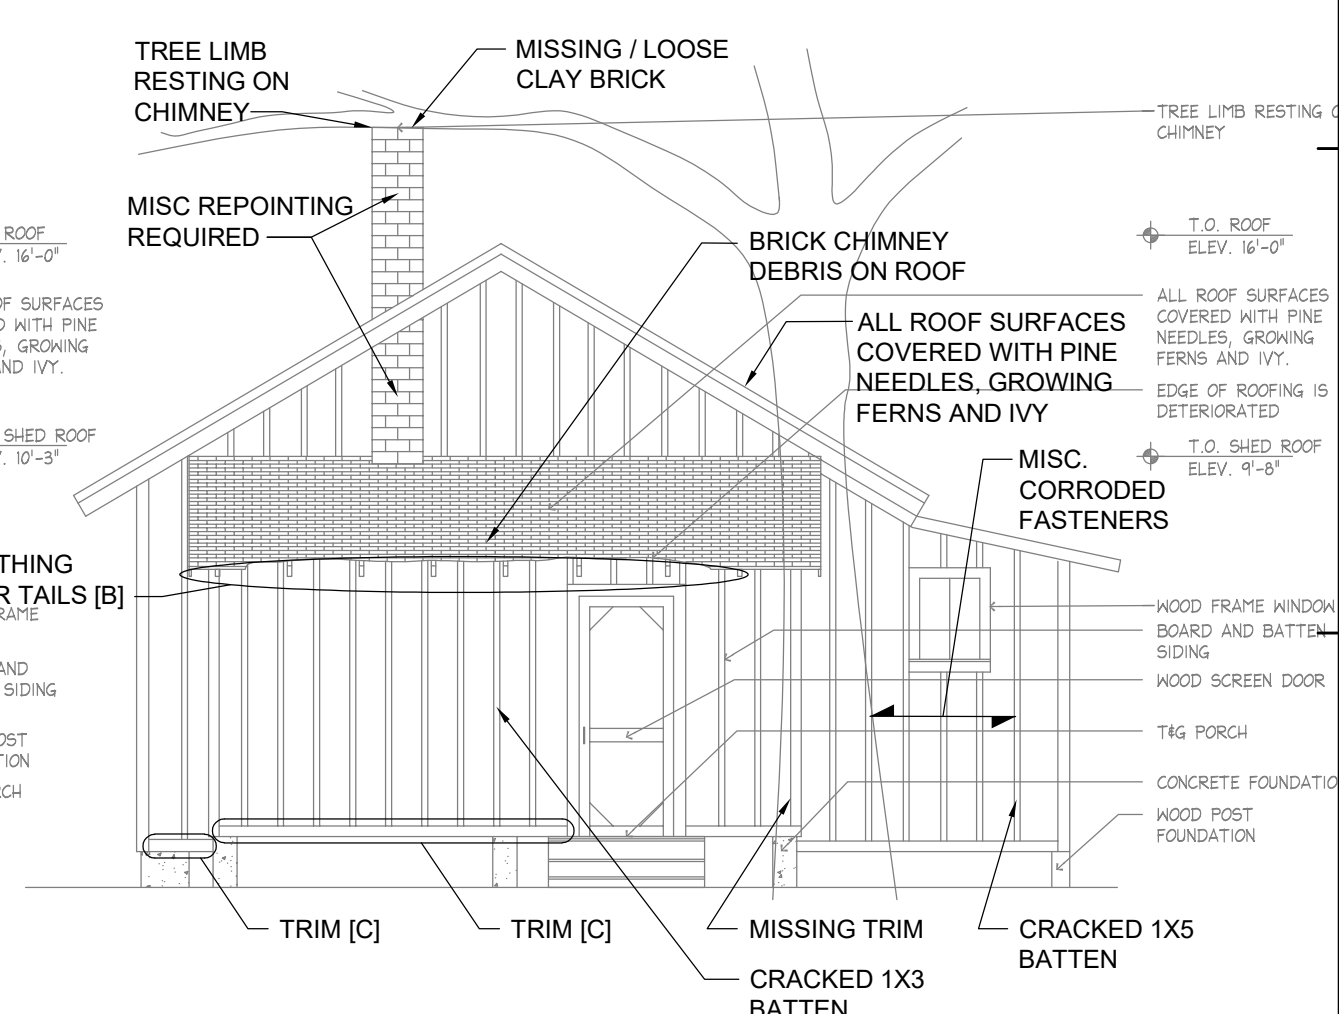
**COOKS HOUSE SOUTH ELEVATION**  
SCALE: 3/16" = 1'-0"

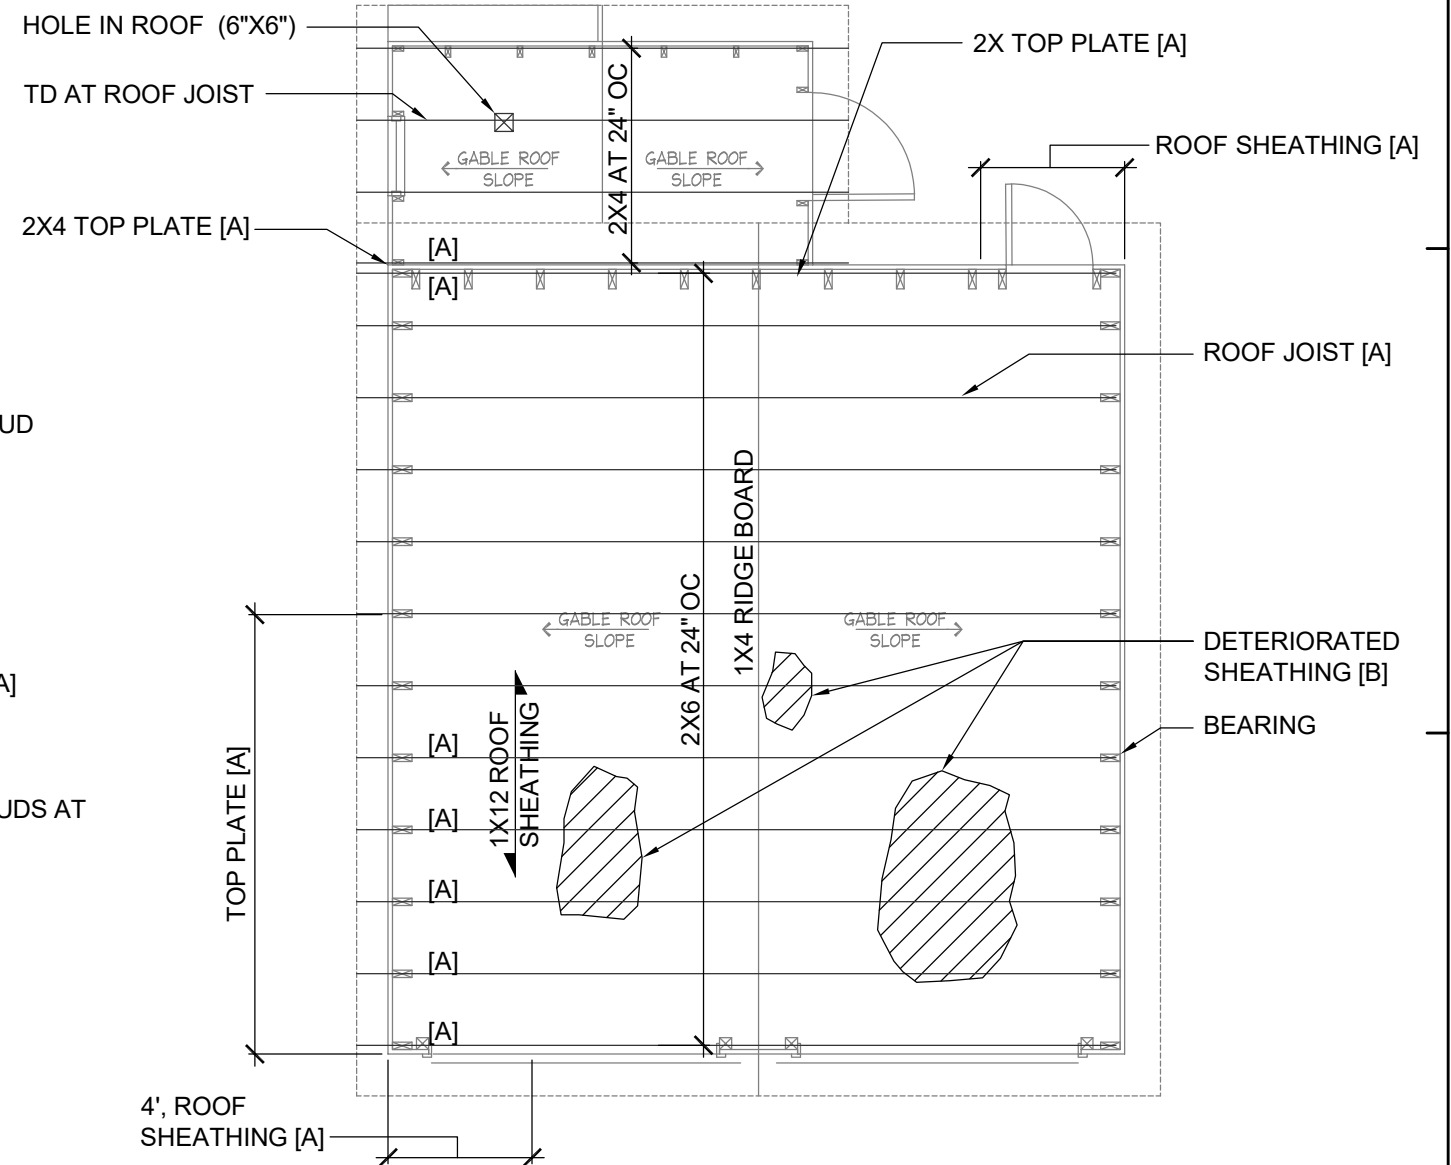
**DOUBLE GARAGE ROOF PLAN**

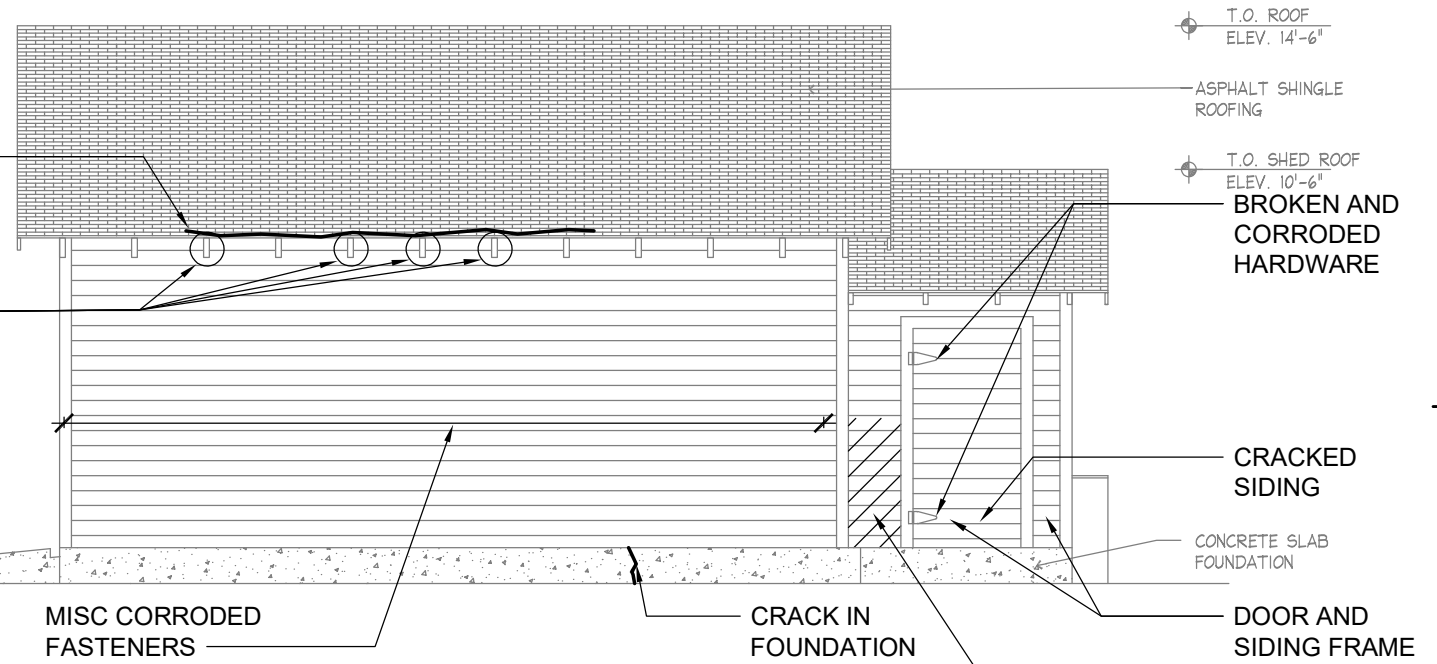
**DOUBLE GARAGE NORTH ELEVATION**  
SCALE: 3/16" = 1'-0"

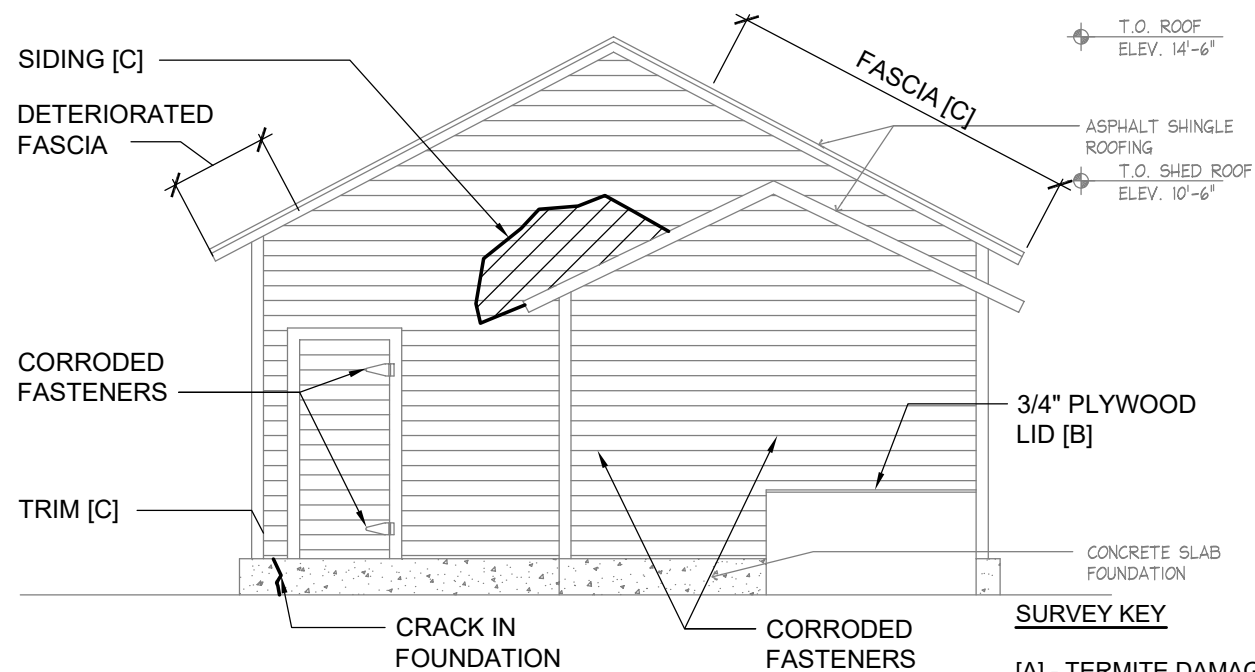
**DOUBLE GARAGE WEST ELEVATION**  
SCALE: 3/16" = 1'-0"

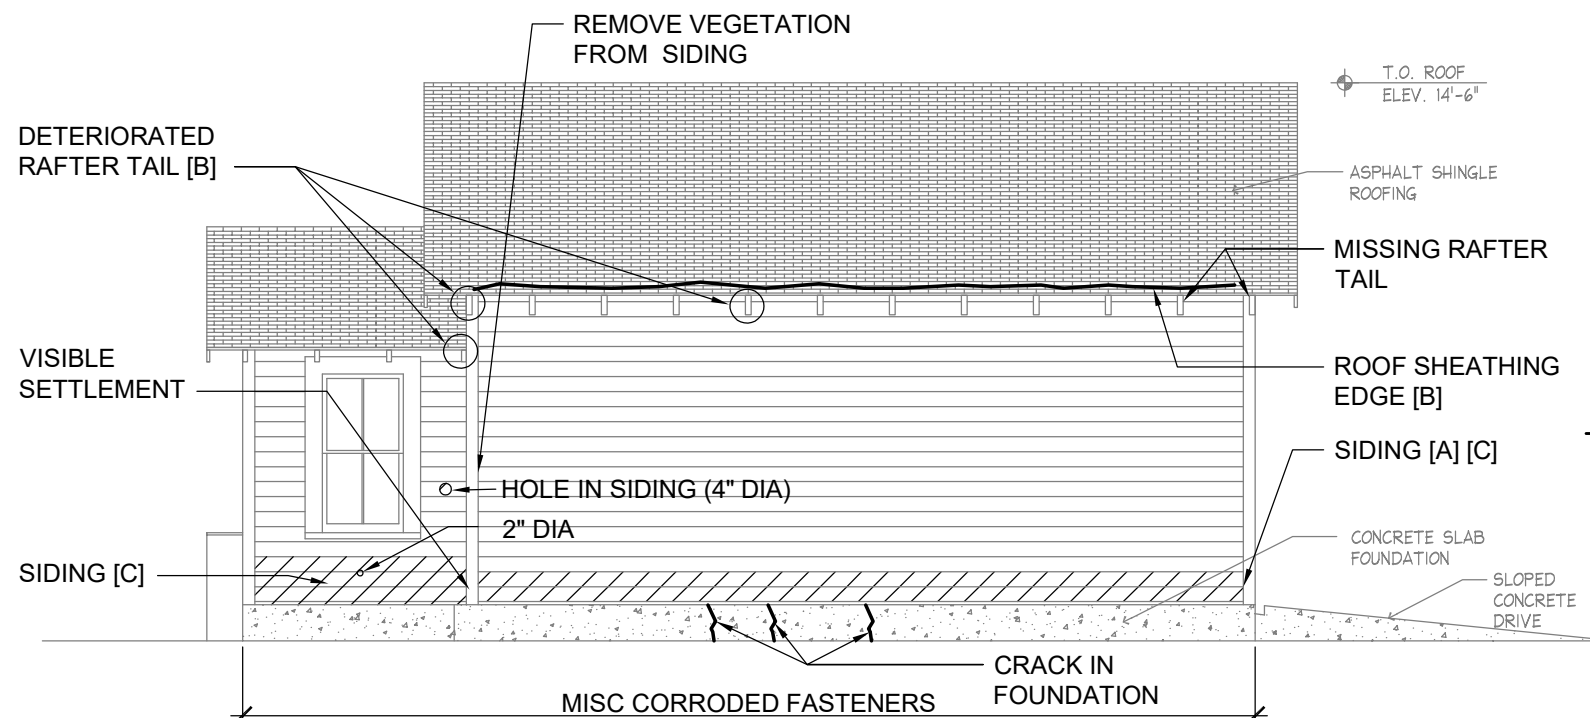
**DOUBLE GARAGE SOUTH ELEVATION**  
SCALE: 3/16" = 1'-0"

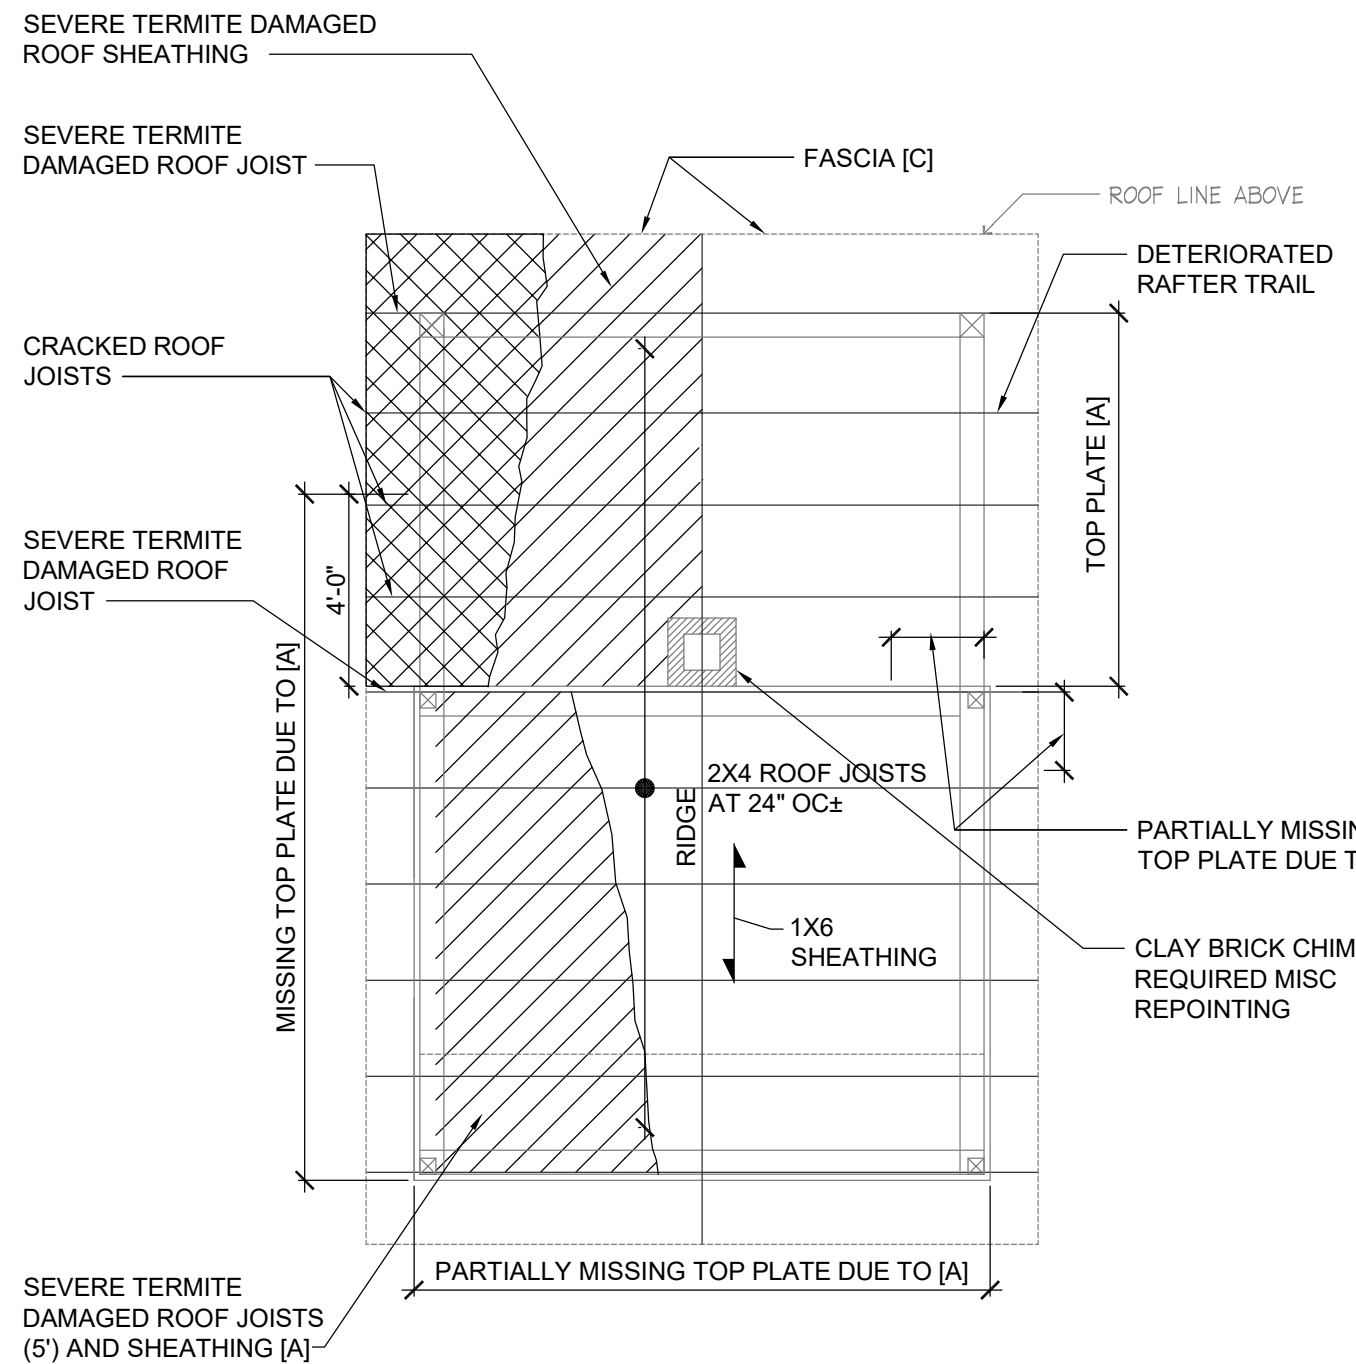
- SURVEY KEY**
- [A] - TERMITE DAMAGE
  - [B] WATER DAMAGE
  - [C] WEATHERED TIMBER

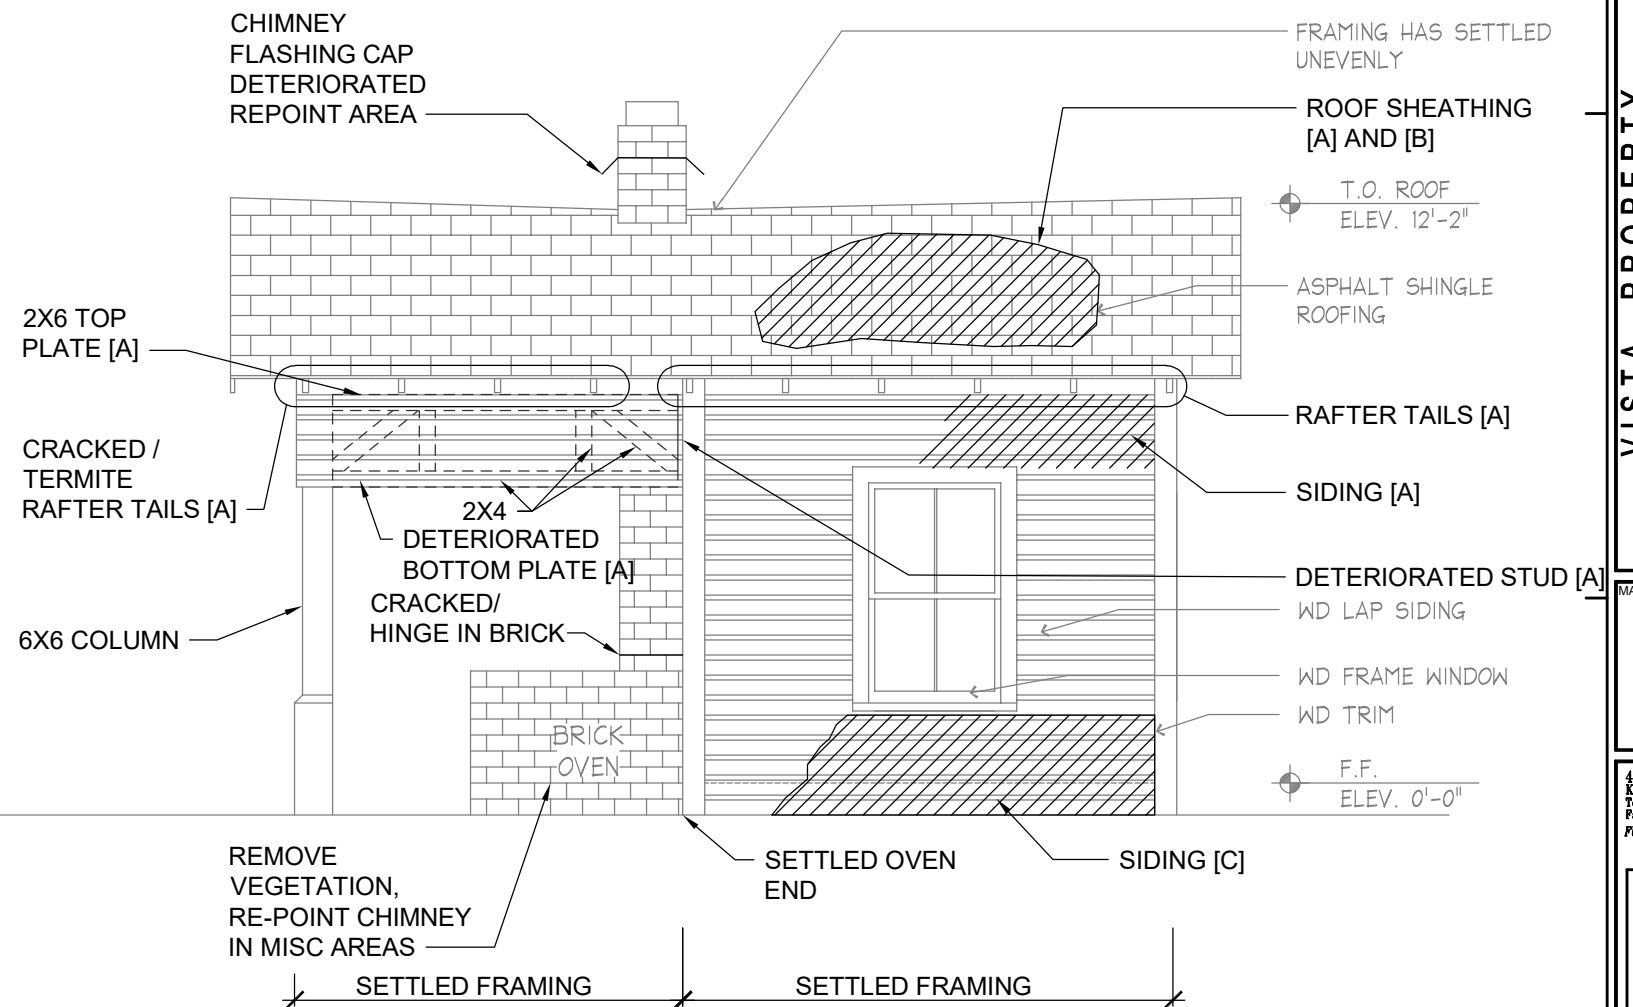
**FRYER SHED SOUTH ELEVATION**  
SCALE: 1/4" = 1'-0"
