# **HISTORIC STRUCTURE ASSESSMENT REPORT**

## **VISTA HISTORIC SITE Lower Suwannee National Wildlife Refuge**

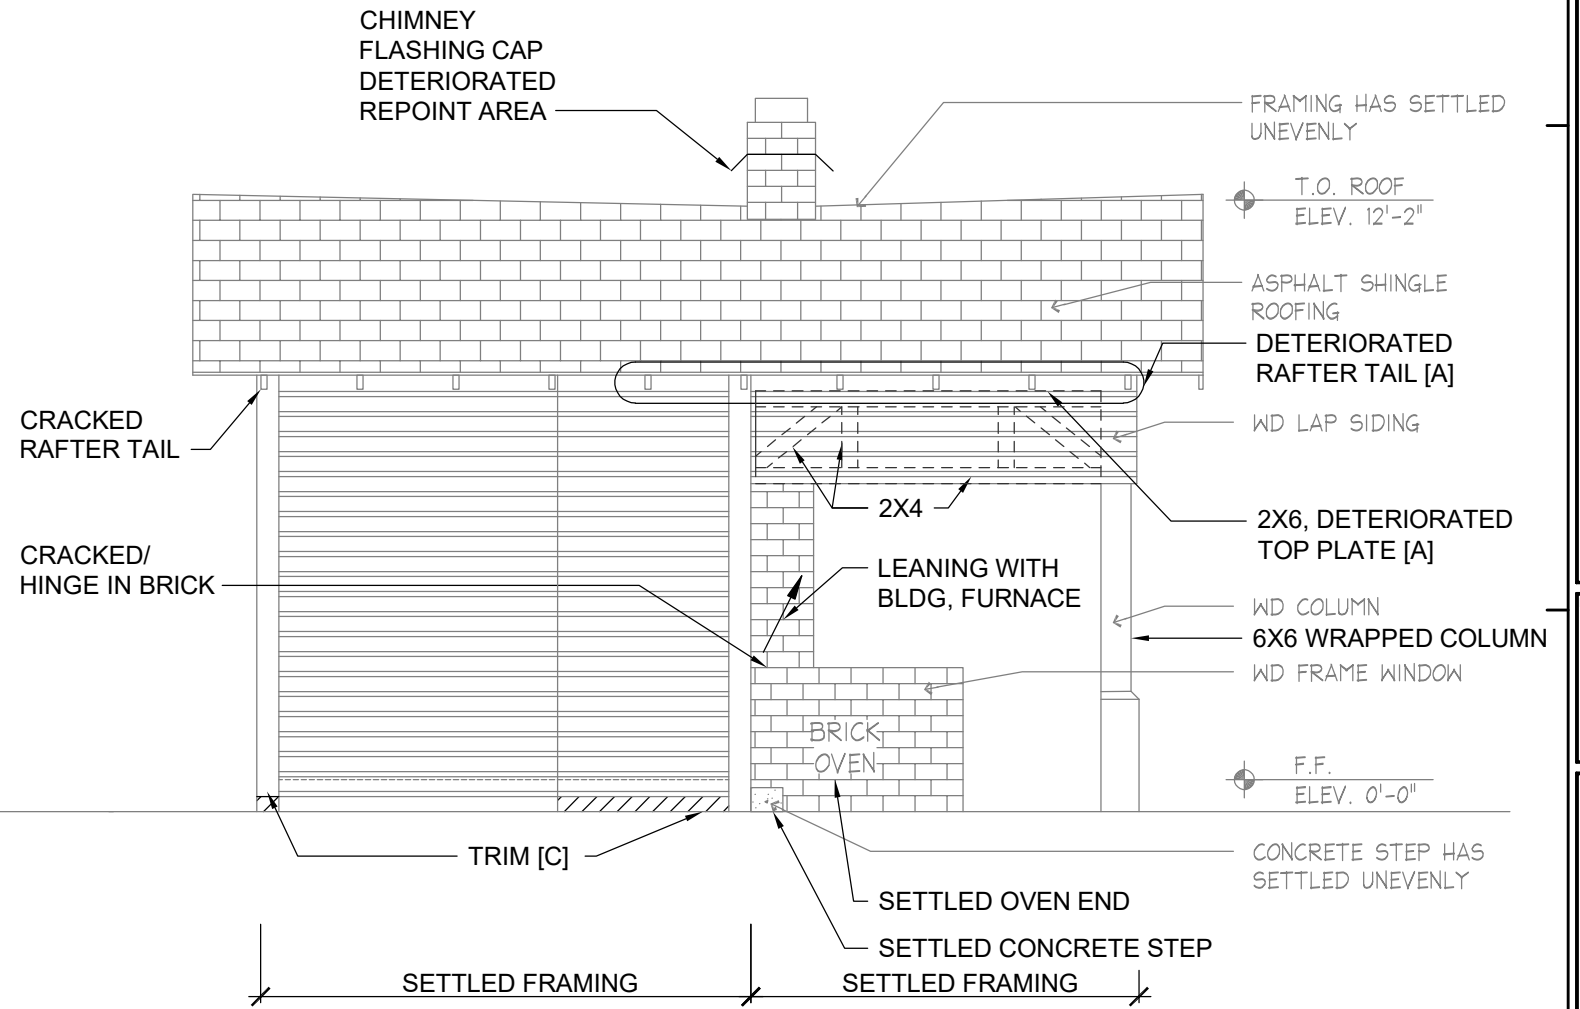
**FRYER SHED NORTH ELEVATION**  
SCALE: 1/4" = 1'-0"

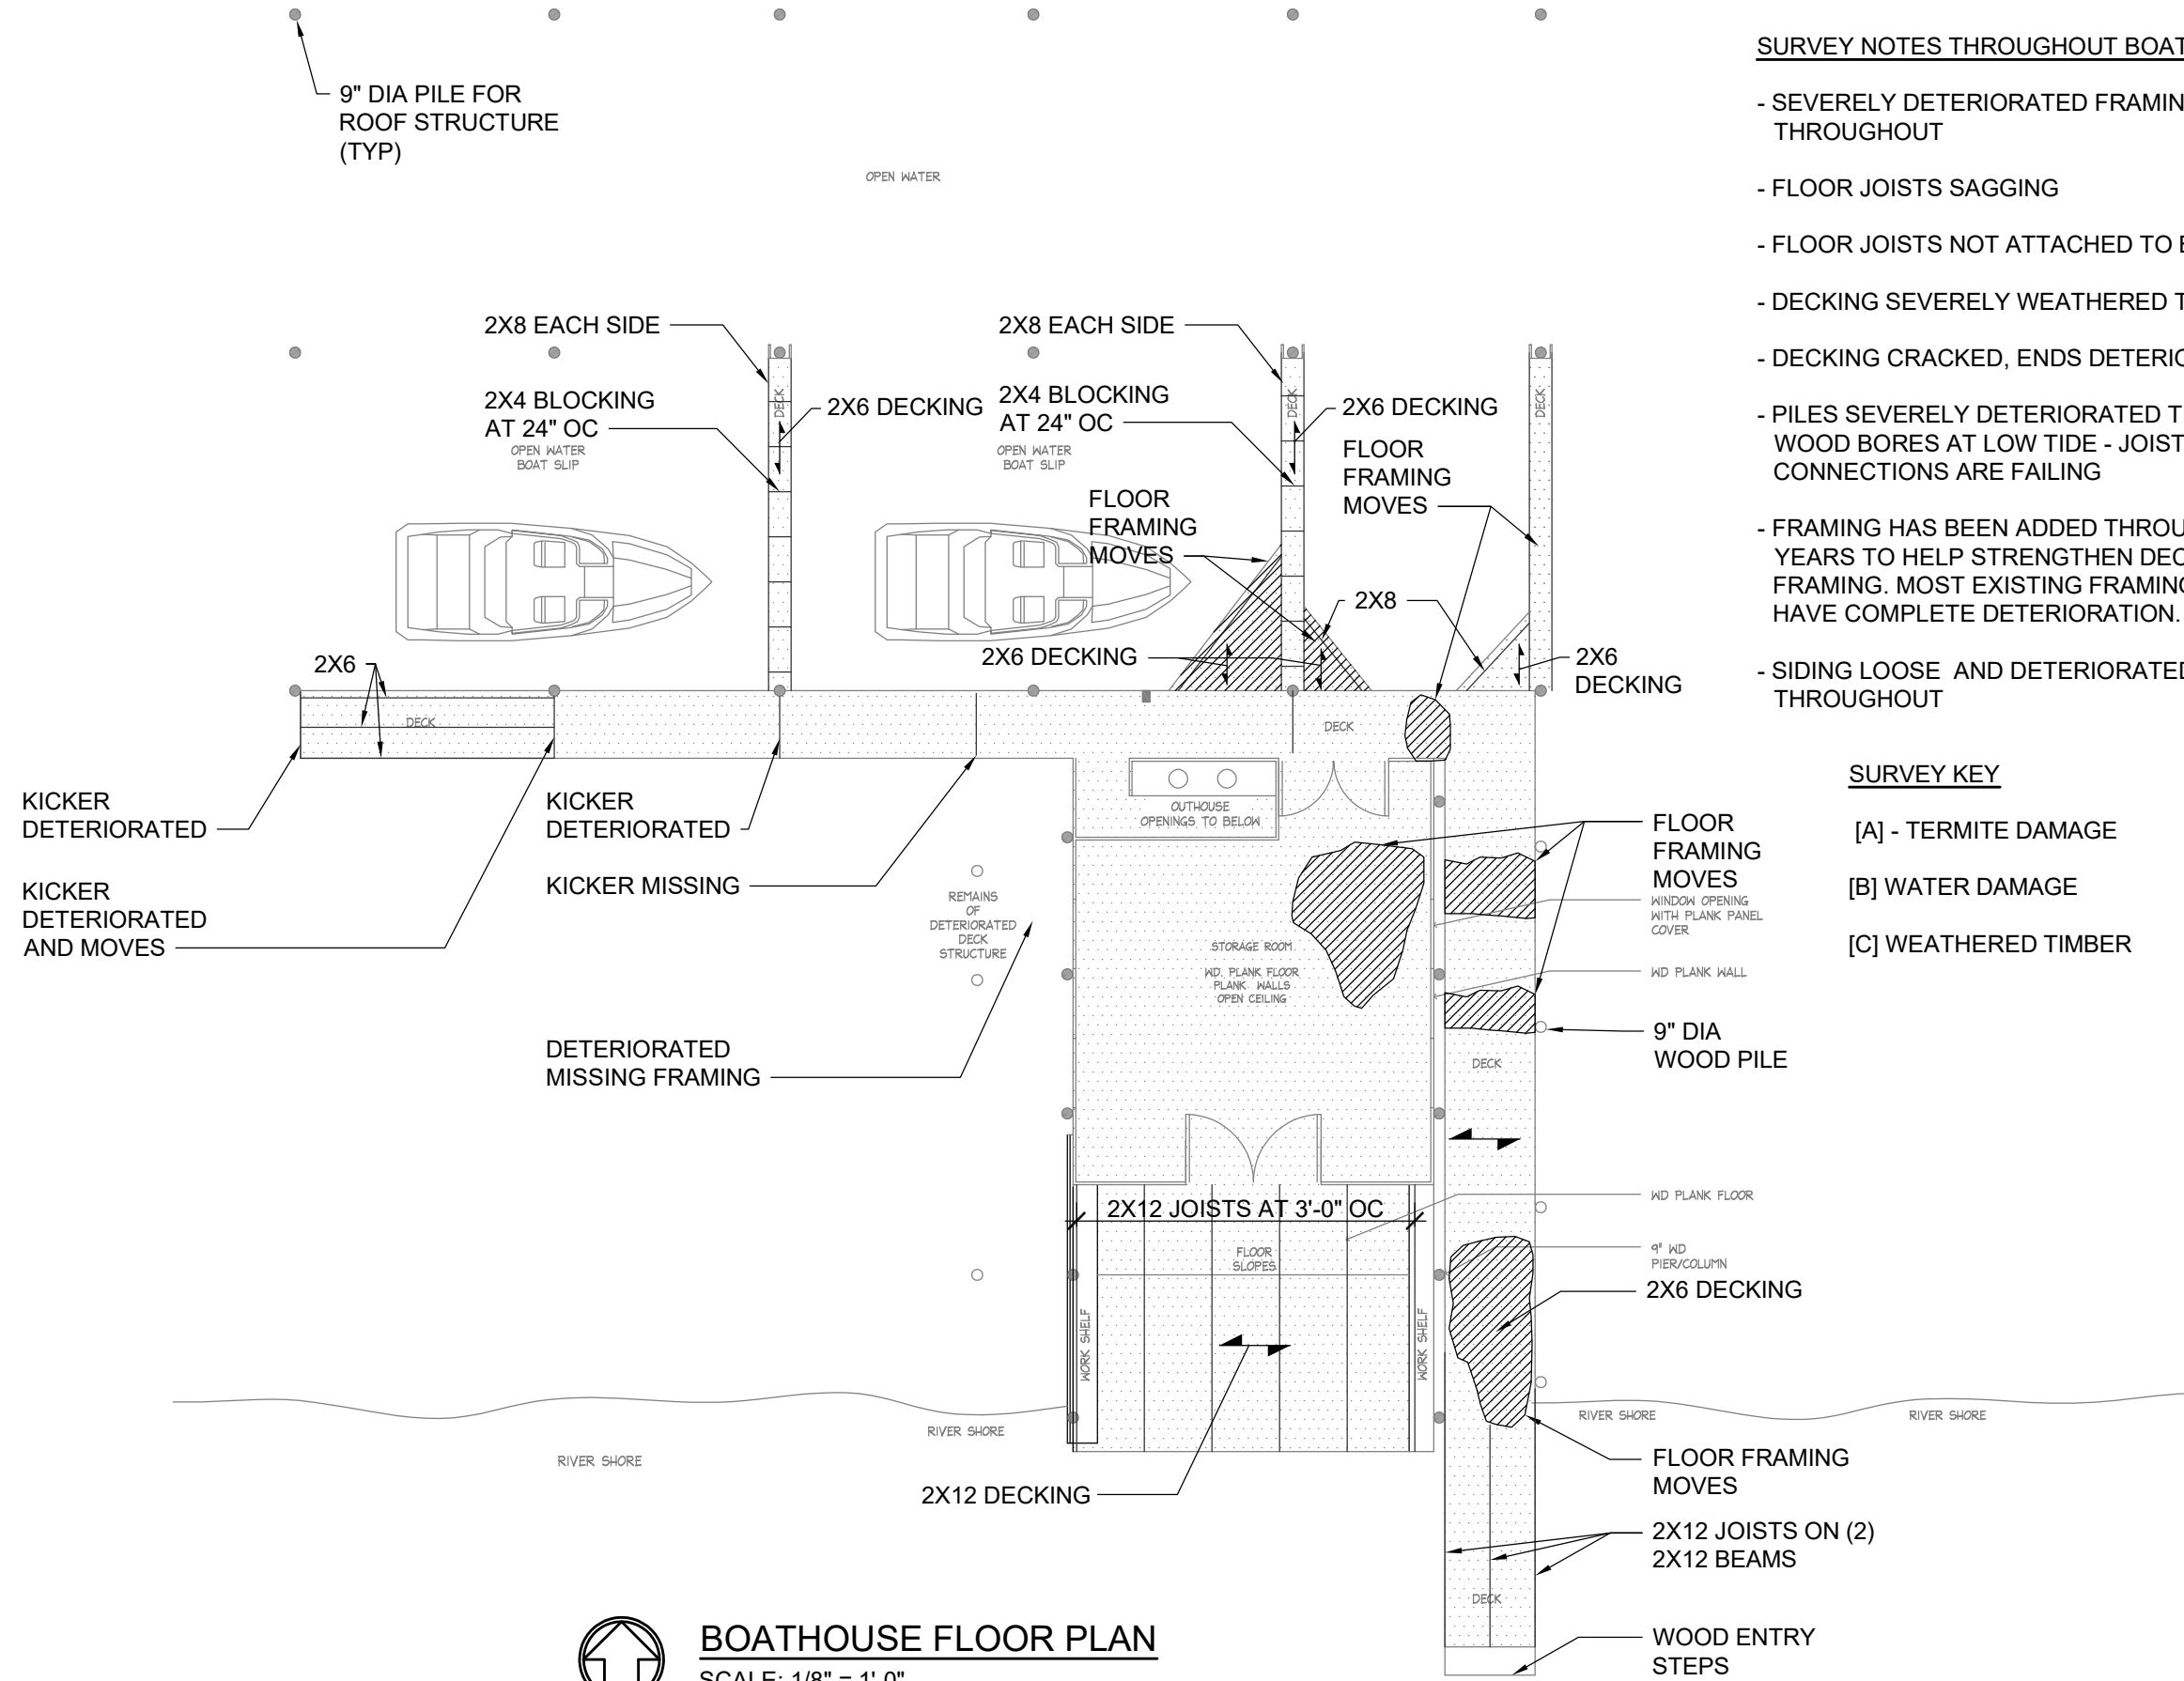
SURVEY NOTES THROUGHOUT BOATHOUSE

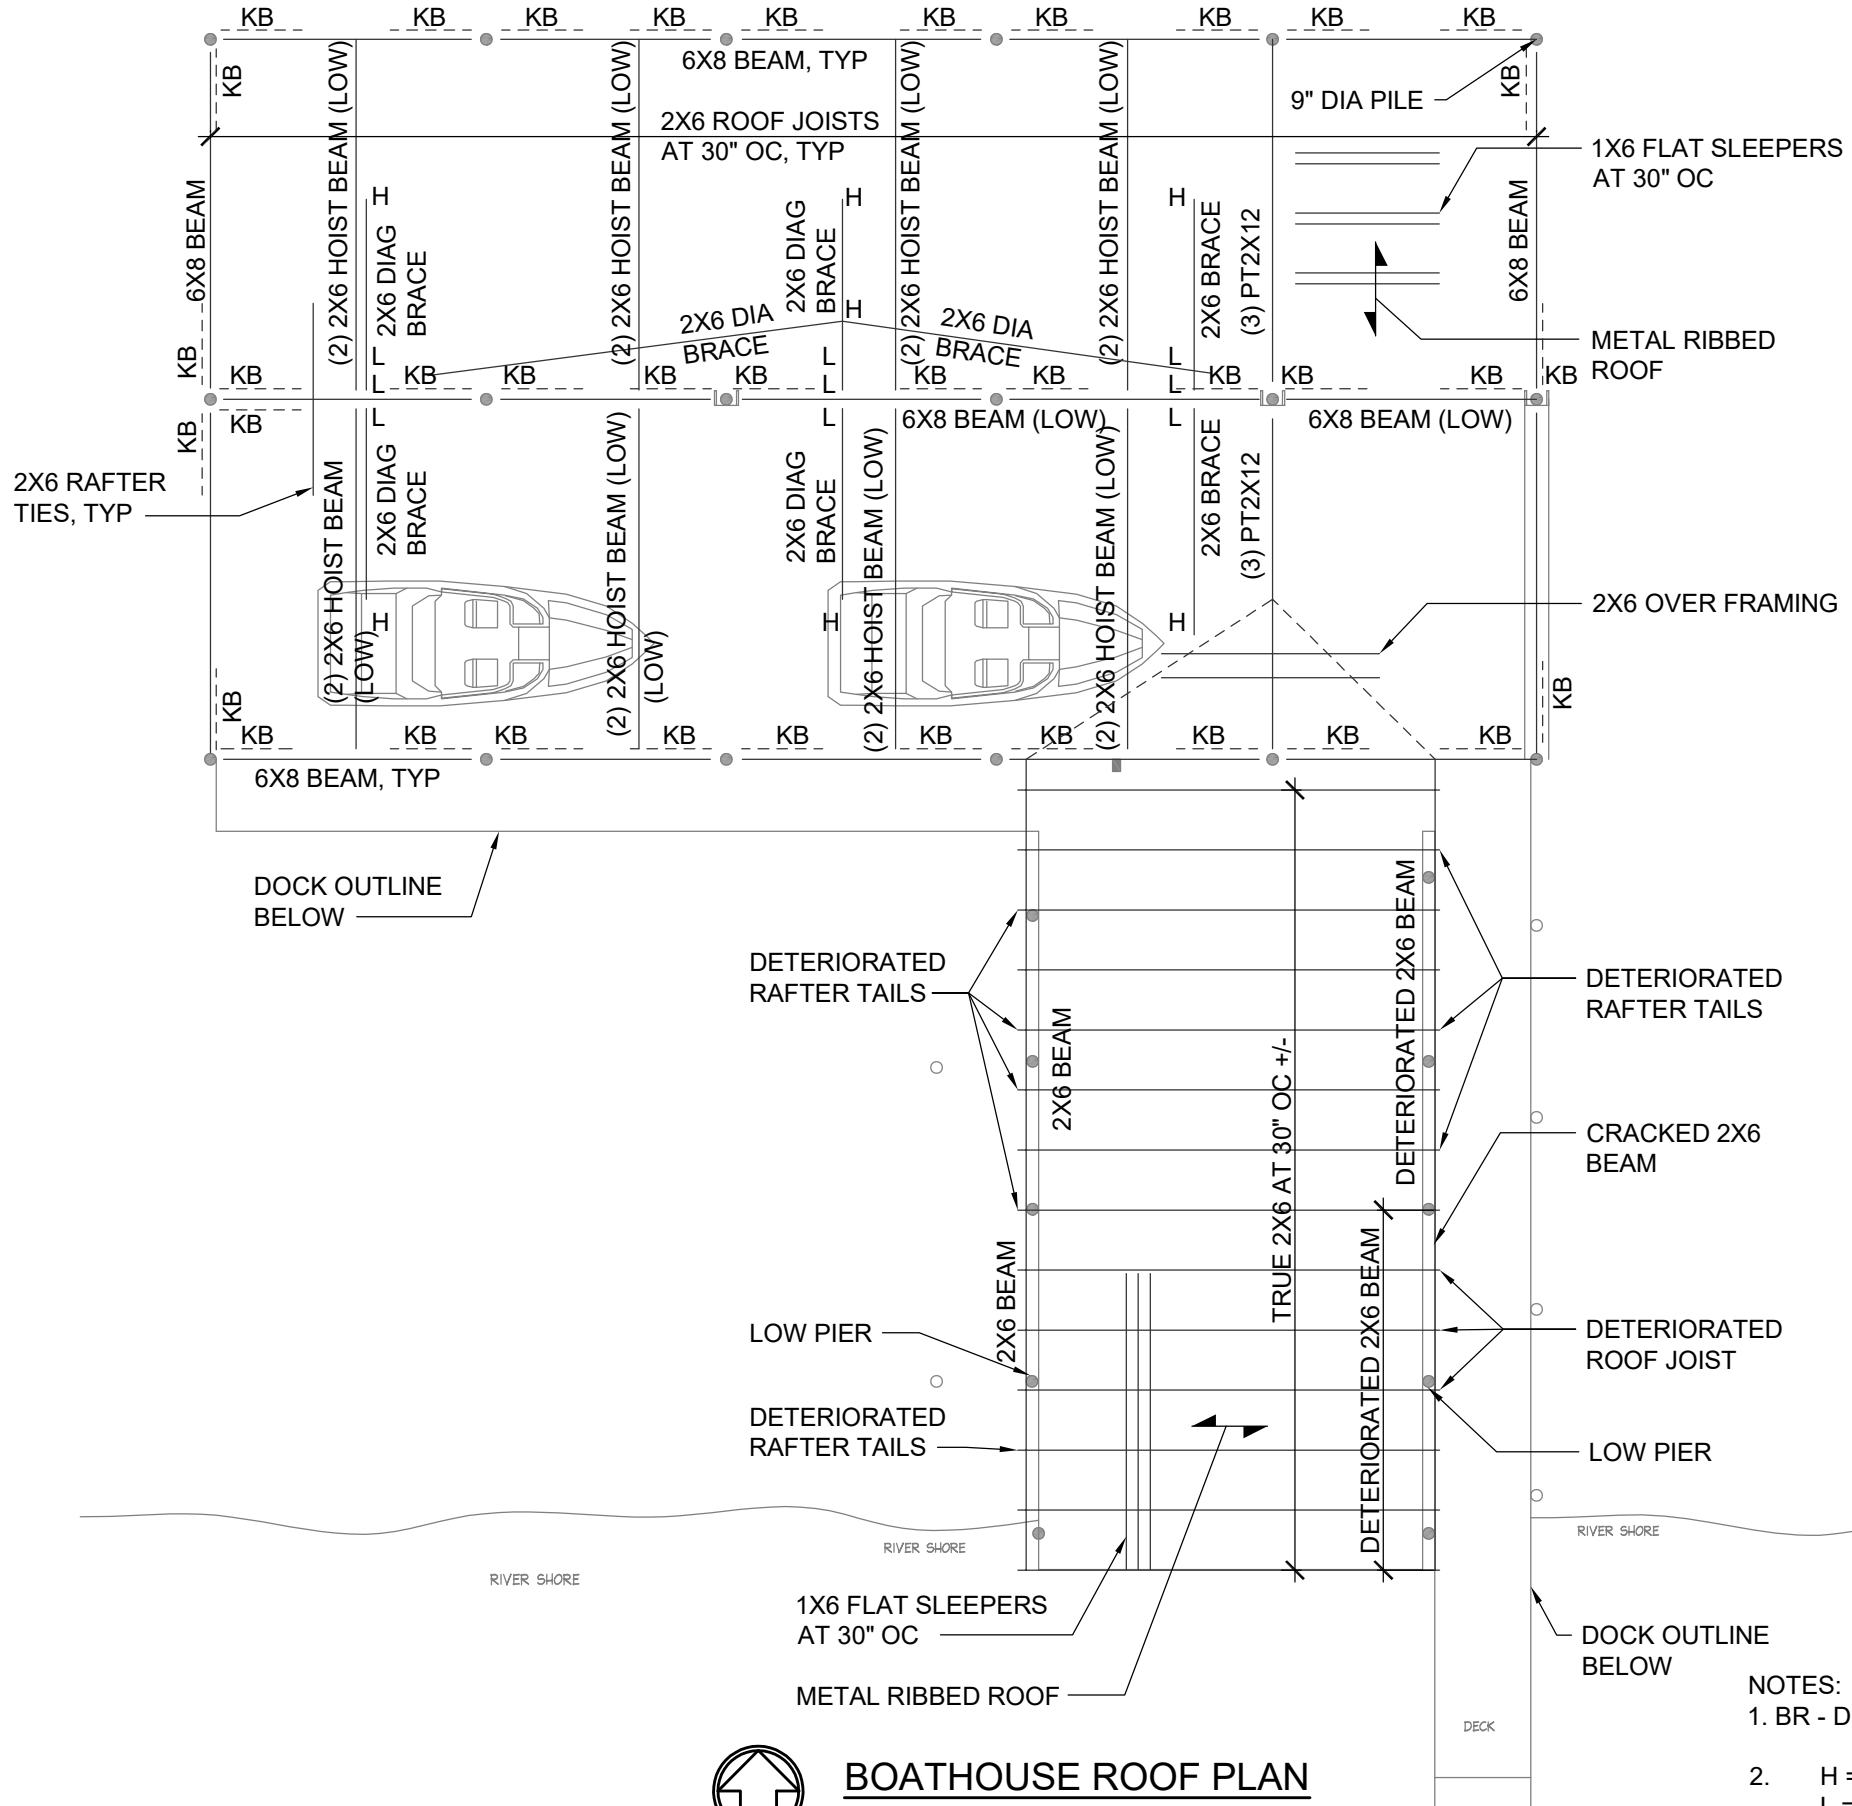
SURVEY NOTES THROUGHOUT BOATHOUSE

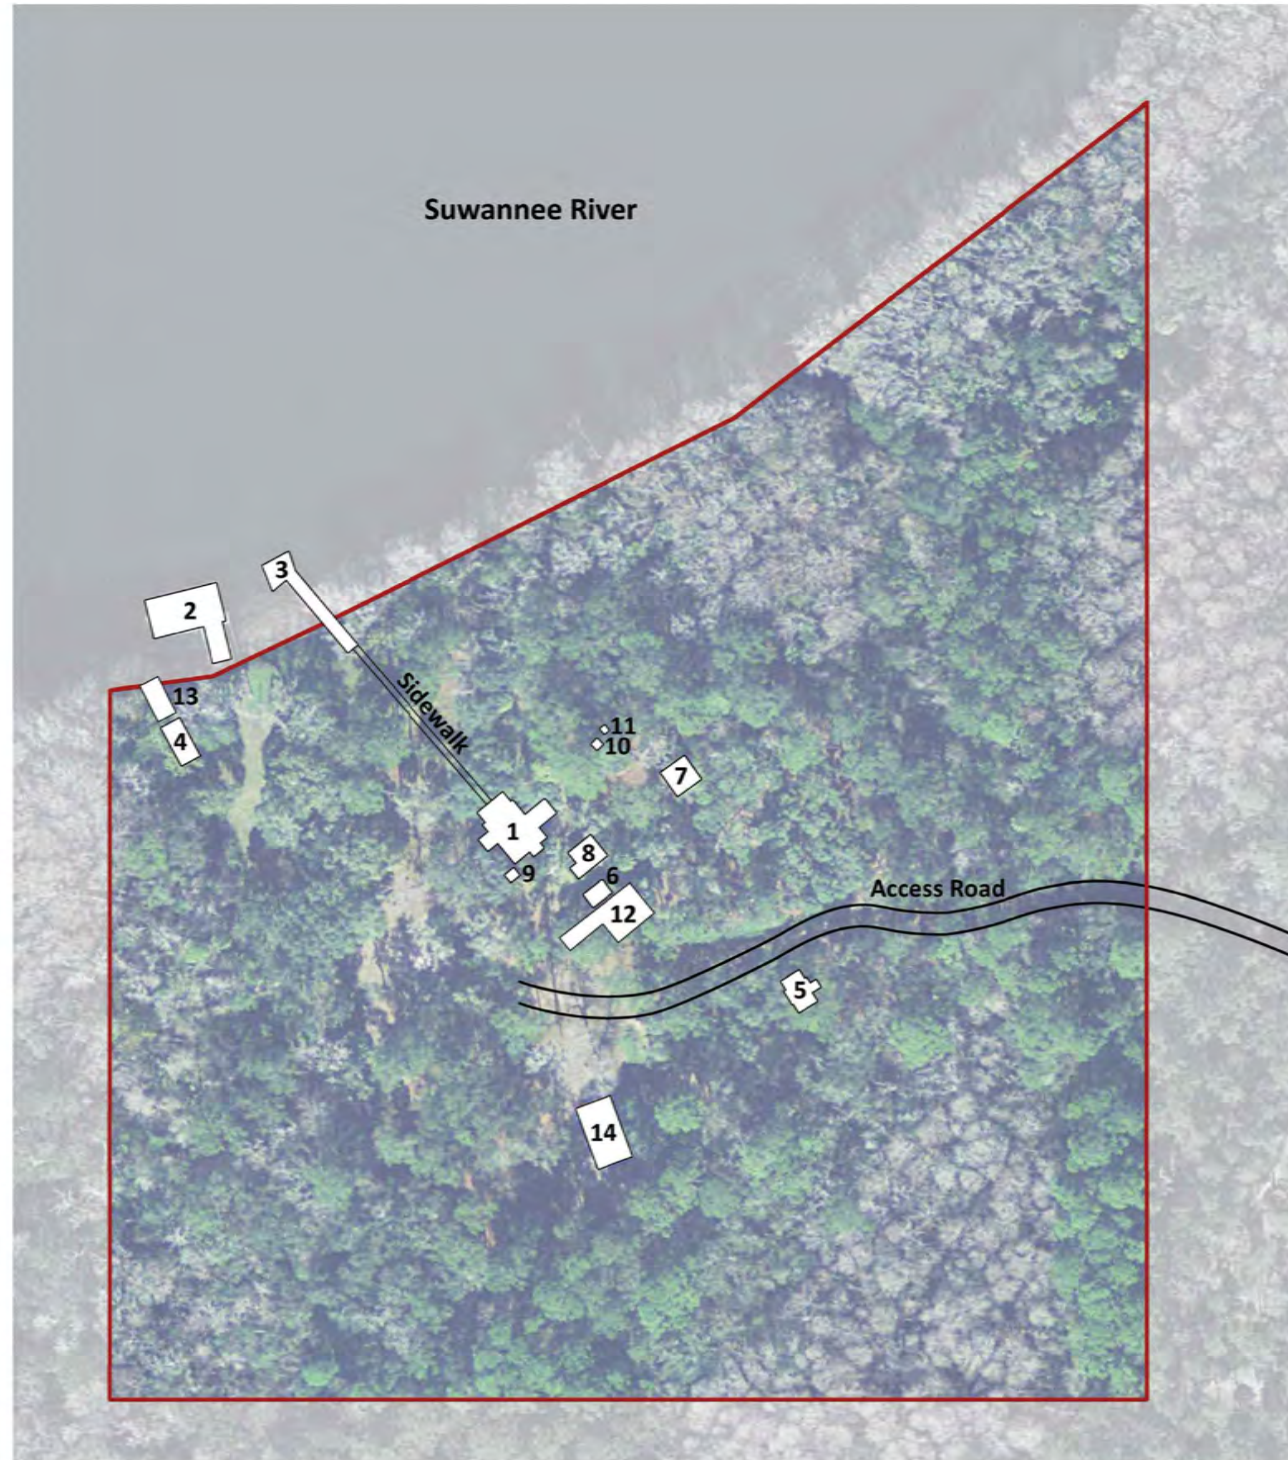
**Site Map of Vista Property and Surrounding Area**

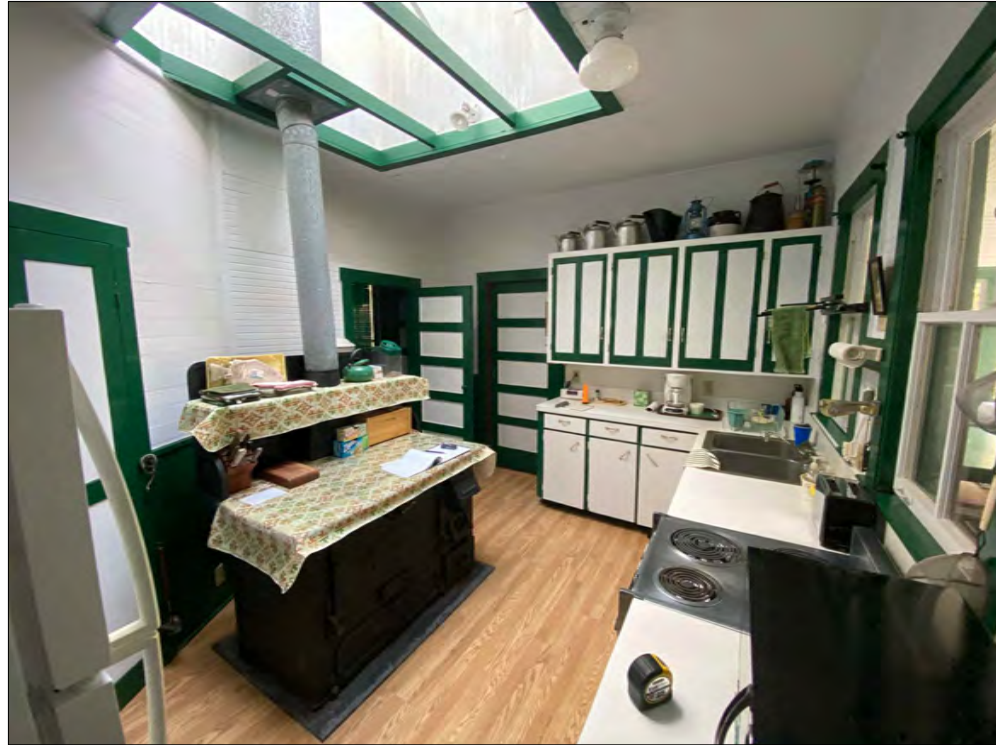
4 KITCHEN (DINING ROOM BEYOND)  
SCALE: N.T.S.

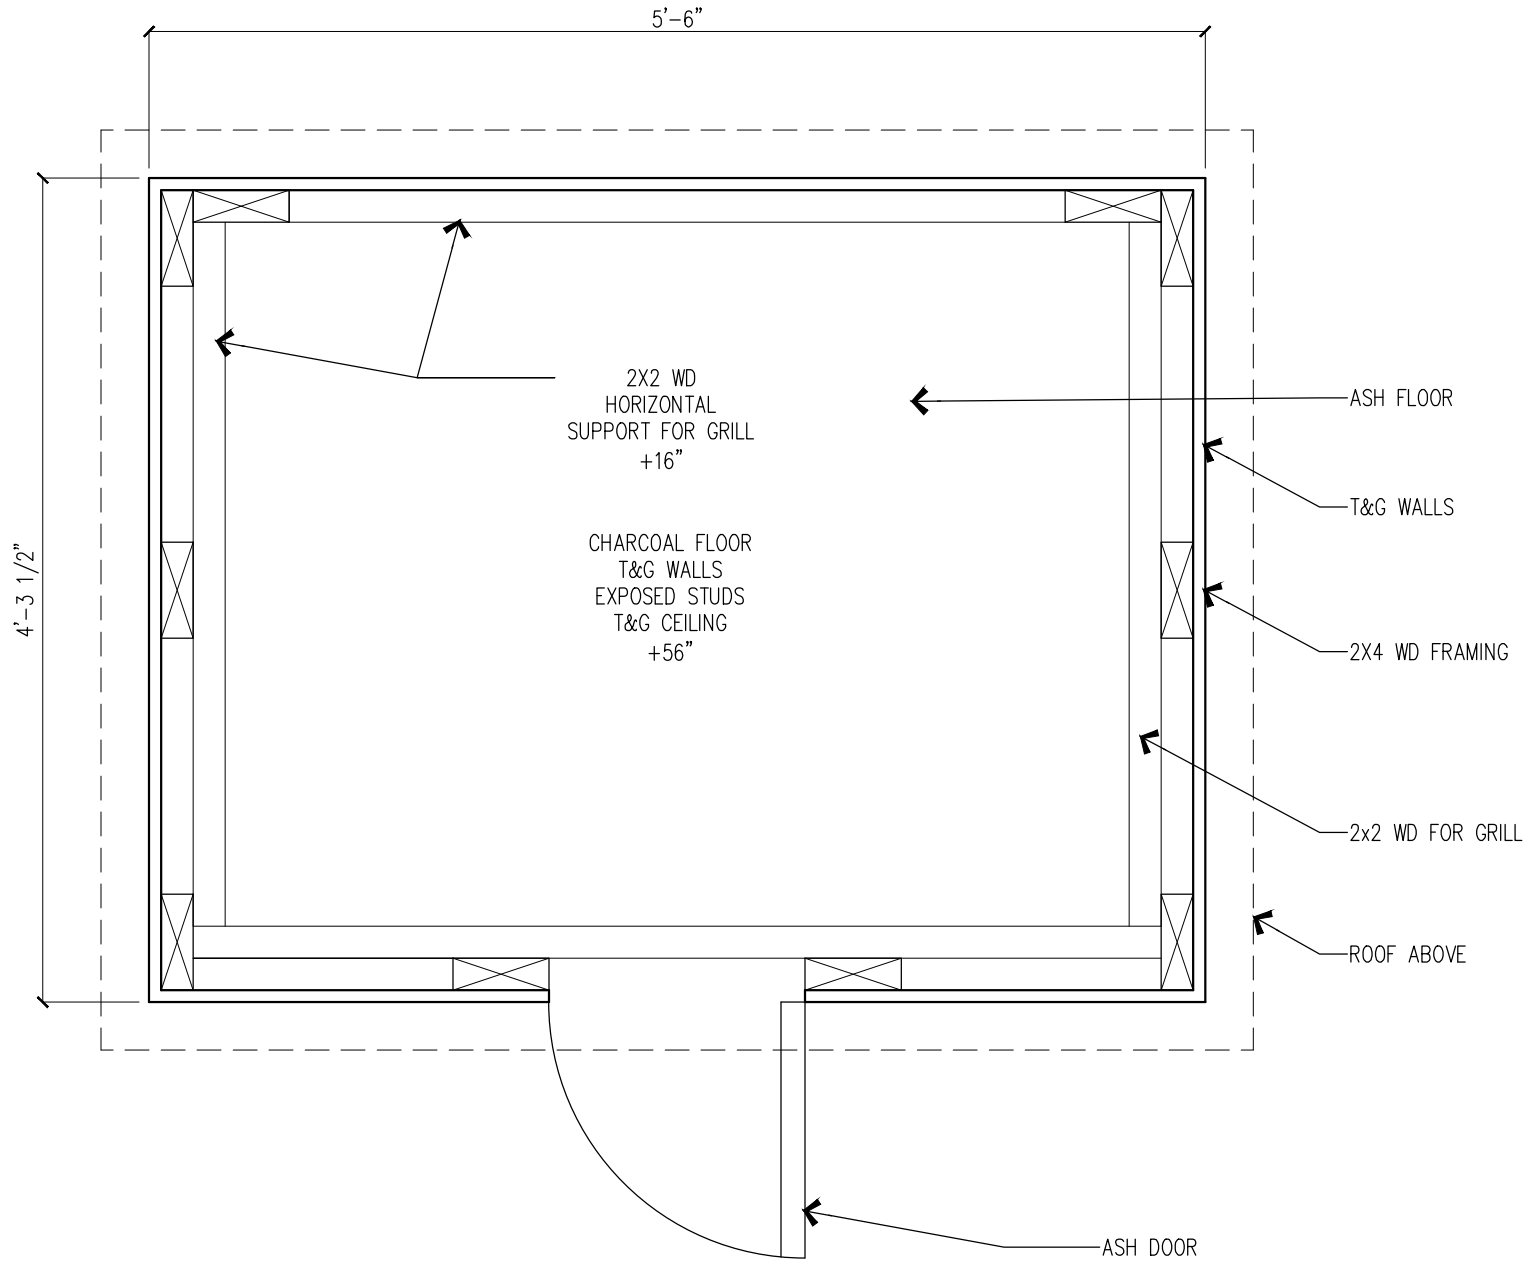
② SMOKER PLAN  
SCALE: 1" = 1'-0"

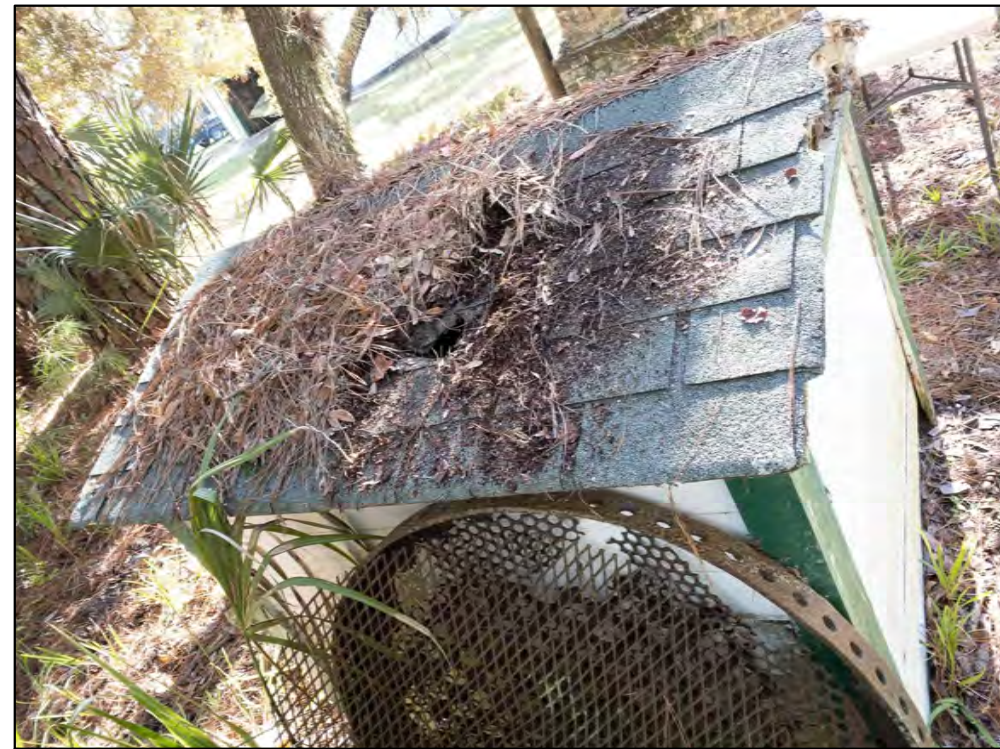
2 SMOKER ROOF DAMAGE (OYSTER GRILL IN FOREGROUND)  
SCALE: N. T. S.

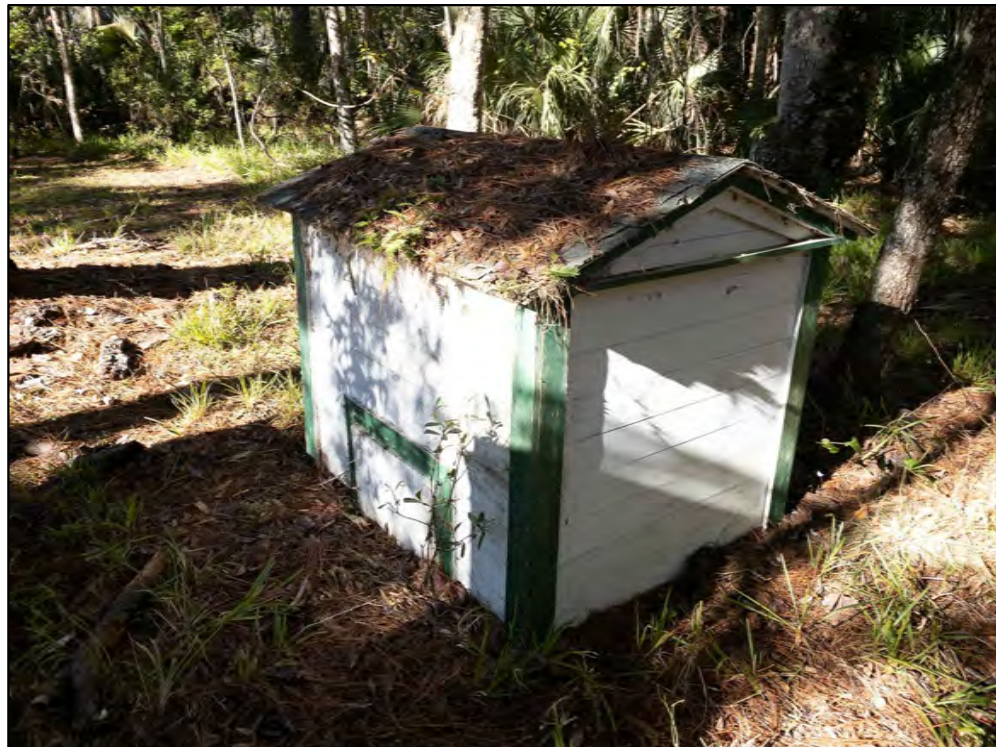
3 SMOKER OBLIQUE (SOUTHWEST)  
SCALE: N. T. S.

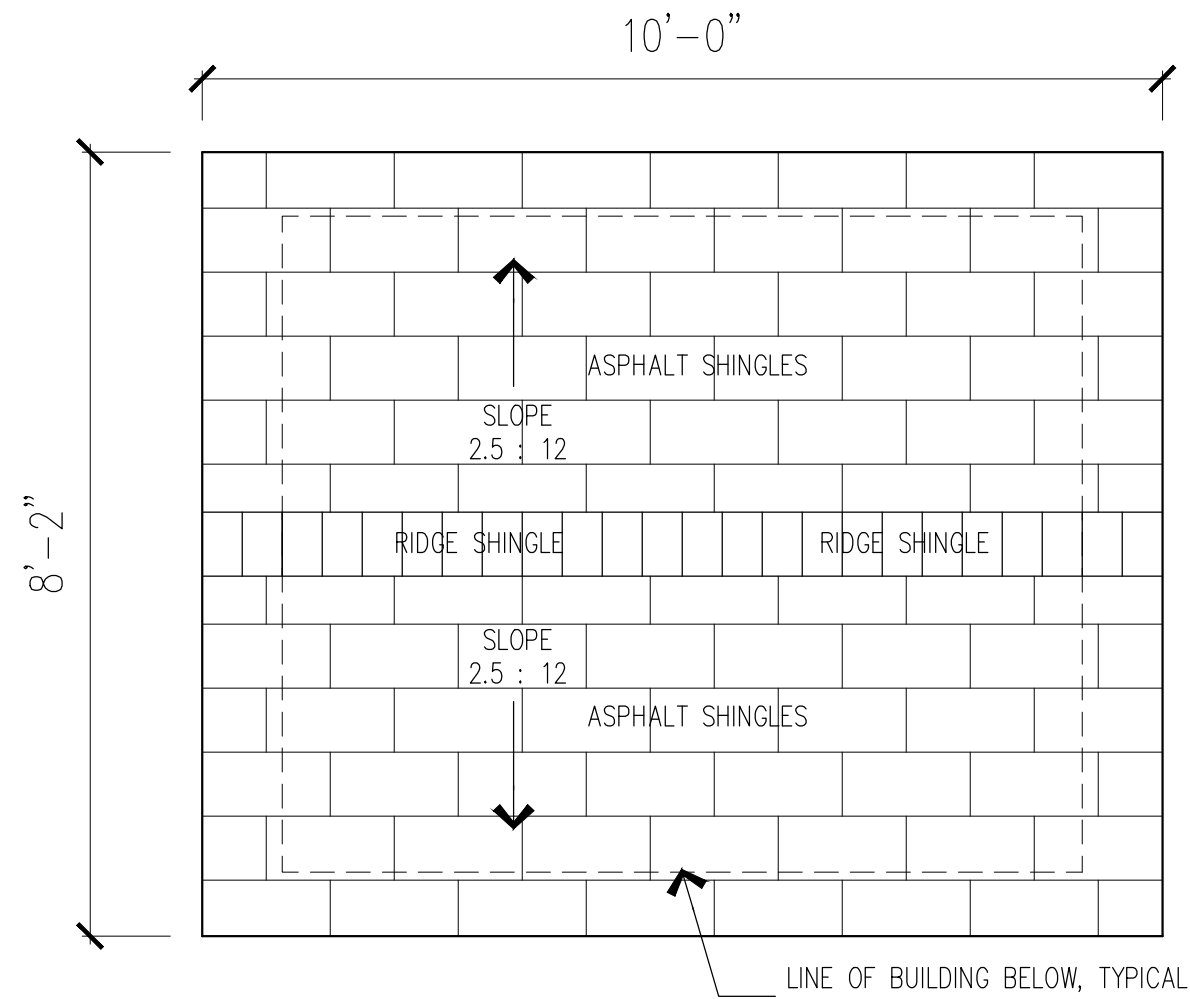
2 WOODSHED ROOF PLAN  
SCALE: 1/2" = 1'-0"

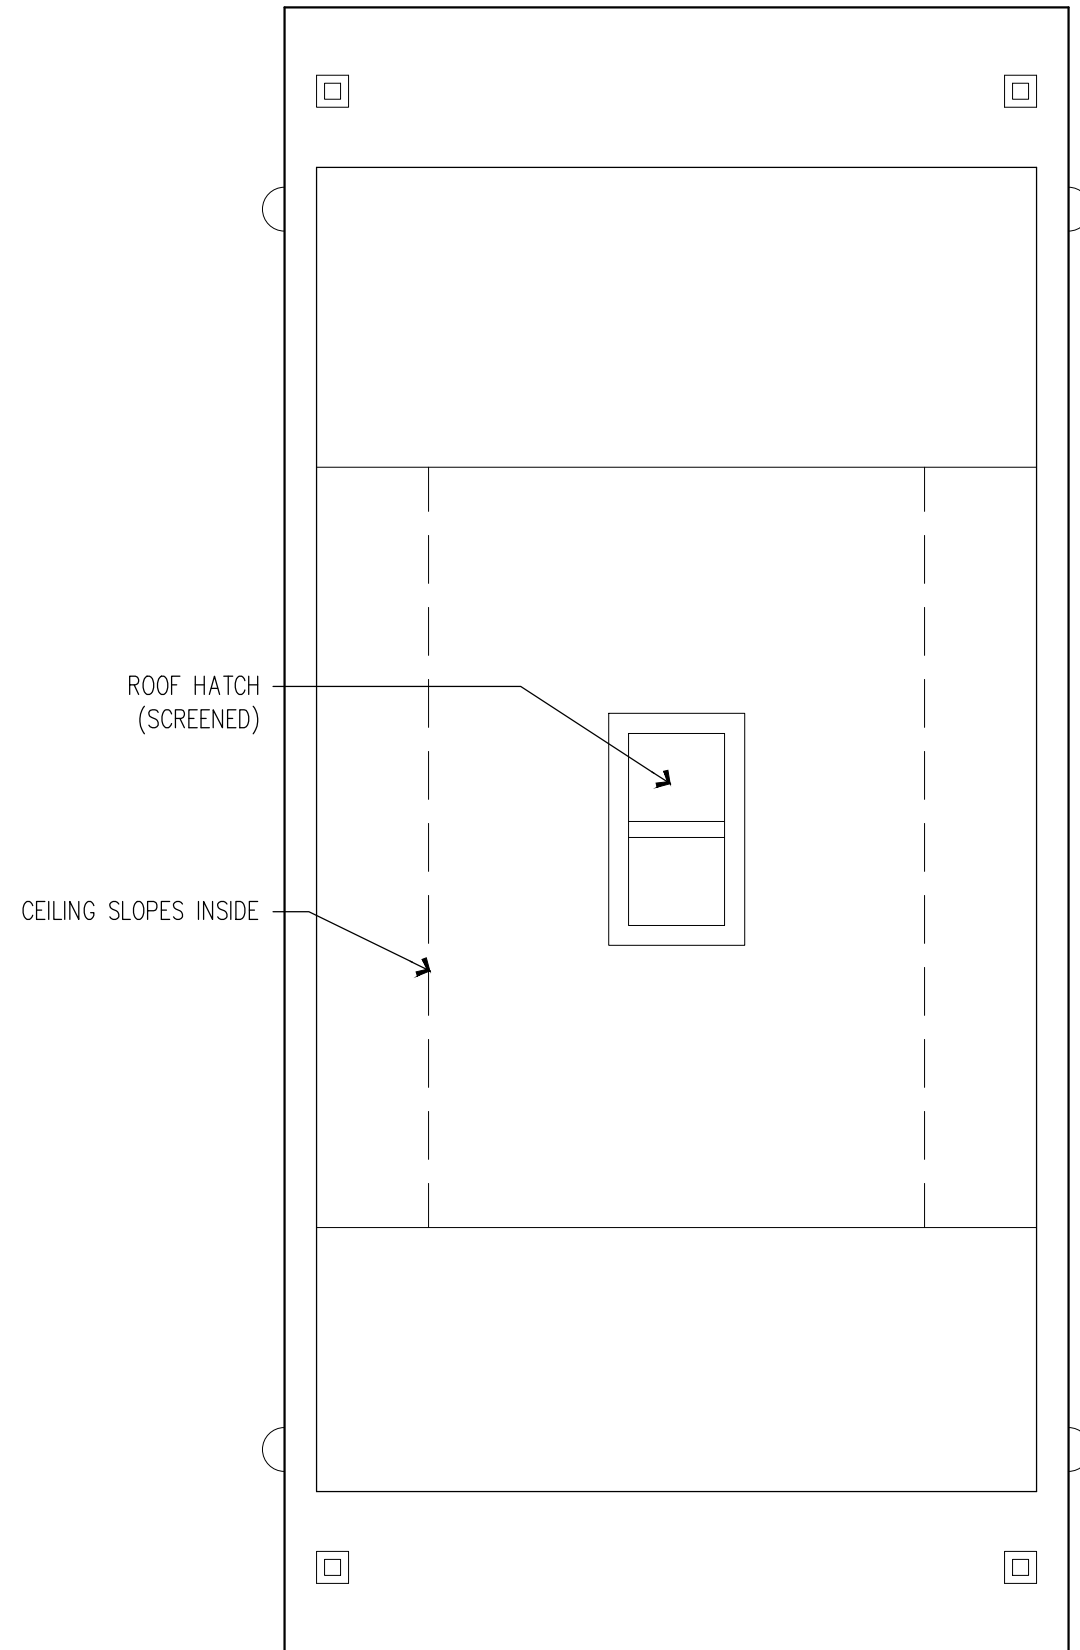
2 HOUSEBOAT ROOF PLAN  
SCALE: 1/4" = 1'-0"

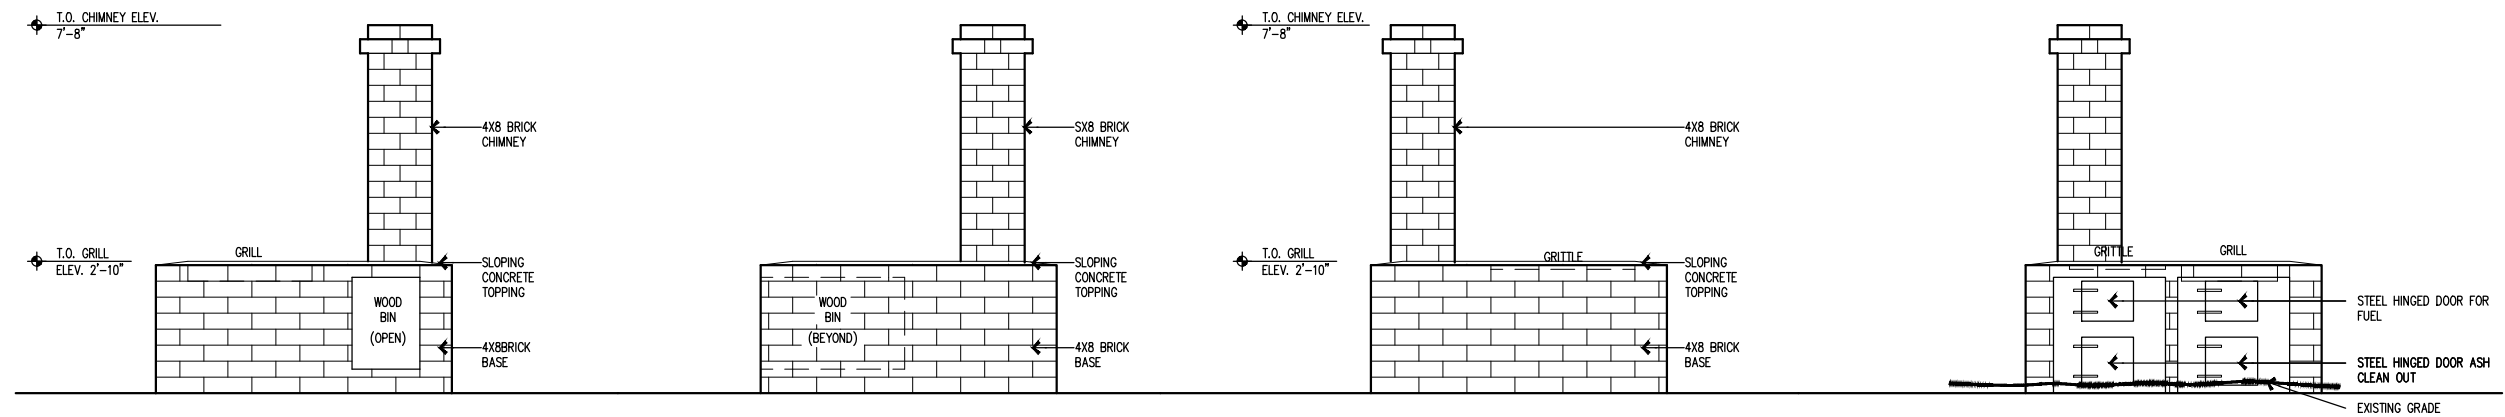
5 RIGHT ELEV  
SCALE: 1/2" = 1'-0"

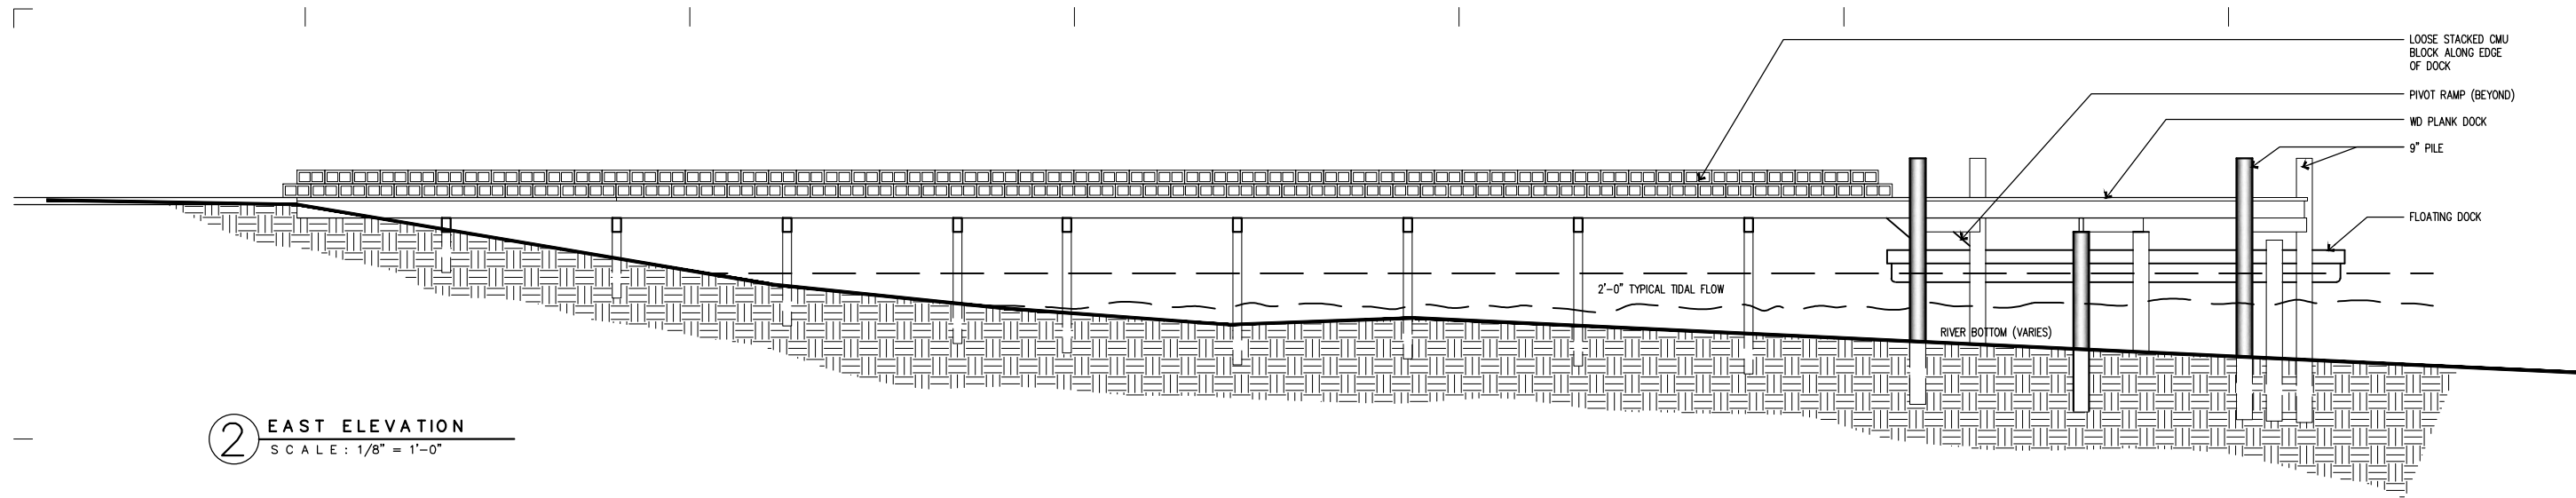
**2 EAST ELEVATION**  
SCALE: 1/8" = 1'-0"

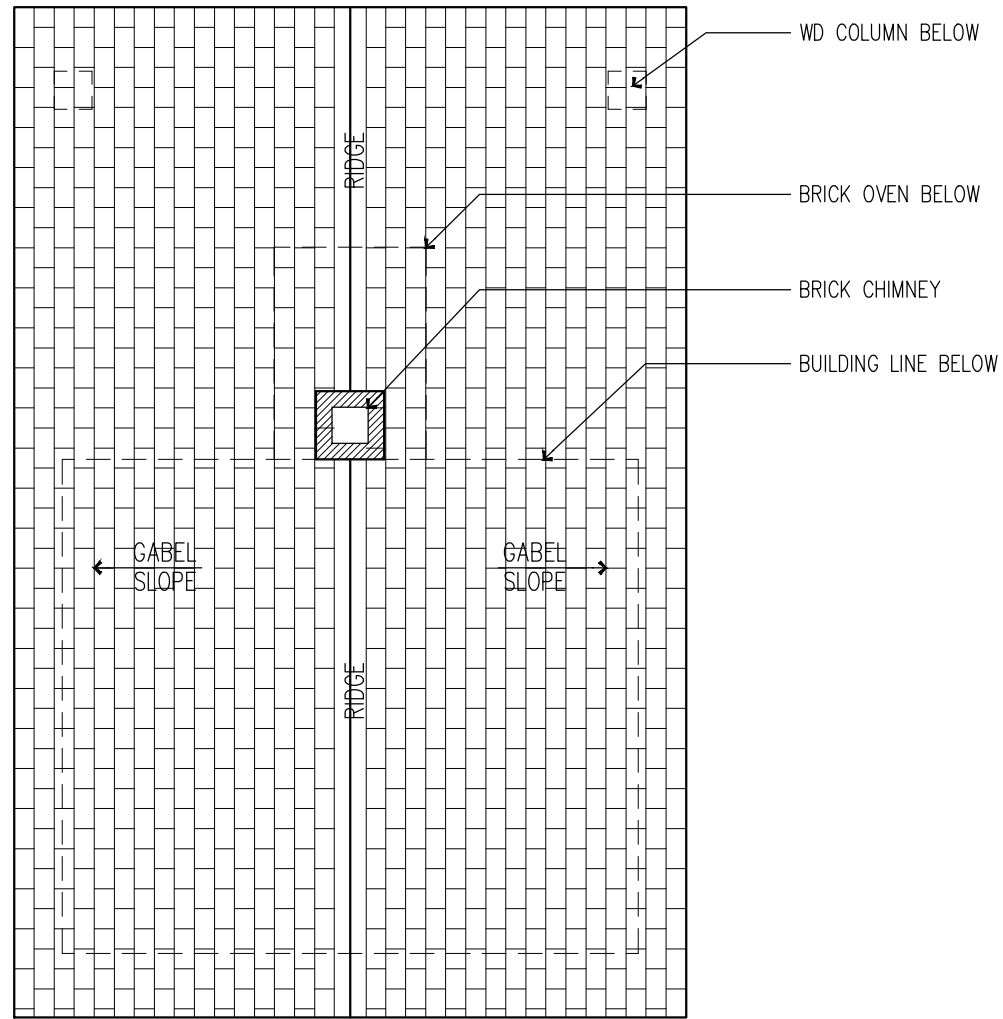
2 FRYER SHED ROOF PLAN  
SCALE: 1/4" = 1'-0"
