# **HISTORIC STRUCTURE ASSESSMENT REPORT**

## **VISTA HISTORIC SITE Lower Suwannee National Wildlife Refuge**

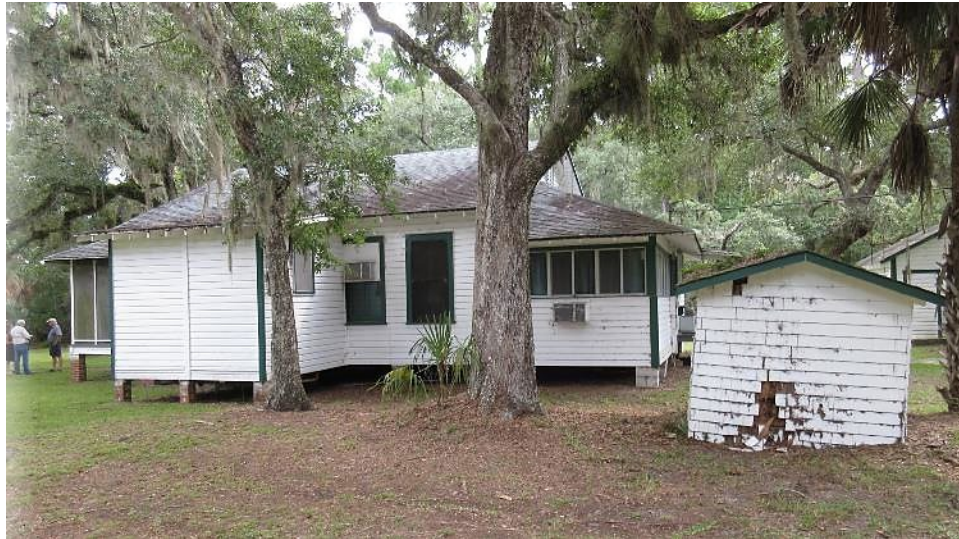
View of the west façade.

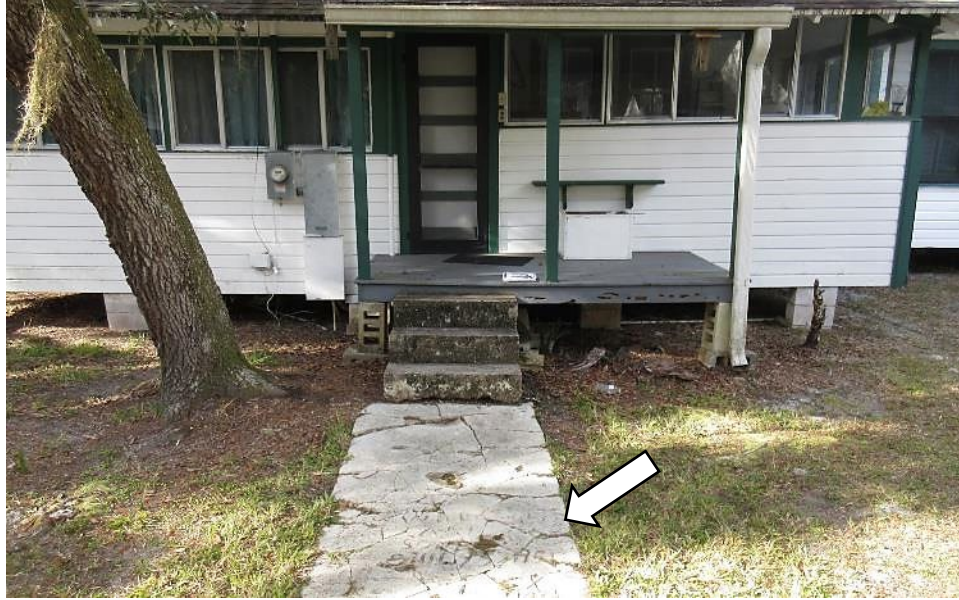
Detail of the back porch. Note the walkway inscription: "W. H. Leggett and Son, July 15, 1951."

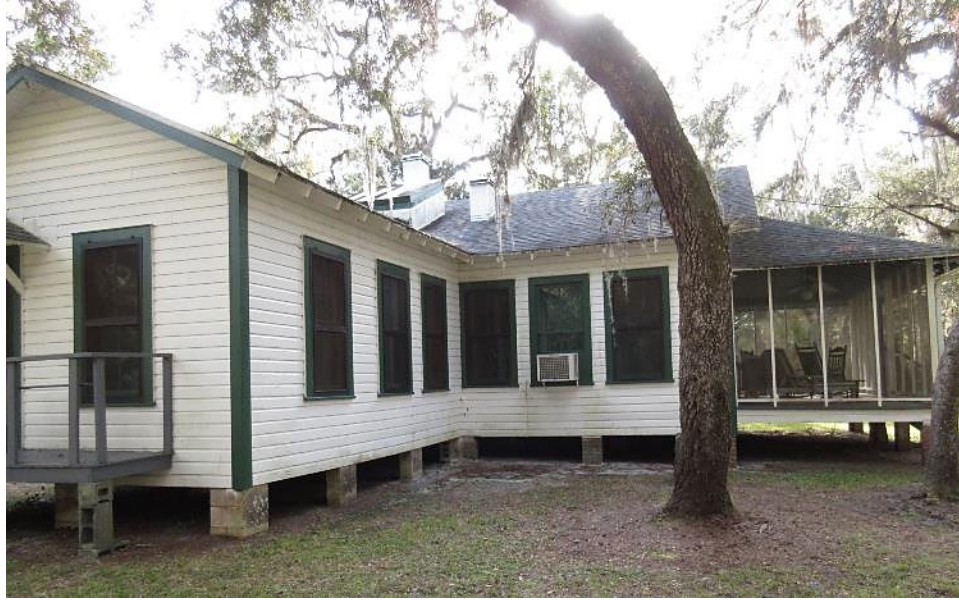
View of the northeast portion of the building with the dining room addition at left.

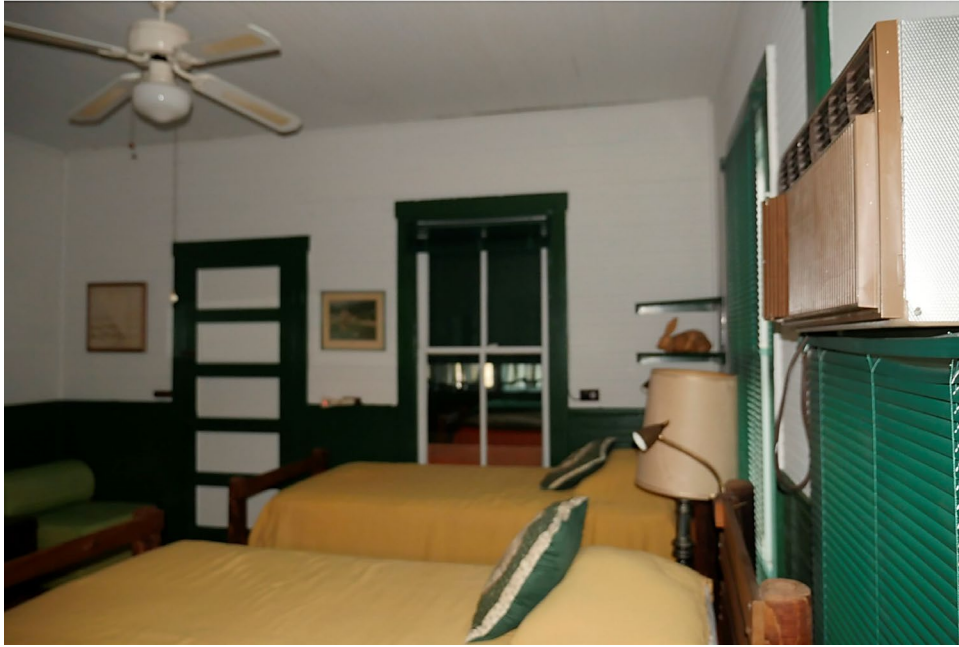
View south of Bedroom #2 toward Bedroom #3.

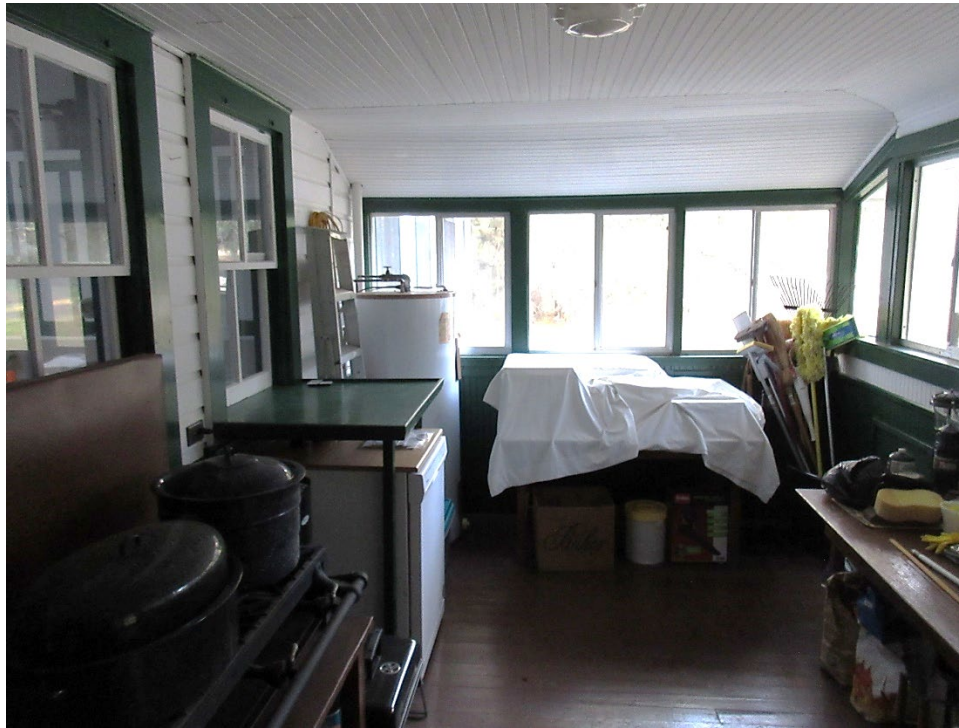
View east of the back porch.

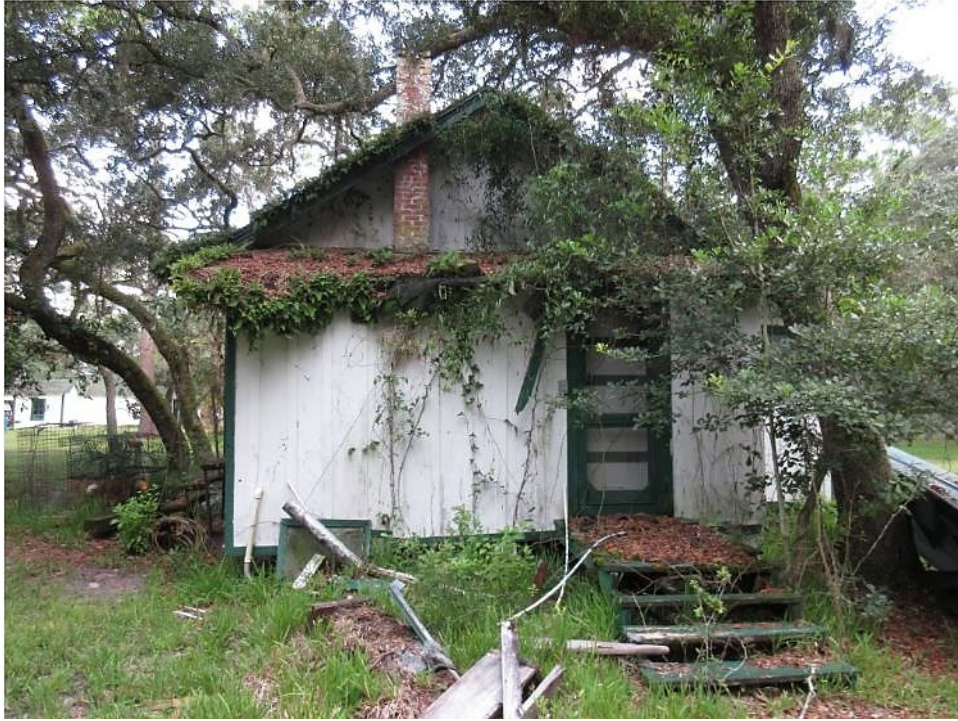
Rear (south) façade of the Cook's House.

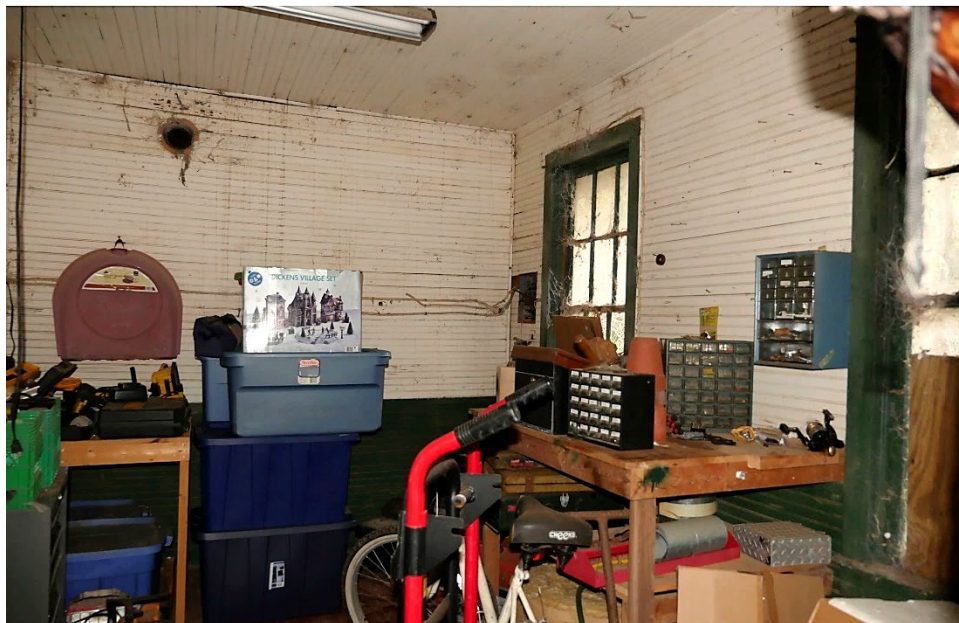
Interior of the Cook's house in the room at the northwest corner.

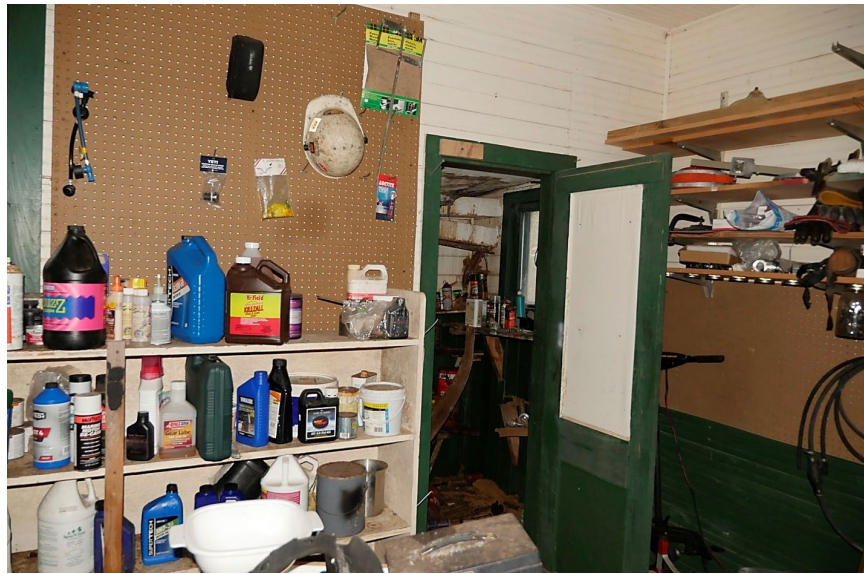
Interior of the Cook's House looking from the northeast front room to the door to the bathroom addition.

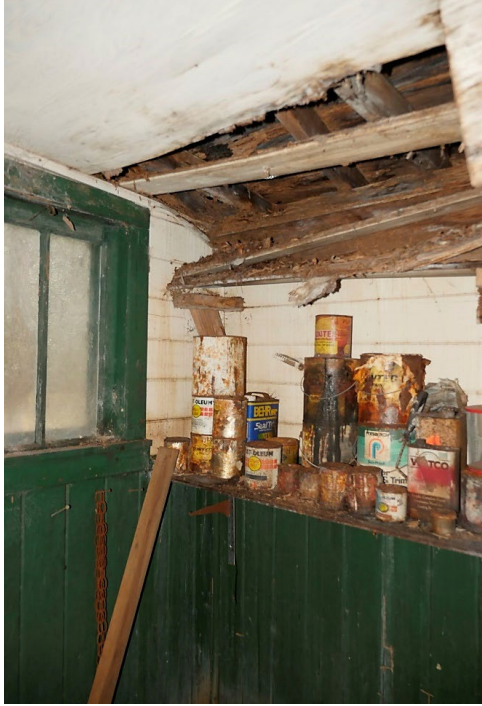
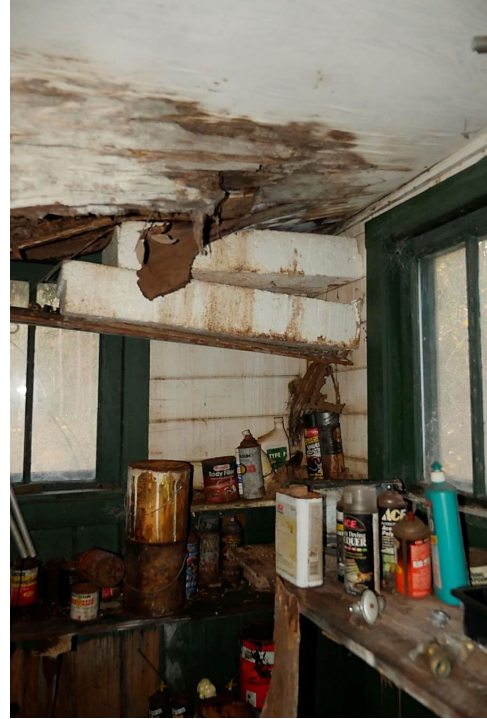
Photos of the bathroom interior showing the damaged ceiling.

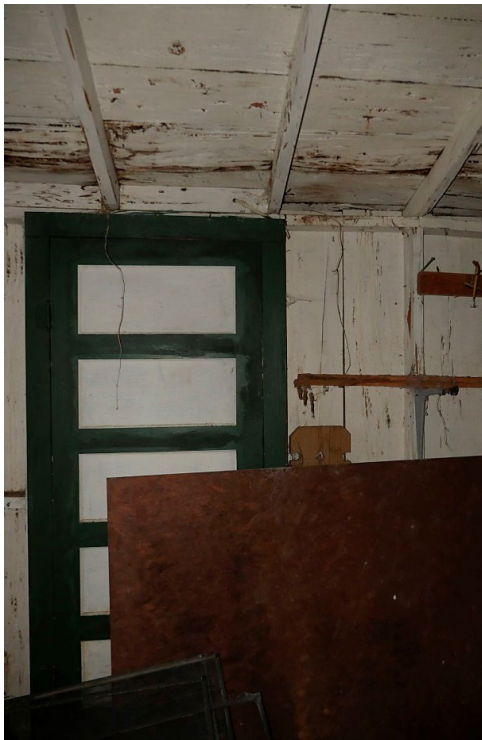
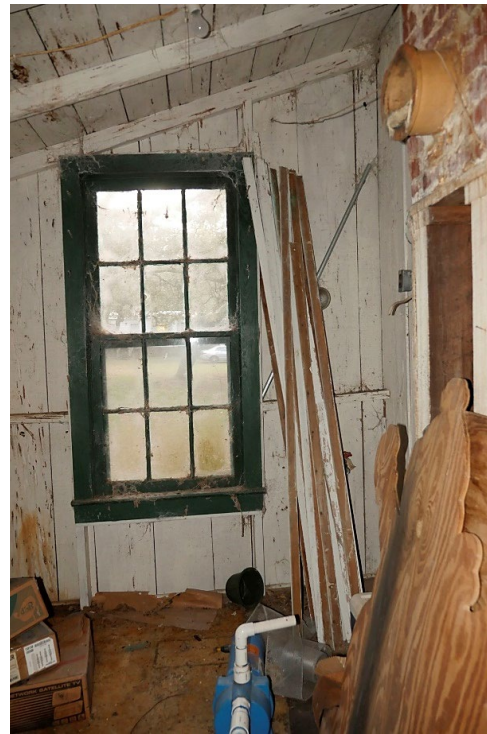
View of back porch toward the rear door (left). View to west wall (right).

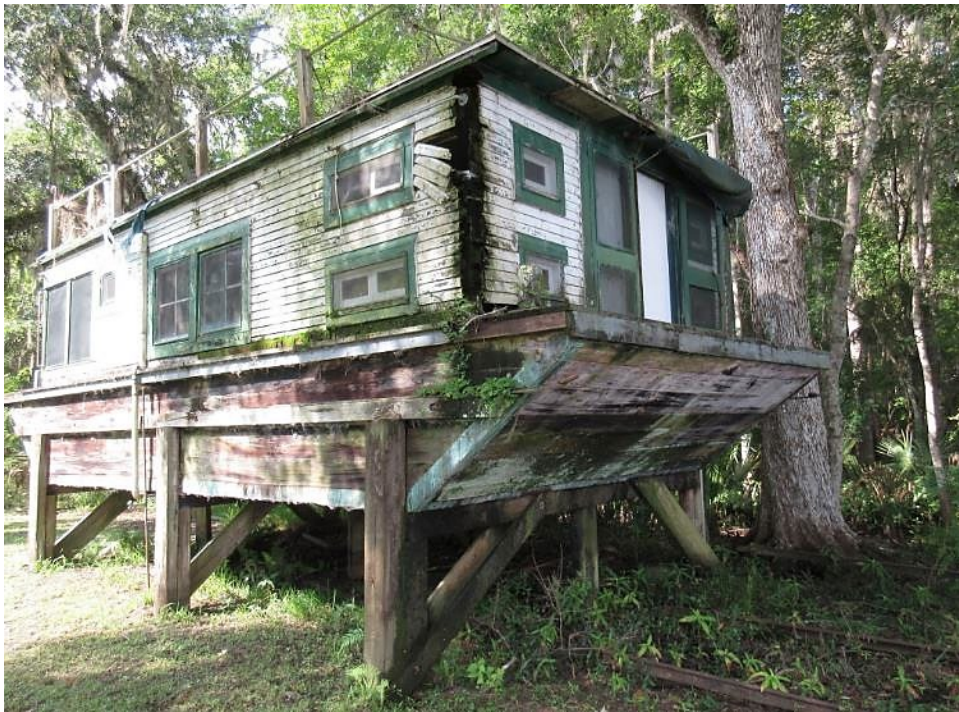
East and north sides of the Houseboat. Note wood rot damage at the northeast corner.

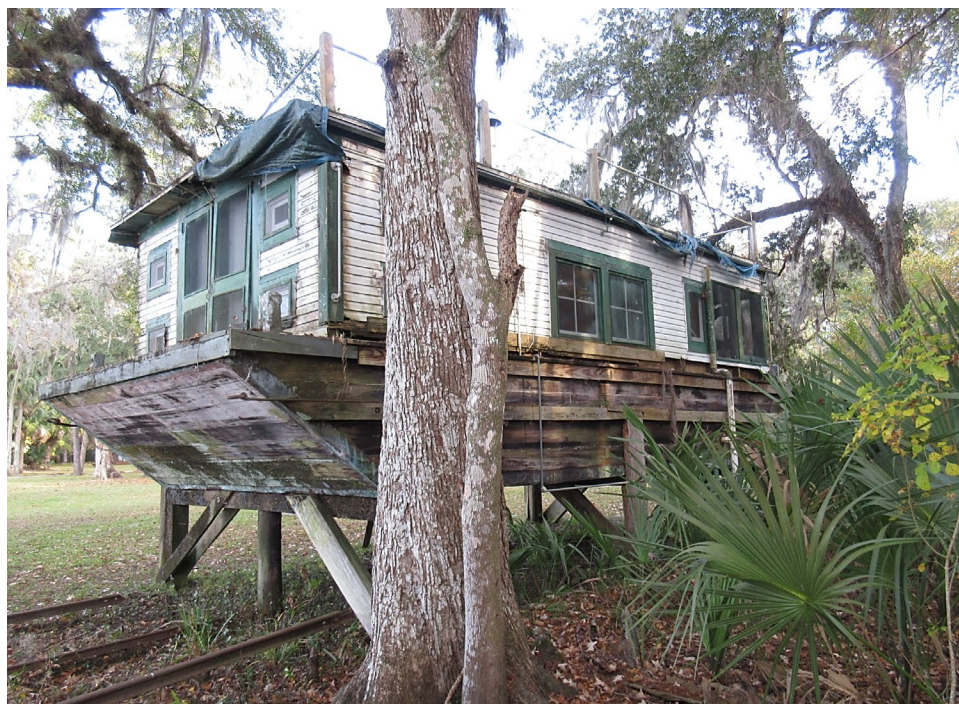
View southeast toward the starboard side of the Houseboat.

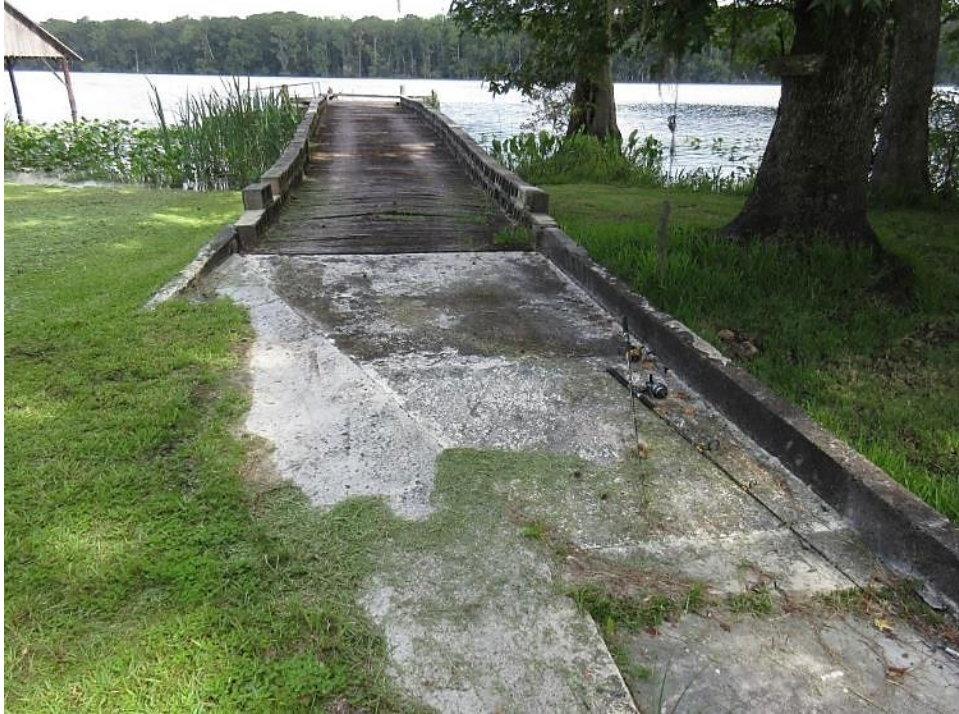
View north along the approach to the Dock from the Main House.

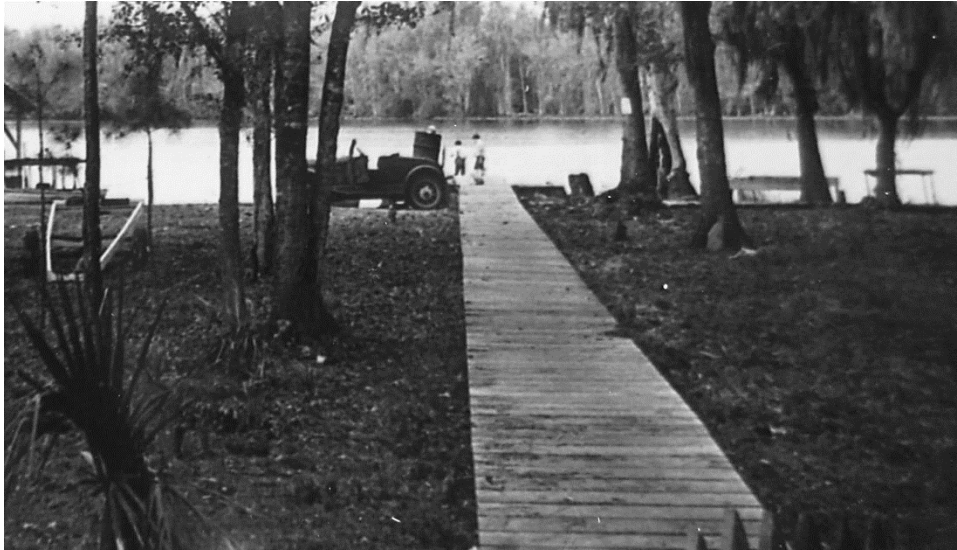
Circa late 1930s view of the walkway to the dock from the front porch of the Main House.  
(Photo courtesy Bob McKinstry)

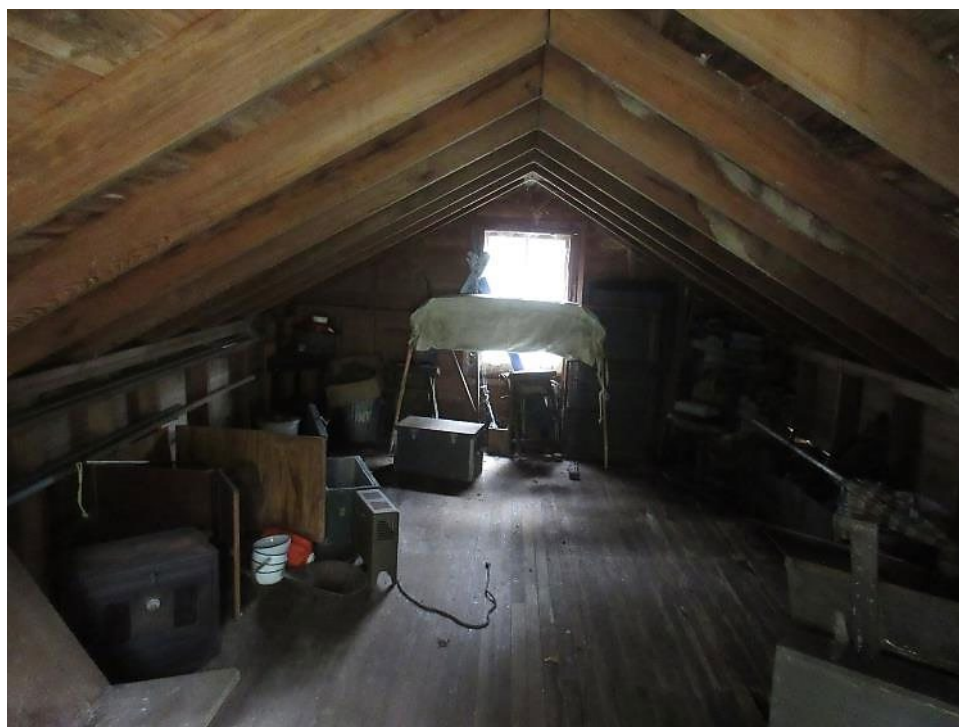
Interior of the Loft garage.

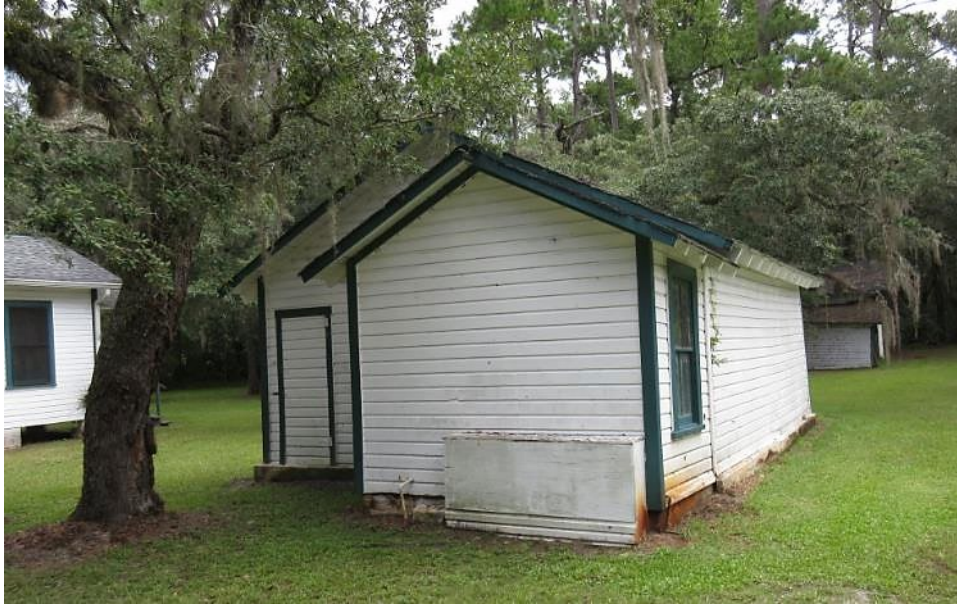
Rear (west) and south facades of the Garage.

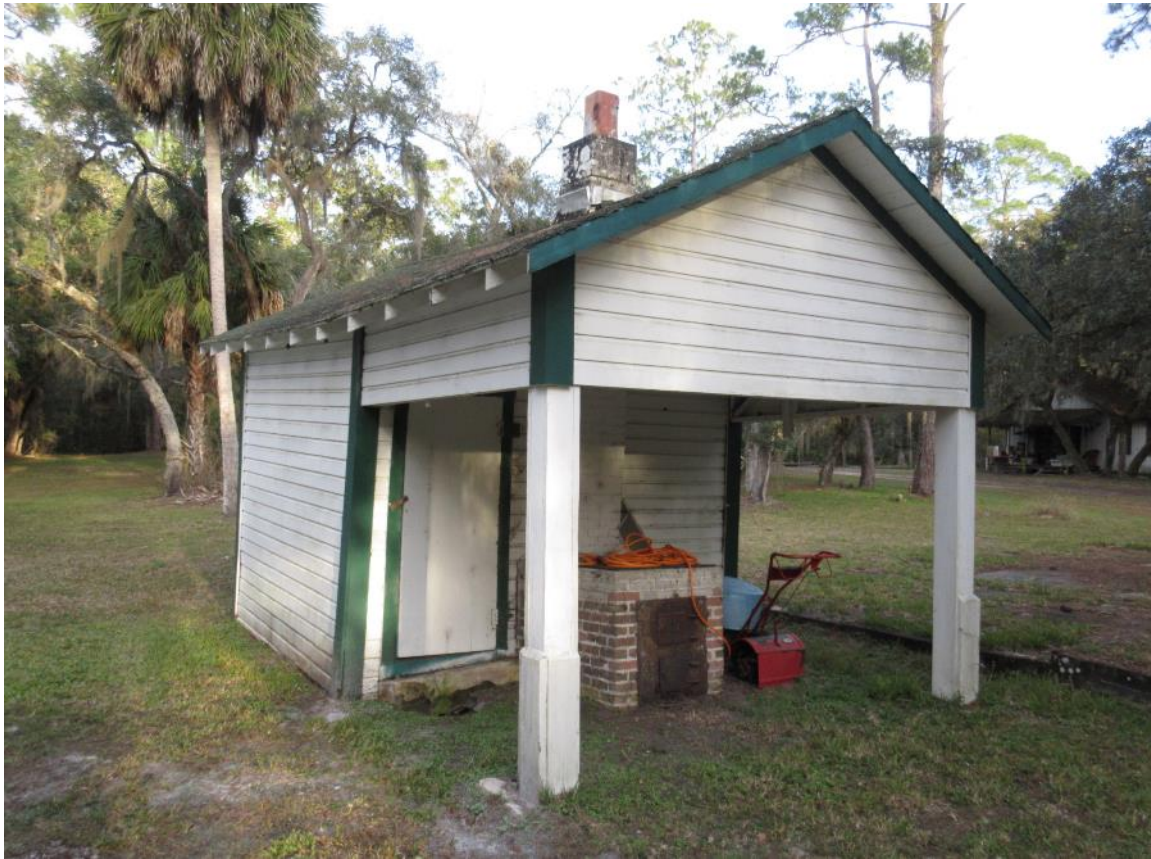
View southeast of the primary (west) and north facades of the Kettle Shed.

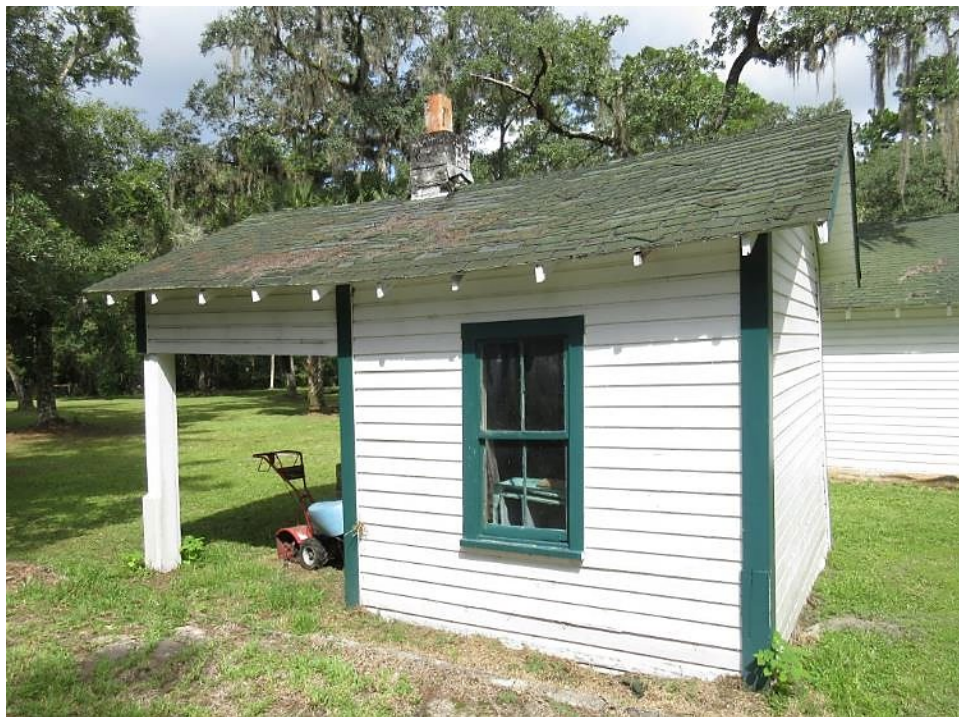
View north of the south façade of the Fryer Shed.

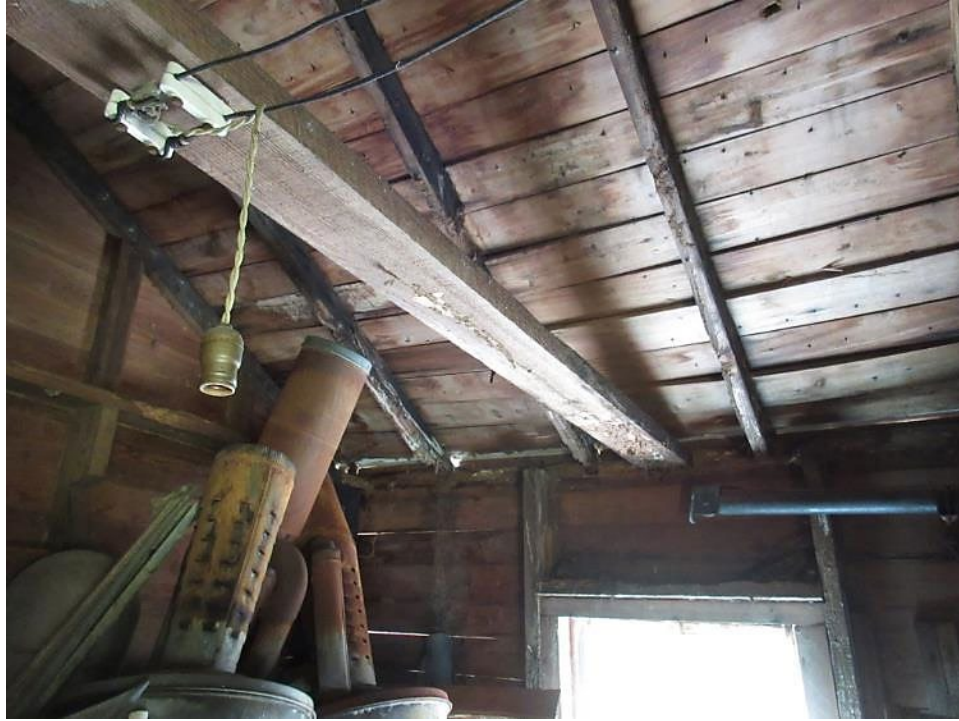
Detail of roof damage on the southern side of the interior storage area.

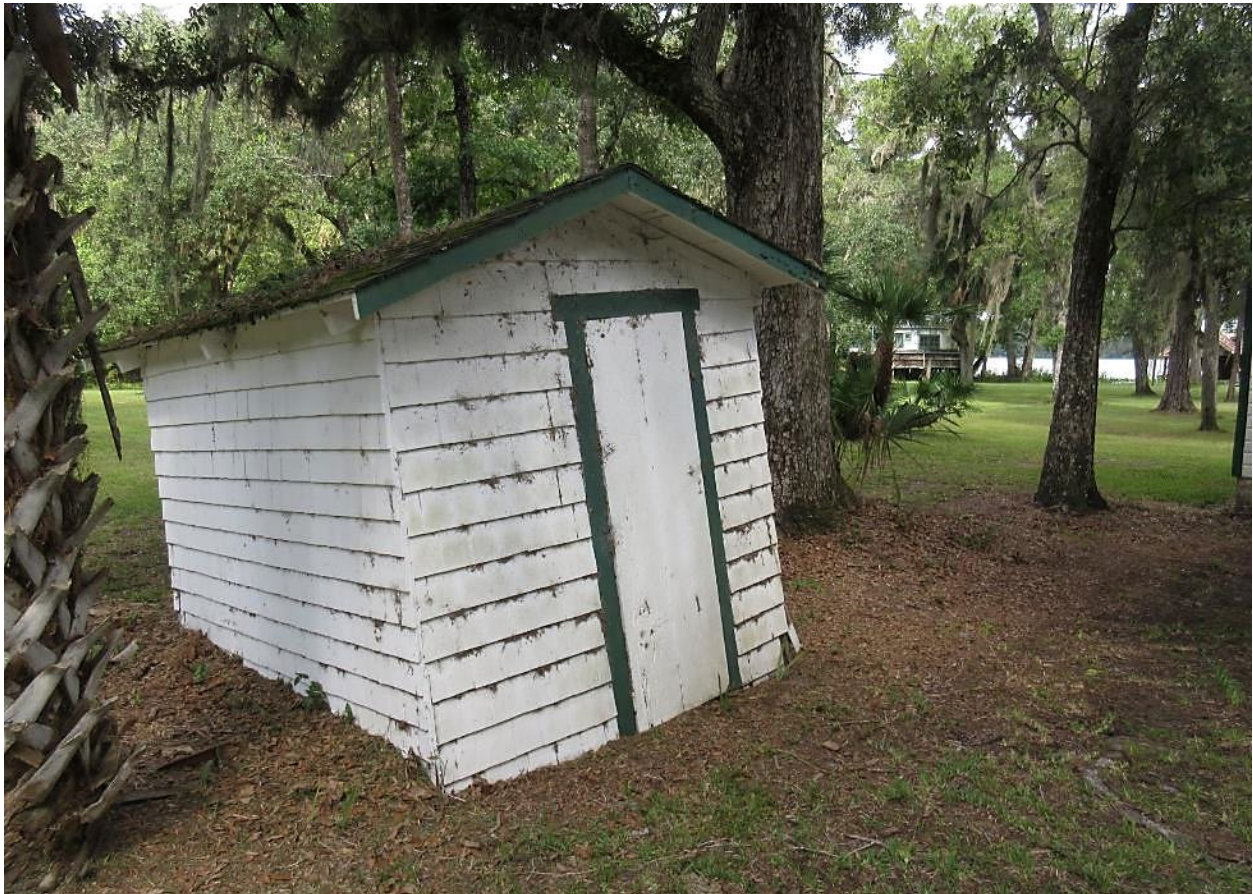
South and east sides of the Woodshed.

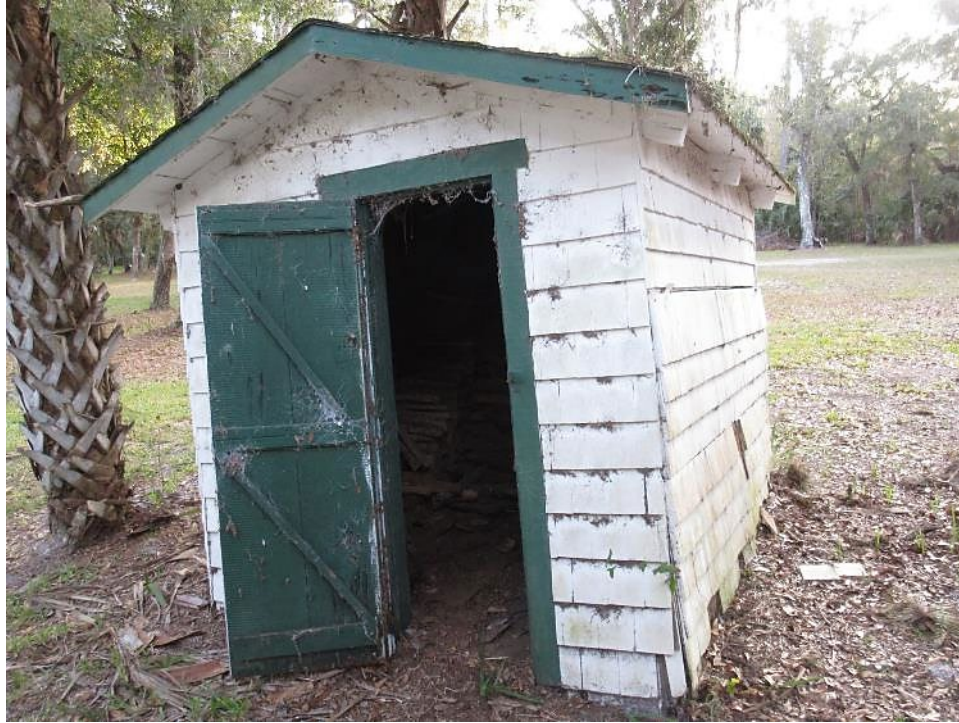
Detail view showing door construction.

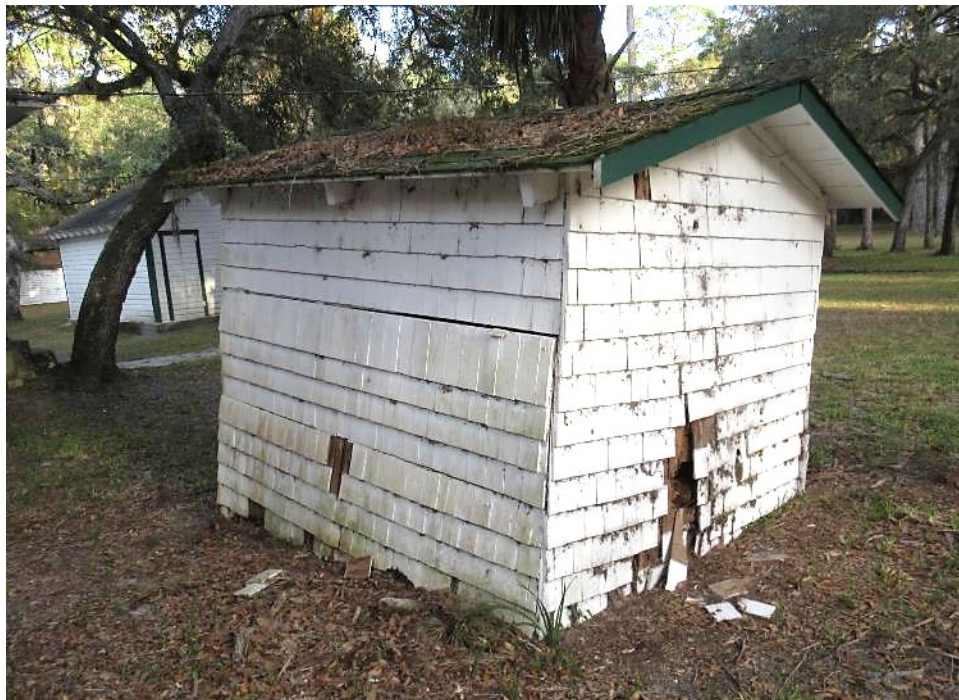
Detail view showing the access panel along the north façade, as well as the termite damage at the rear.

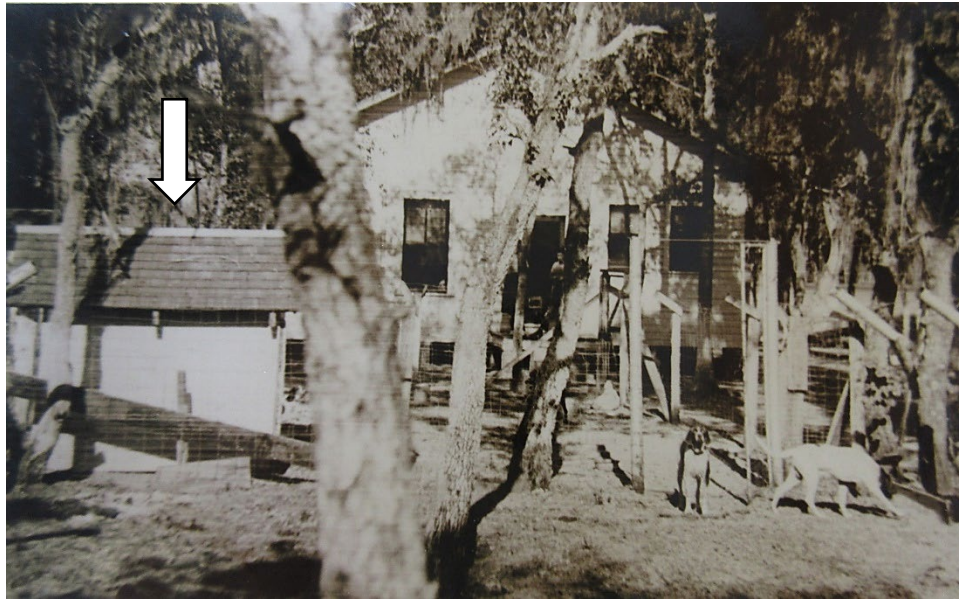
December 1939 view looking north toward the back of the Main House with arrow pointing to the woodshed. (Photo courtesy Bob McKinstry)

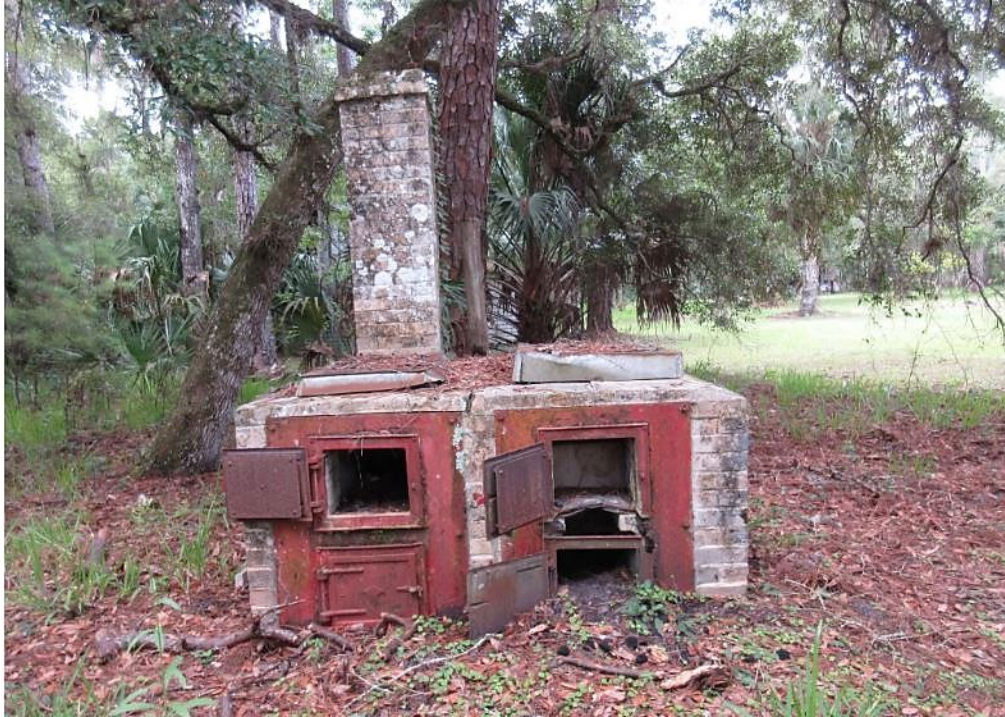
View of the Cahill fireboxes at the front of the Grill.

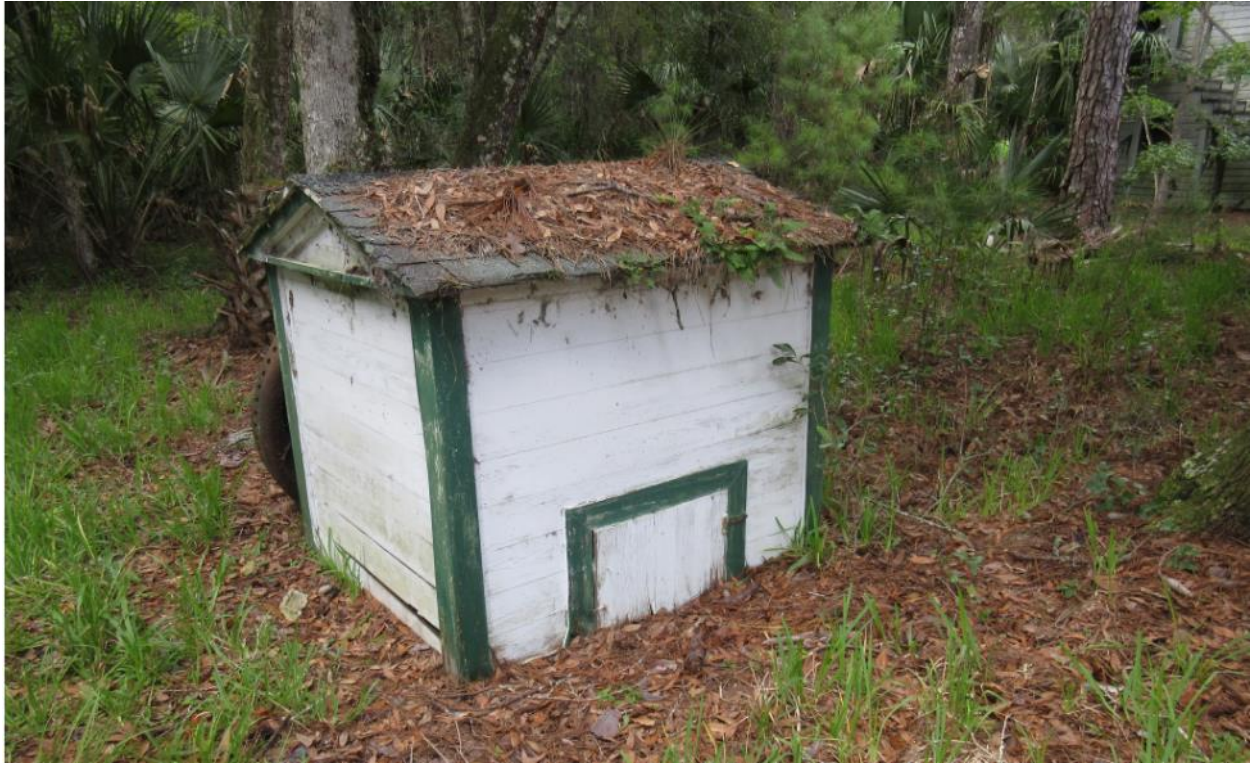
View toward the north and west sides of the smoker.

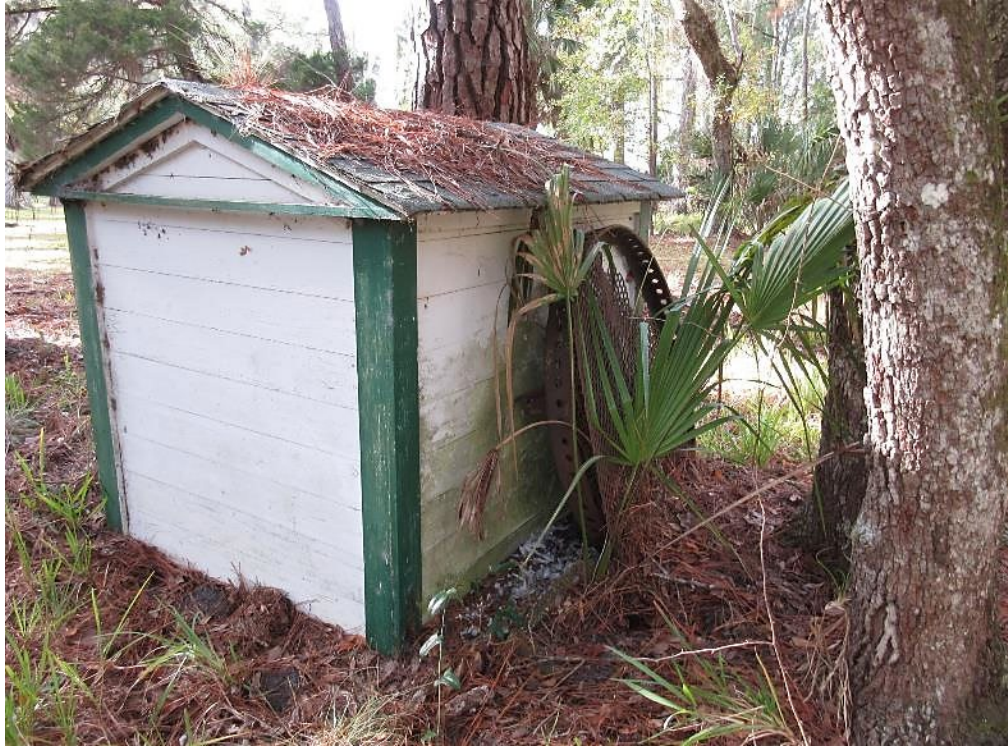
View toward the south and east sides of the smoker.

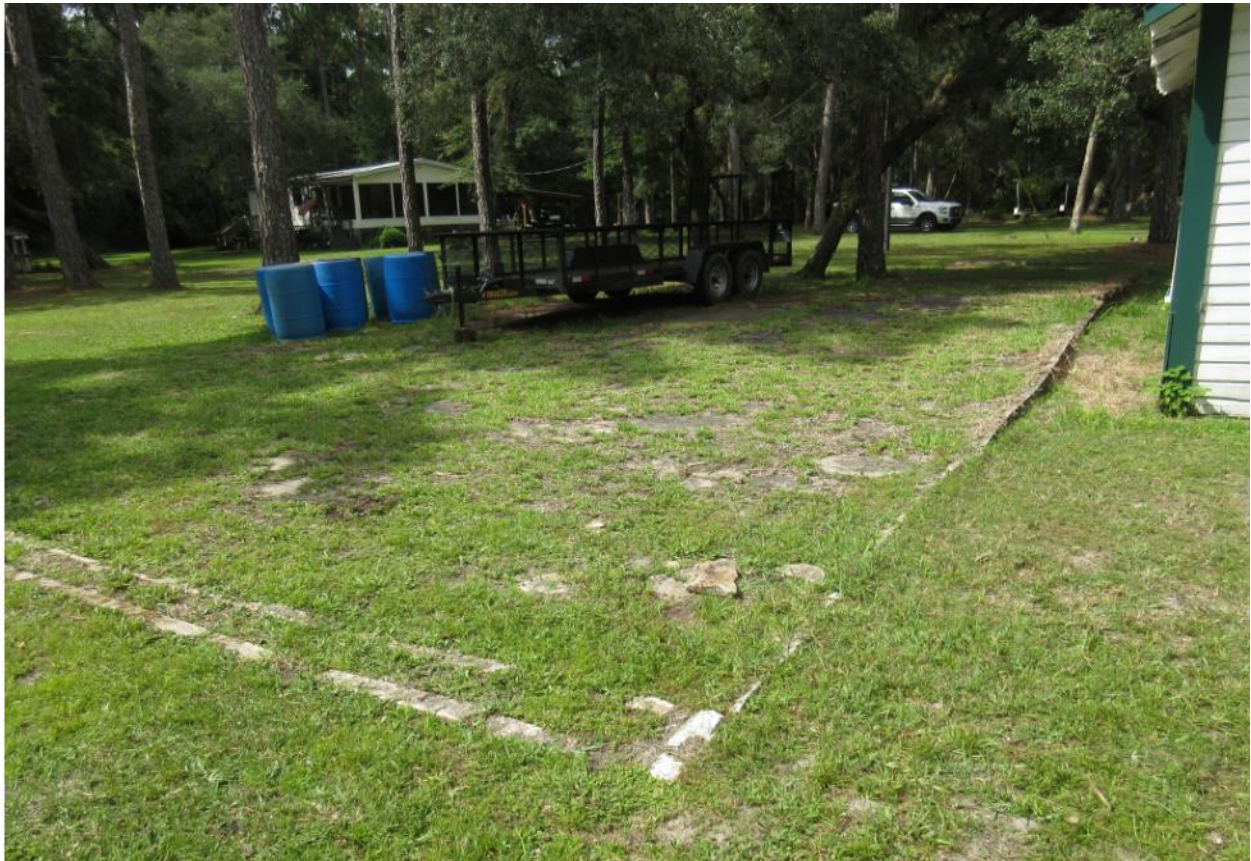
View southwest of the Dog Kennel Foundation.

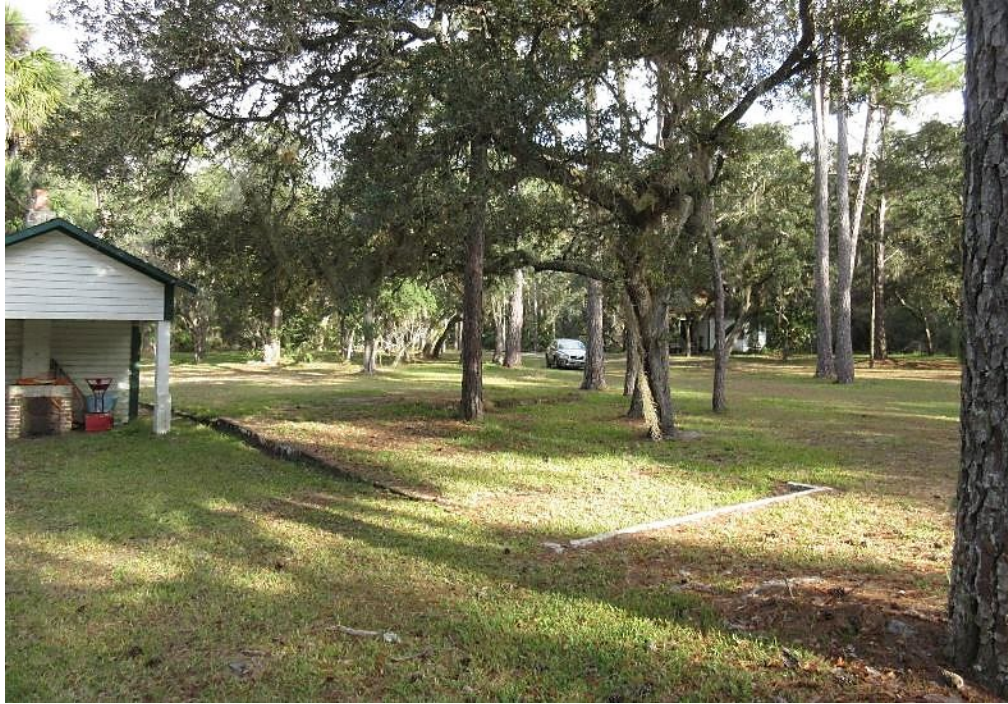
View southeast showing the sloped northwest corner of the Dog Kennel Foundation.

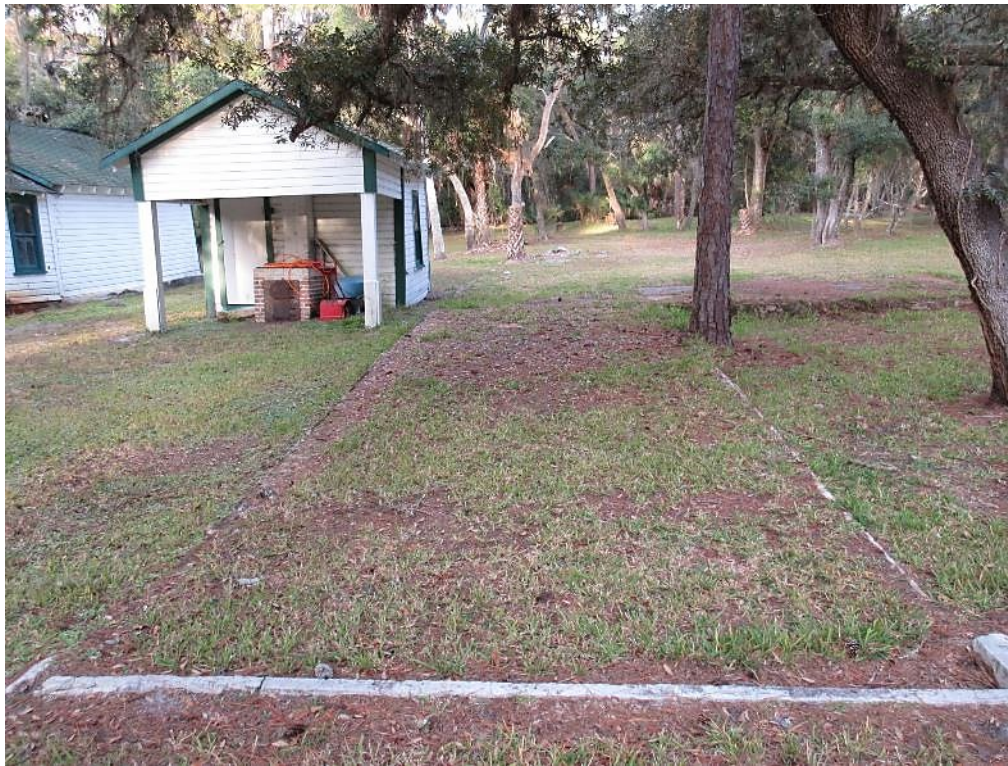
View east of the Dog Kennel Foundation.

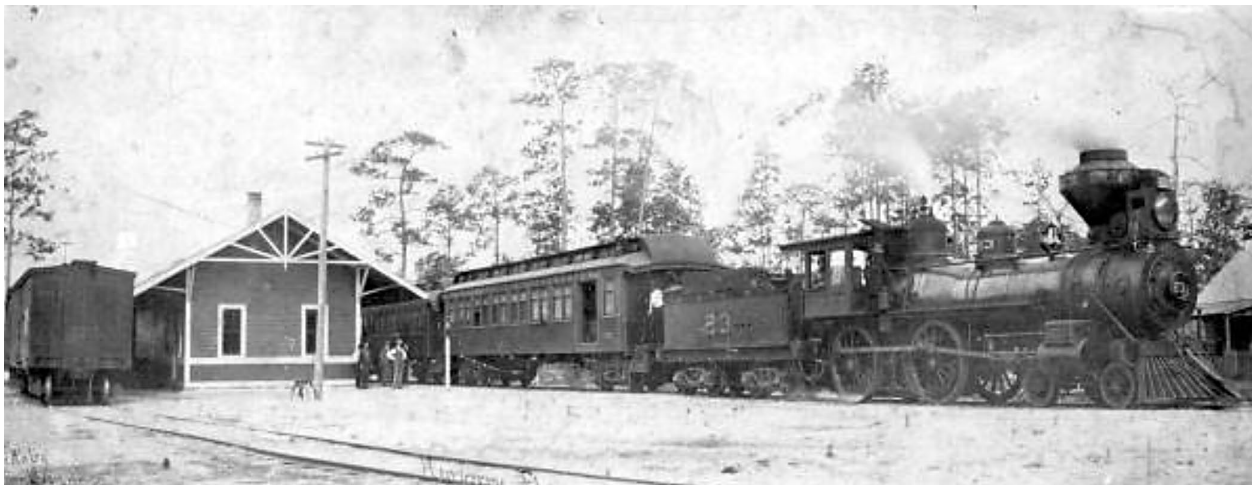
Engine No. 23 of the Jacksonville & Southwestern Railroad at Newberry, circa 1900.  
(Florida Memory, Image No. RC12968)

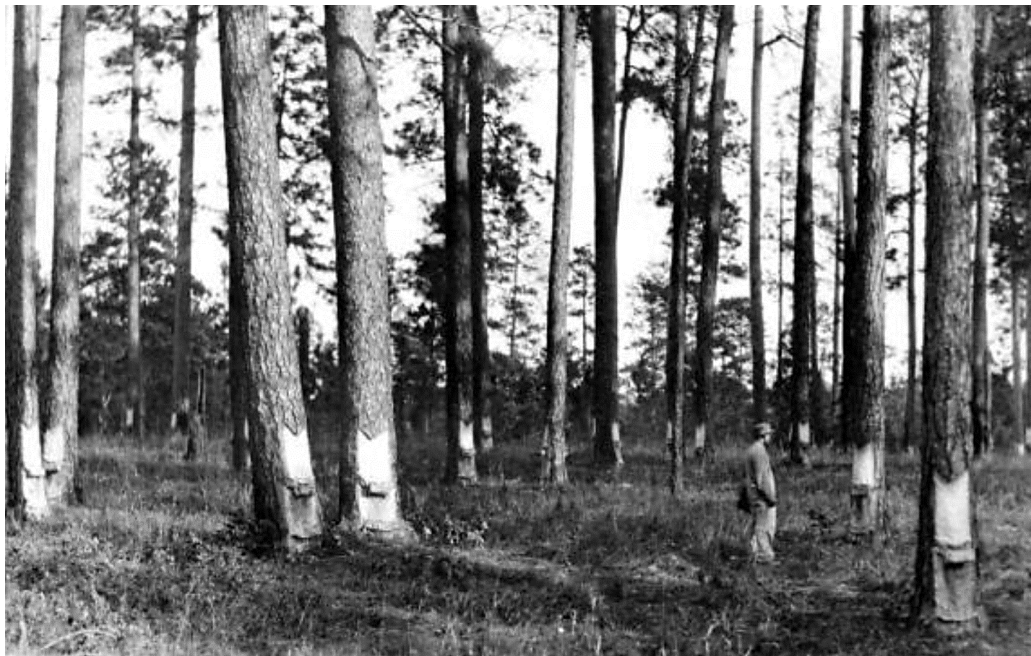
Pine trees with Herty style boxes to catch the sap flow, circa 1910s.  
(Florida Memory, Image No. NO43977)

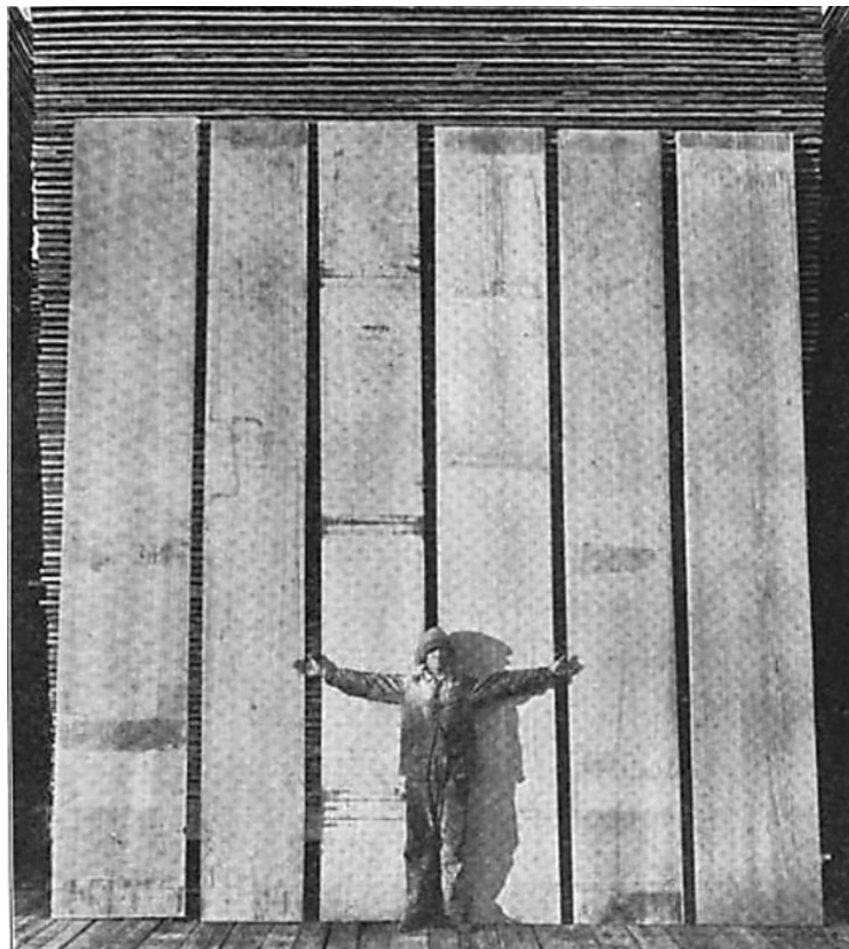
Cypress boards cut at Sumner on display at the company wharves in Jacksonville prior to shipment.  
(*Lumber World Review*, February 10, 1922, p. 30.)
