# **HISTORIC STRUCTURE ASSESSMENT REPORT**

## **VISTA HISTORIC SITE Lower Suwannee National Wildlife Refuge**

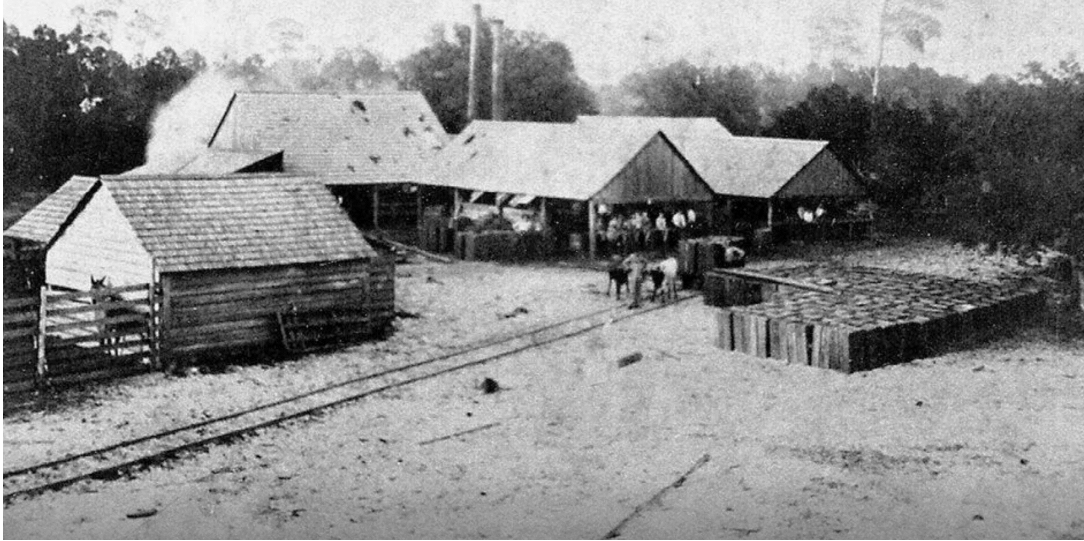
Undated photo purported to show the Yearty sawmill at Vista.  
This photo may have been taken from the upper deck of the *City of Hawkinsville*.  
(Evelyn Walrath Yearty / Facebook Group / Yearty's of Levy County, Florida)

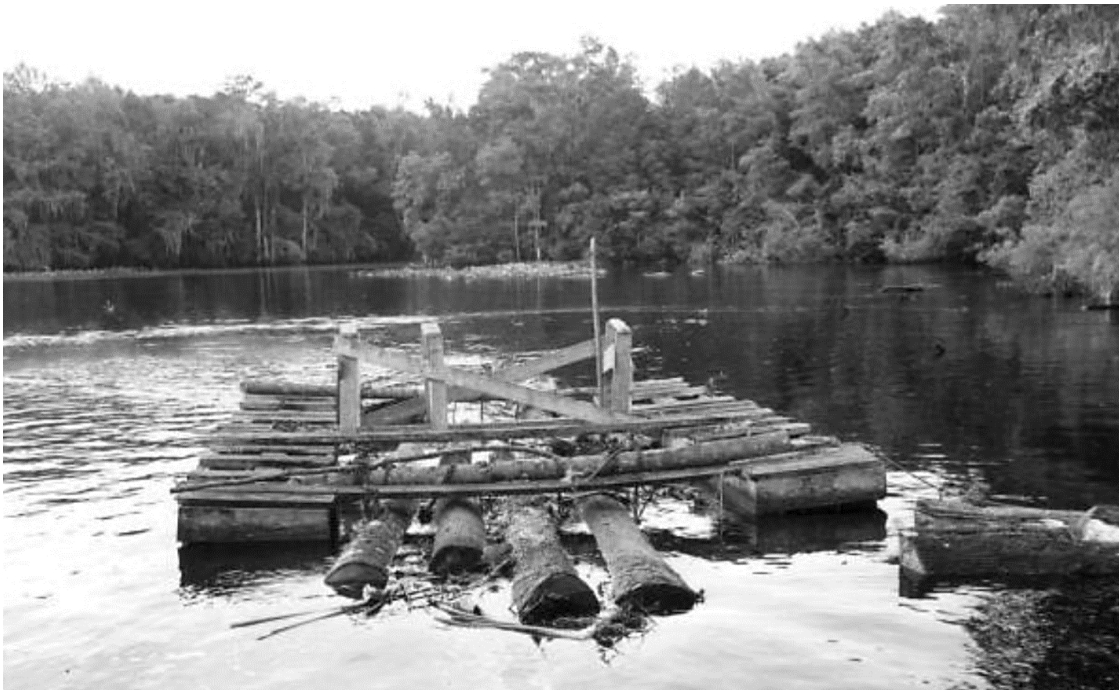
A raft of deadhead logs in the Suwannee River, 1958.  
(Florida Memory, Image No. CO27531)

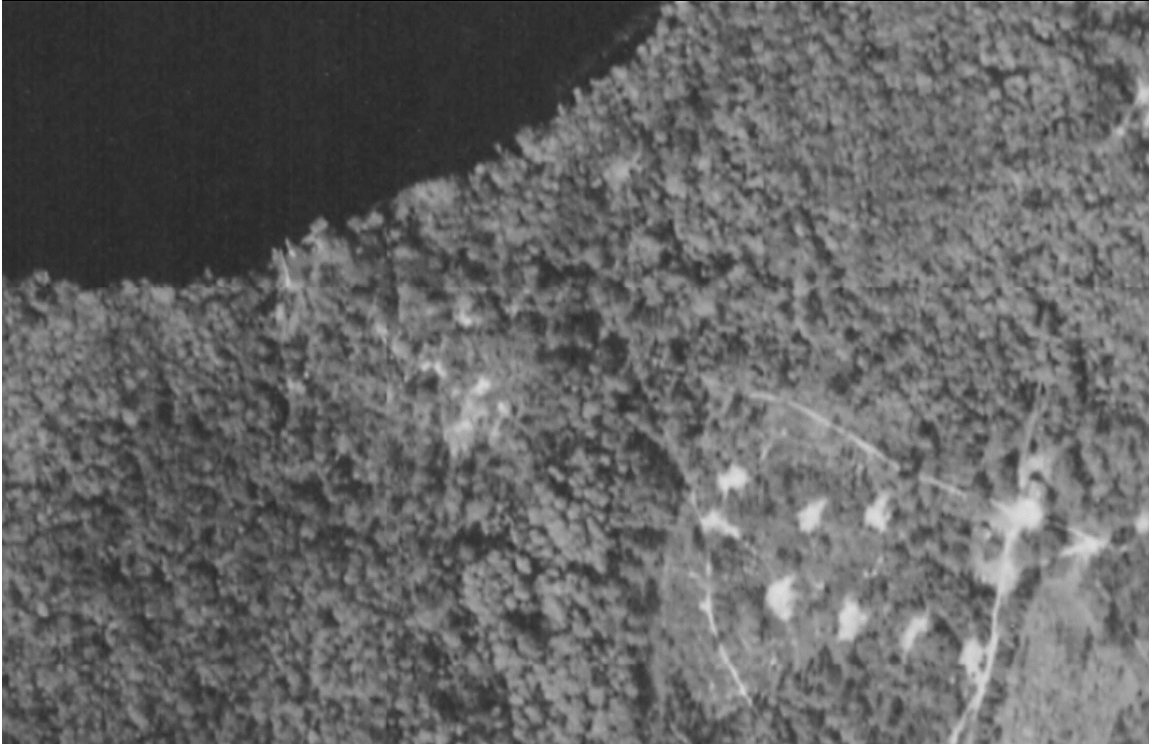
November 18, 1944 aerial photo of the Vista camp. Note that the Boathouse is not visible. It may have been reconstructed around this time. (University of Florida Digital Collections)

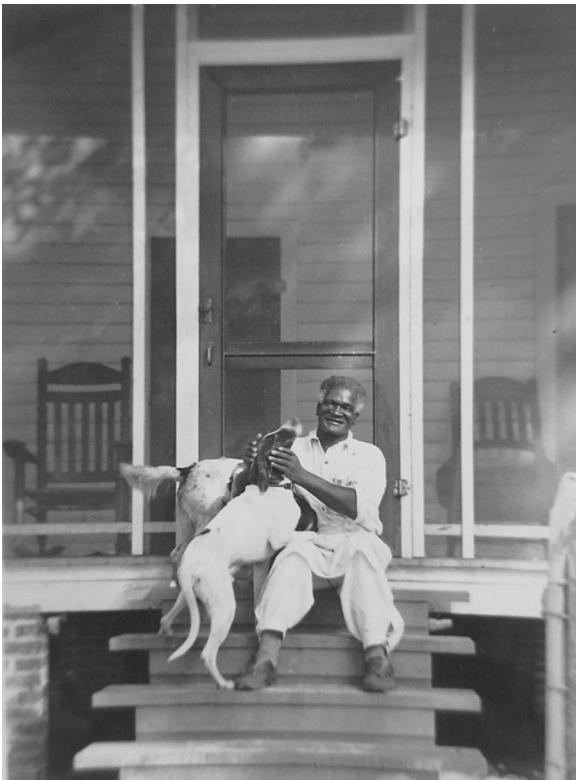
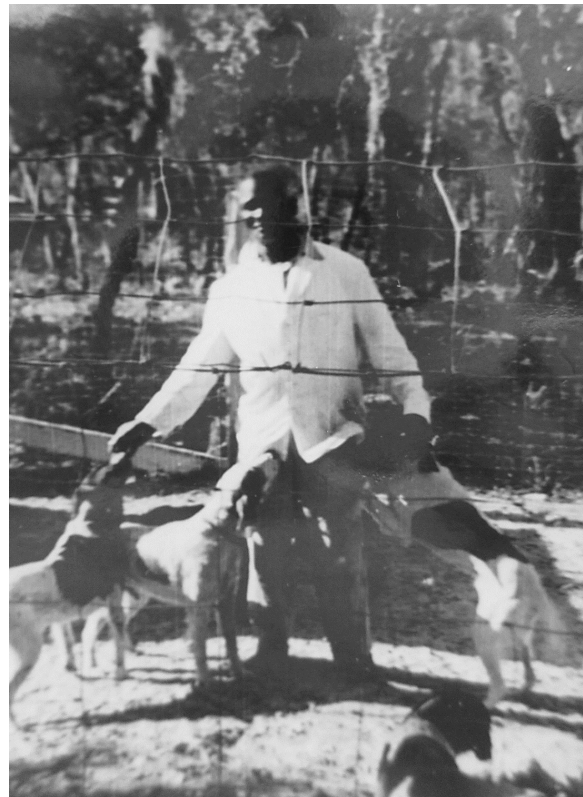
Circa 1940 photos of William Larry (“Uncle William”) at Vista.  
(Photo courtesy Bob McKinstry)

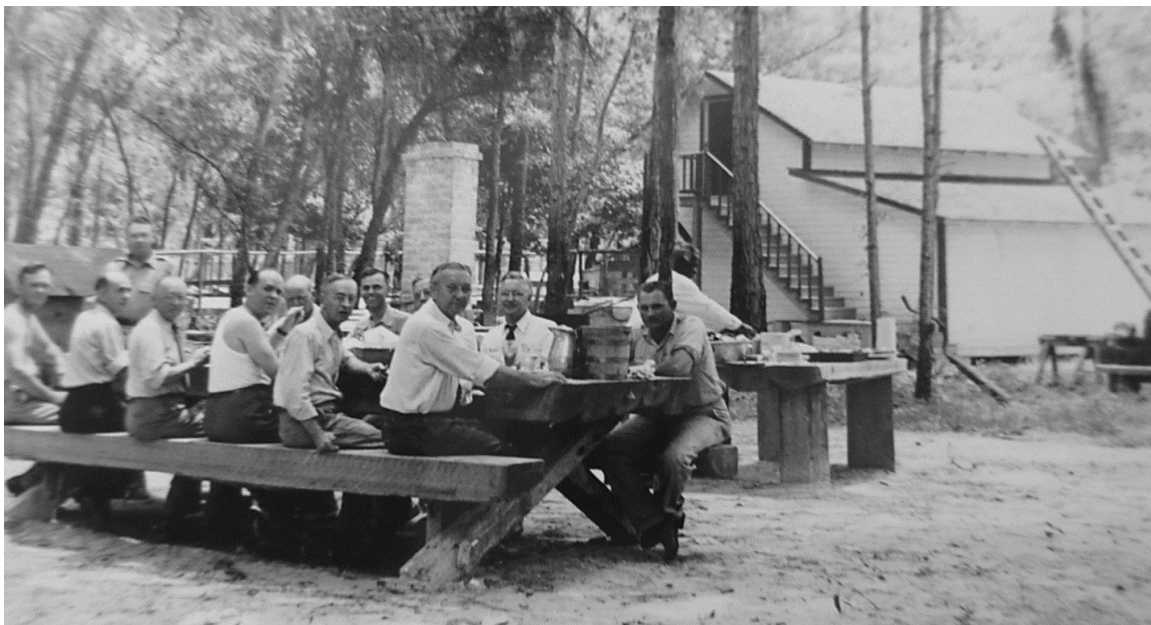
Circa 1942 photo of Cummer company officials gathered at Vista. Note the smoker (far left) and chimney for the outdoor grill (center). Bill McKinstry is at the far right of the table. Behind him, William Larry is preparing food. (Photo courtesy Bob McKinstry)

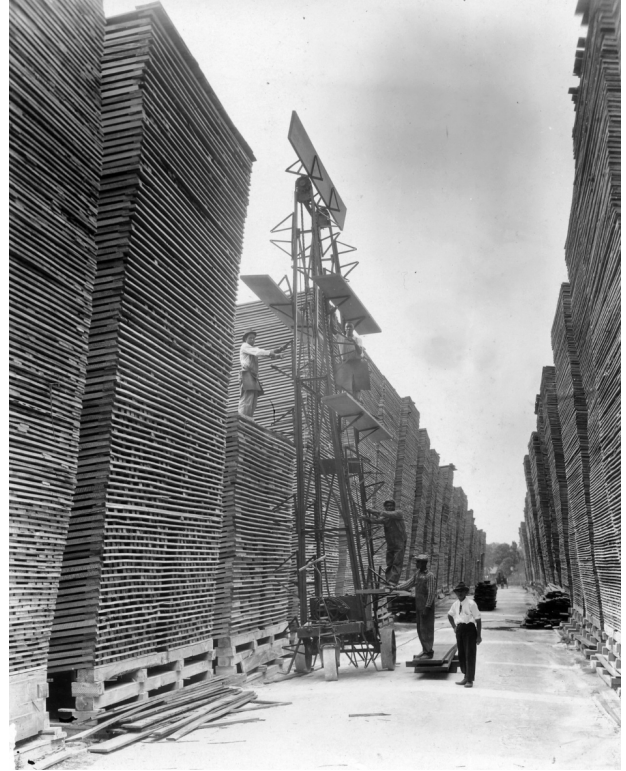
Circa 1930s images from the Lacoochee mill. At left, a worker attaches a hook to a log for transport to the sawmill. At right, stacks of lumber in the Lacoochee yard.  
(Jeff Miller, via Flickr)

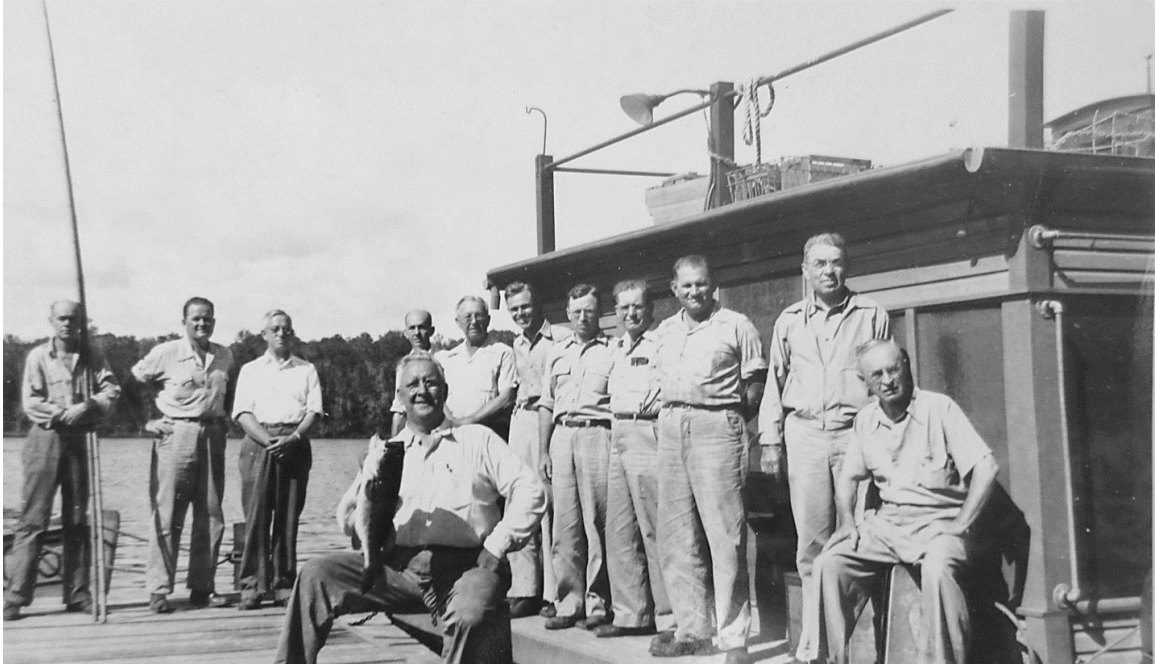
1958 photo of Cummer company officials with the houseboat moored at the Vista dock. The Lacochee sawmill would close the following year. From far left standing: Dr. William Walters (1<sup>st</sup>), Edward Roe (2<sup>nd</sup>), Brantley Thomas (6<sup>th</sup>), Bill McKinstry (9<sup>th</sup>). (Photo courtesy Bob McKinstry)

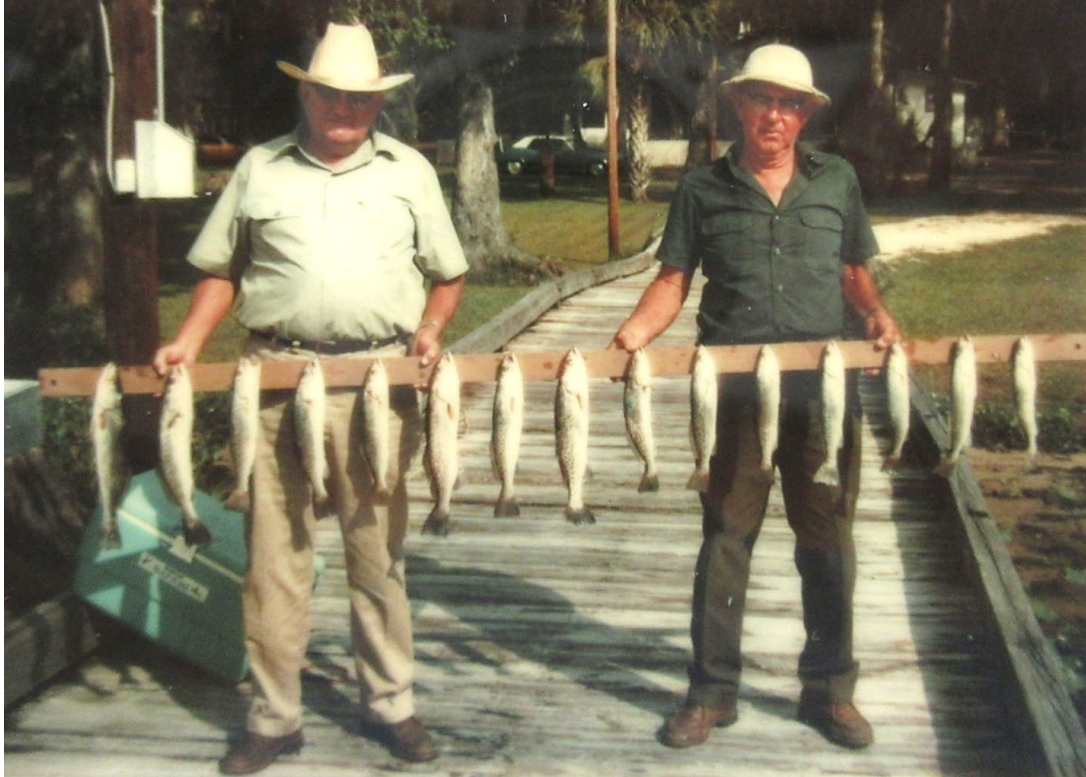
1974 photo of Bill McKinstry and Alton Marsh on the dock at Vista.  
(Photo courtesy Bob McKinstry)

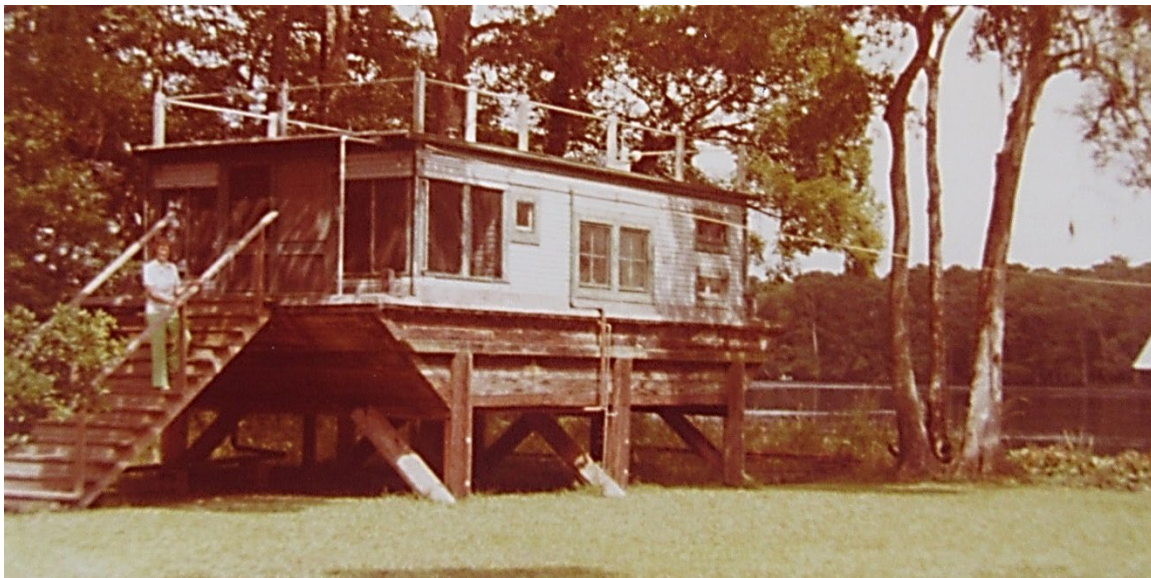
Circa 1980 photo of the Houseboat. (Photo courtesy Bob McKinstry)

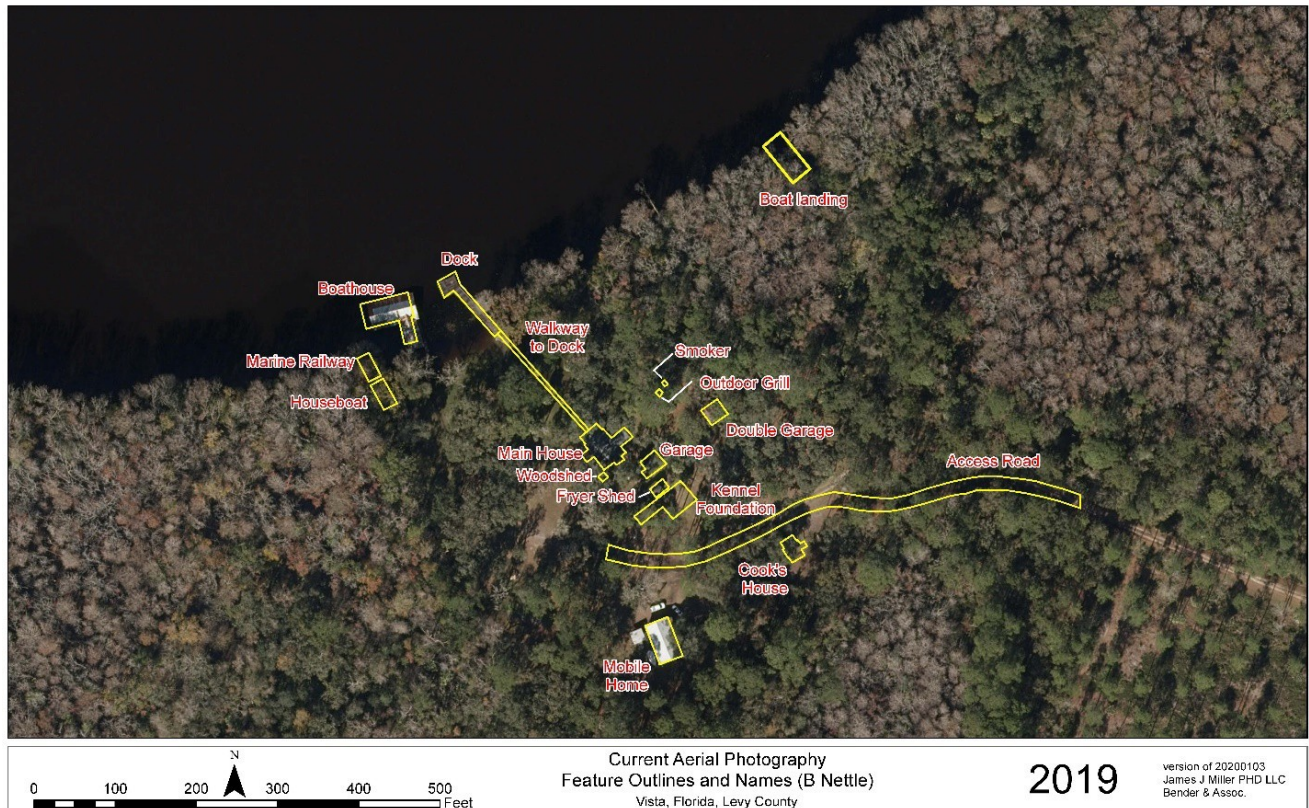
**PROJECT:** Vista Sites  
**ELEMENT:** Main House  
**ITEM:** General Description  
**EVALUATION:** Historic, Good Condition

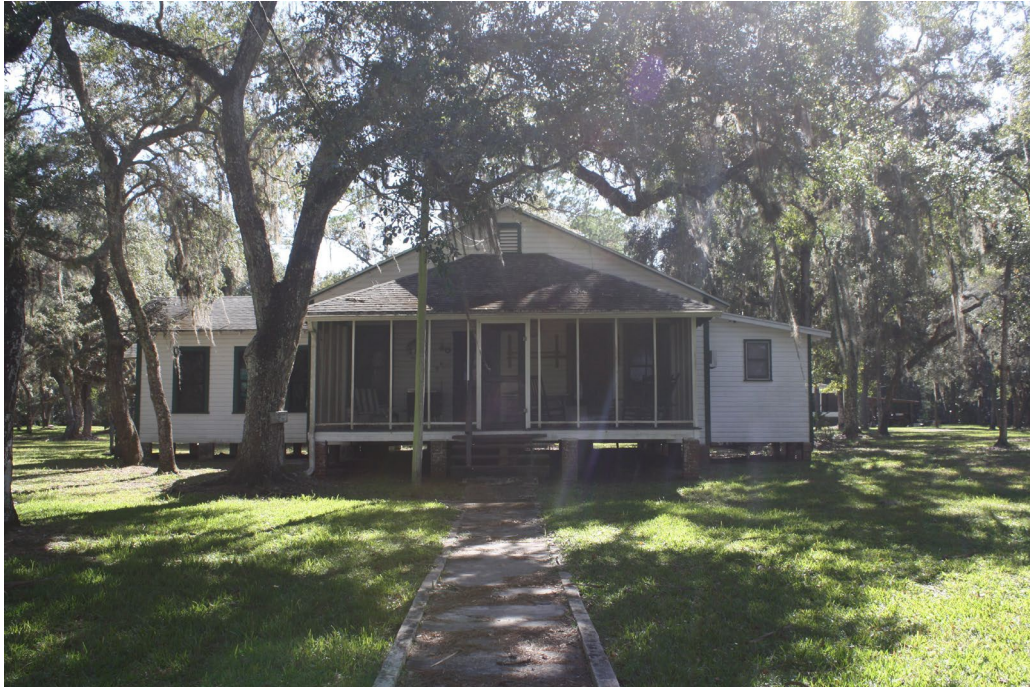
North elevation of the Main House in November 2019

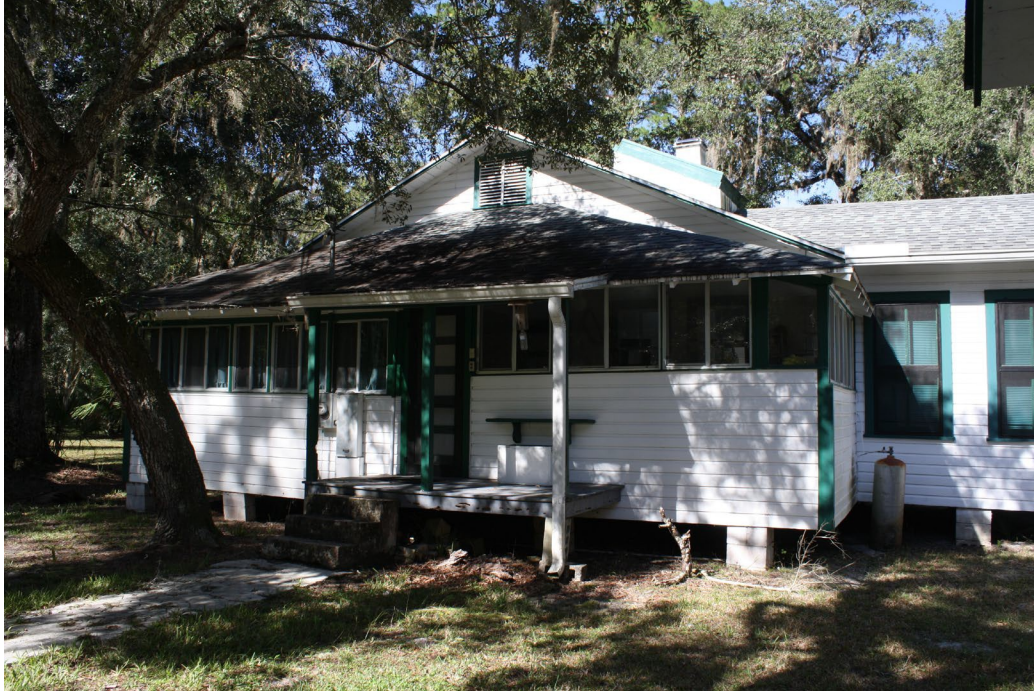
South elevation of the Main House. This elevation shows later additions, including the south porch, it's enclosure with glass windows, extension to the east, and dining room addition.

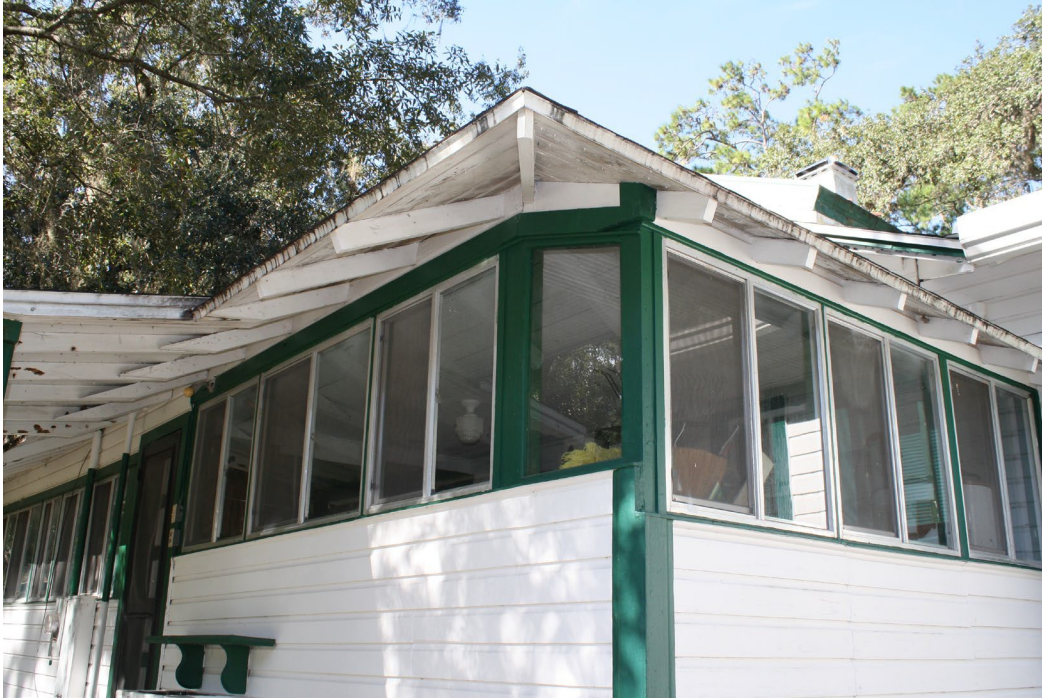
Detail of the south porch addition showing the east side extension.

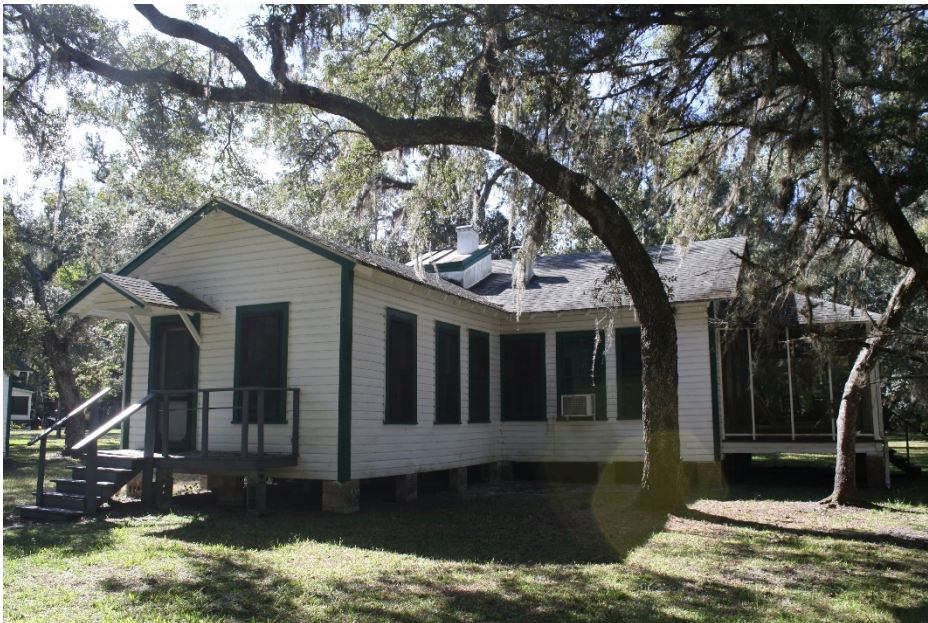
**PROJECT:** Vista Sites  
**ELEMENT:** Main House  
**ITEM:** Exterior Openings / Doors & Windows  
**EVALUATION:** Historic, Good Condition.

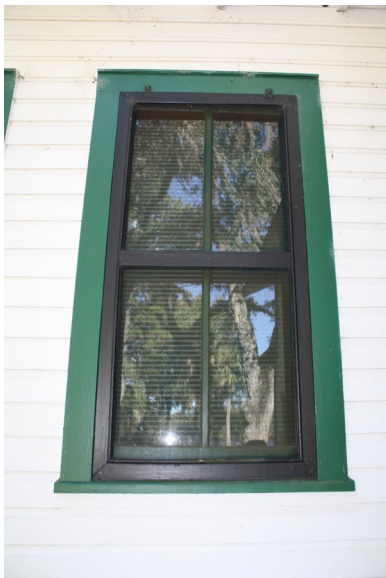
This window is on the Main House and is in good condition as are other elements on the Main House due to ongoing maintenance.

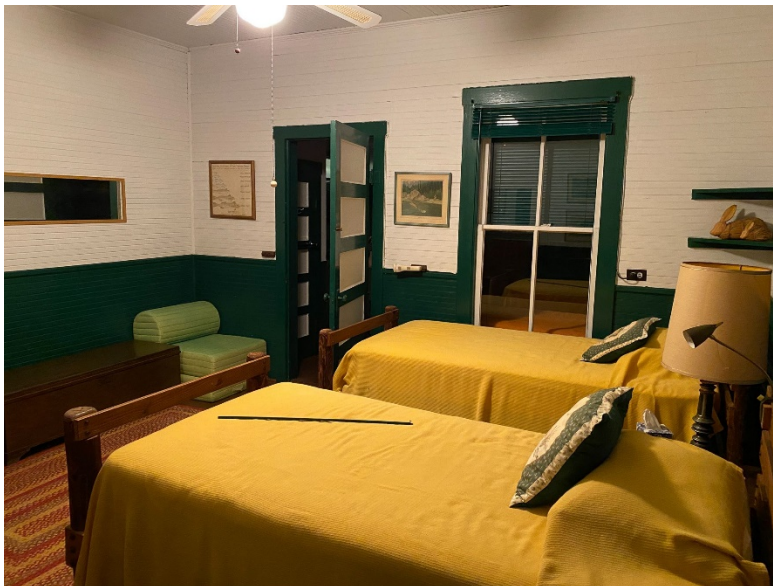
The northeast corner of the room includes an original five-panel wood door that offers a pass-through to the Living Room. There is a small wooden door above the closet door with flat board trim. It is presumably used for storage. The northwest corner of the room includes a small niche which accesses a bathroom. That room was probably constructed after the Master Bedroom Bath.

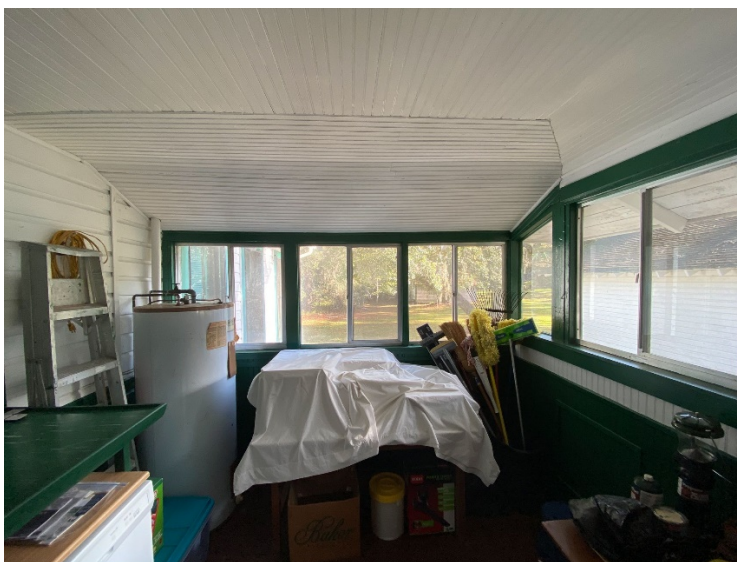
### **RECOMMENDATIONS:**

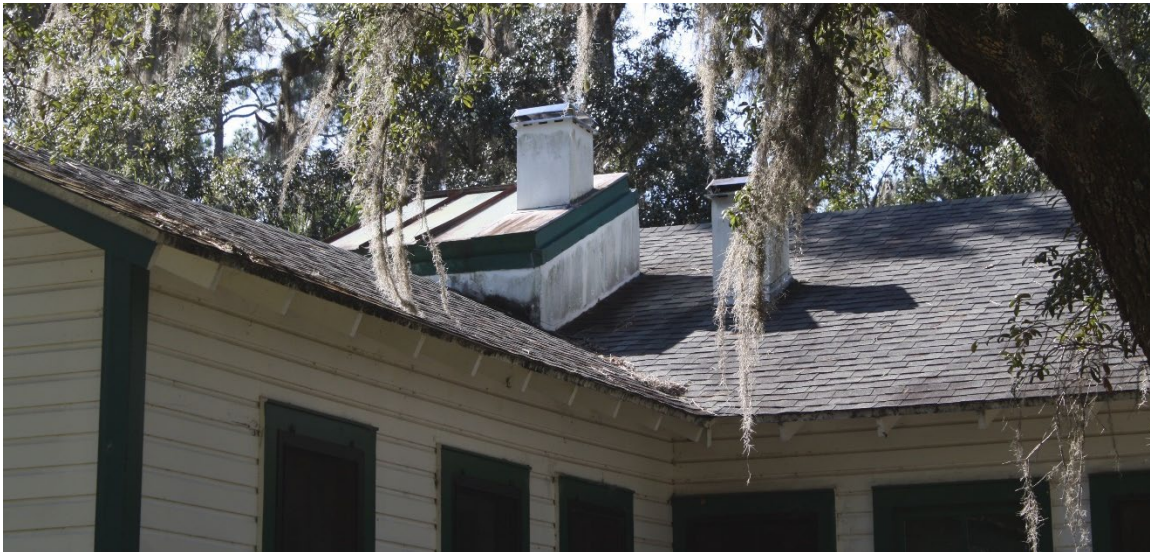
**RECOMMENDATIONS:**

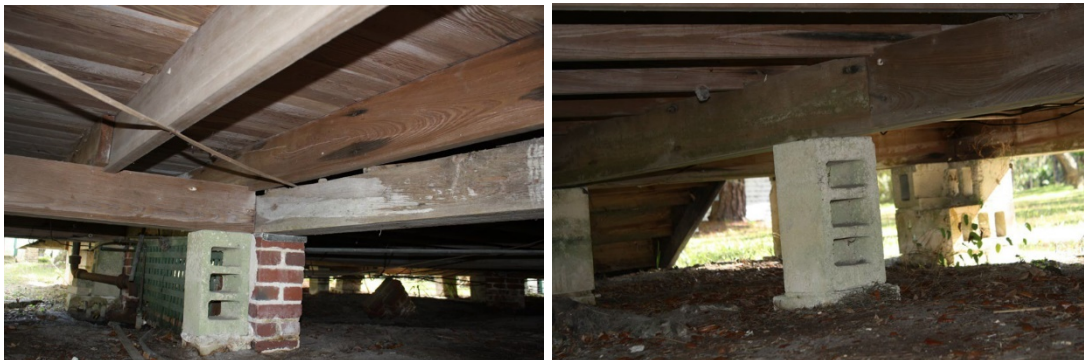
**RECOMMENDATIONS:**

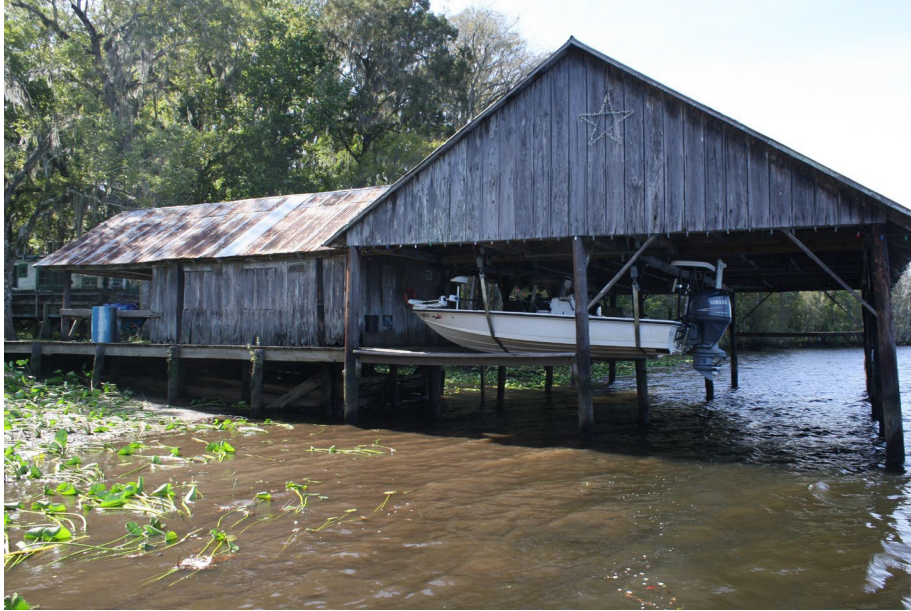
The Boathouse and shed components.

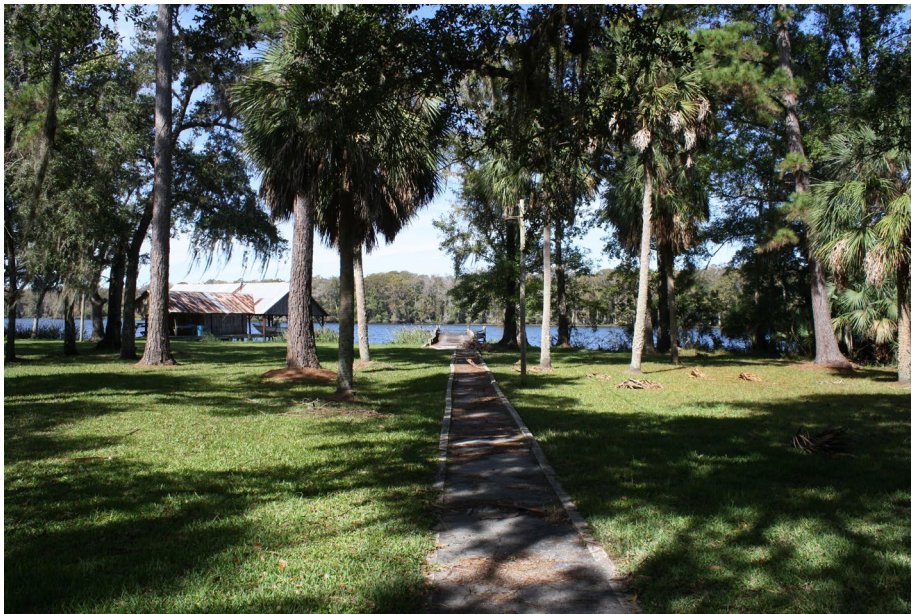
View of the Boathouse and dock areas from the Main House.

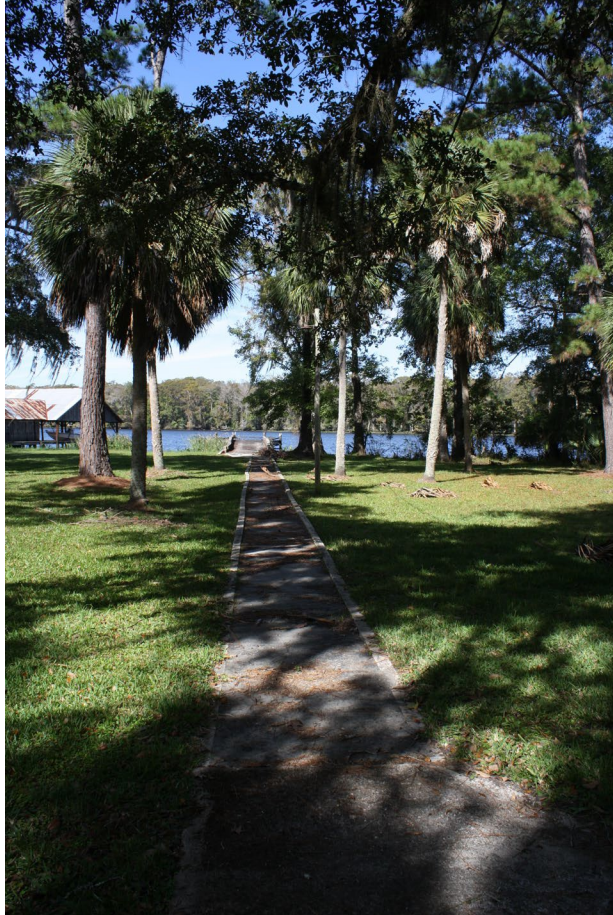
Concrete walk to the Dock area.

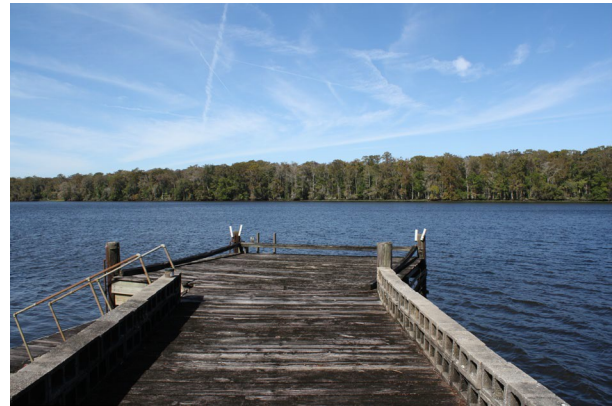
Upper and Lower Docks.

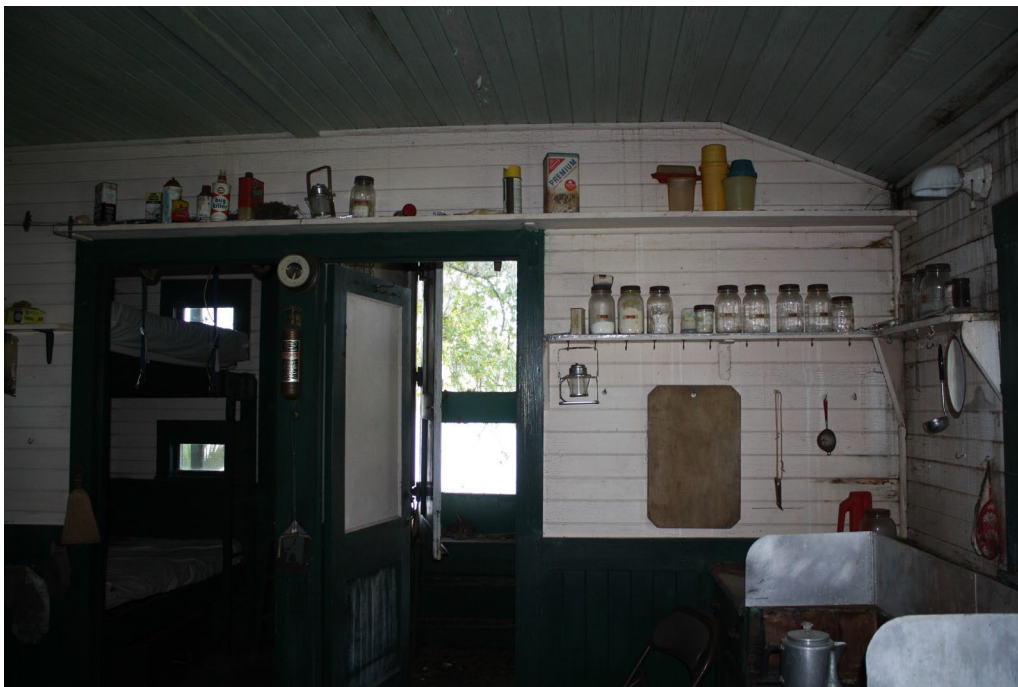
Looking toward the stern.

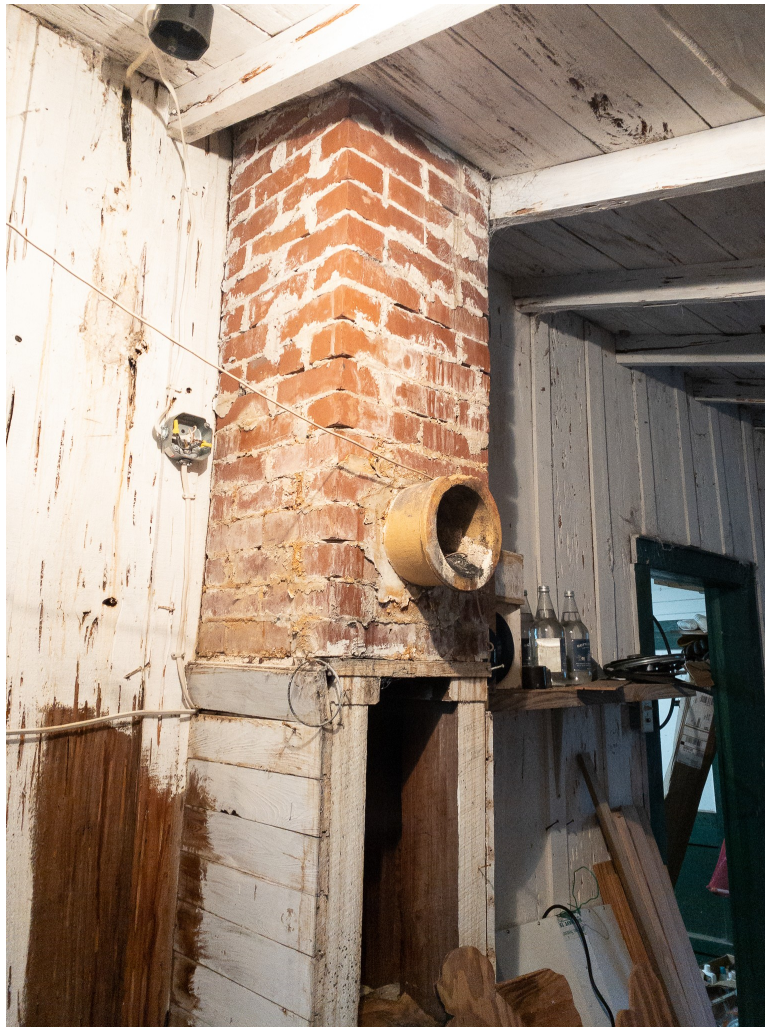
This is the chimney in the south side addition with opening for the stove and wood base.

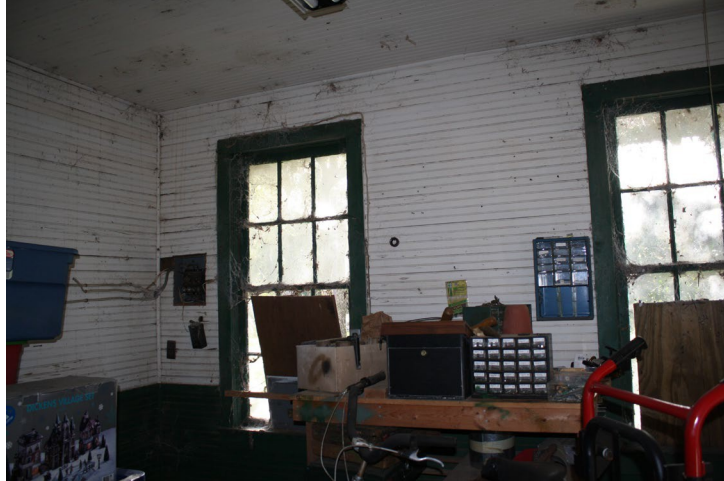
Northwest room of the Cook's House looking west.

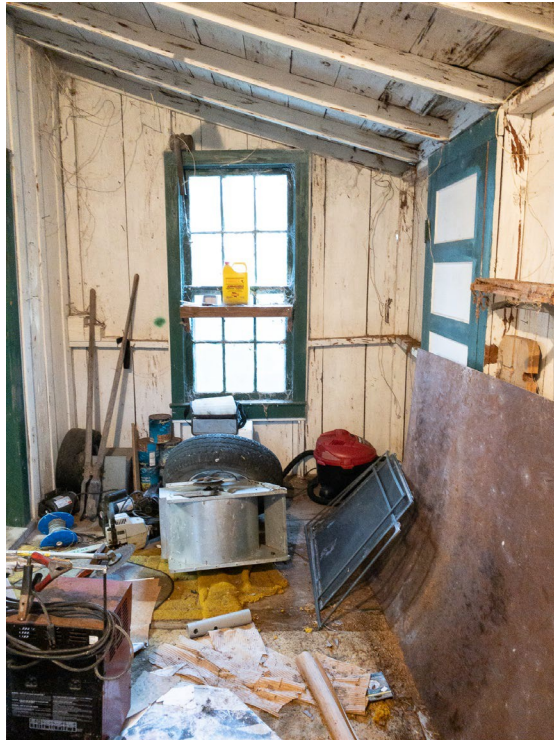
## **RECOMMENDATIONS:**

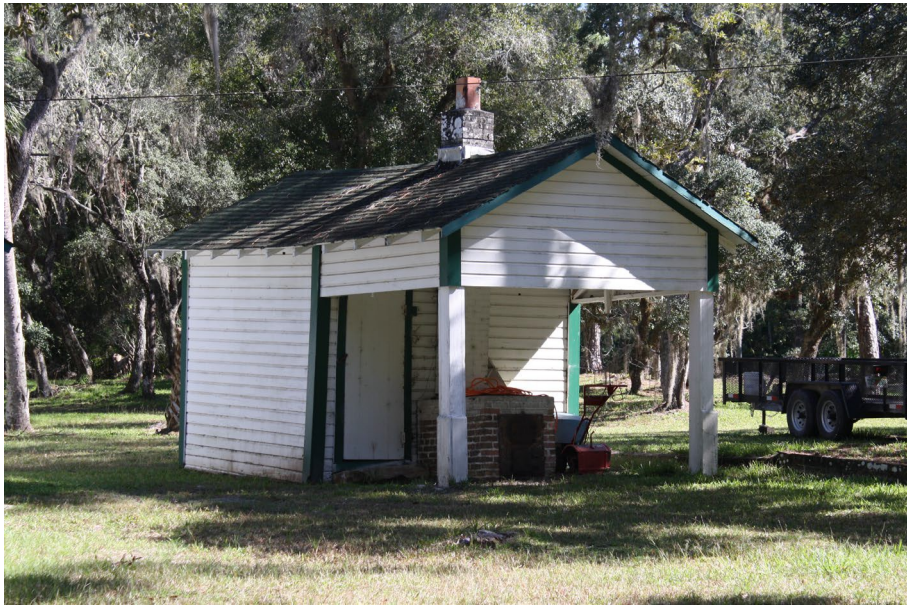
Fryer Shed from the west side.

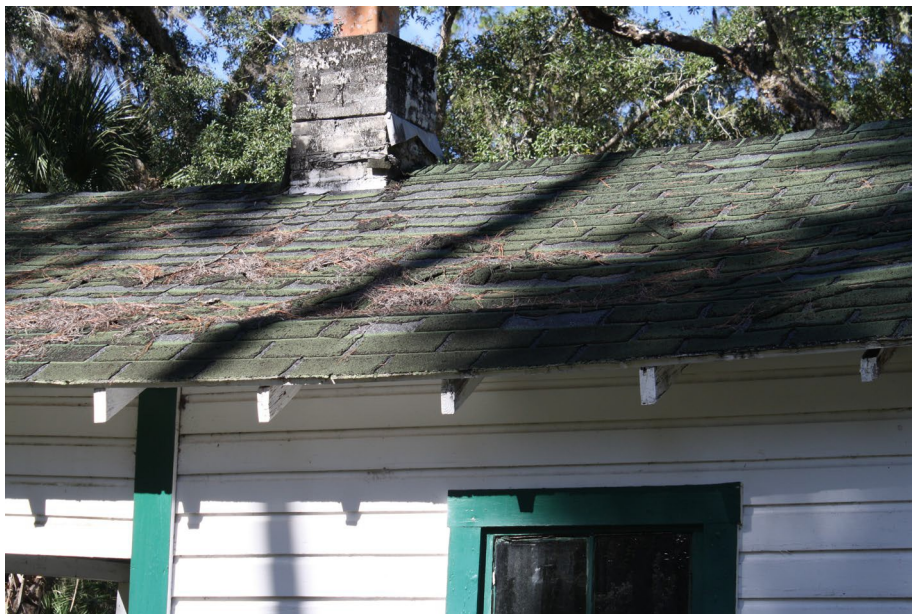
Fryer Shed chimney. Deteriorated and needs restoration.

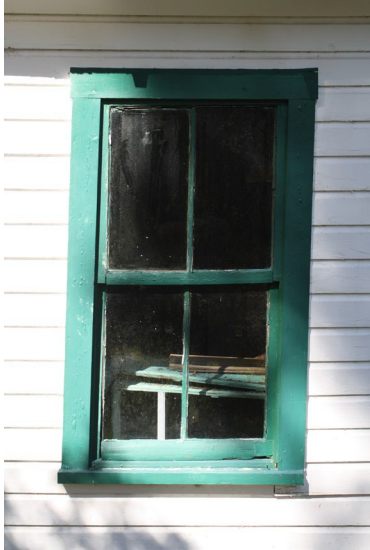
Fryer Shed window with deterioration.

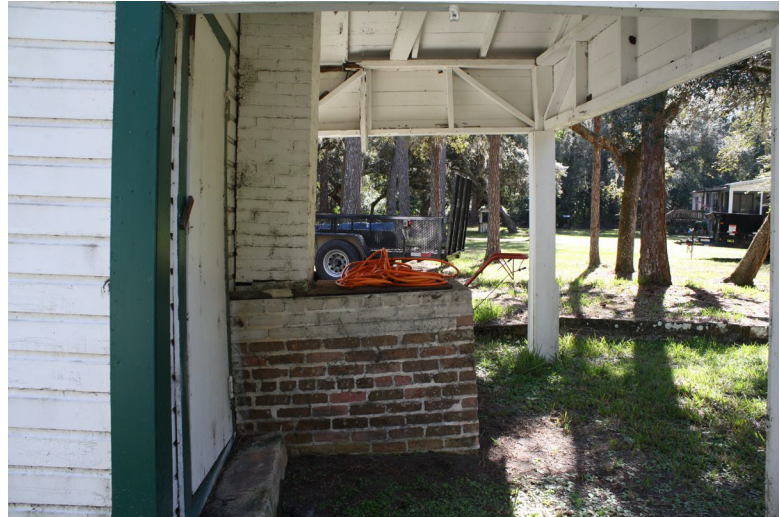
Fryer Shed base has dropped at the building.

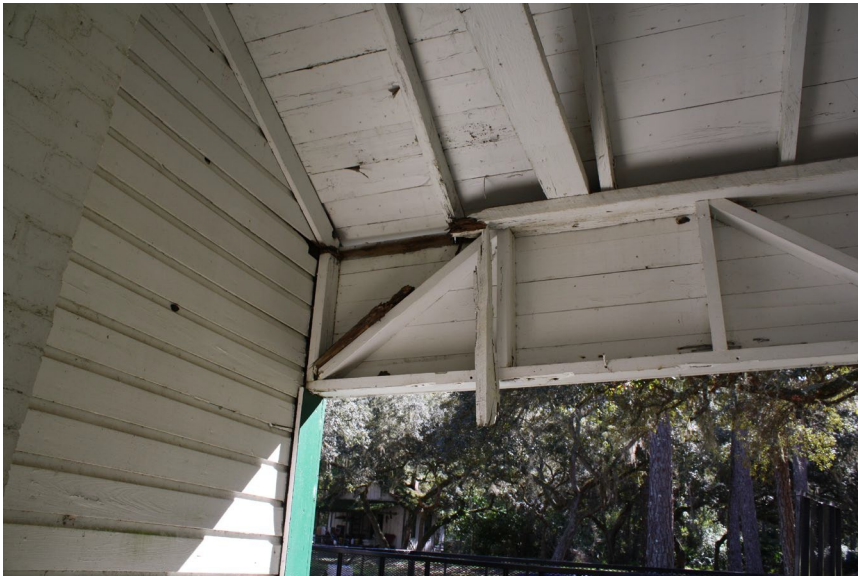
Fryer Shed plate deterioration.

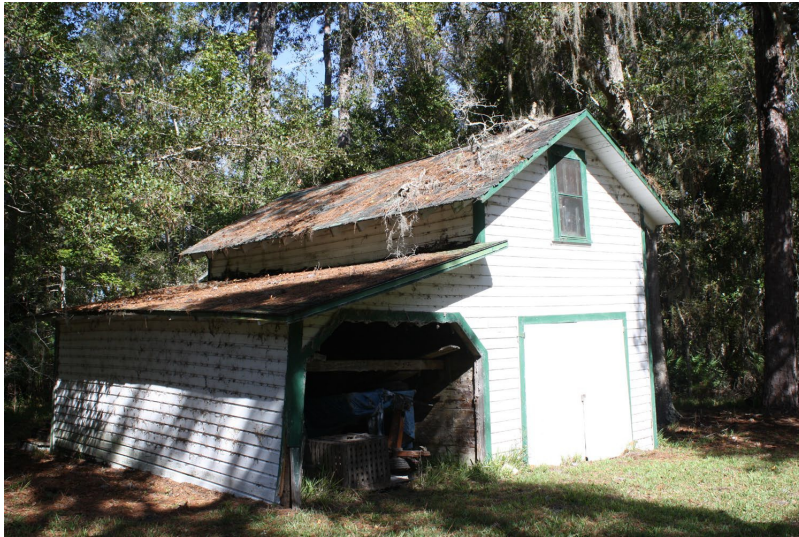
Front of Attic Garage.

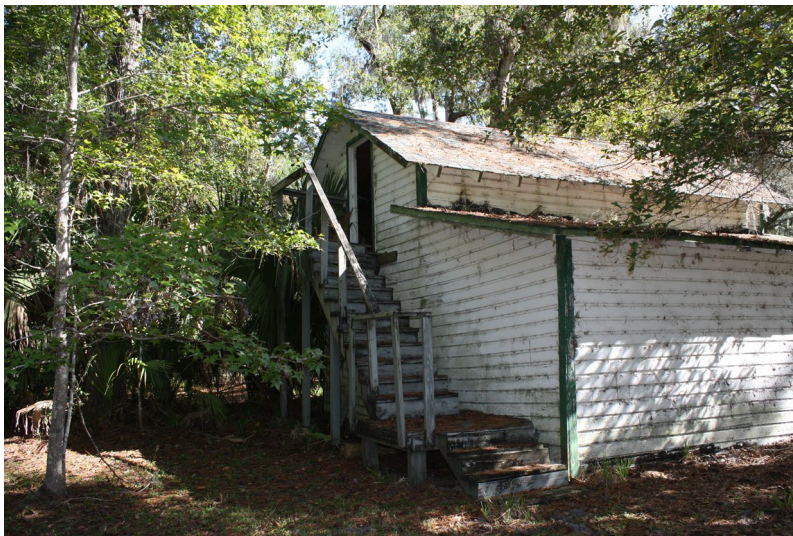
Rear of Attic Garage.

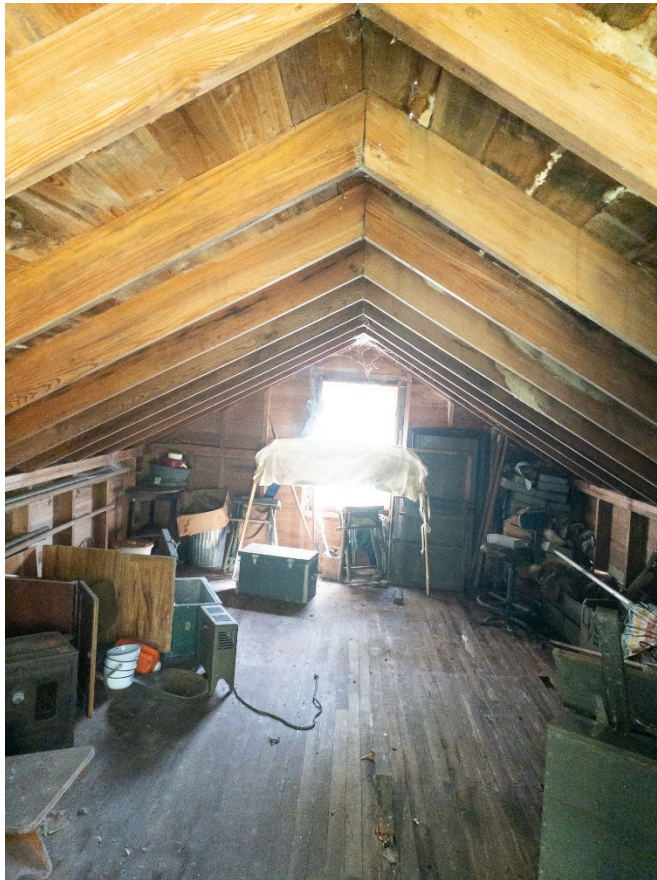
Attic of Attic Garage.

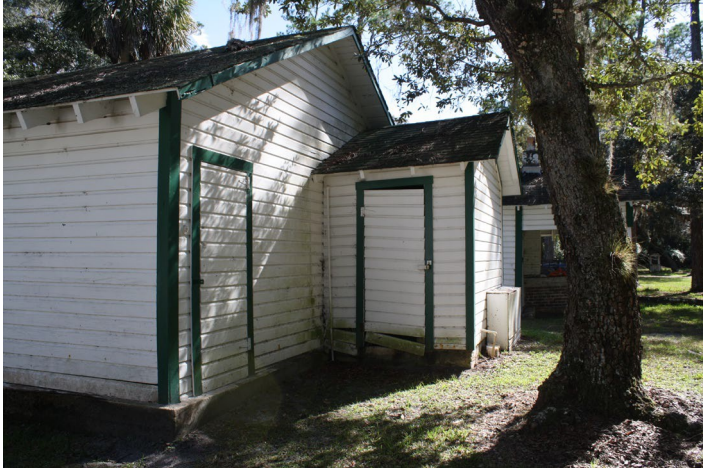
Rear of the Double Garage with deterioration on the rear addition.

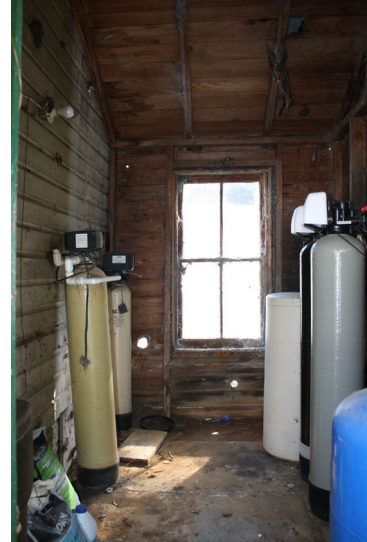
Rear storage room at Double Garage.

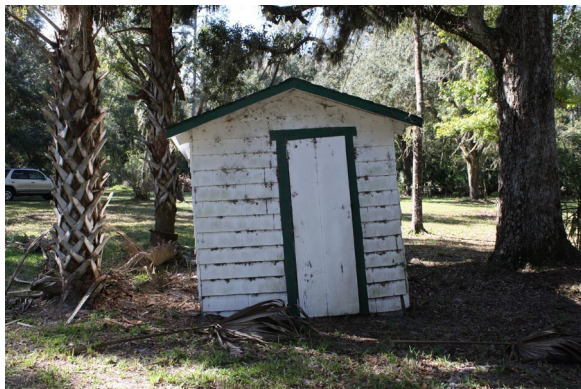
The north façade includes a hinged access panel constructed of shingle slats. Several shingles have fallen from the building toward the base of this façade. There is a large section of termite damage that has opened a hole in the rear (west) side of the structure and caused a number of shingles to fall away from the building.

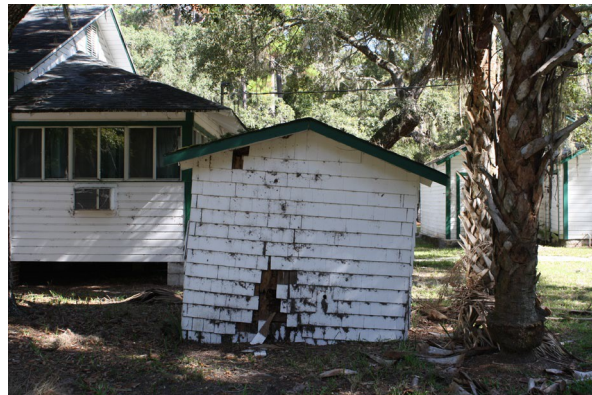
Woodshed for the Main House has lost shingles and is falling into the ground due to no foundation.

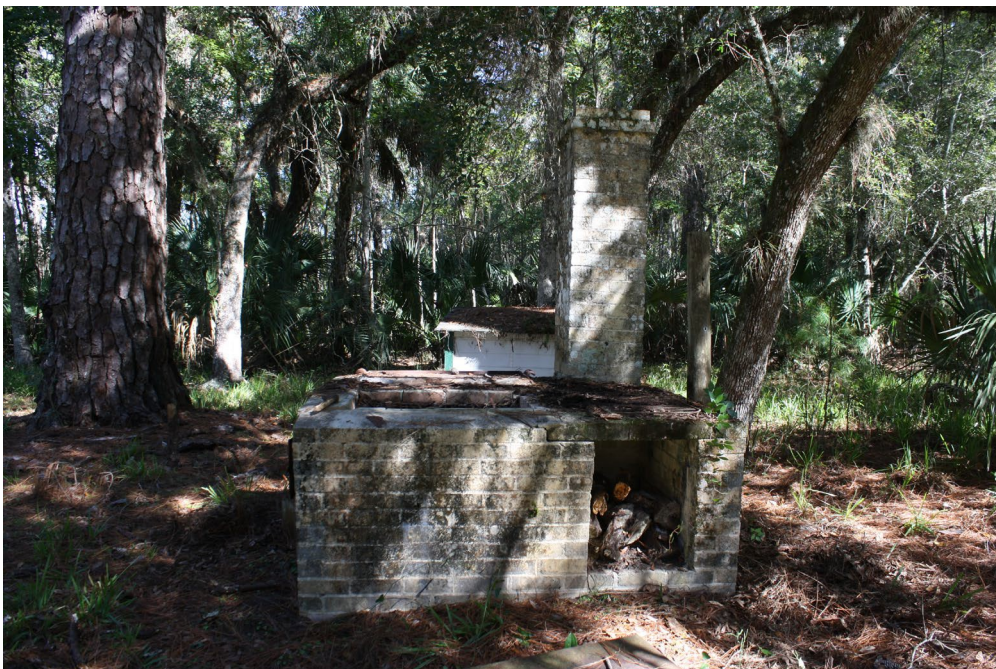
West side elevation of the grill.
