# **HISTORIC STRUCTURE ASSESSMENT REPORT**

## **VISTA HISTORIC SITE Lower Suwannee National Wildlife Refuge**

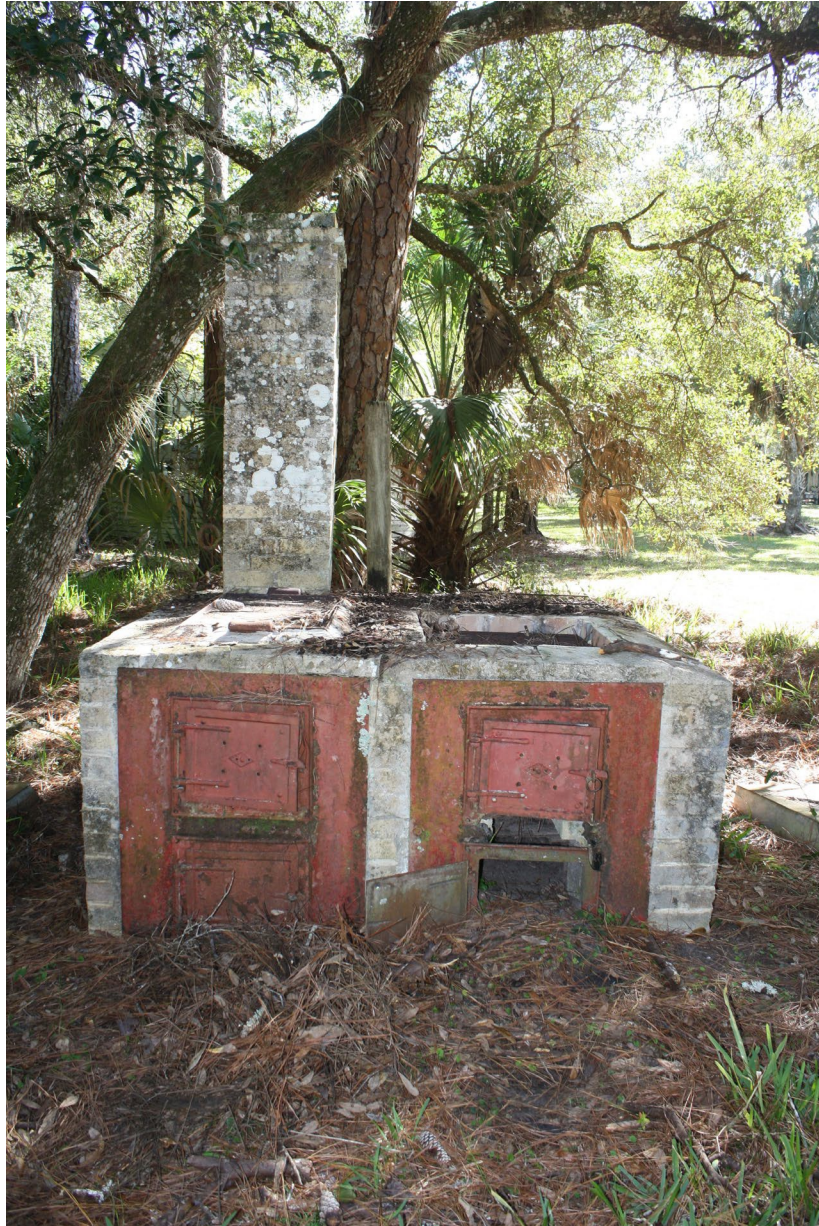
North side elevation of the grill. Note that some components will need restoration, including the concrete top.

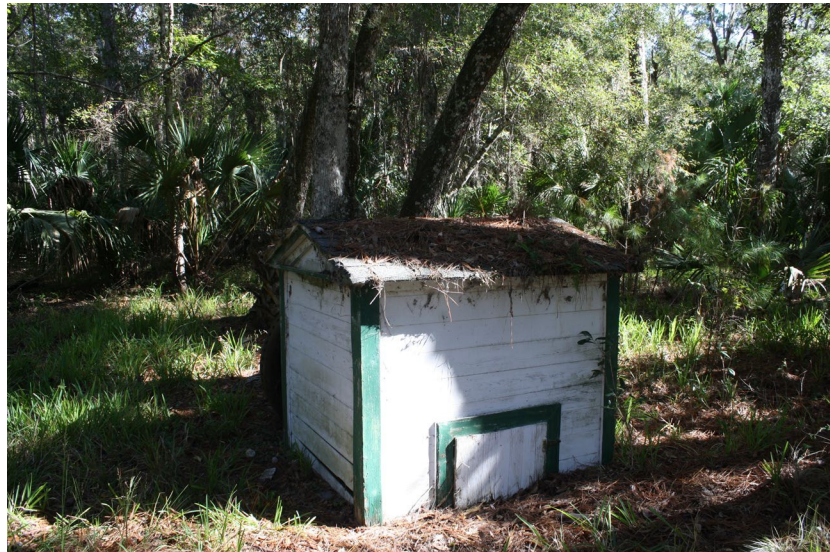
The smoker needs some repairs, most notably at the ground level.

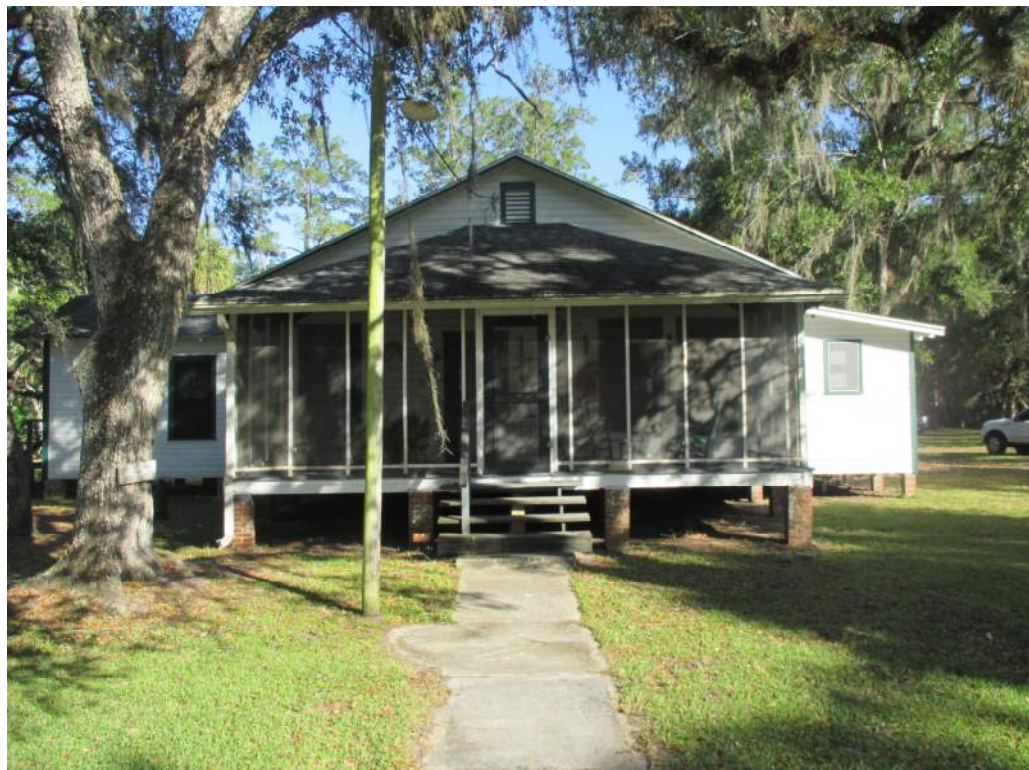
**Photograph 1**  
**Primary Facade of Main House**

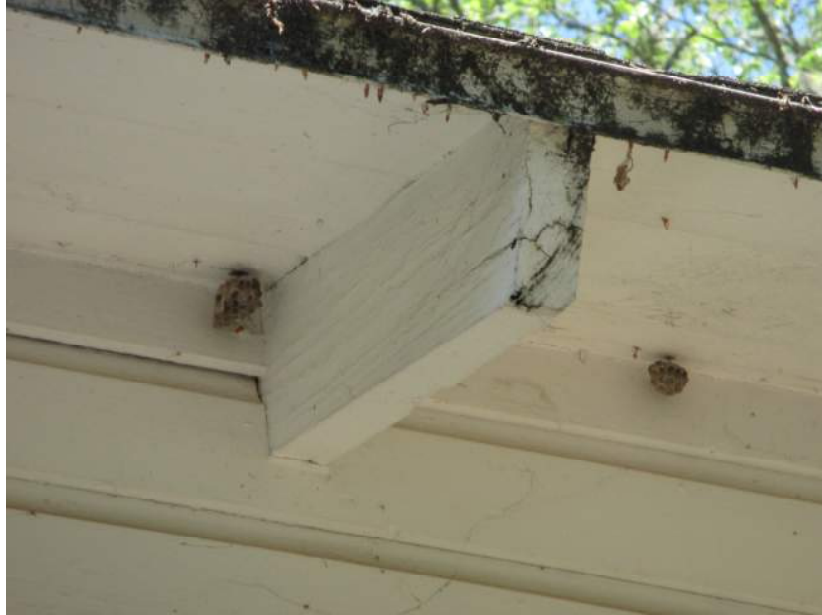
**Photograph 4**  
**Deteriorated Rafter Tail**

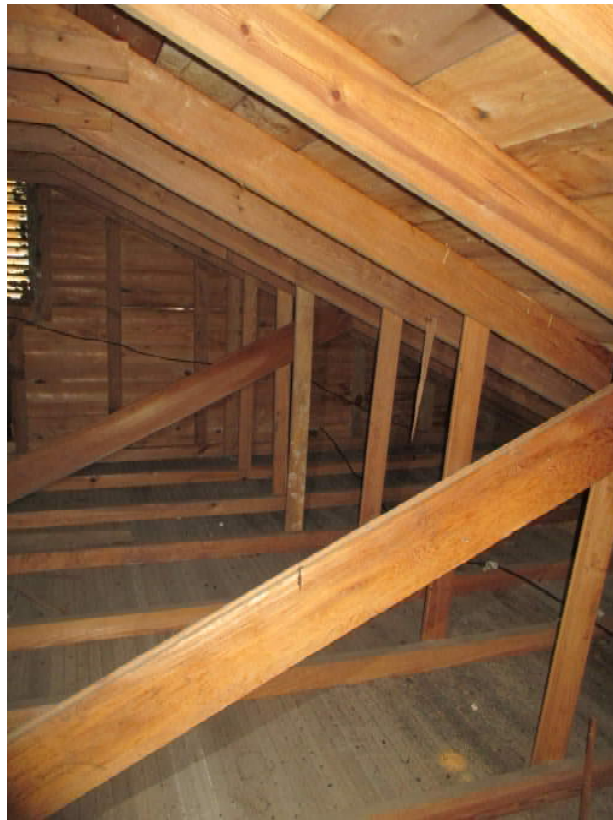
**Photograph 5**  
**Missing Diagonals within Attic**

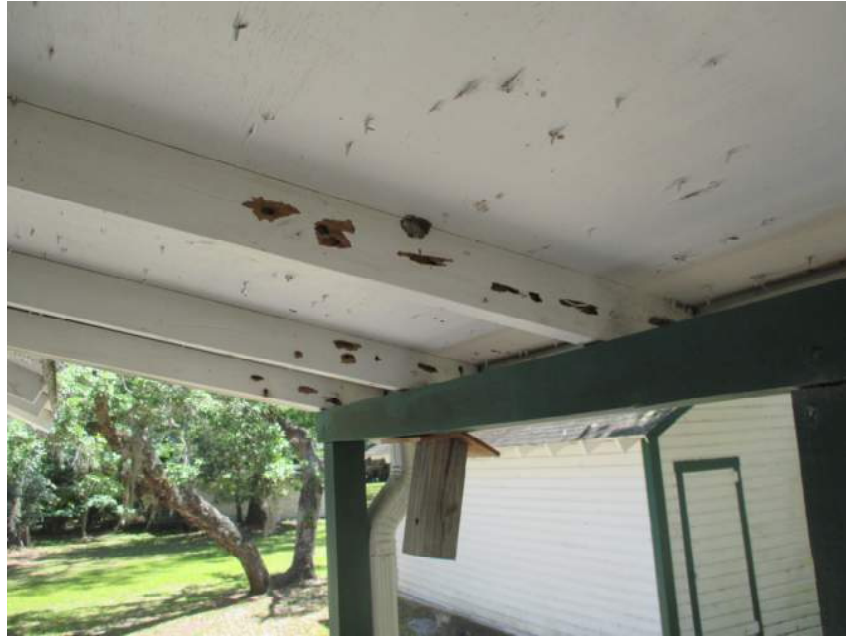
**Photograph 6**  
**Termite Damaged Rafter Tail at Rear Porch**

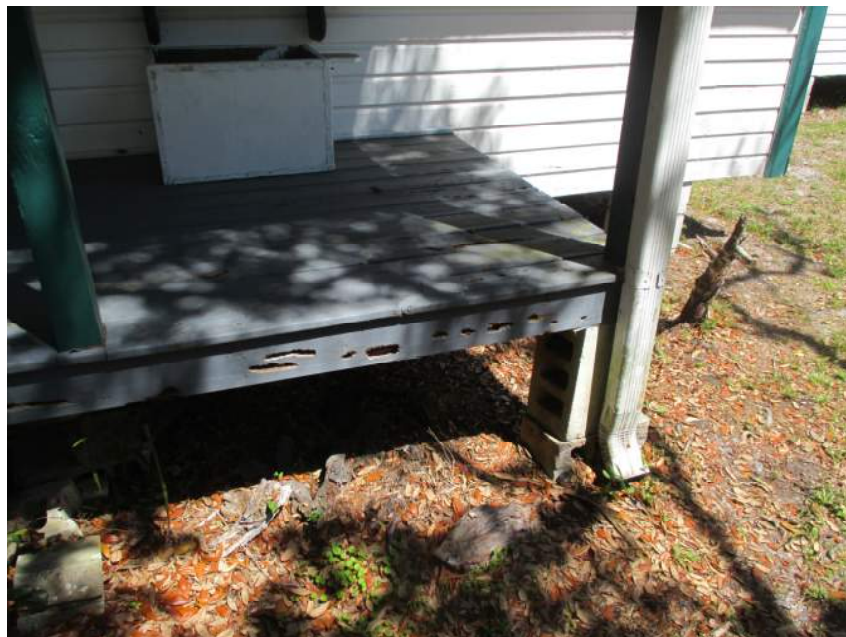
**Photograph 7**  
**Termite Damaged Rear Porch Entry Framing**

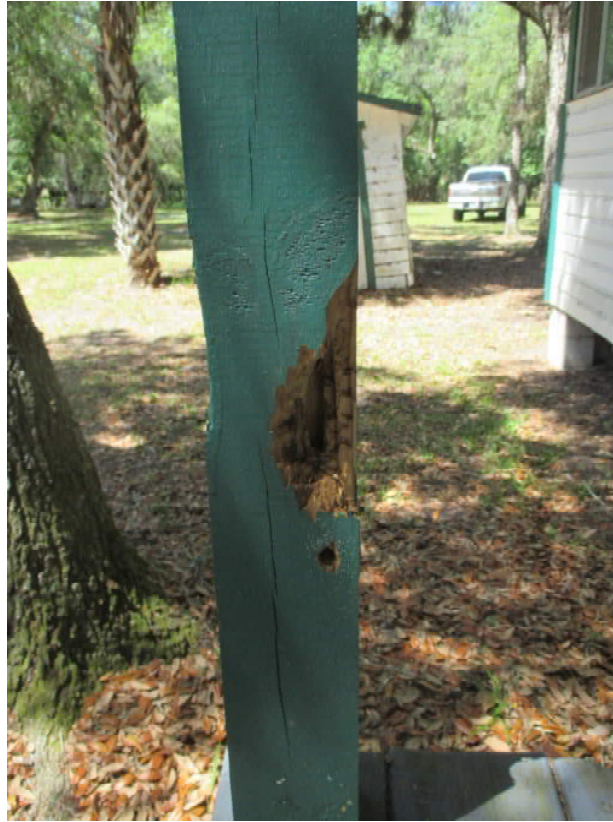
**Photograph 8**  
**Termite Damaged Porch Column**

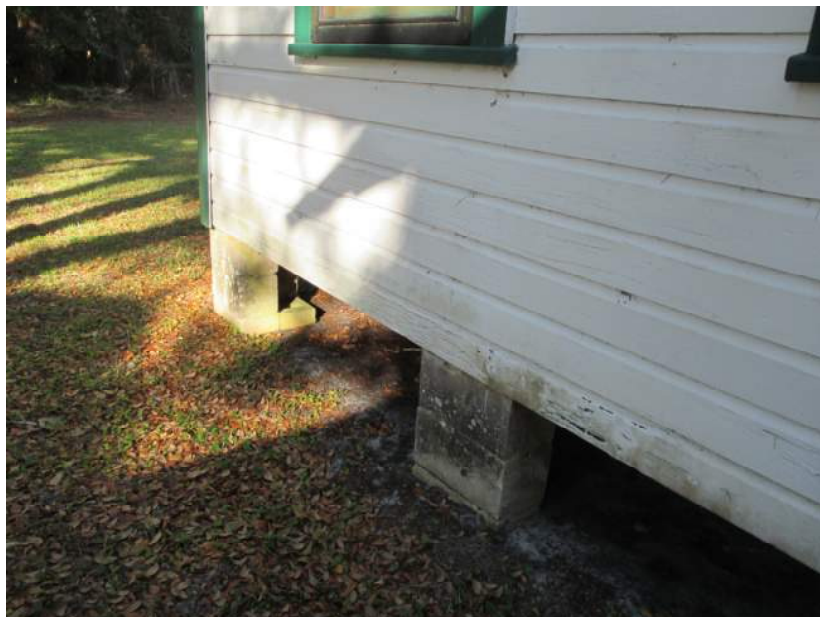
**Photograph 9**  
**Weathered Siding and Trim**

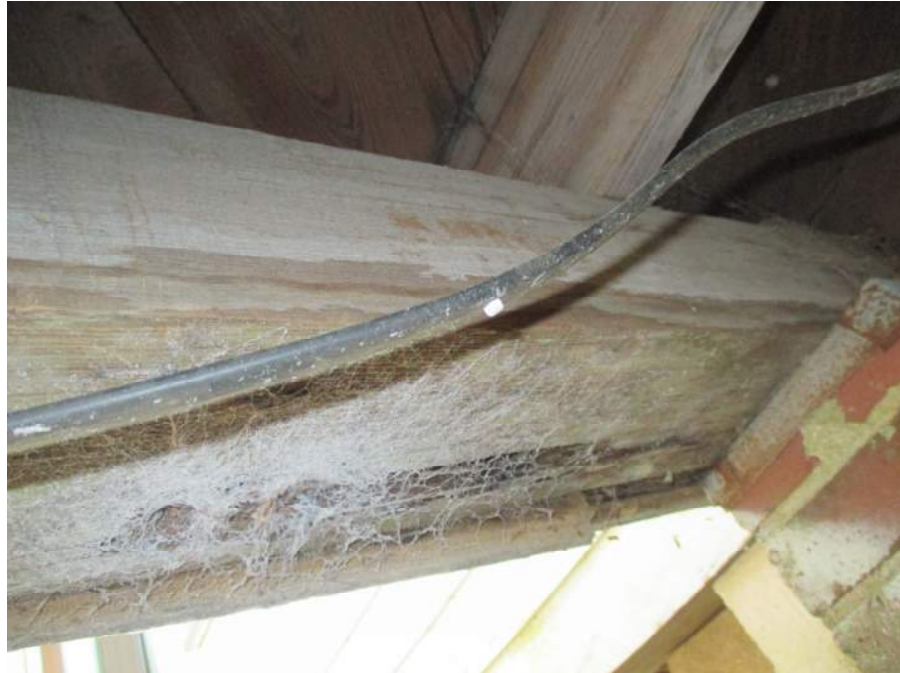
**Photograph 10**  
**Termite Damaged Floor Framing**

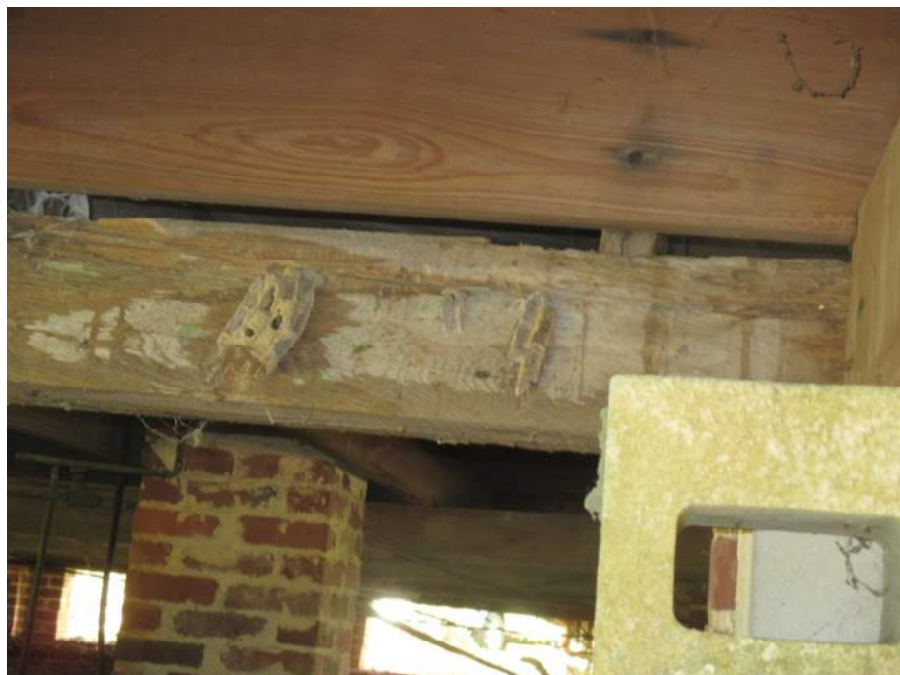
**Photograph 11**  
**Weathered Floor Framing**

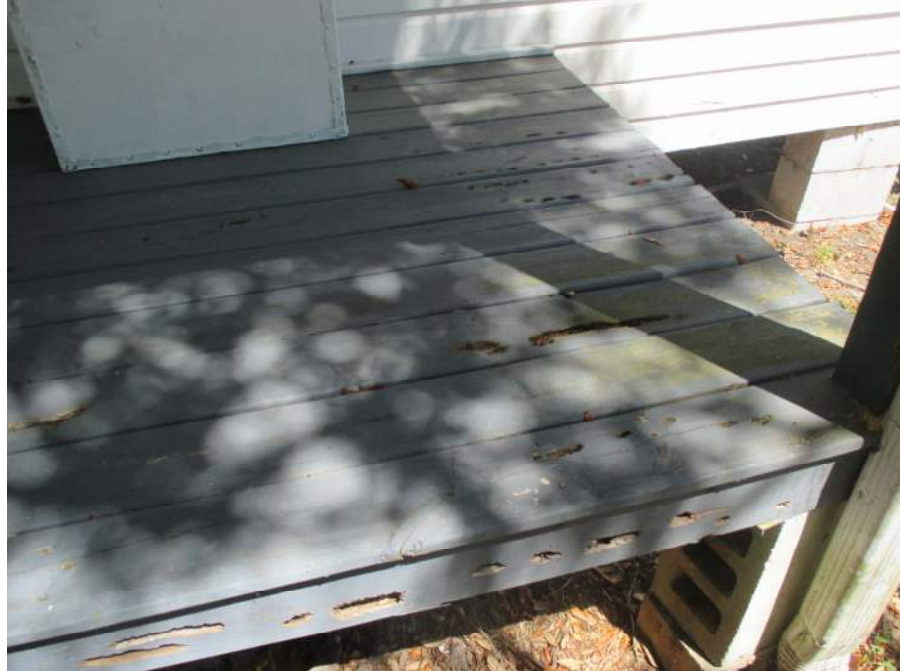
**Photograph 12**  
**Termite Damaged Floor Decking of Rear Porch Entry**

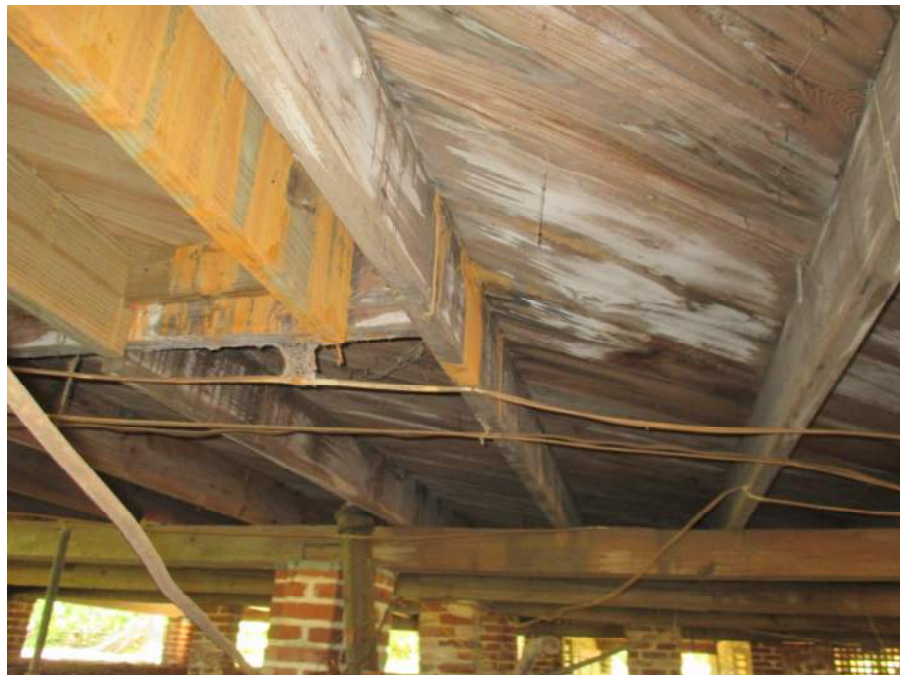
**Photograph 13**  
**Water Damaged Floor Decking**

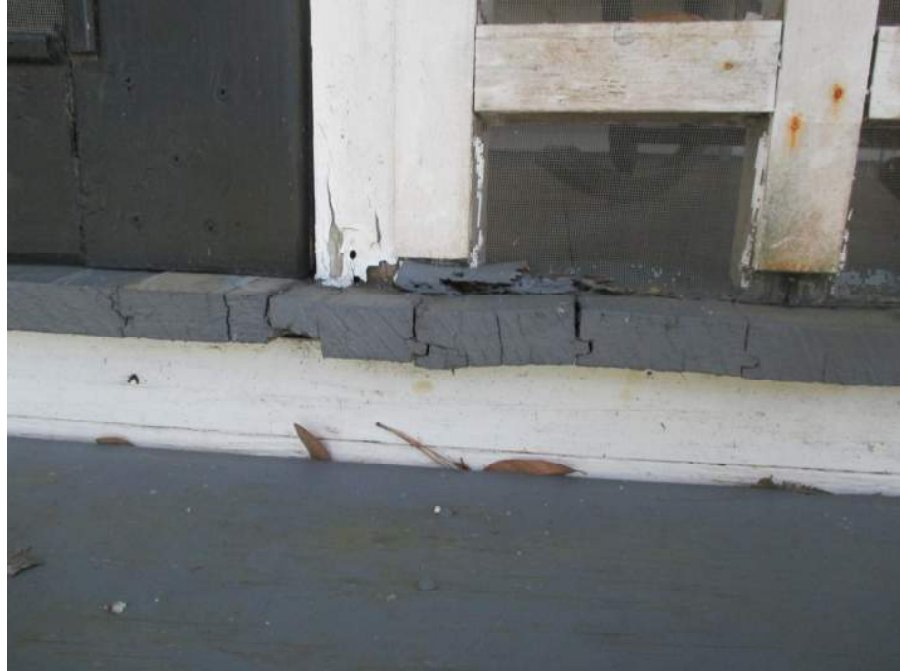
**Photograph 14**  
**Water Damaged Decking at Main Entry Porch**

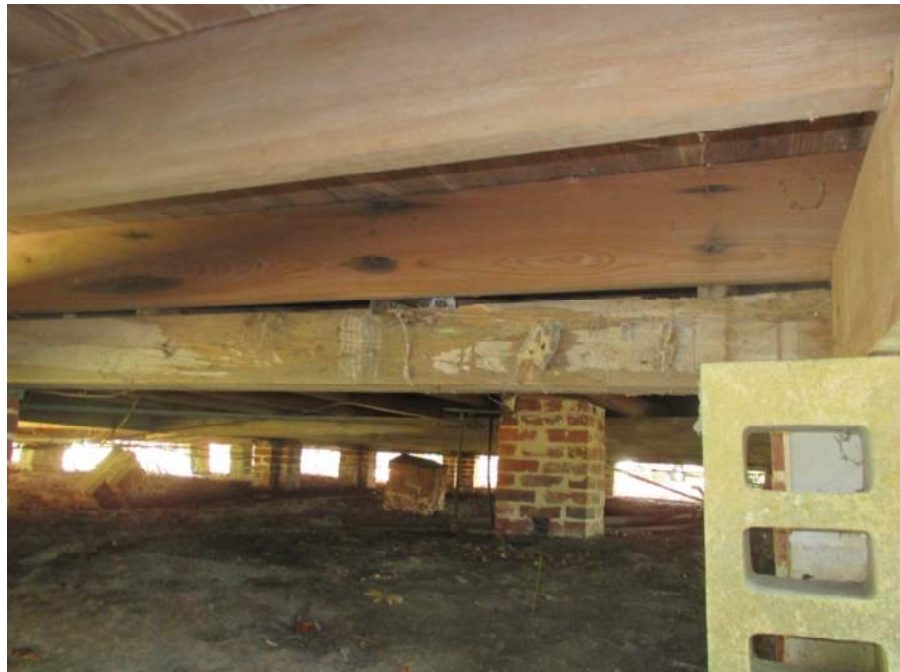
**Photograph 15**  
**Rotated and Settled Foundation Piers**

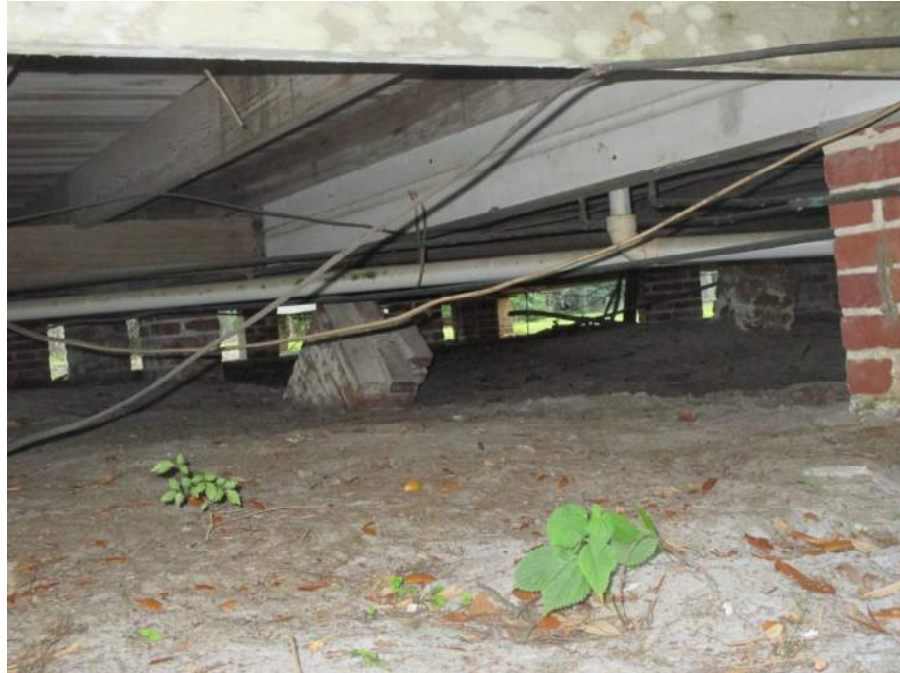
**Photograph 16**  
**Rotated and Settled Foundation Piers**

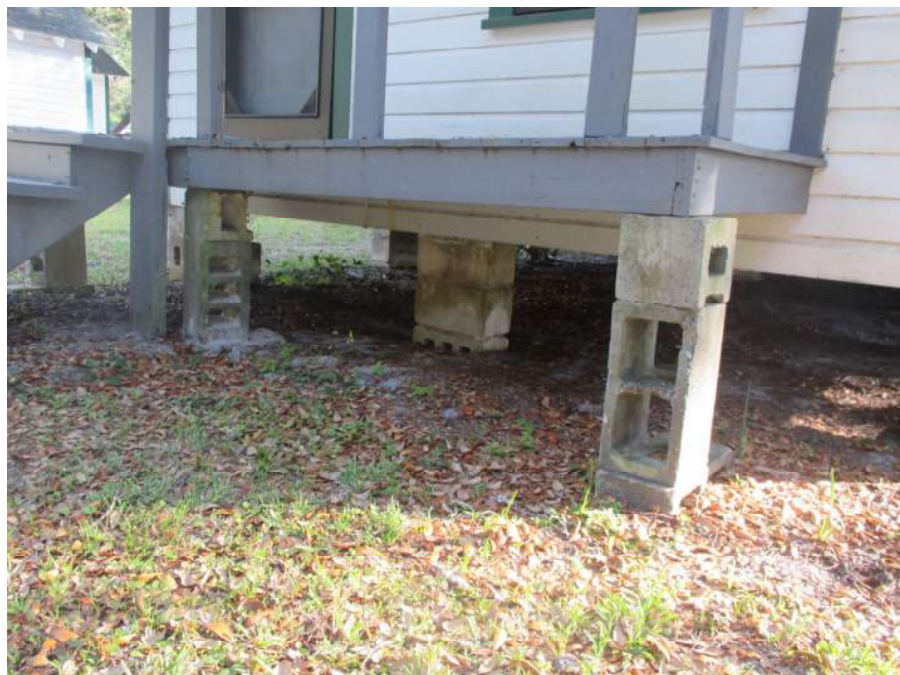
**Photograph 17**  
**Dry-Stacked and Unstable CMU Piers**

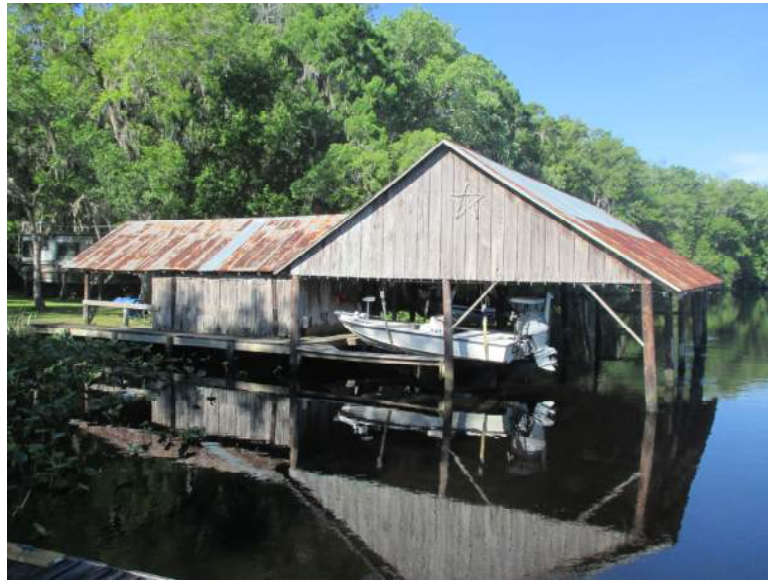
**Photograph 1**  
**East Facade of Boathouse**

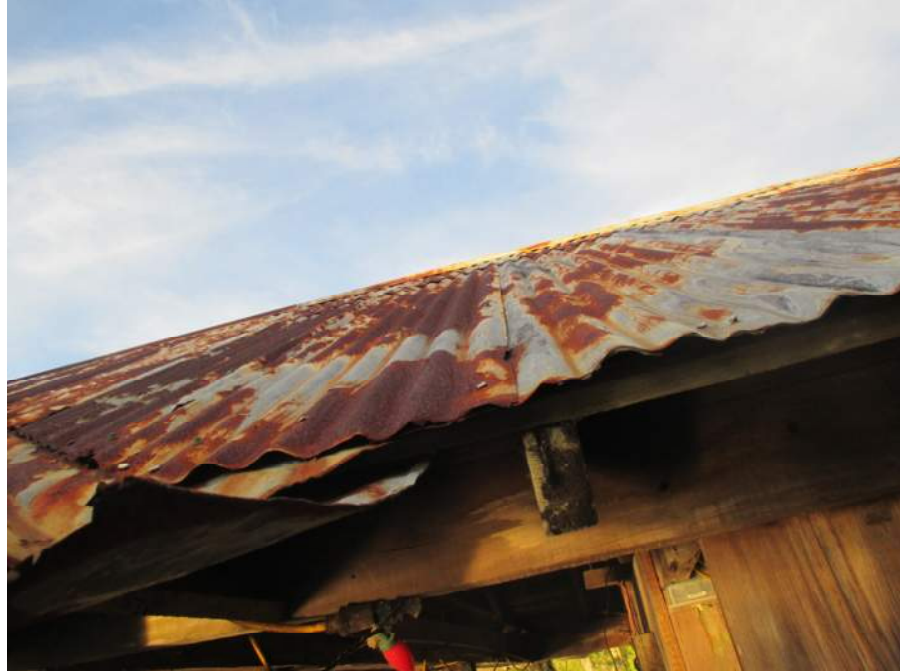
**Photograph 3**  
**Surfacial Rust on Metal V-Crimp Roofing**

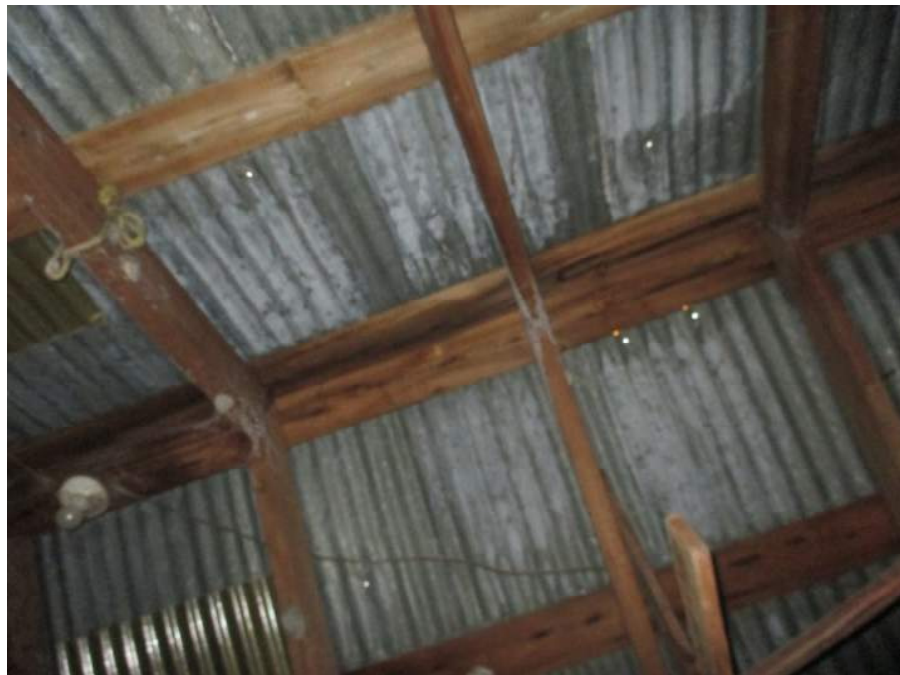
**Photograph 4**  
**Underside of Metal Roofing**

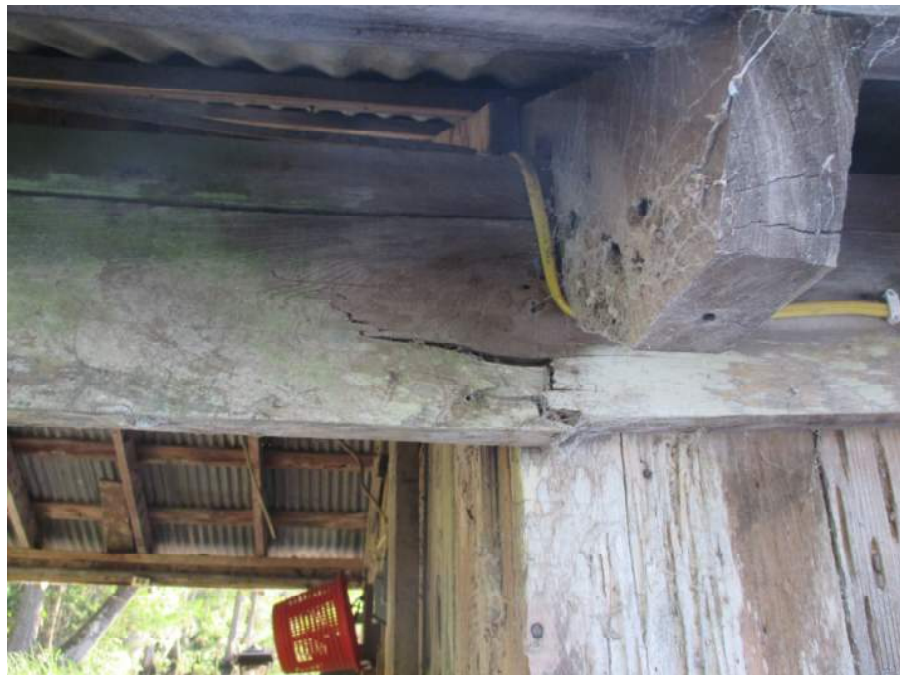
**Photograph 6**  
**Cracked Perimeter Beam**

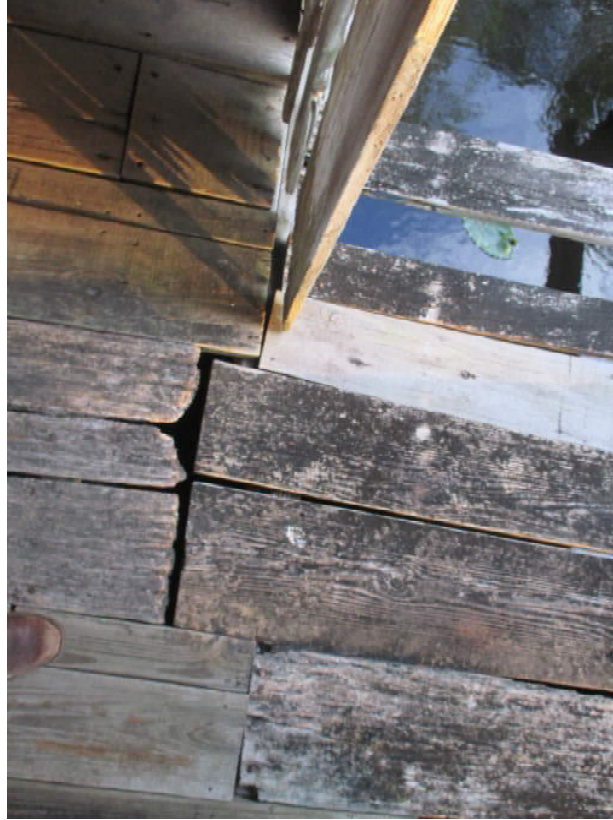
**Photograph 7**  
**Decking Deteriorated and Not Fastened**

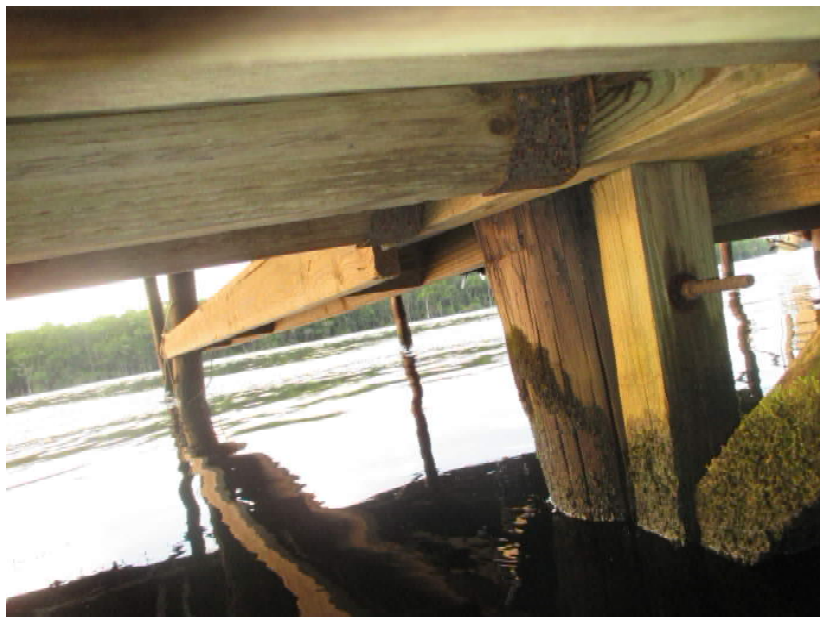
**Photograph 8**  
**Joist Hangers Deteriorated**

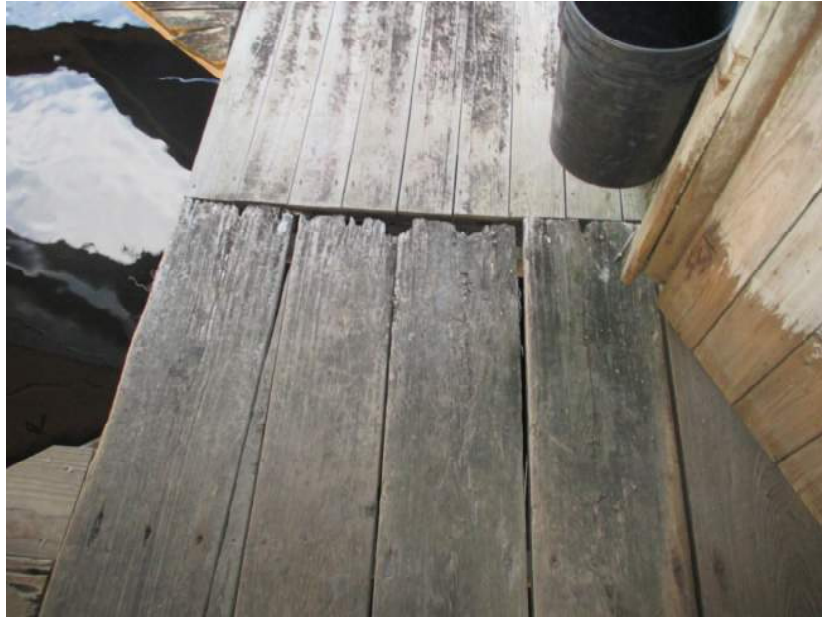
**Photograph 9**  
**Decking Deteriorated and Not Fastened**

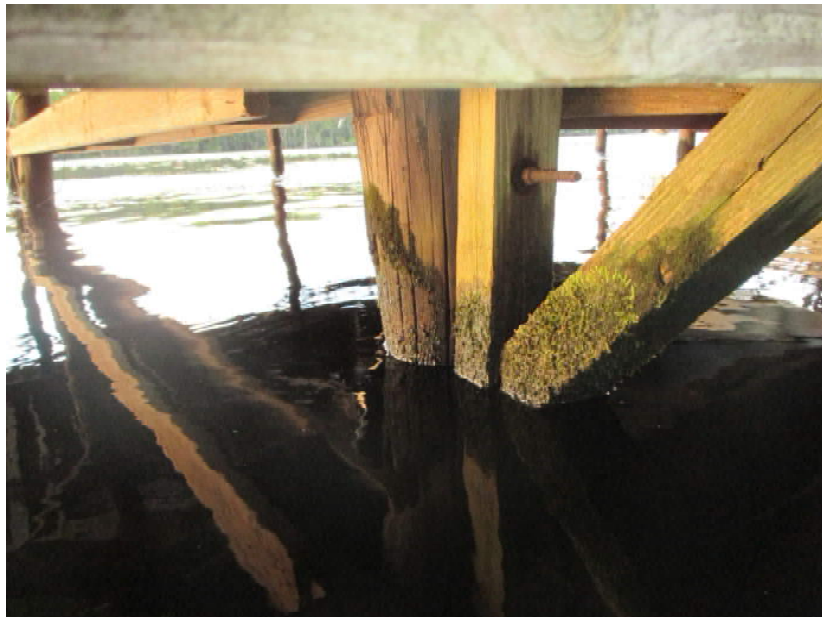
**Photograph 10**  
**Biological Growth at Waterline and Weather Checking**

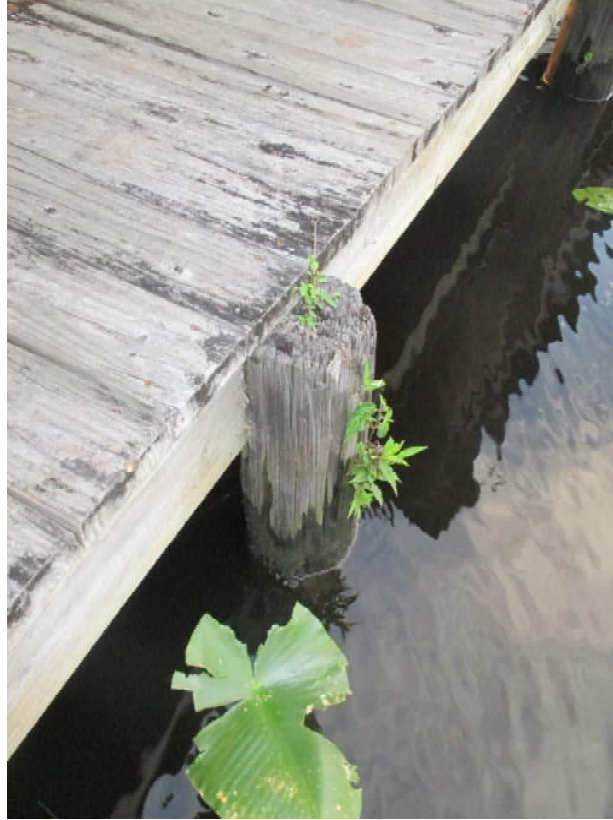
**Photograph 11**  
**Deterioration at Top of Timber Pile**

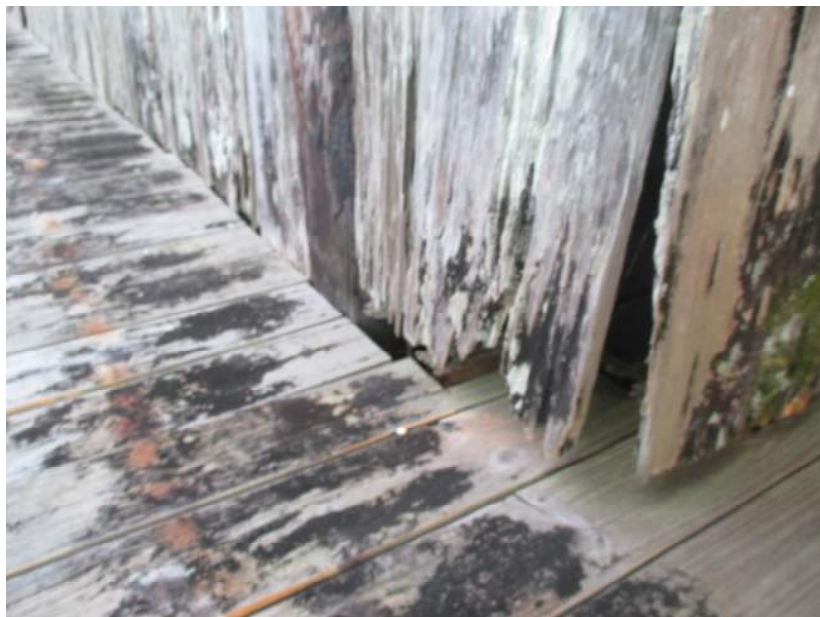
**Photograph 12**  
**Deterioration at Base of Siding**

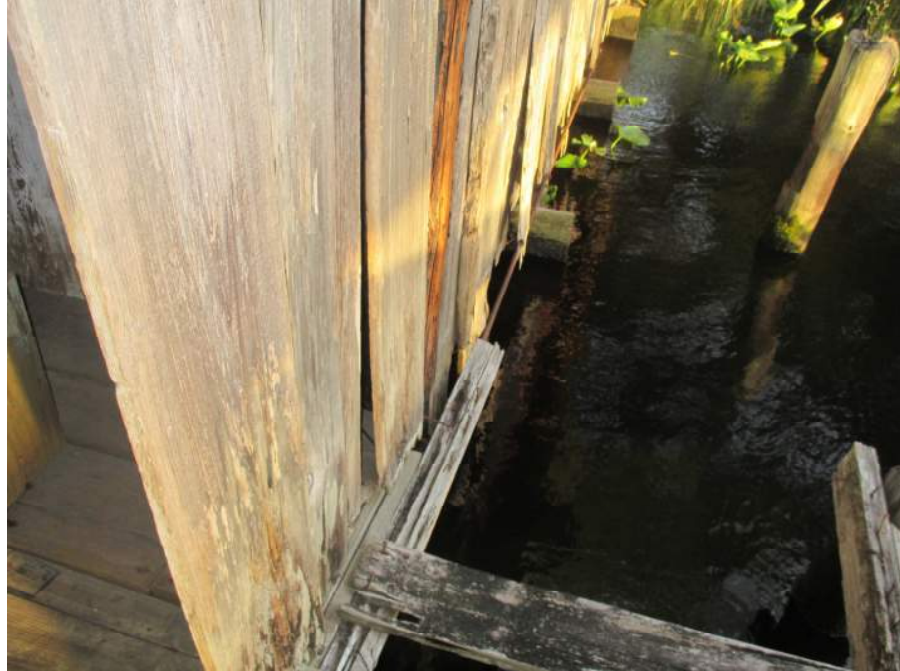
**Photograph 13**  
**Deterioration at Base of Siding and Missing Deteriorated Framing**

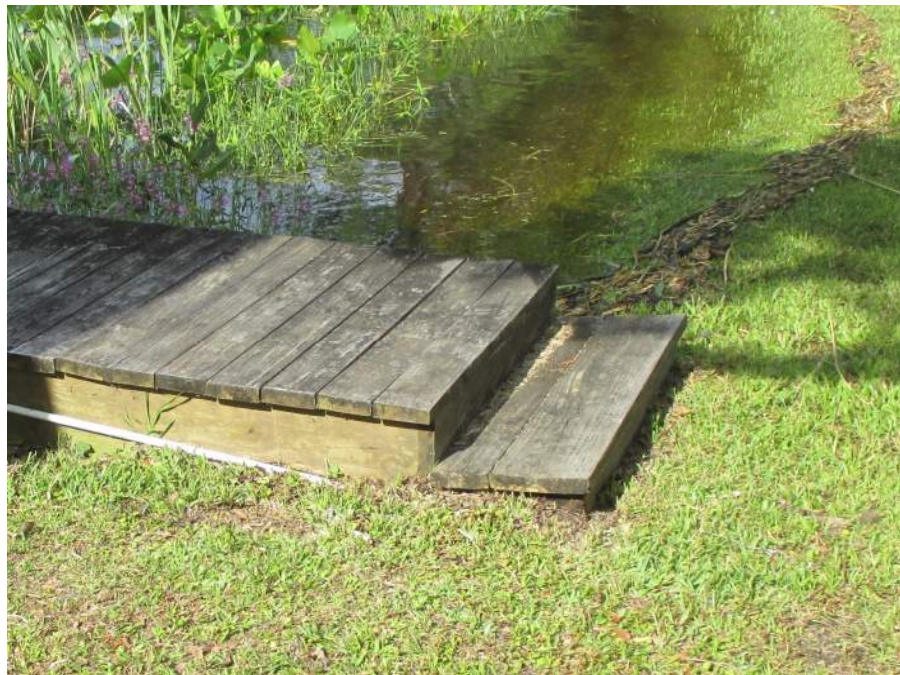
**Photograph 14**  
**Settled Entry Step**

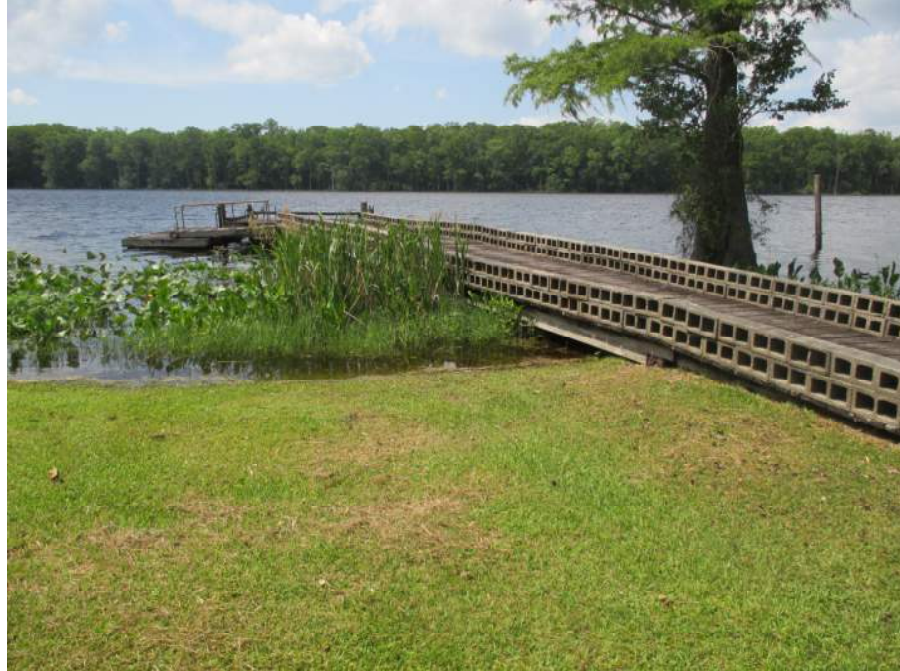
**Photograph 1**  
**Overall of Dock**

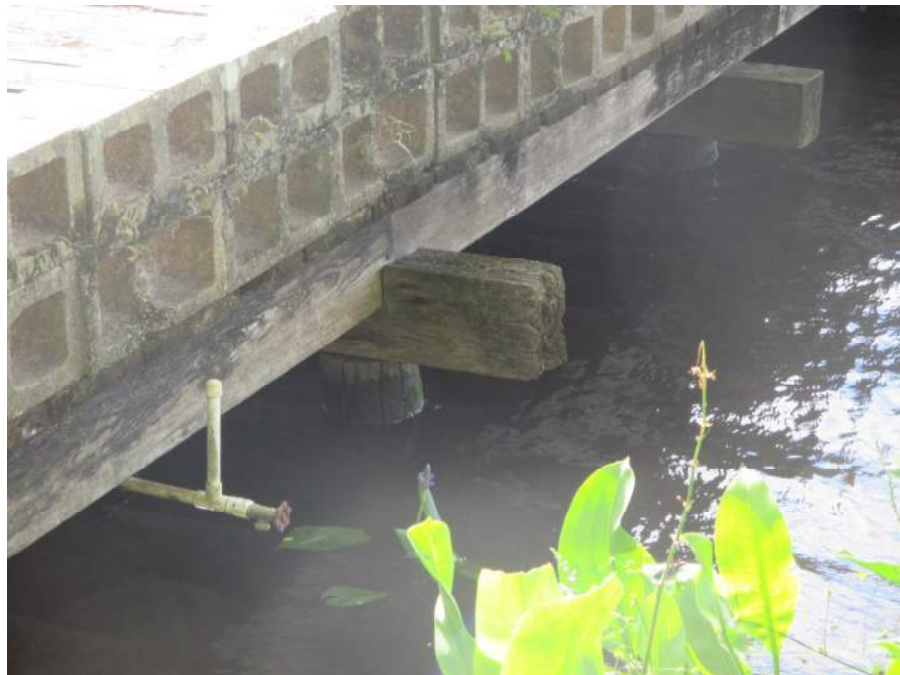
**Photograph 2**  
**Deteriorated Beam End Cantilevered Over Timber Pile**

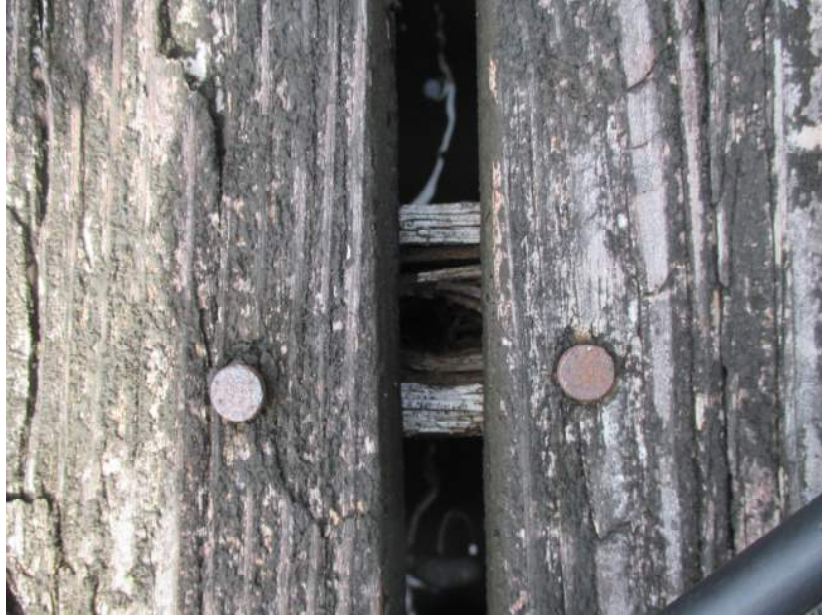
**Photograph 3**  
**Deteriorated 2x Stringer**

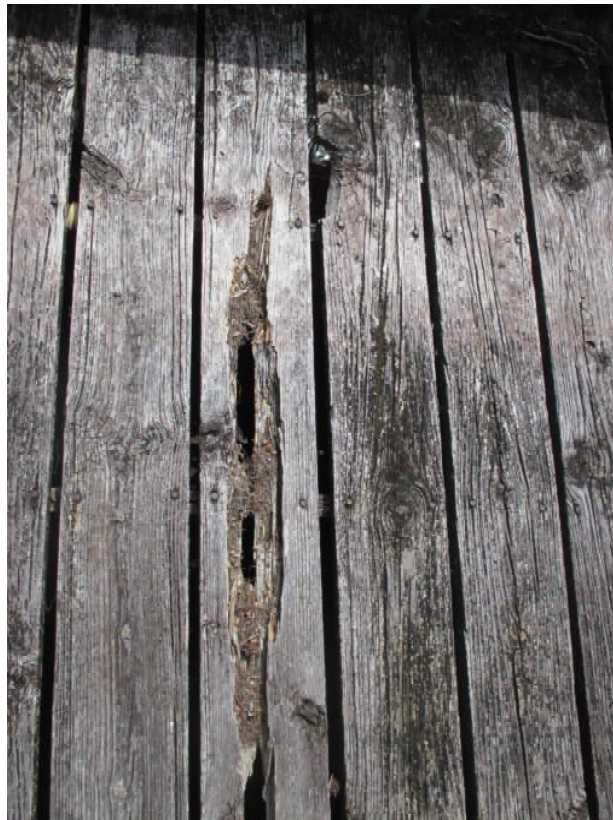
**Photograph 4**  
**Deteriorated Decking**

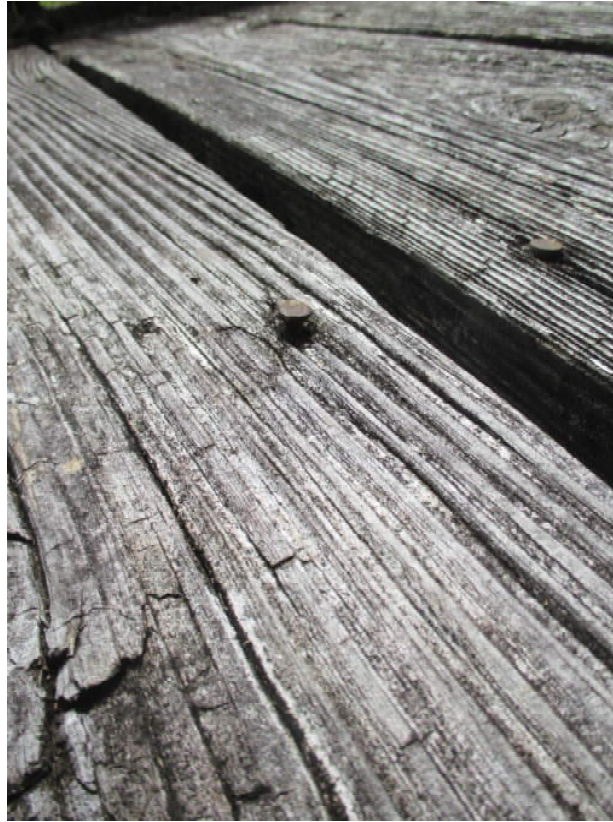
**Photograph 5**  
**Raised Nail Heads**

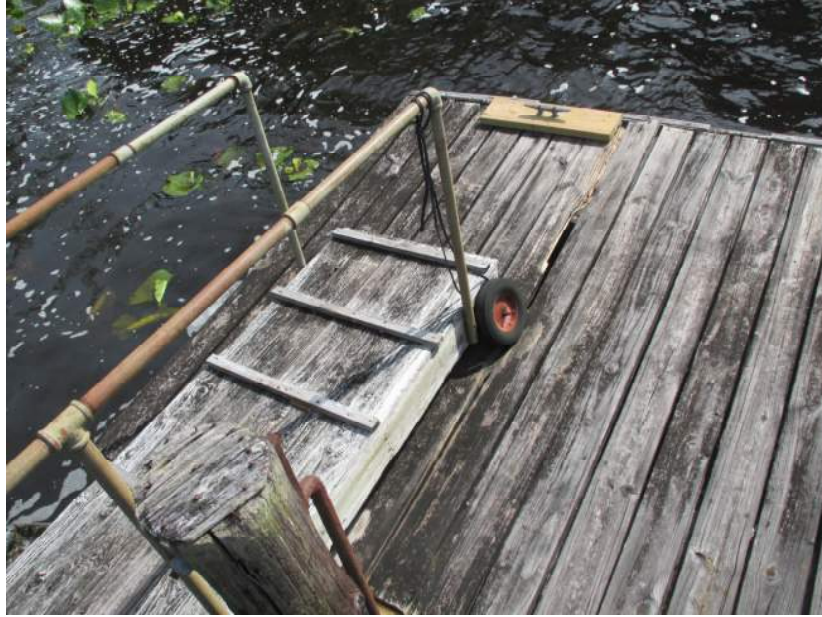
**Photograph 9**  
**Deteriorated Decking at Pivot Ramp**

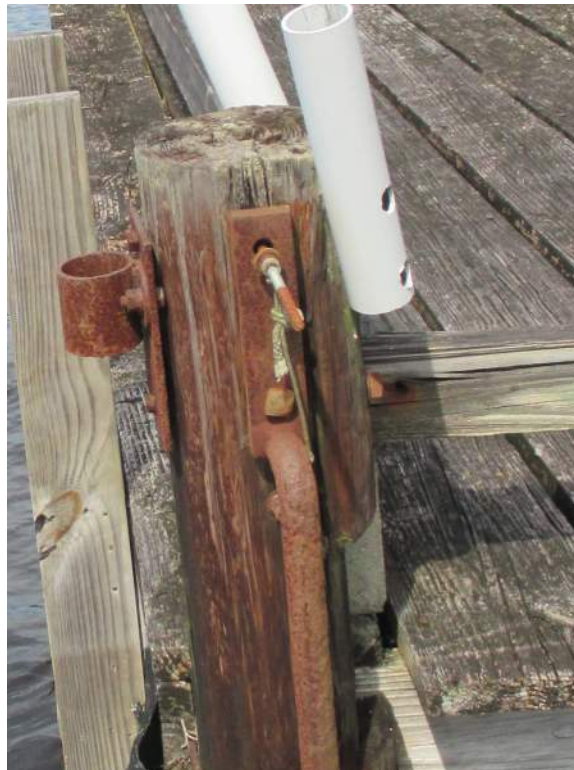
**Photograph 10**  
**Corroded and Missing Hardware**

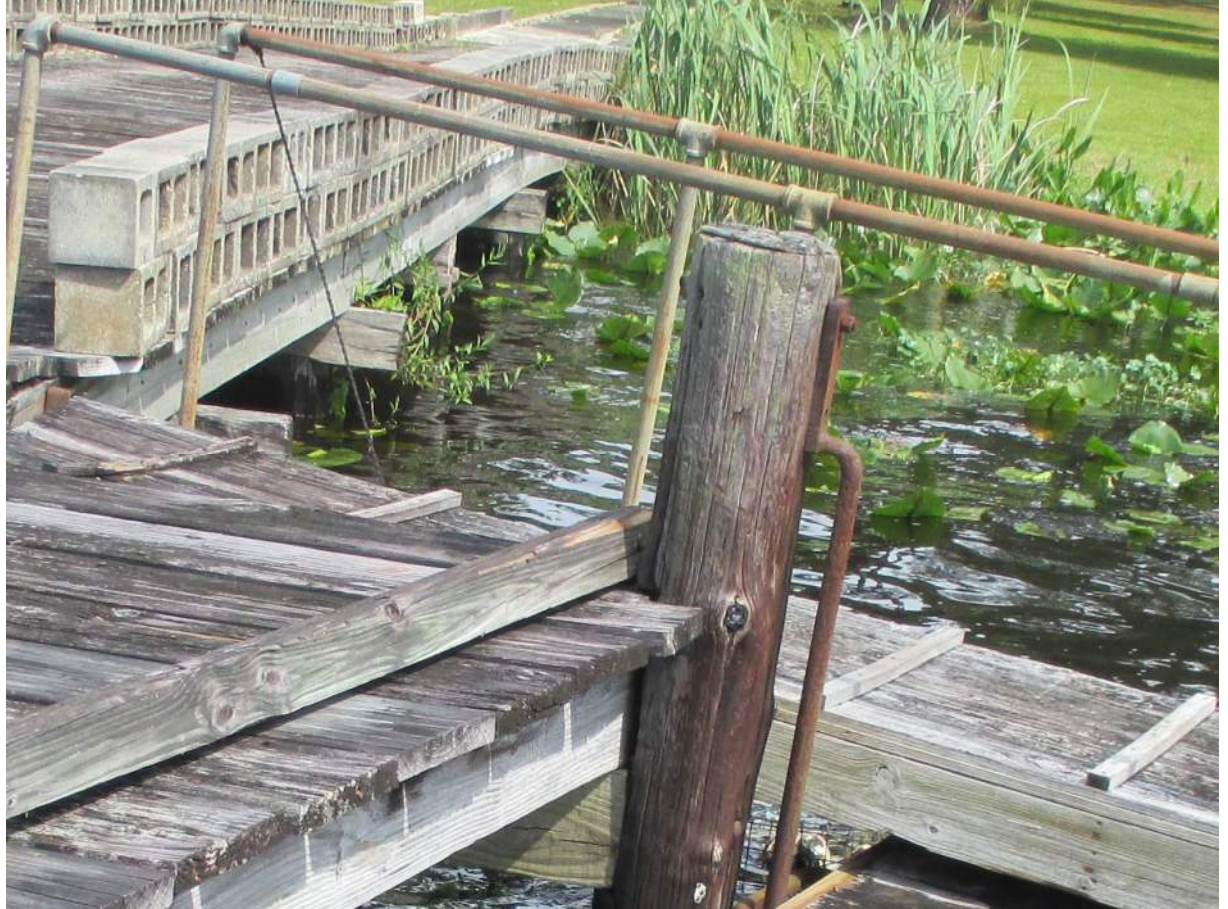
**Photograph 11**  
**Perimeter Timber Unattached**

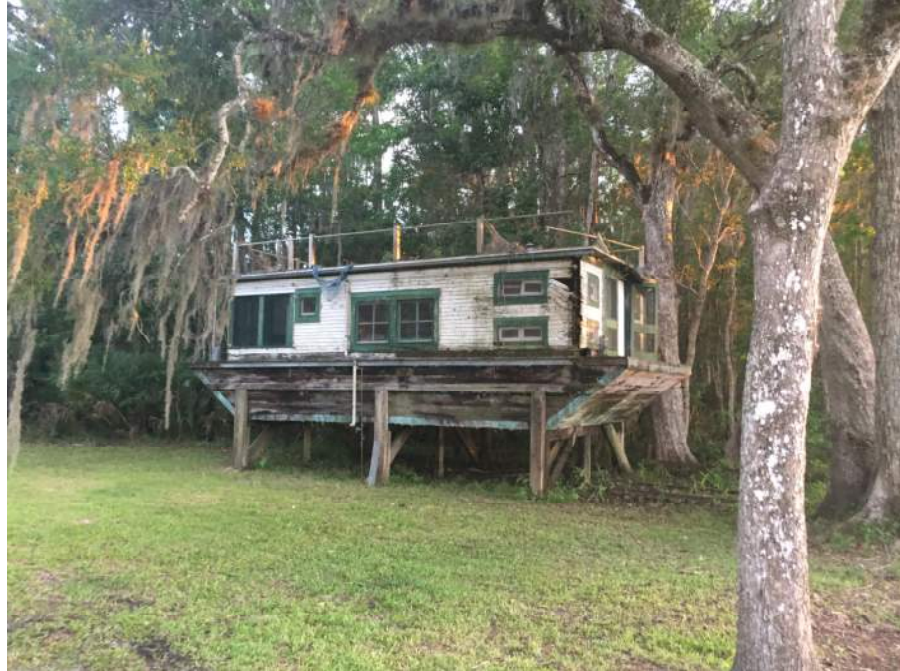
**Photograph 1**  
**West Wall (Starboard) Overall**
