# **HISTORIC STRUCTURE ASSESSMENT REPORT**

## **VISTA HISTORIC SITE Lower Suwannee National Wildlife Refuge**

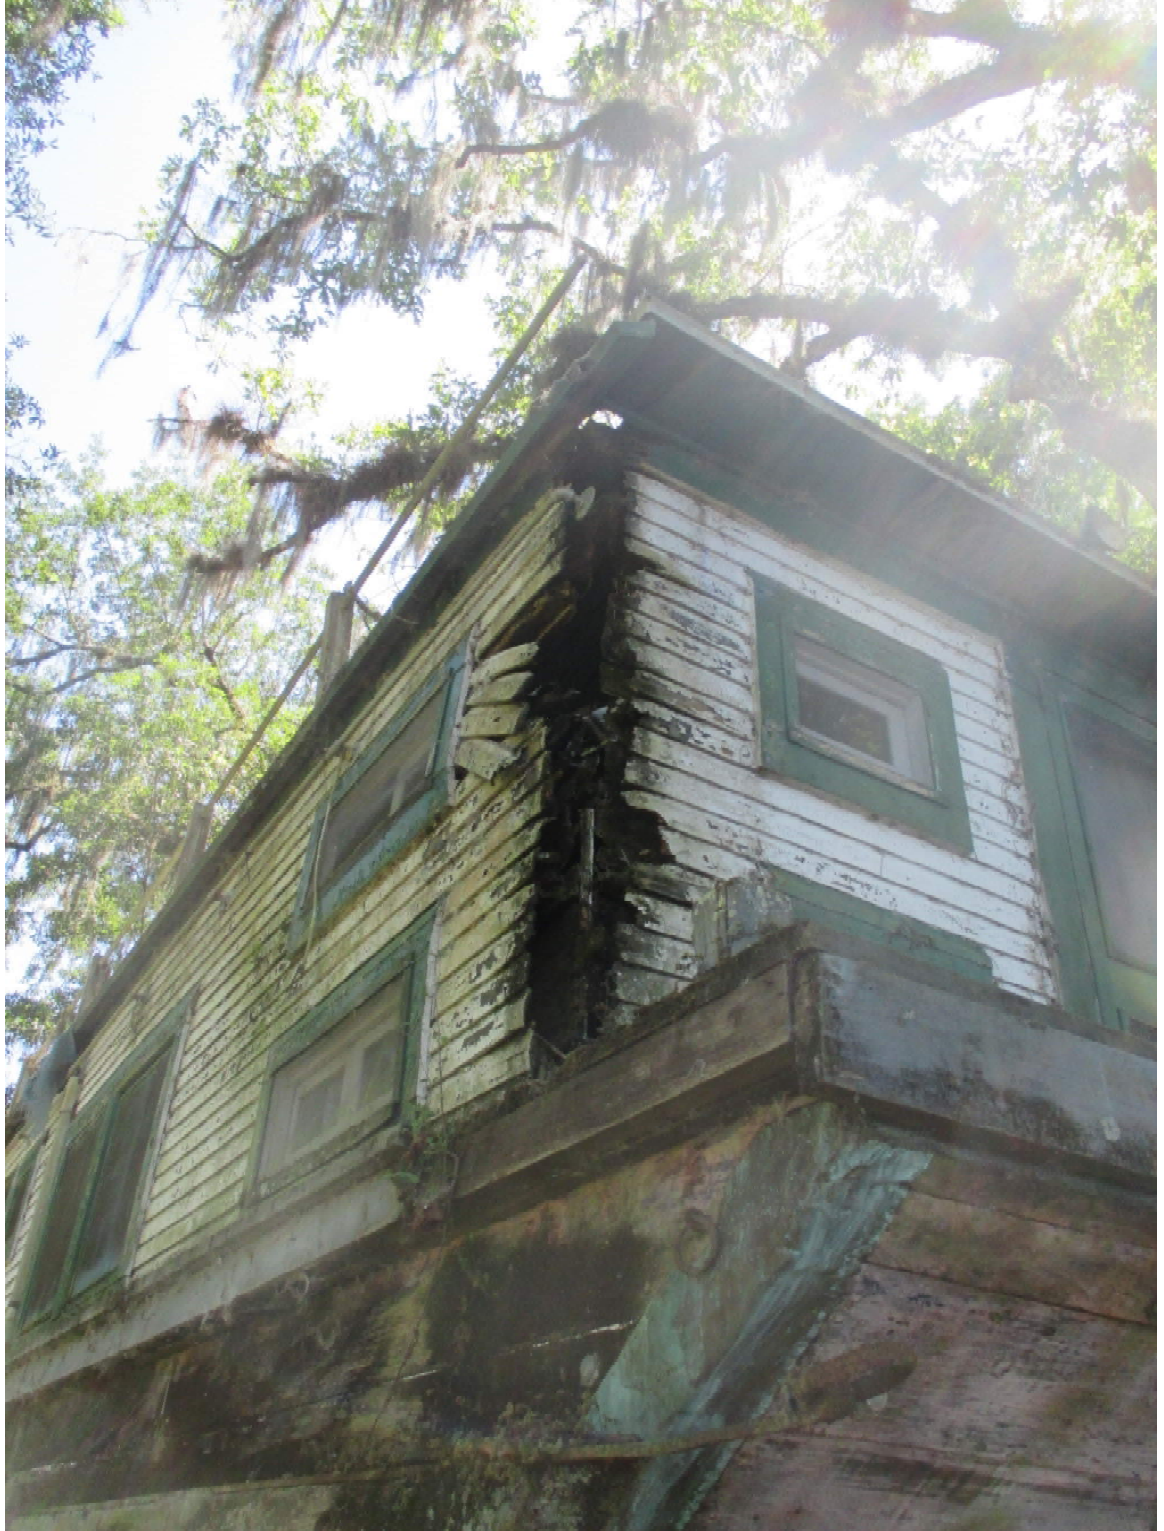
**Photograph 3**  
**Northwest Corner Severely Deteriorated**

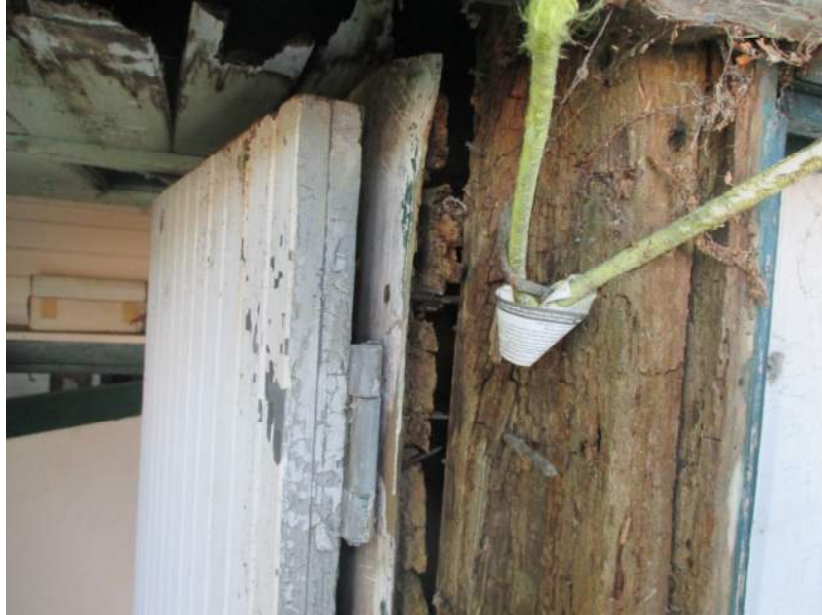
**Photograph 4**  
**North Wall and Roof Joists Severely Deteriorated**

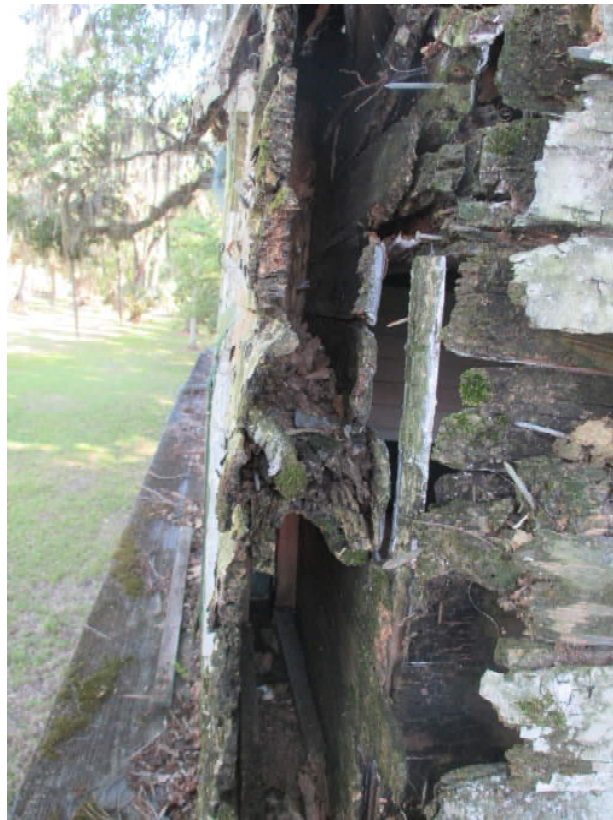
**Photograph 5**  
**Wall Studs, Siding, Blocking, and Decking Severely Deteriorated**

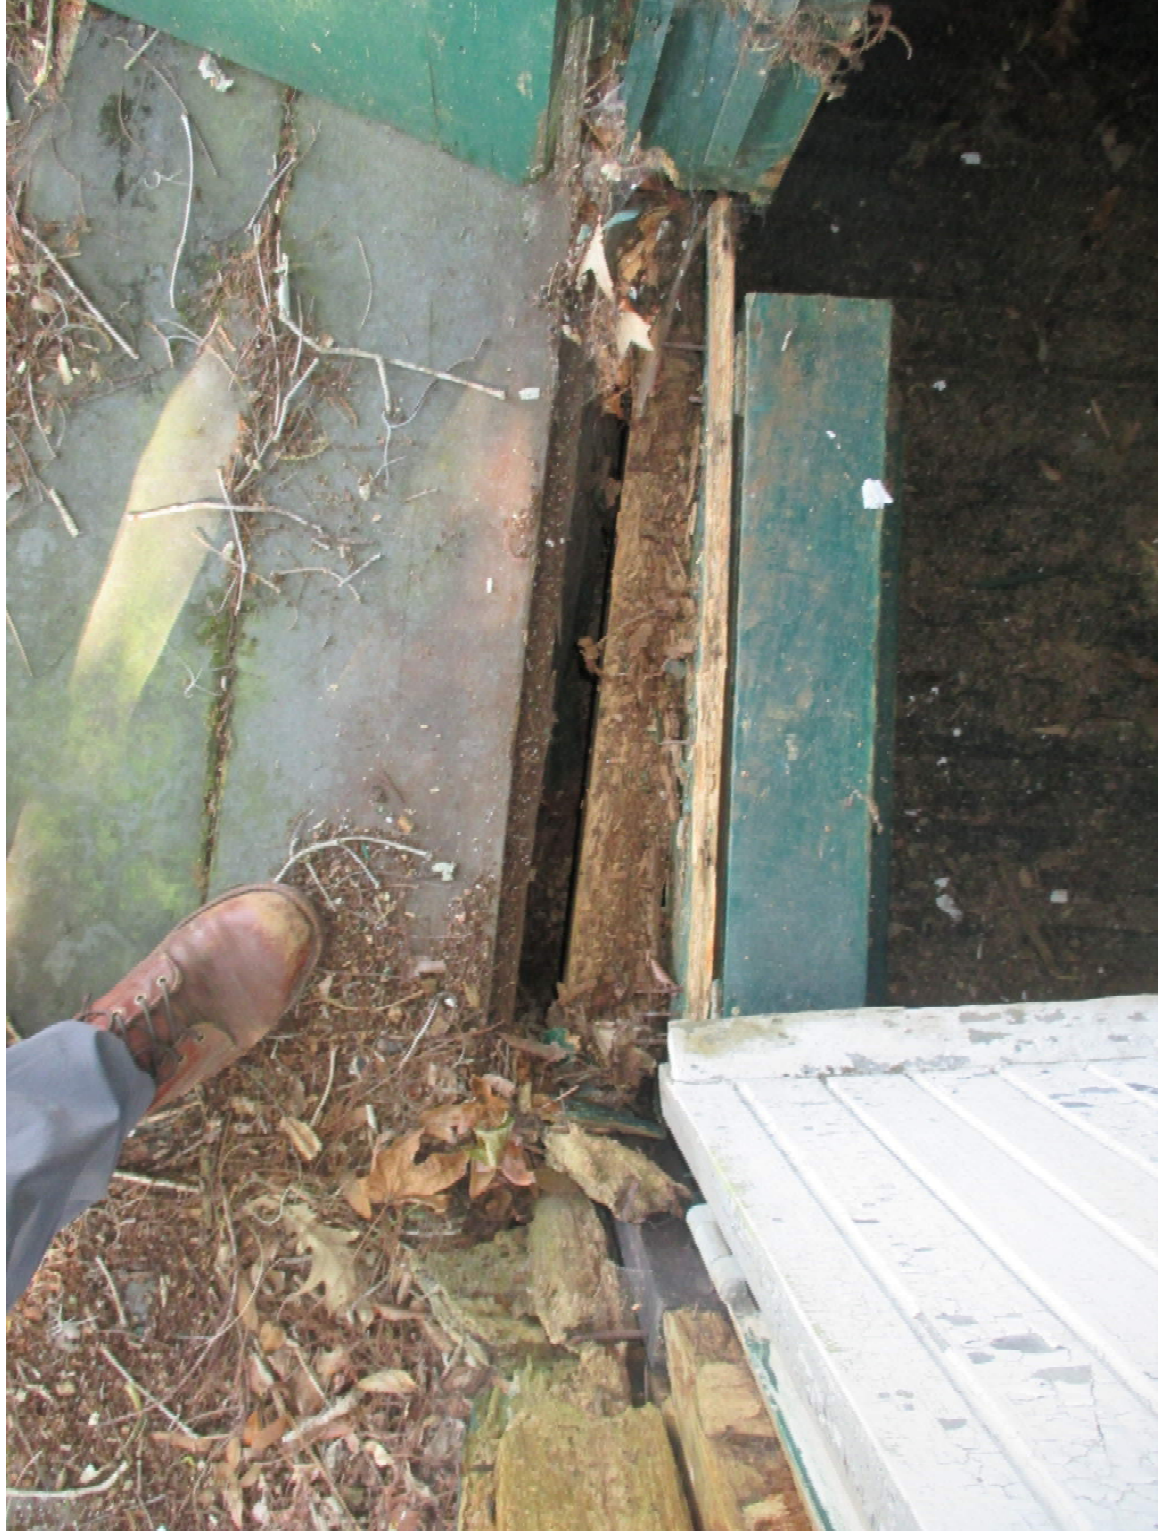
**Photograph 6**  
**Decking, Entry Step, and Wall Framing Severely Deteriorated**

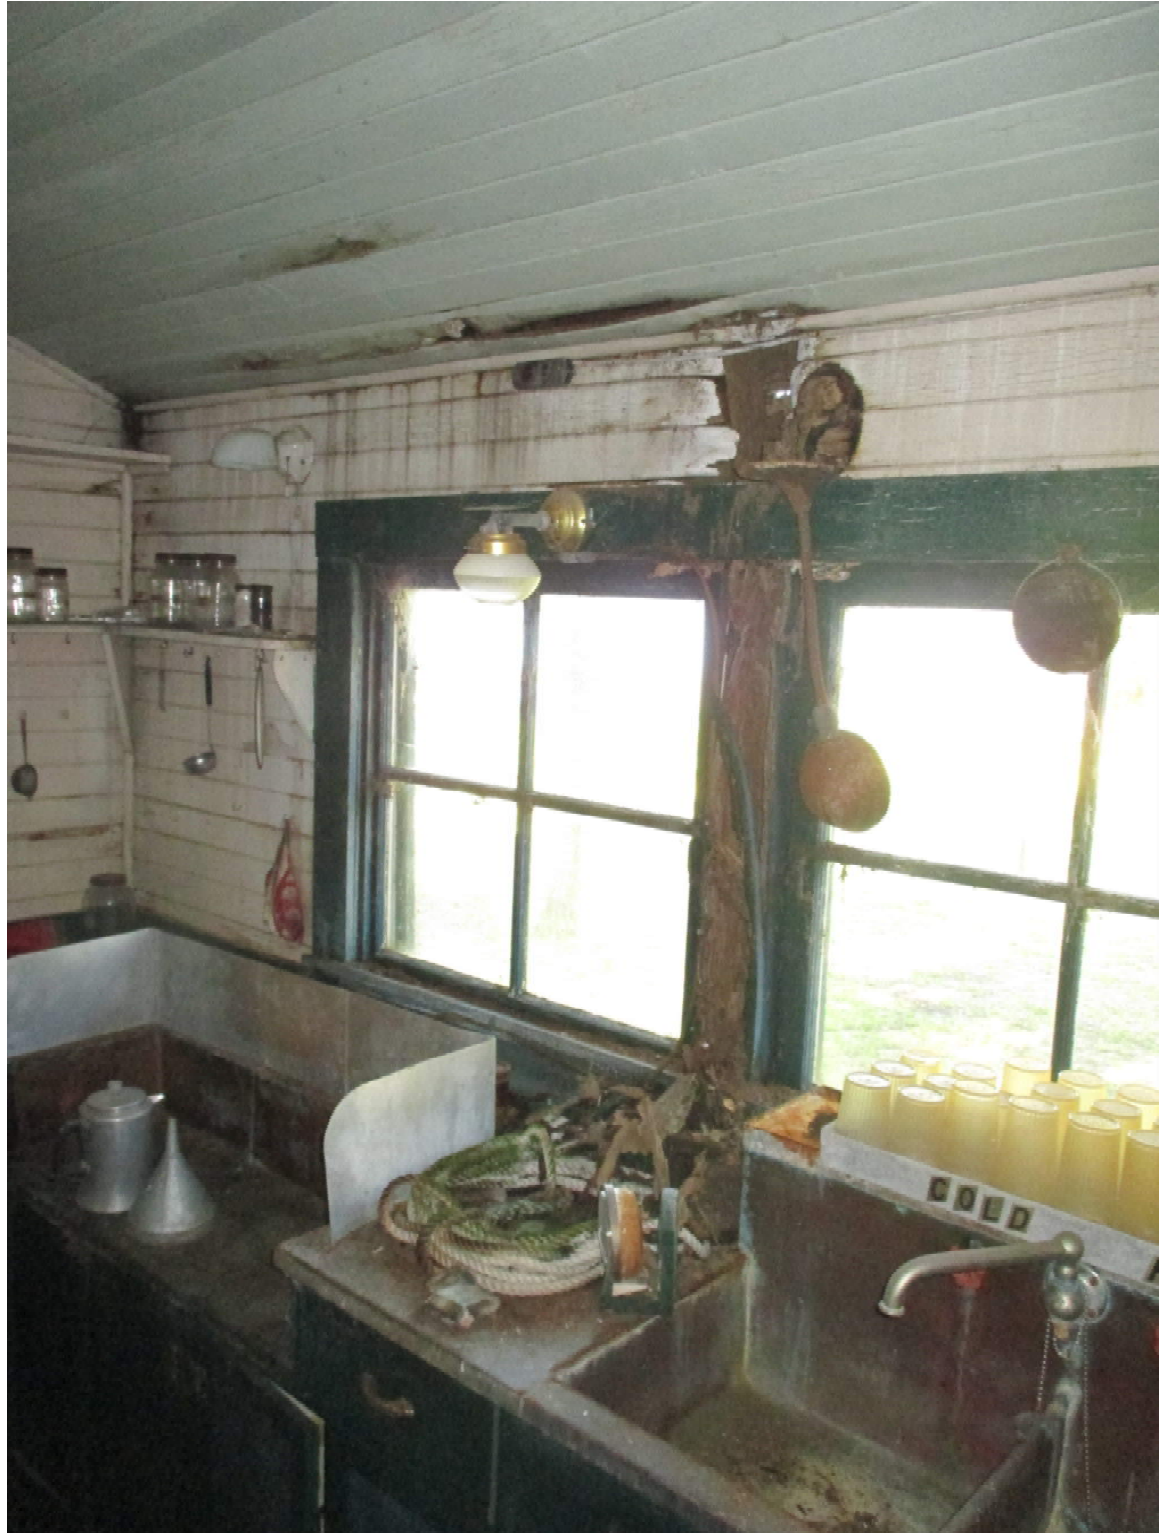
**Photograph 7**  
**Wall Framing and Siding Severely Deteriorated**

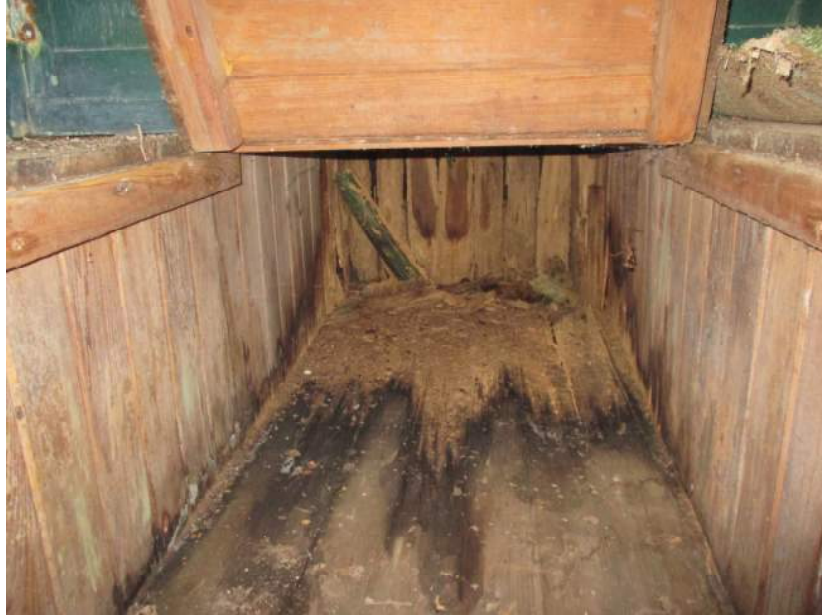
**Photograph 8**  
**Kitchen Floor Storage Well Moisture Damage**

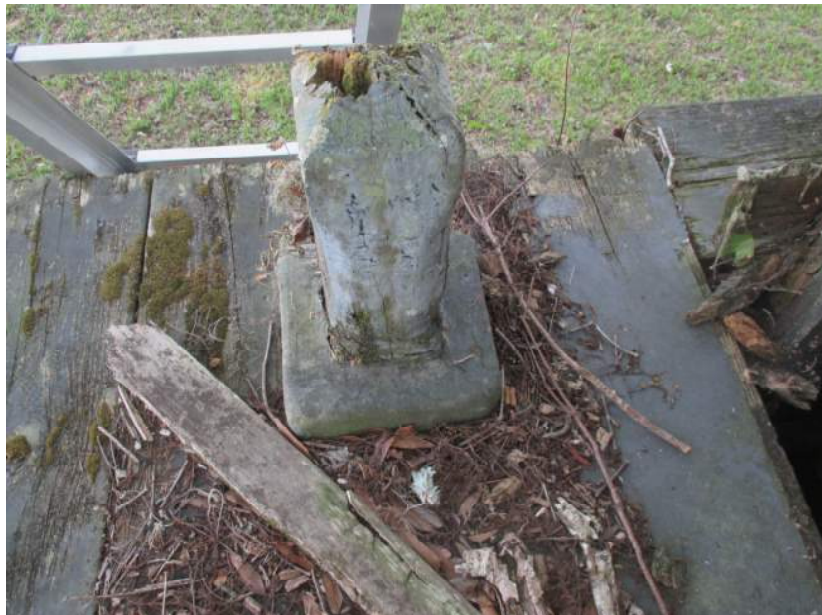
**Photograph 9**  
**Mooring Davit Deteriorated**

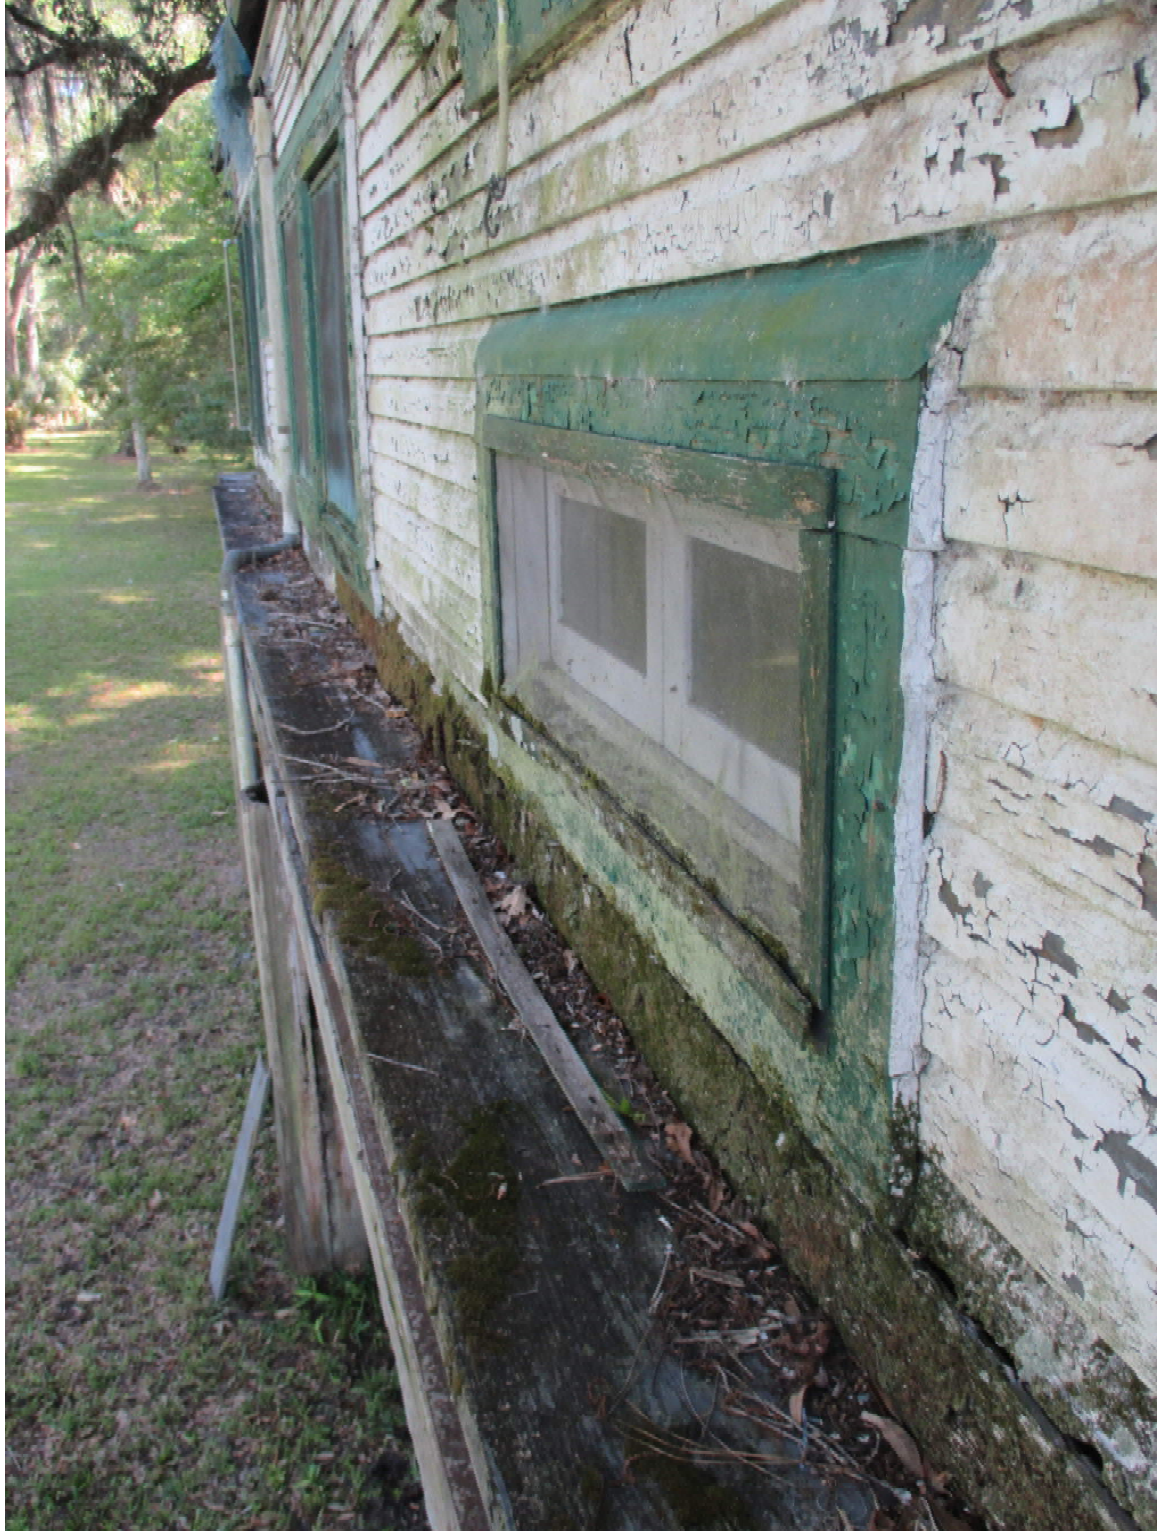
**Photograph 10**  
**Siding, Trim, Decking, and Wall Framing Severely Deteriorated**

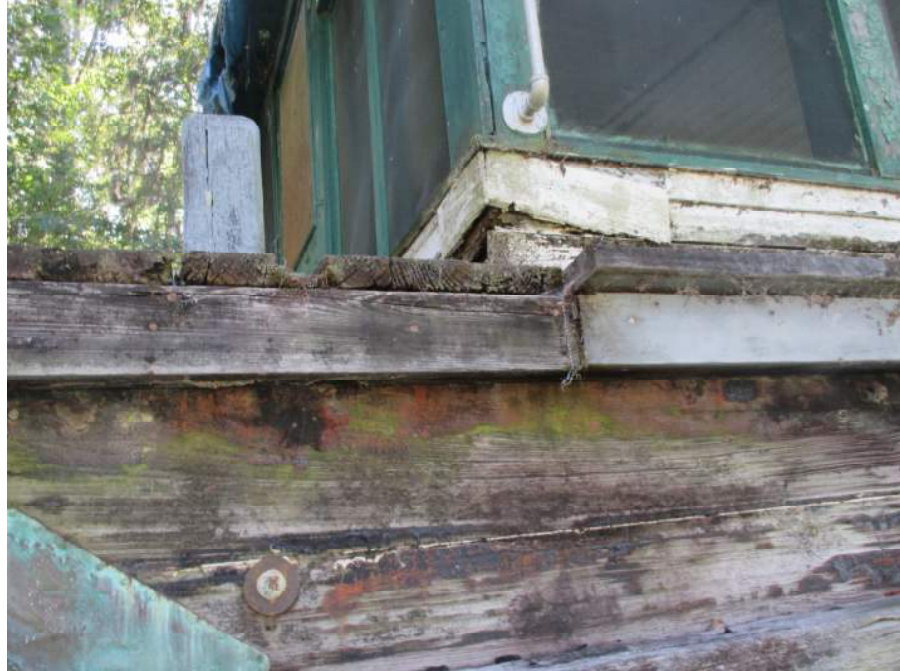
**Photograph 11**  
**Decking and Trim Deteriorated with Corroded Fasteners**

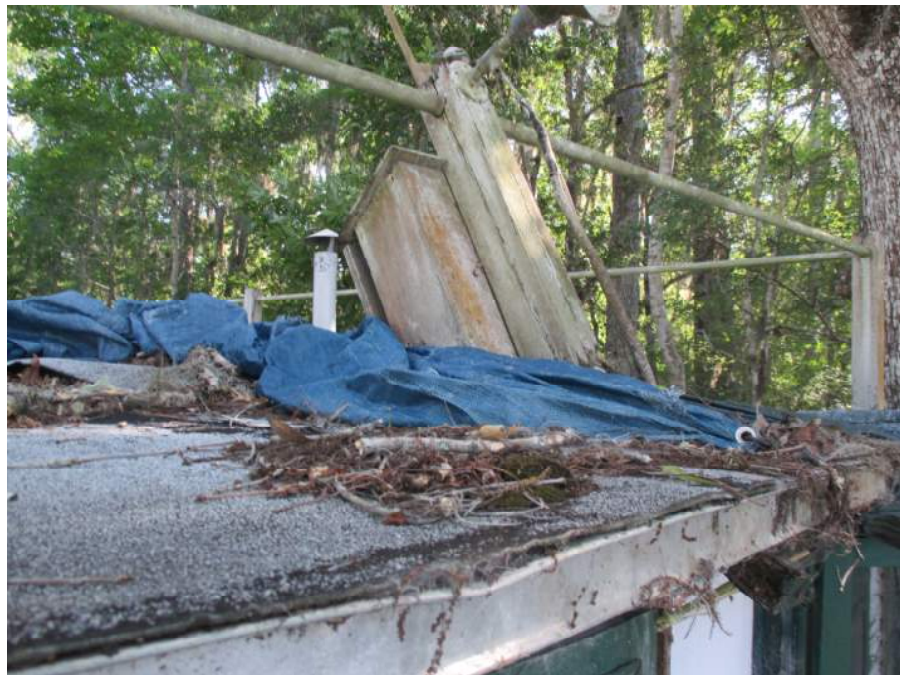
**Photograph 12**  
**Handrail Post Failed with Broken Handrail**

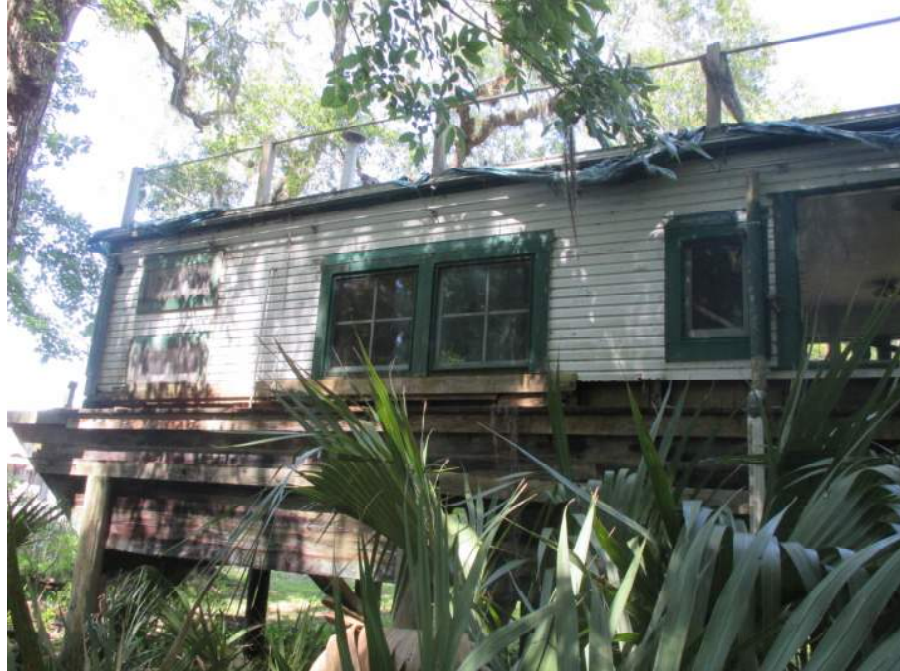
**Photograph 13**  
**Missing and Severely Deteriorated Siding**

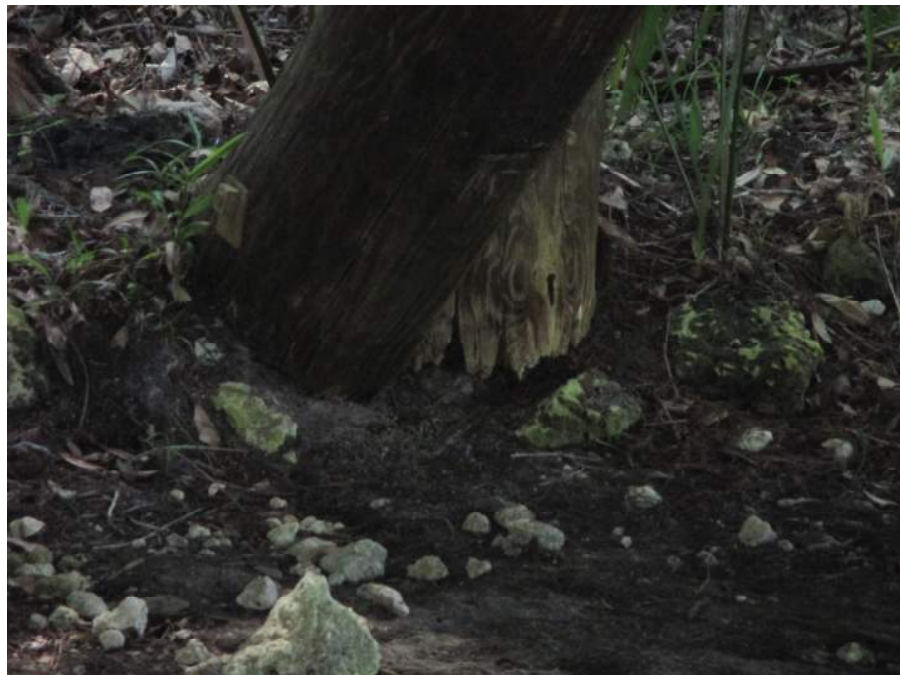
**Photograph 14**  
**Base of Houseboat Supports Deteriorated**

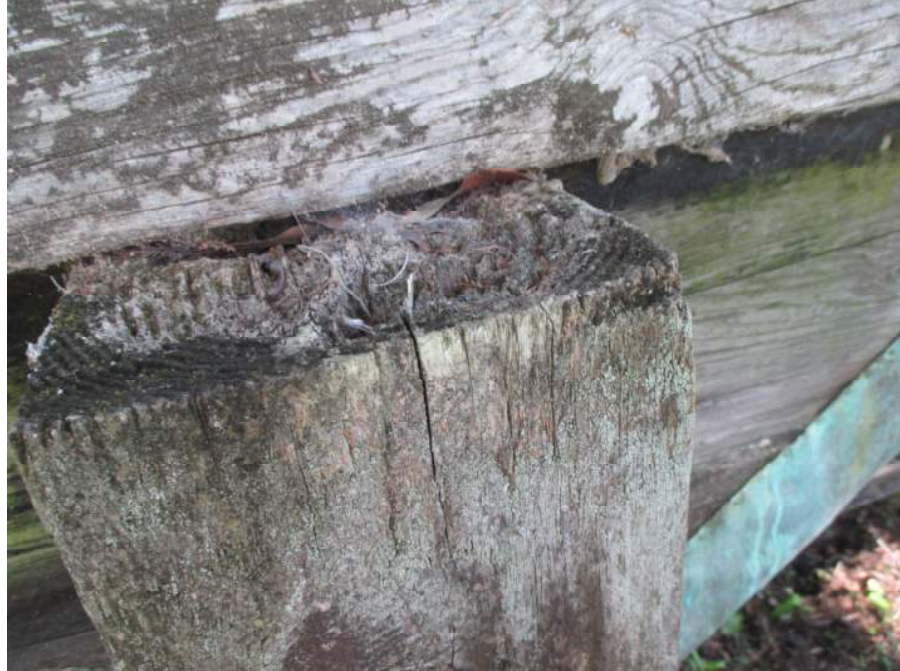
**Photograph 15**  
**Top of Houseboat Support Pile Deteriorated**

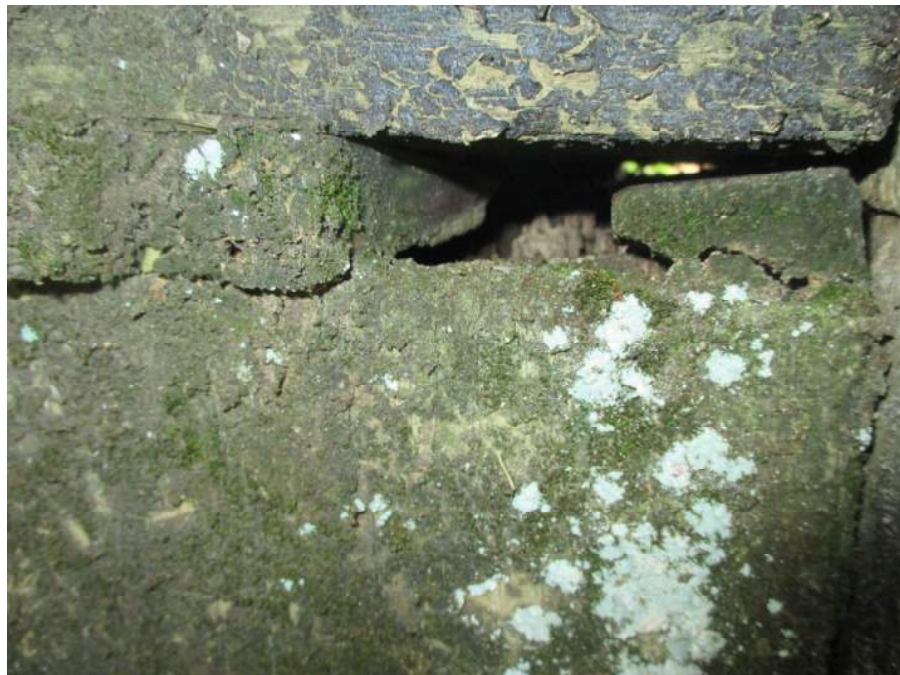
**Photograph 16**  
**Top of Houseboat Support Pile Deteriorated**

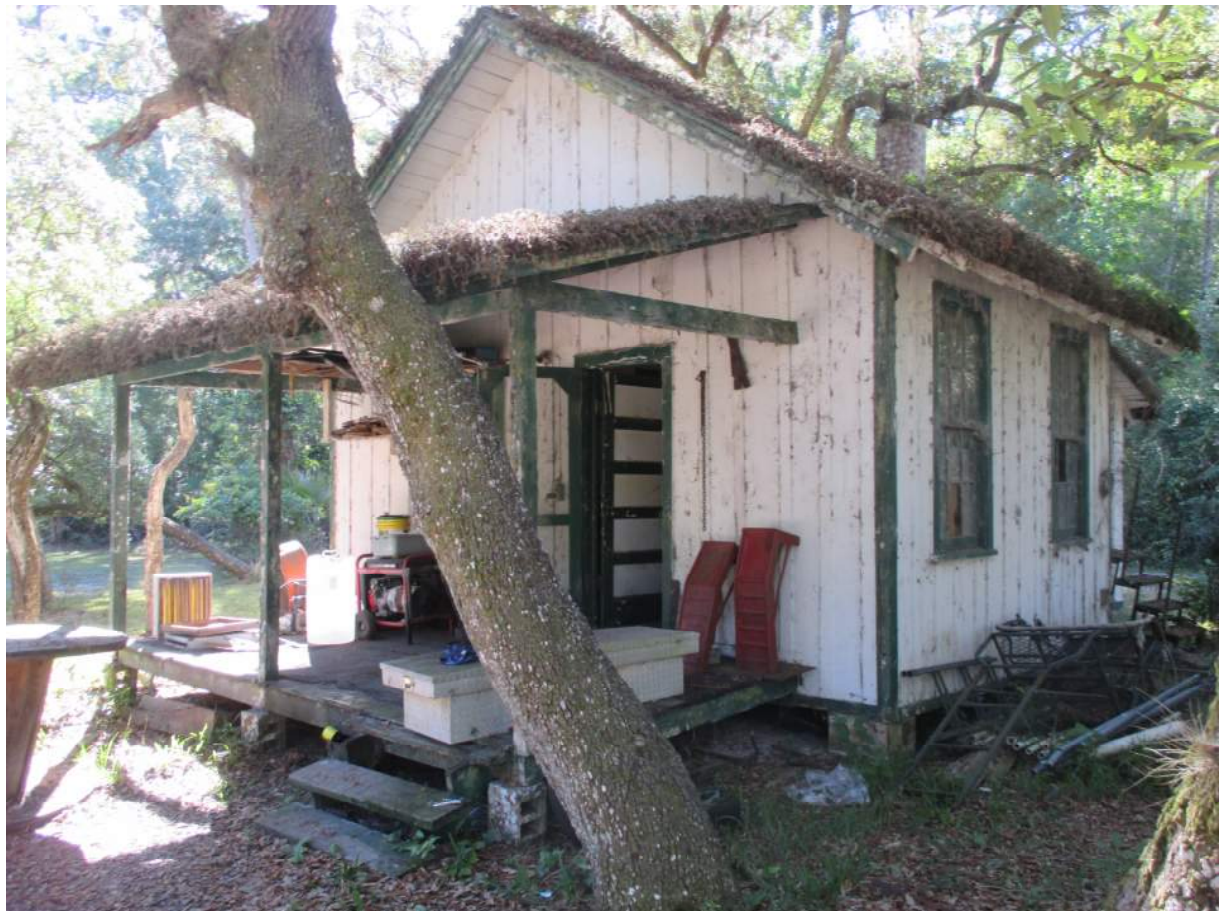
**Photograph 1**  
**Cook's House Main Entry Porch**

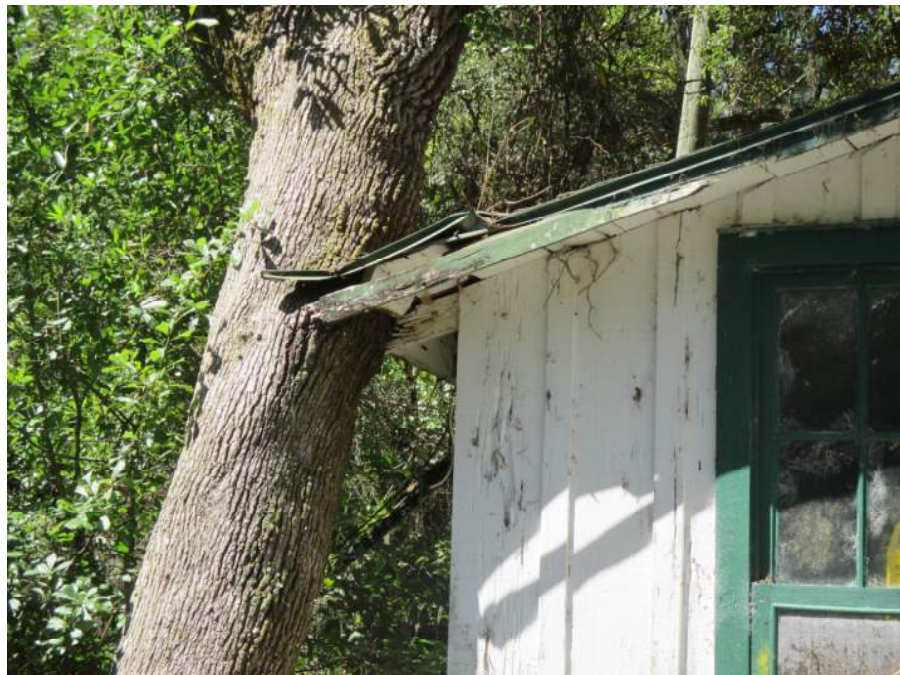
**Photograph 3**  
**Damaged Rear Corner Due to Tree**

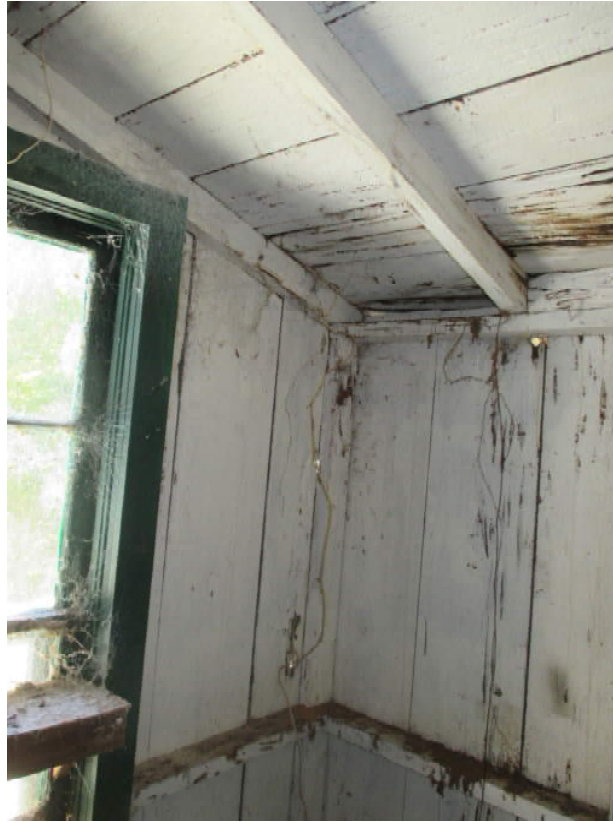
**Photograph 4**  
**Moisture Damaged Framing**

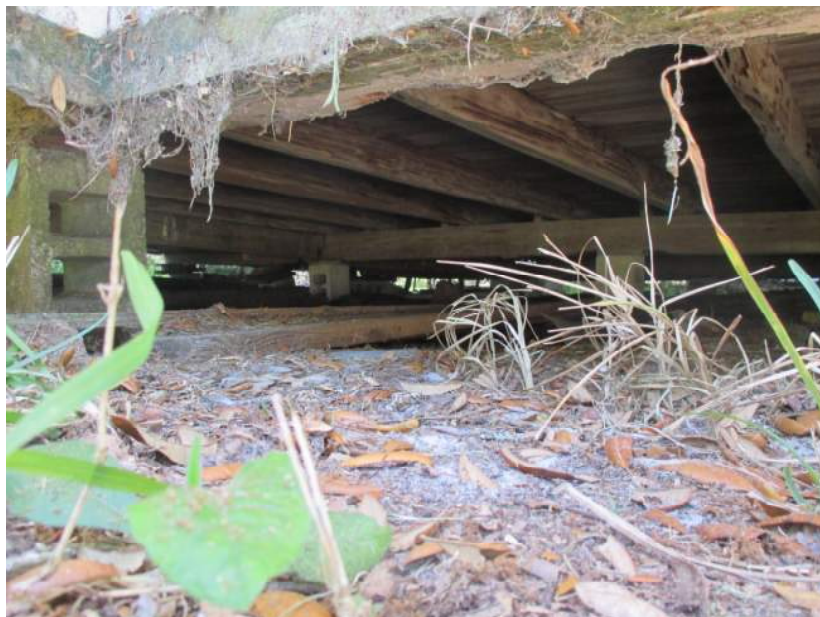
**Photograph 5**  
**Moisture or Termite Floor Framing Deteriorated**

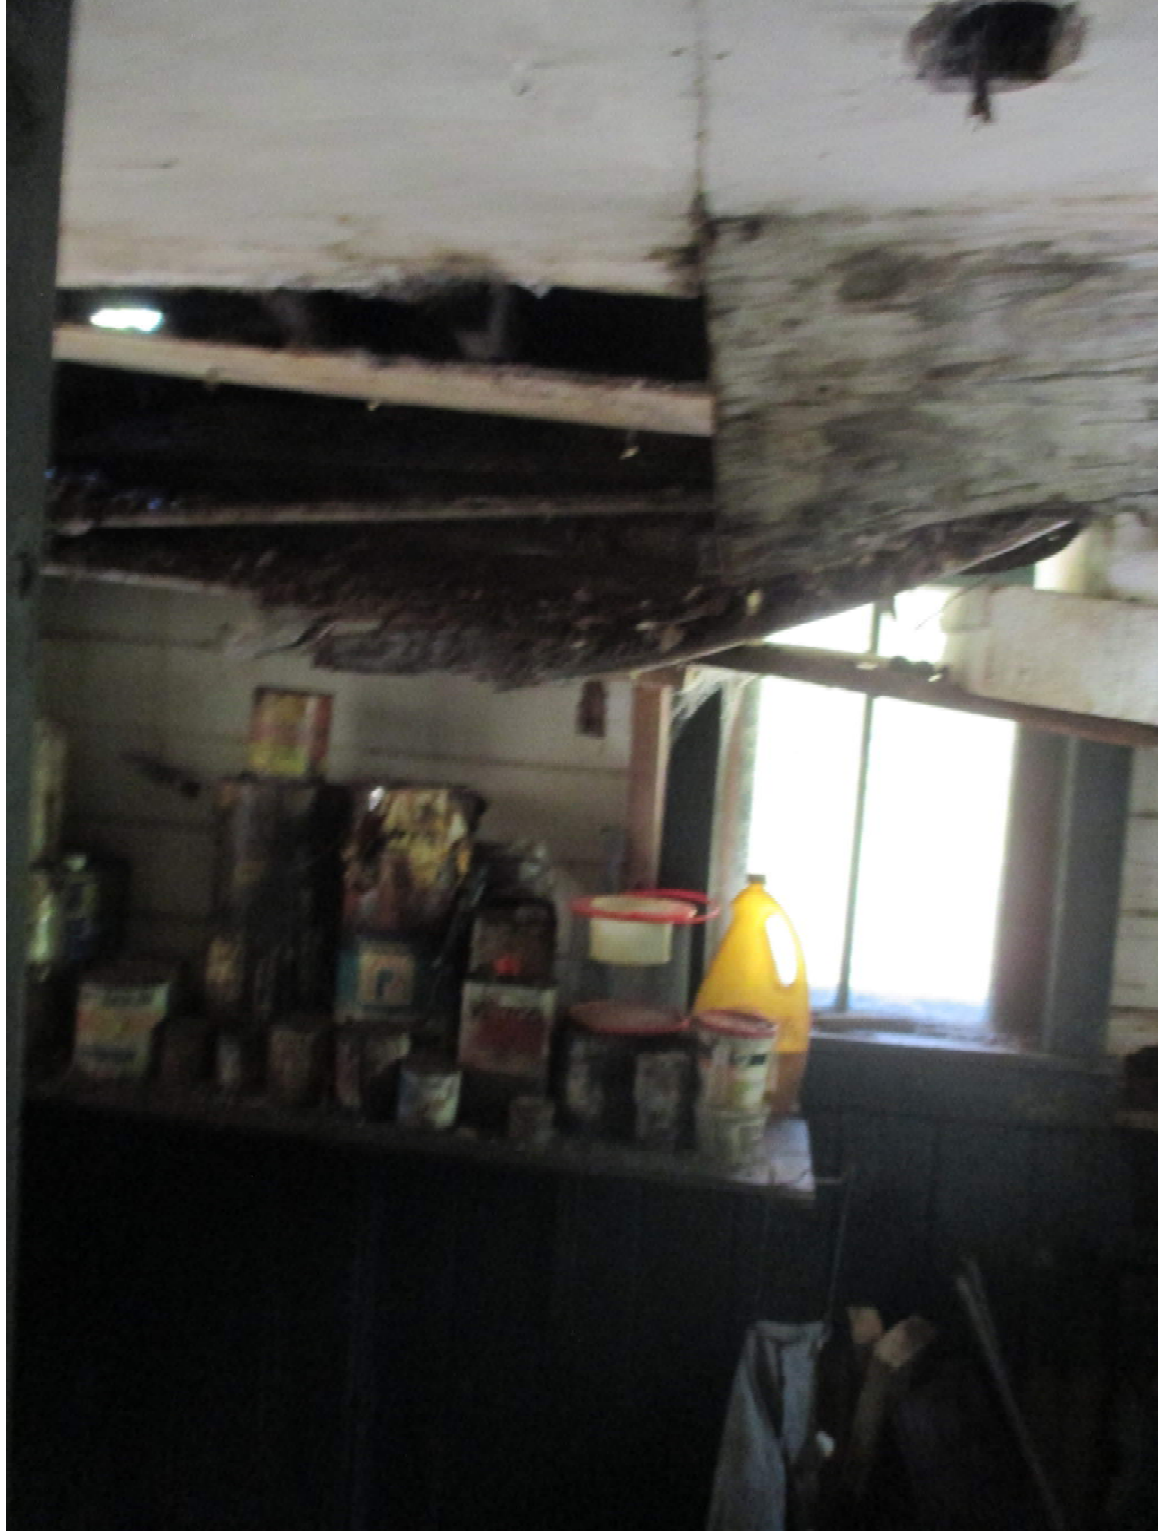
**Photograph 6**  
**Collapsed Roof Framing and Ceiling Due to Moisture**

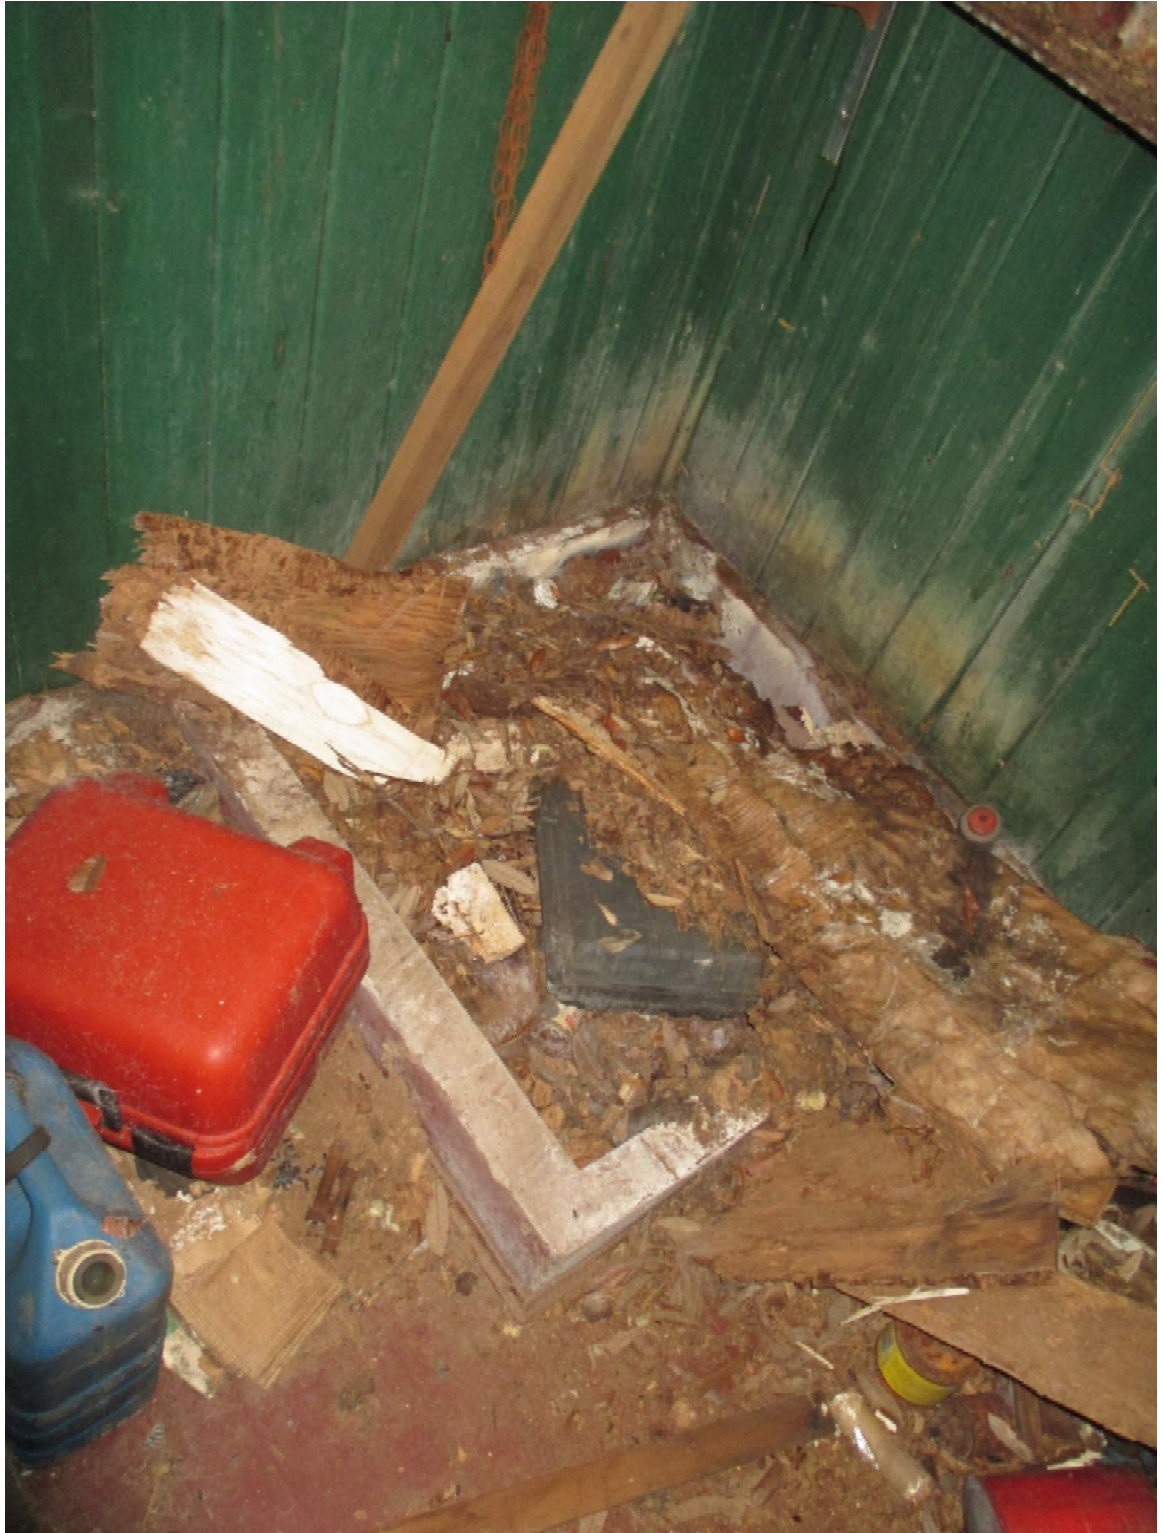
**Photograph 7**  
**Deteriorated Floor Decking at Addition**

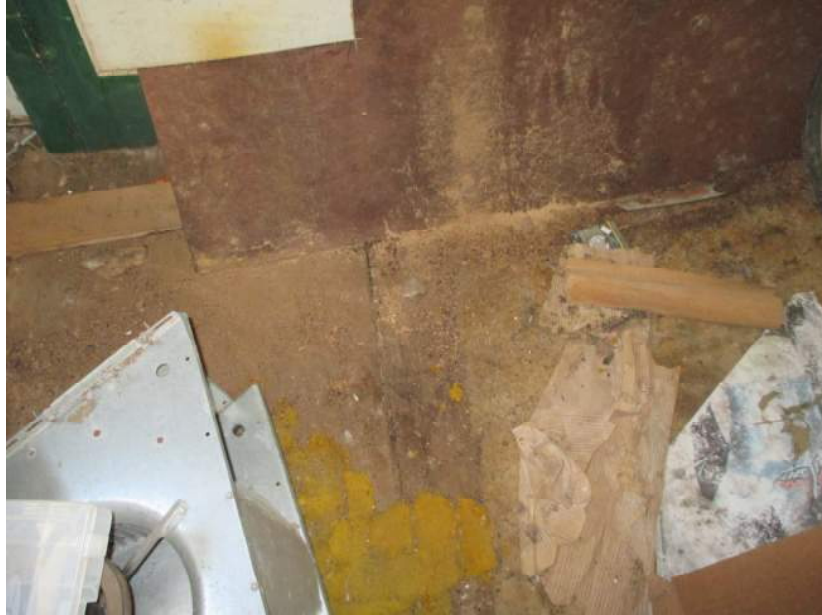
**Photograph 8**  
**Deteriorated Floor Decking at Rear Porch**

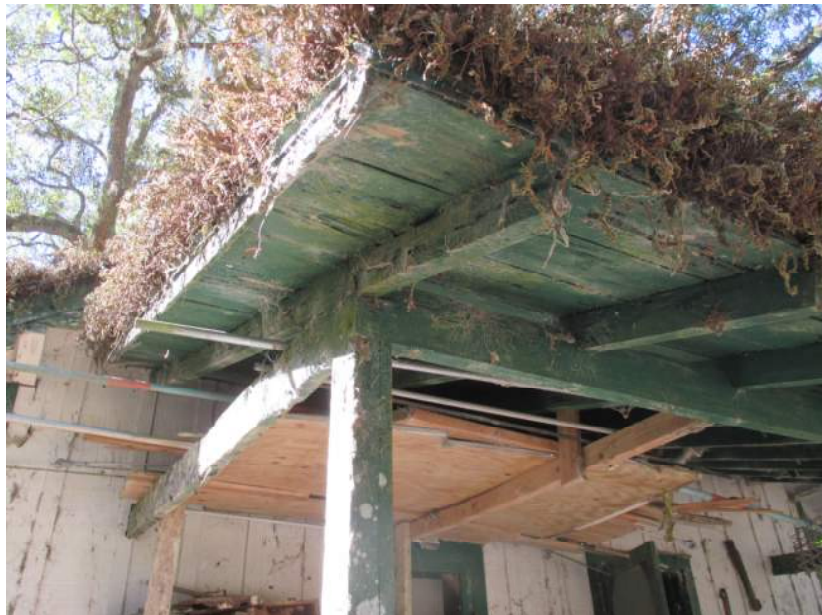
**Photograph 9**  
**Termite Deterioration**

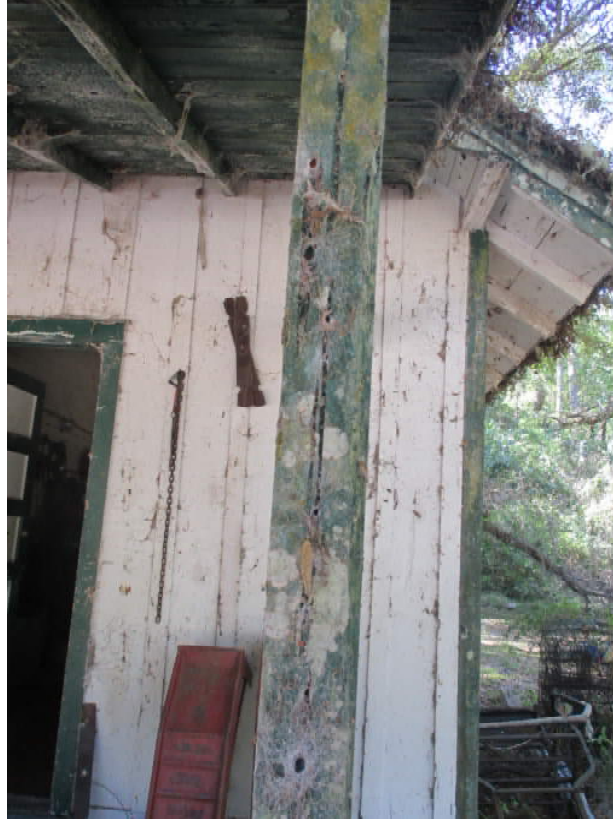
**Photograph 10**  
**Termite Deterioration**

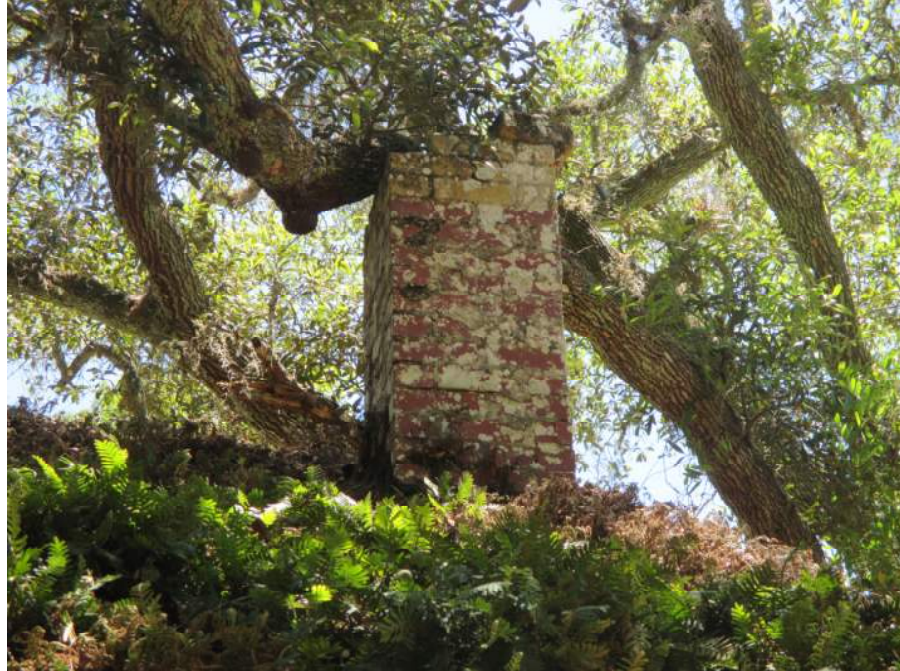
**Photograph 12**  
**Tree Bearing on Brick Chimney with Loose Debris**

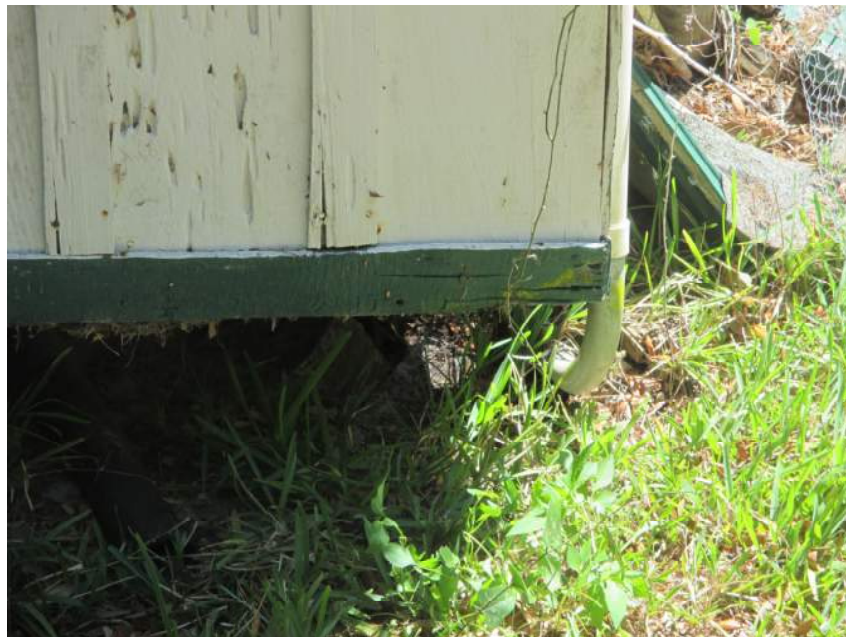
**Photograph 13**  
**Failed Corner Foundation**

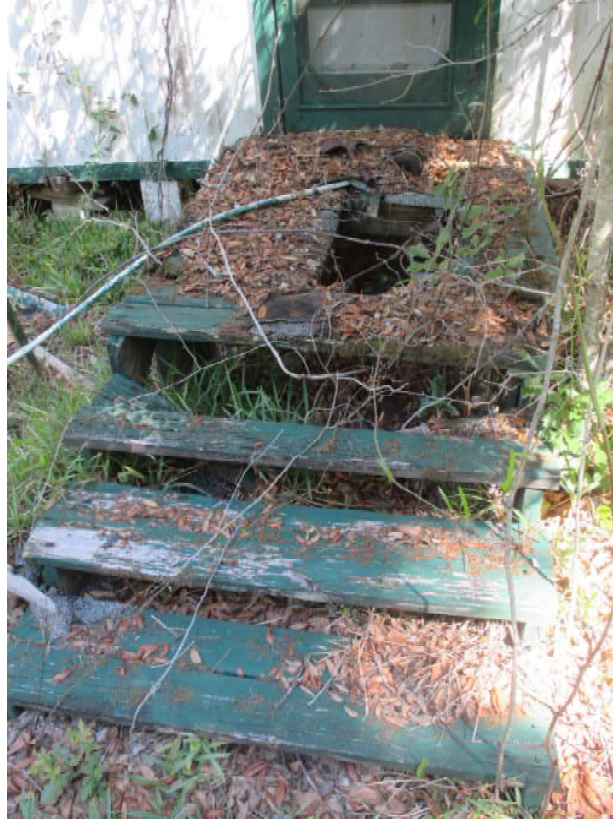
**Photograph 14**  
**Failed Rear Porch Entry Steps**

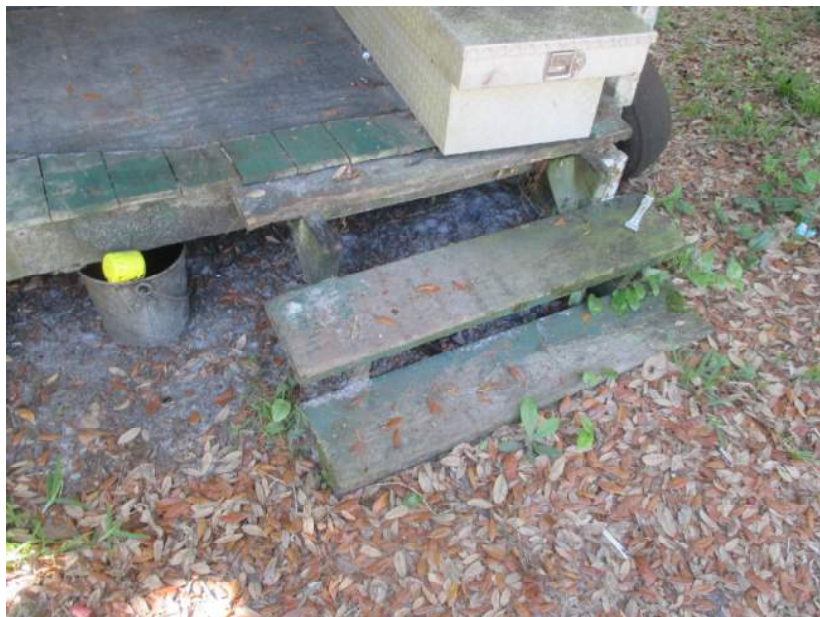
**Photograph 15**  
**Rotated and Deteriorated Main Entry Steps**
