# **HISTORIC STRUCTURE ASSESSMENT REPORT**

## **VISTA HISTORIC SITE Lower Suwannee National Wildlife Refuge**

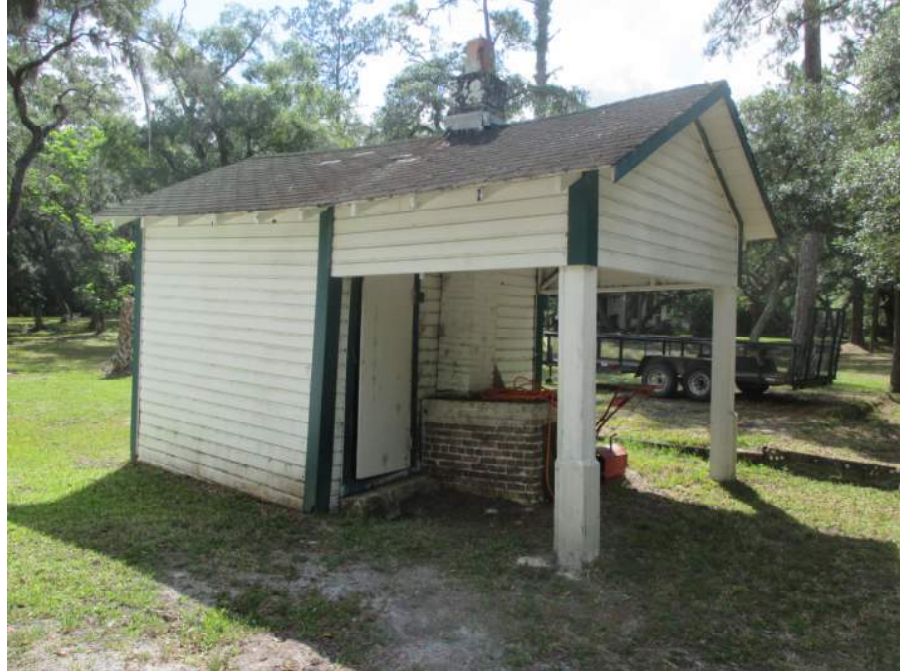
**Photograph 1**  
**Overall of Fryer Shed**

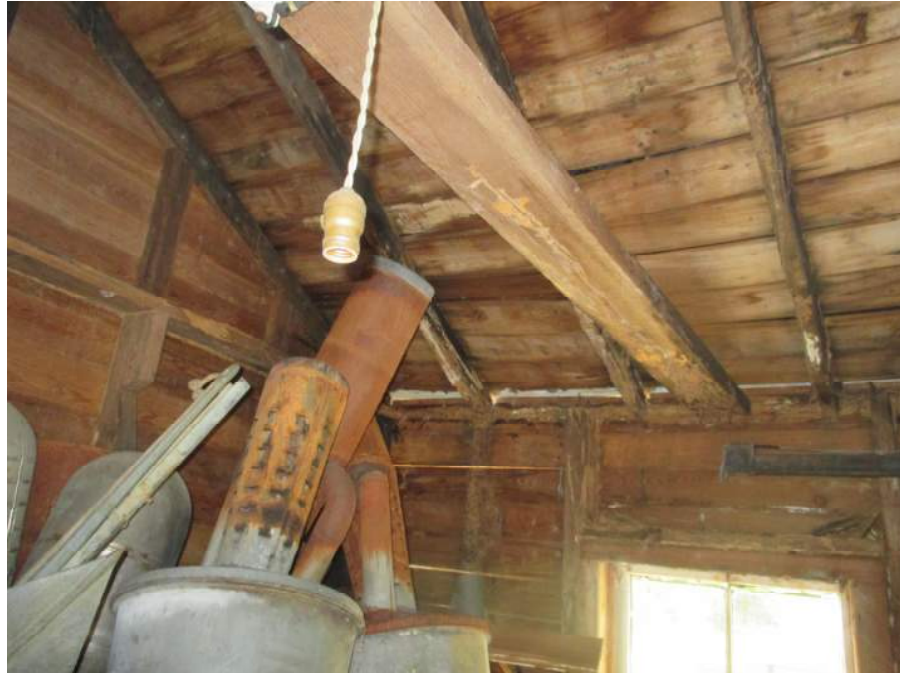
**Photograph 5**  
**Severely Deteriorated Wall and Roof Framing**

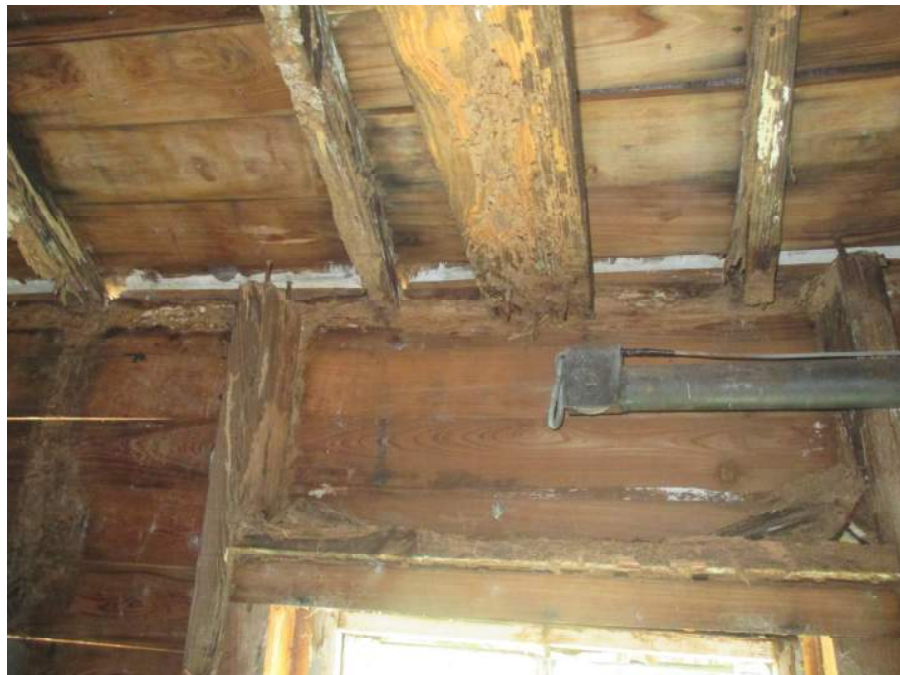
**Photograph 6**  
**Severely Deteriorated Wall and Roof Framing**

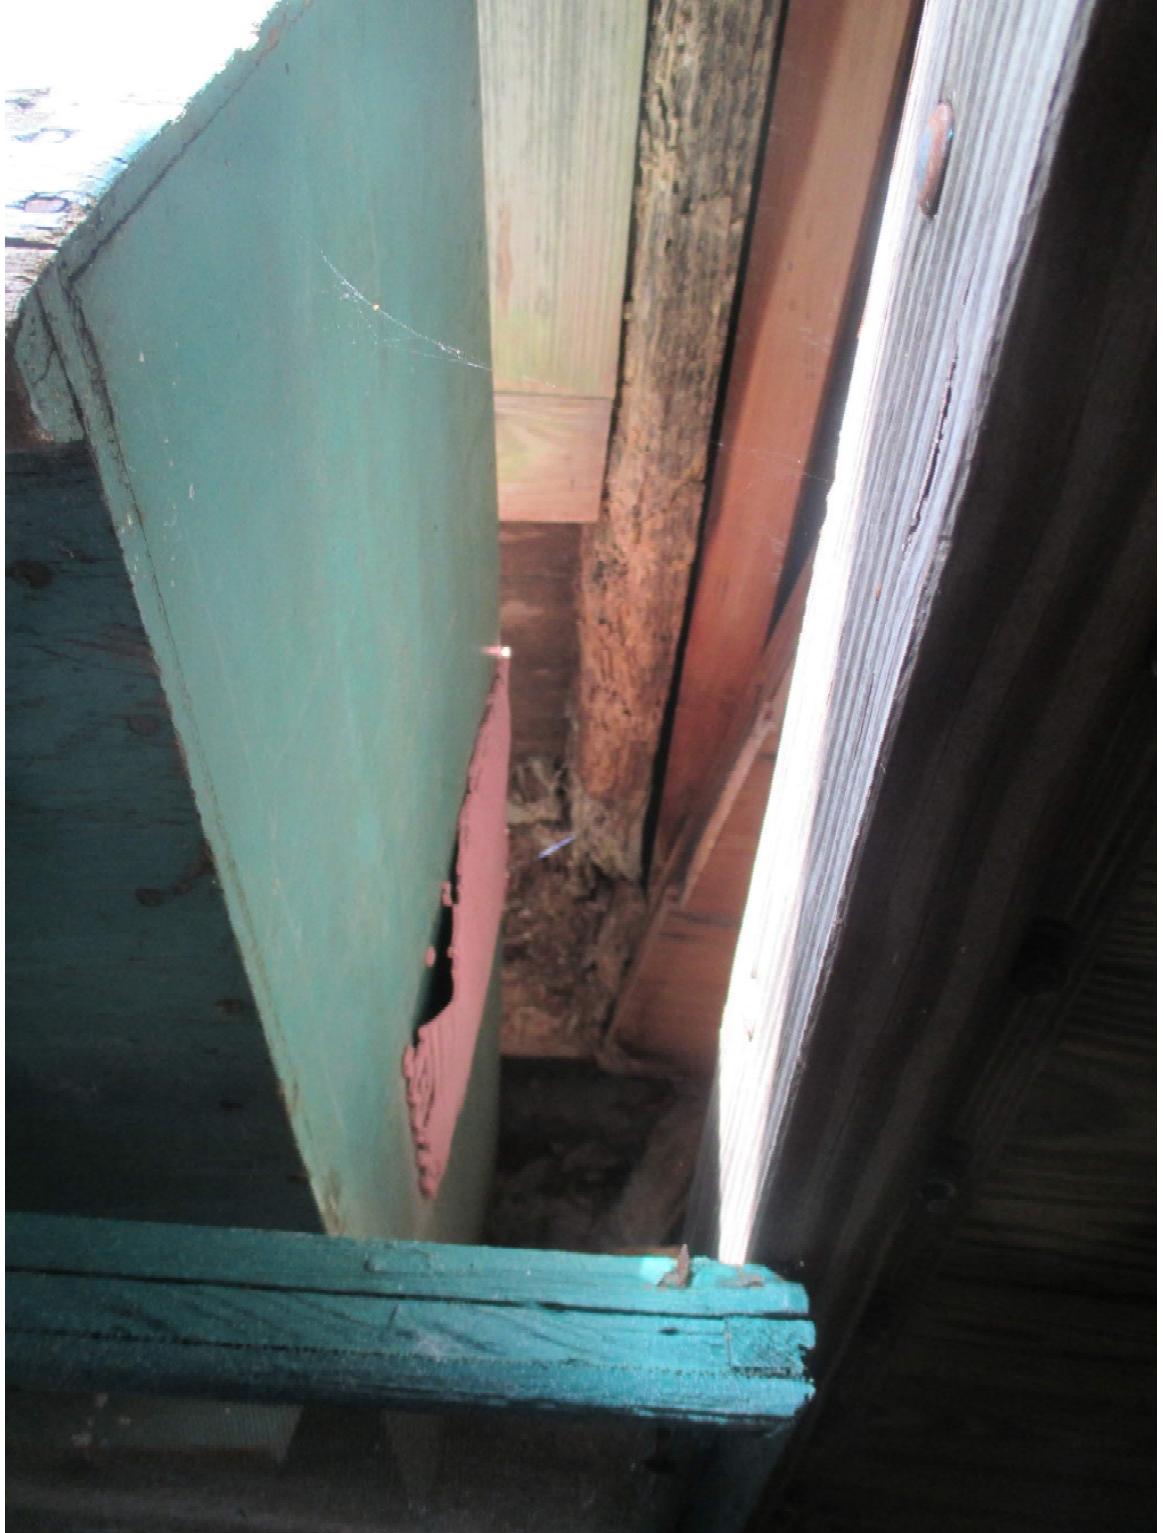
**Photograph 7**  
**Severely Deteriorated Wall Framing**

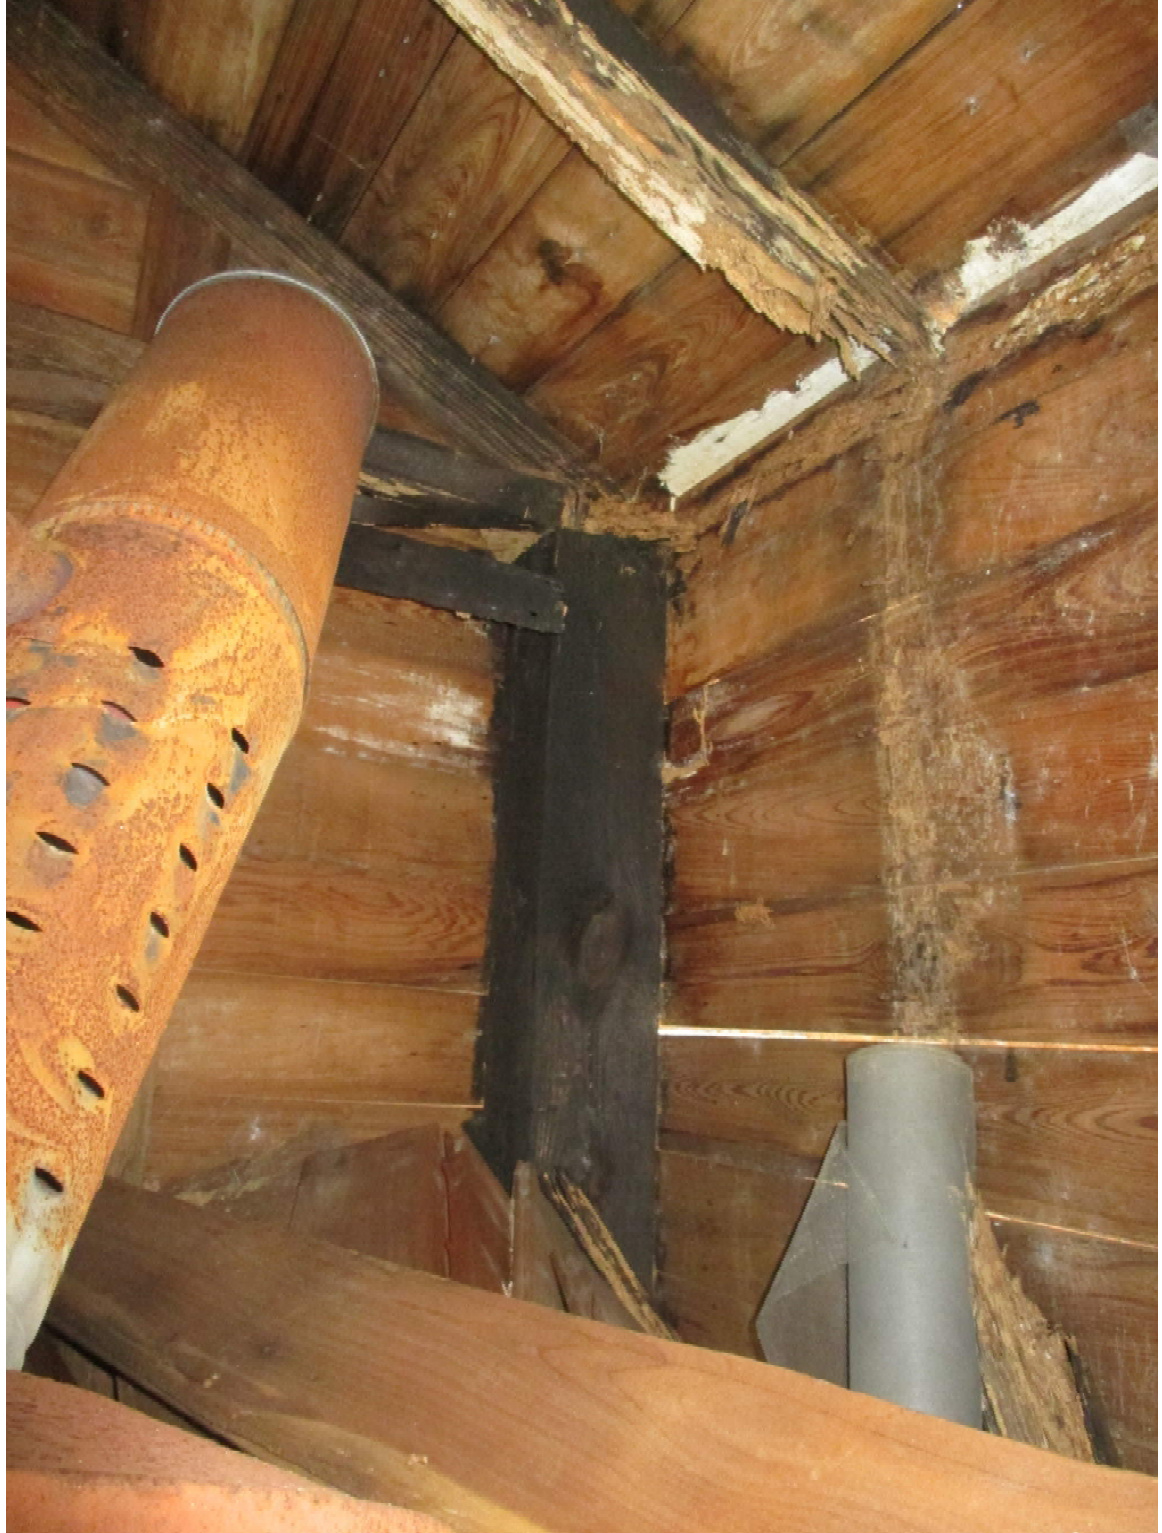
**Photograph 8**  
**Severely Deteriorated Wall and Roof Framing**

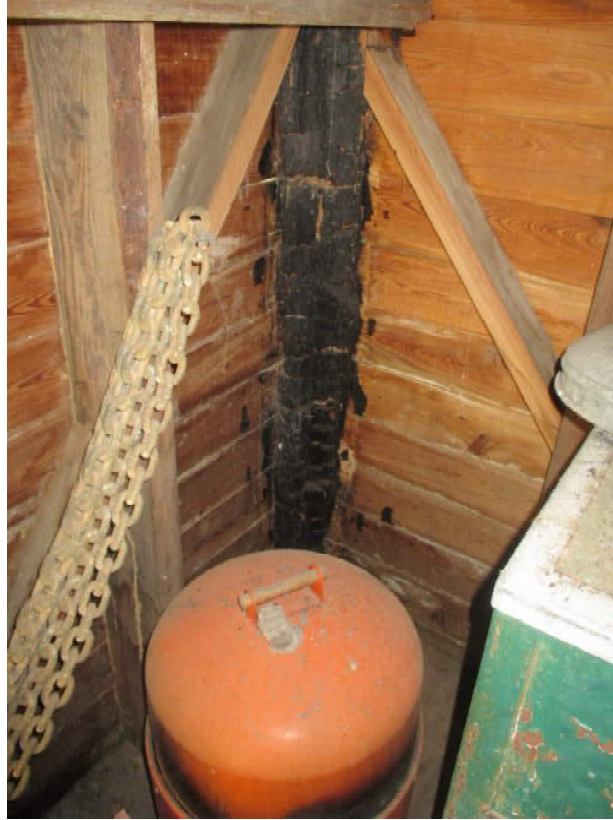
**Photograph 9**  
**Charred and Termite Damaged Column**

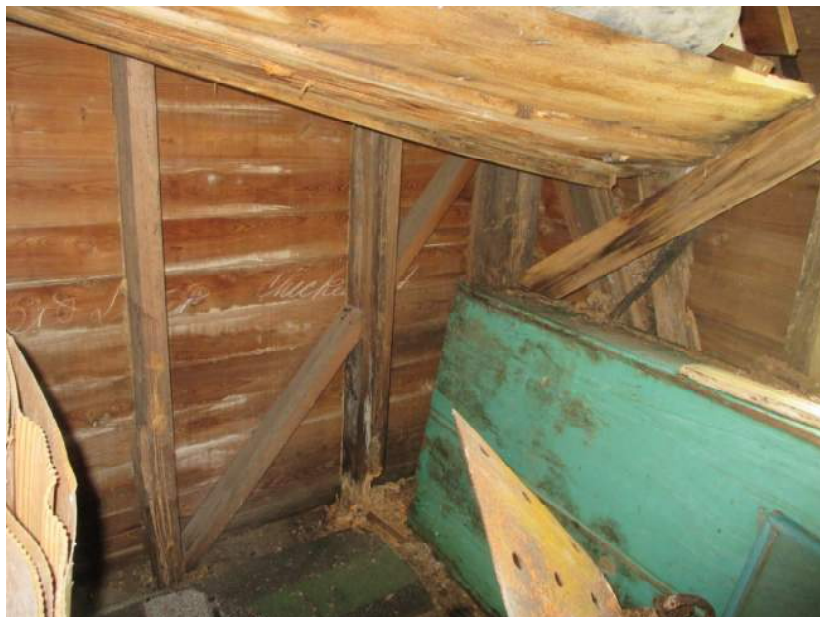
**Photograph 10**  
**Failed Storage Shelf**

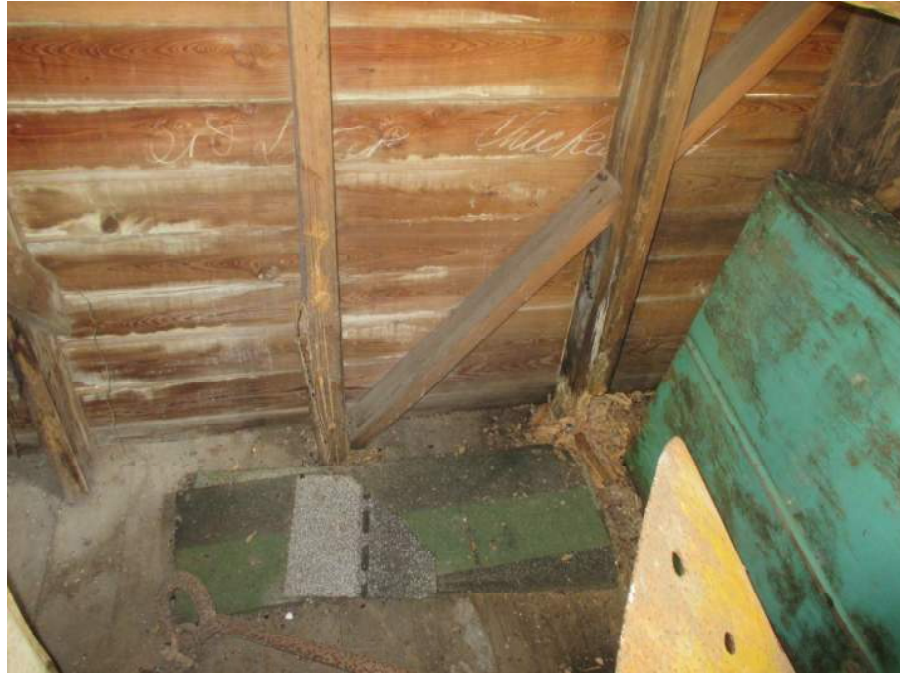
**Photograph 11**  
**Severely Deteriorated Wall Framing**

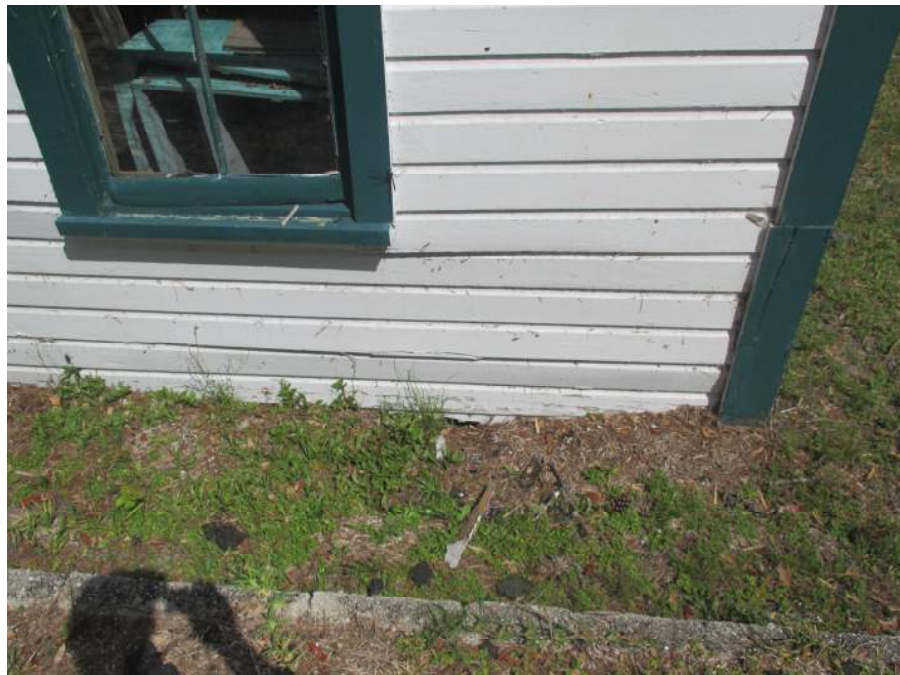
**Photograph 12**  
**Weathered Siding**

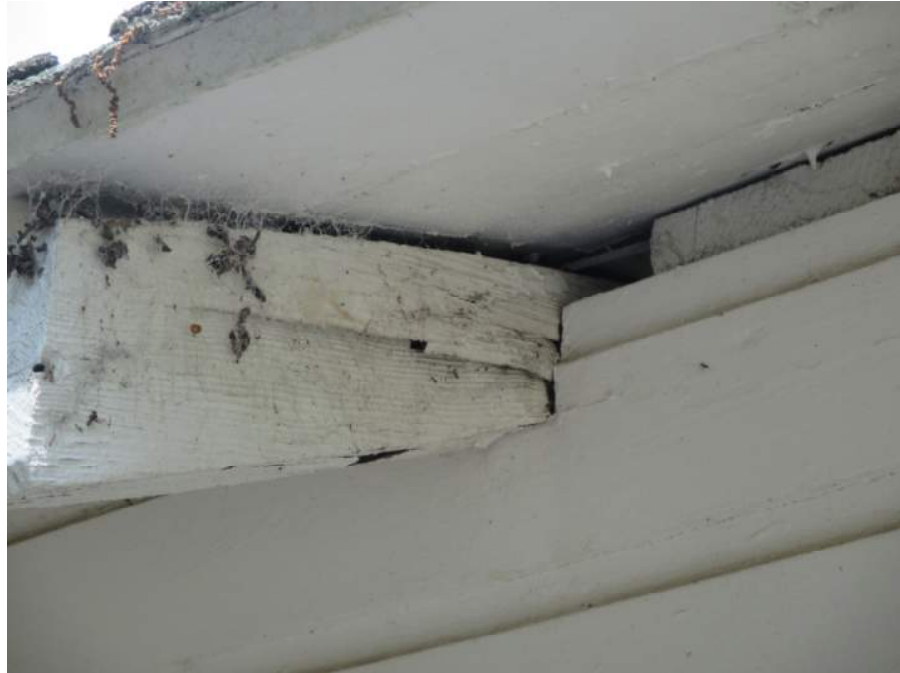
**Photograph 13**  
**Deteriorated Roof Joist**

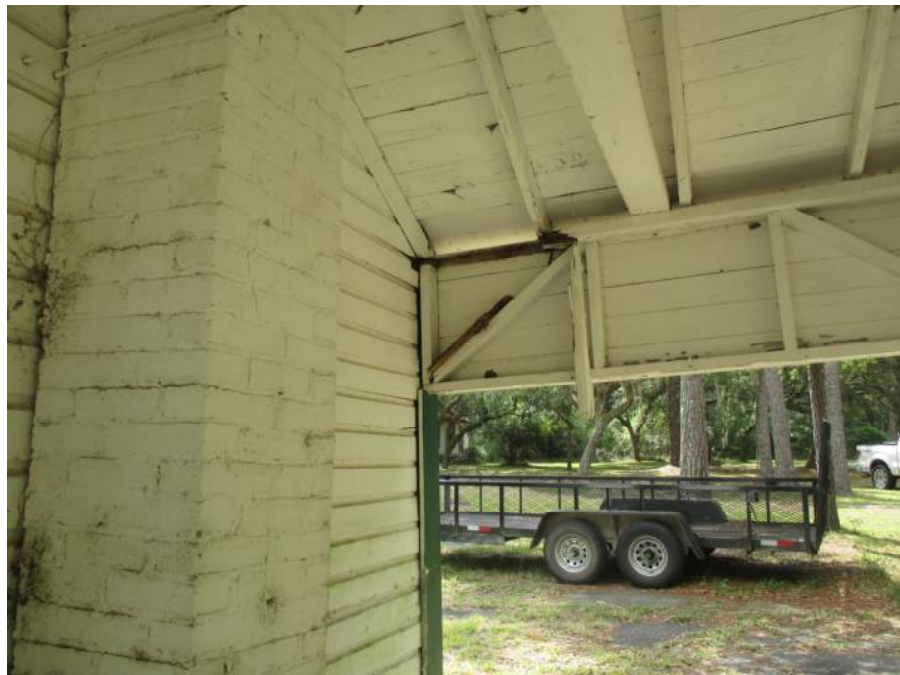
**Photograph 14**  
**Deteriorated Porch Framing**

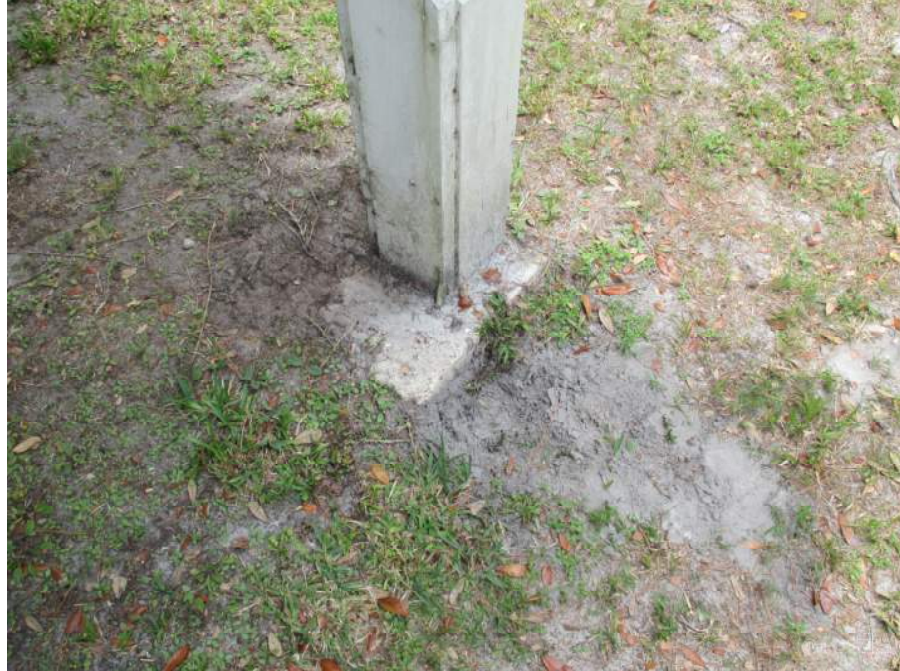
**Photograph 15**  
**Settled Column Foundation**

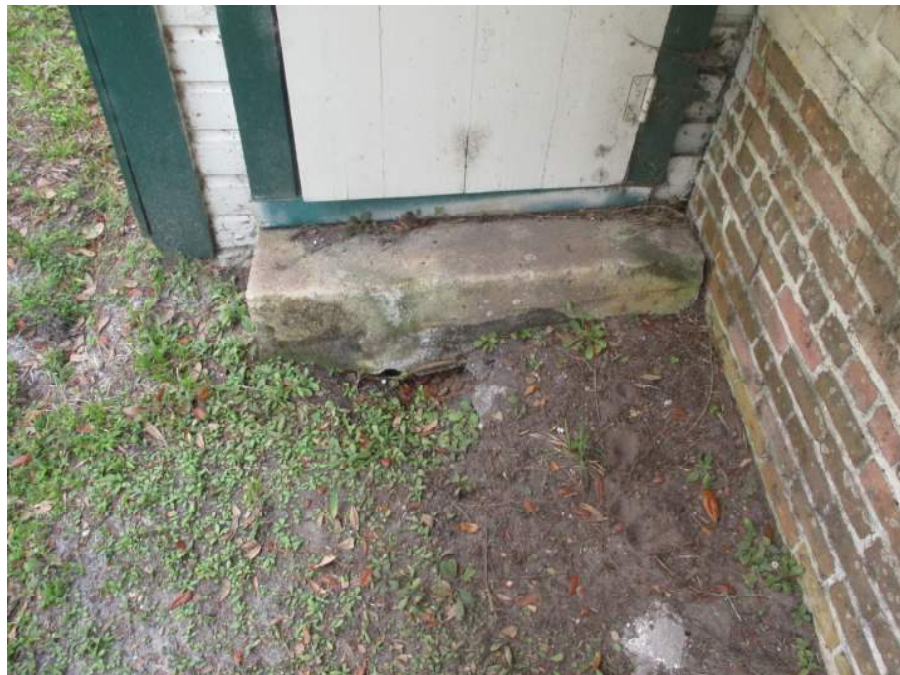
**Photograph 16**  
**Settled Entry Step**

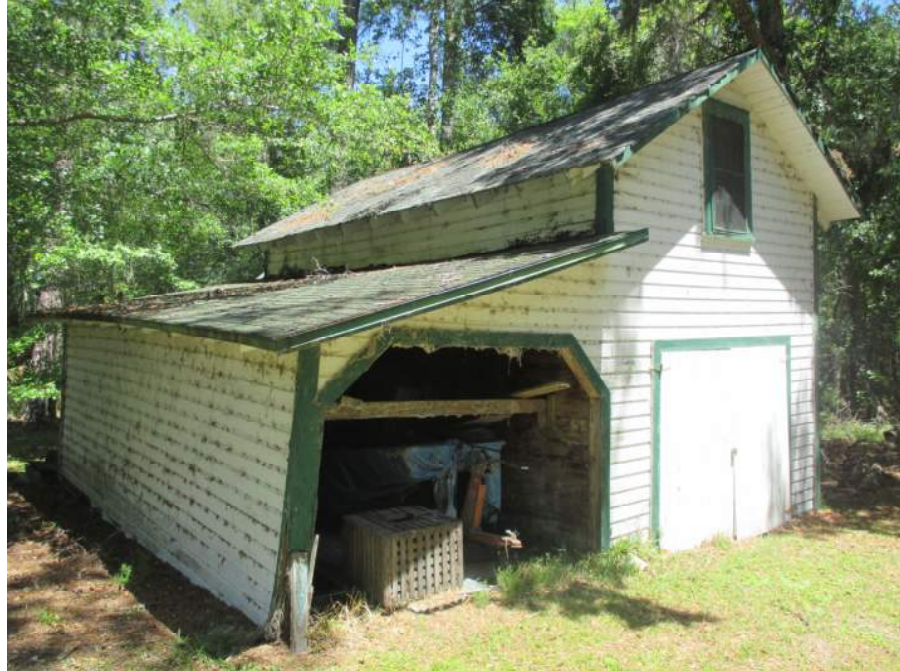
**Photograph 1**  
**Overall Attic Garage**

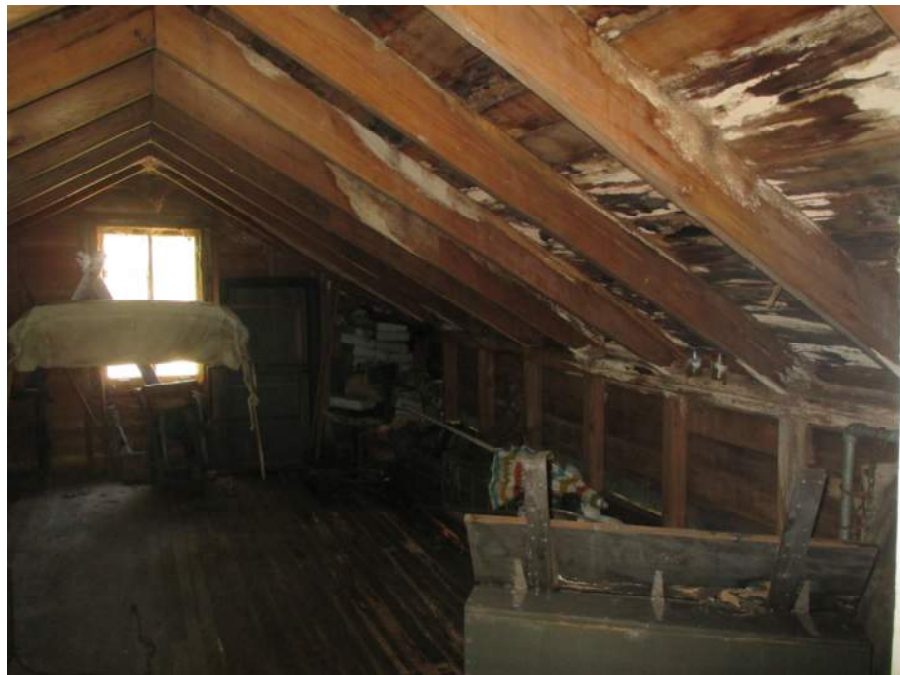
**Photograph 2**  
**Deteriorated Roof and Wall Framing**

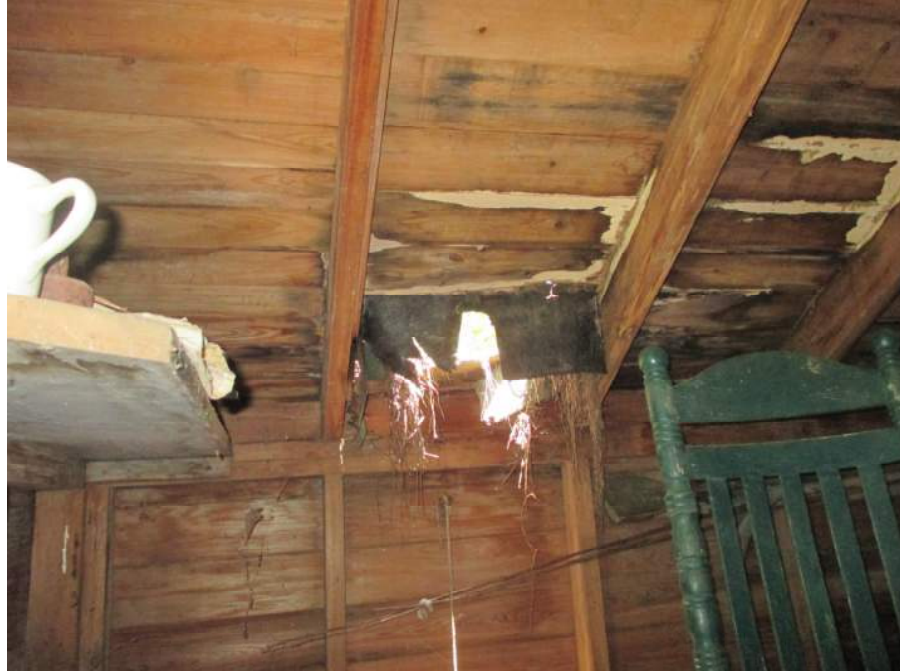
**Photograph 3**  
**Deteriorated Roof Framing and Sheathing**

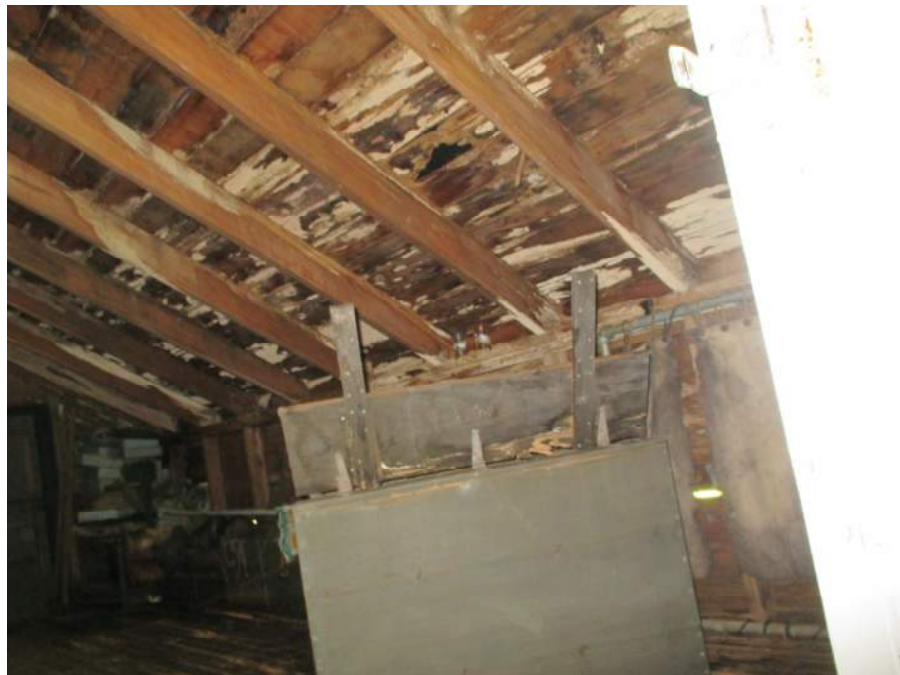
**Photograph 4**  
**Deteriorated Roof Sheathing and Framing**

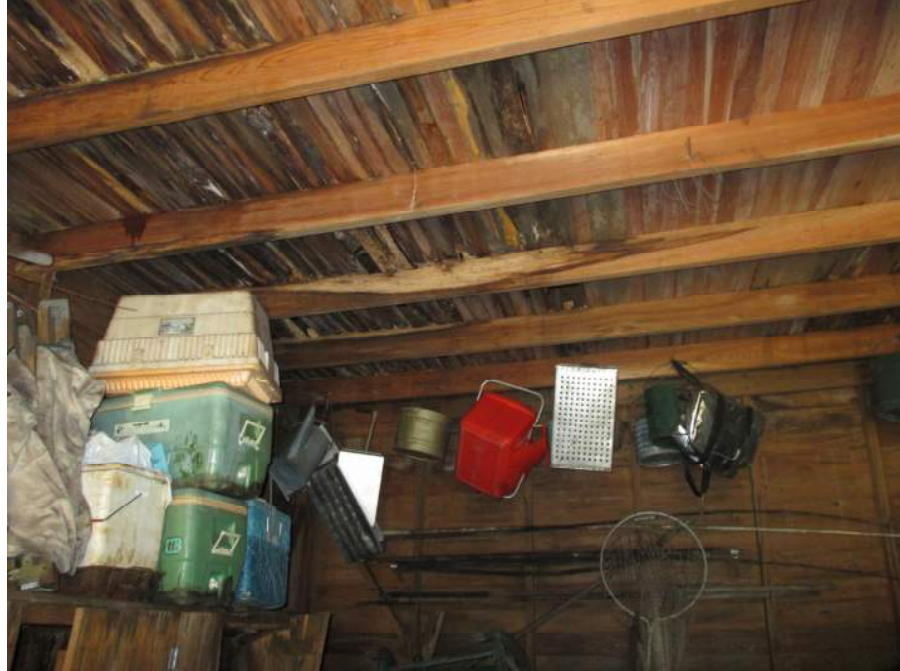
**Photograph 5**  
**Deteriorated Floor Framing and Decking**

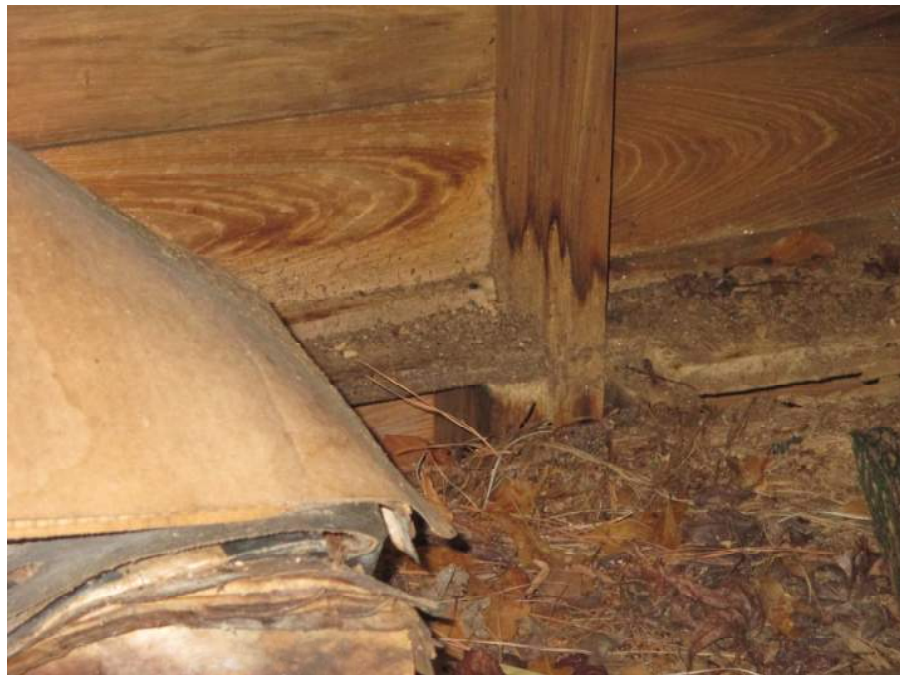
**Photograph 6**  
**Deteriorated Wall to Second-Floor Intersection**

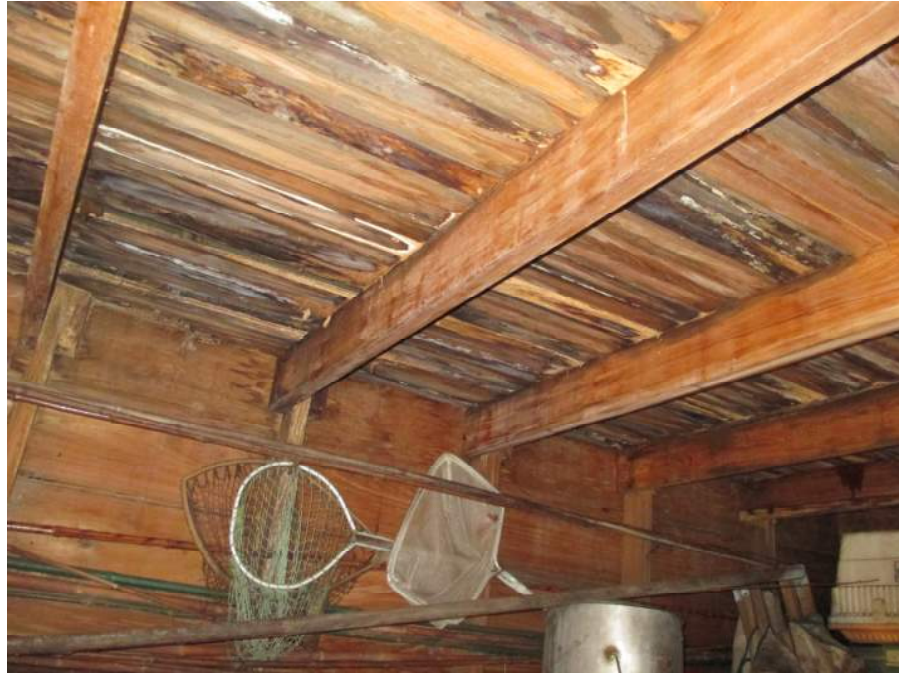
**Photograph 7**  
**Deteriorated Wall to Second-Floor Intersection**

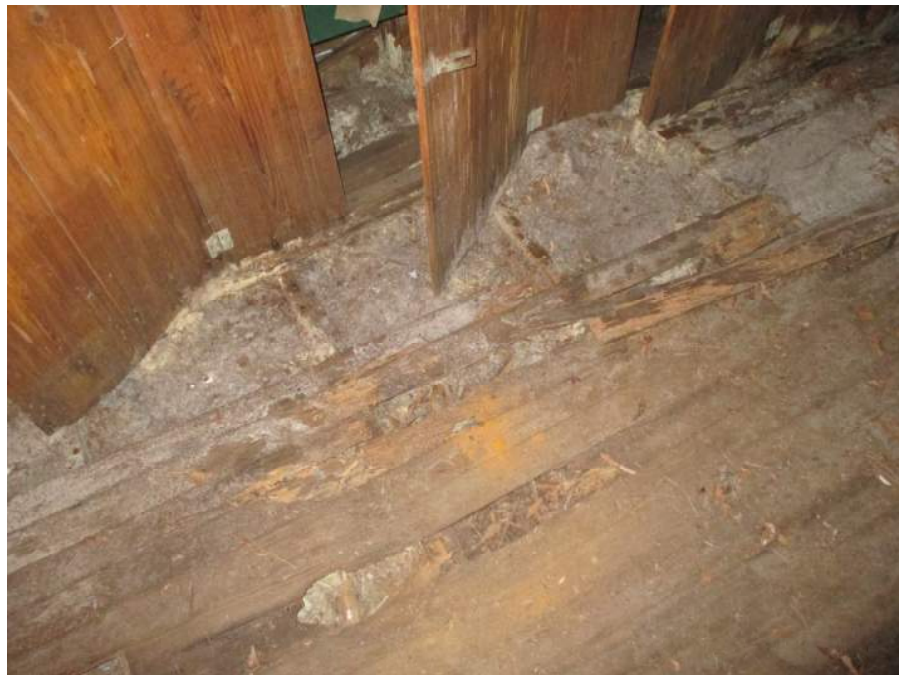
**Photograph 8**  
**Deteriorated Floor Decking and Framing Bearing on Grade**

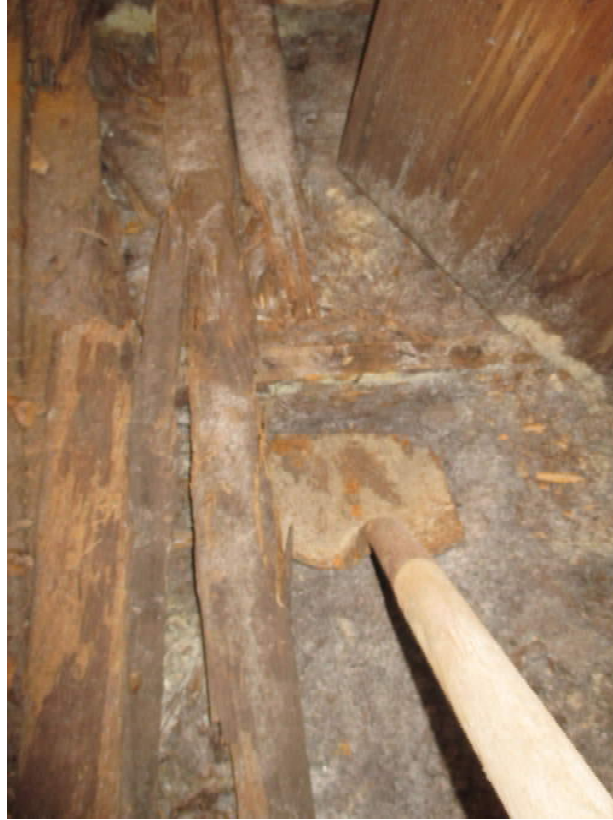
**Photograph 9**  
**Deteriorated Floor Decking and Framing Bearing on Grade**

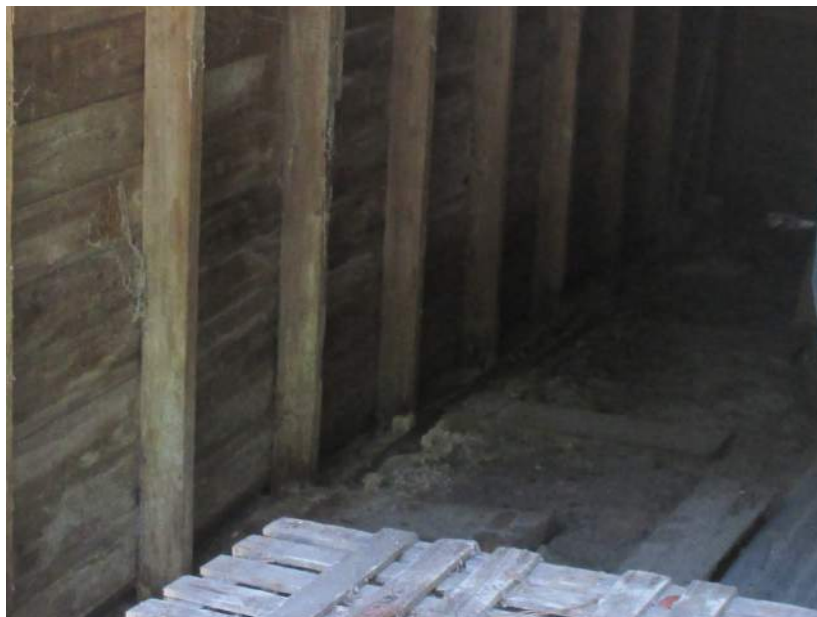
**Photograph 10**  
**Base of Wall Studs Deteriorated**

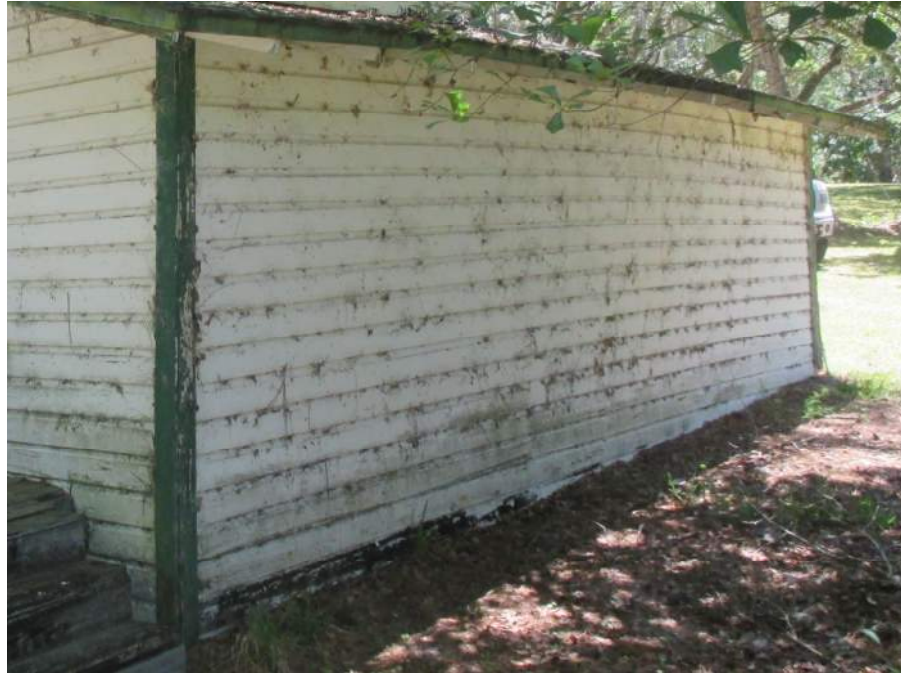
**Photograph 11**  
**Perimeter Vegetation Buildup**

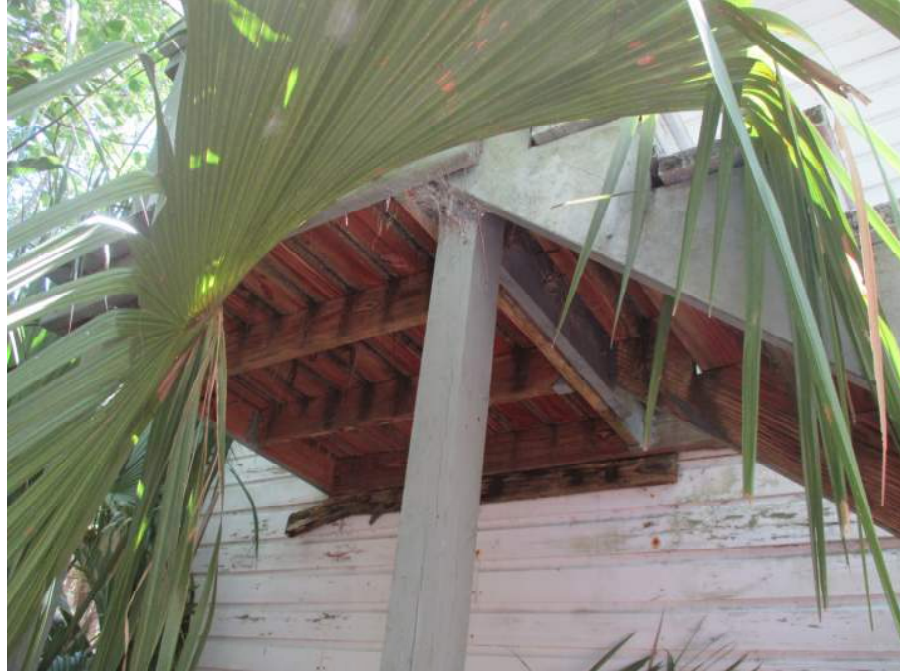
**Photograph 13**  
**Stair Ledger Severely Deteriorated**

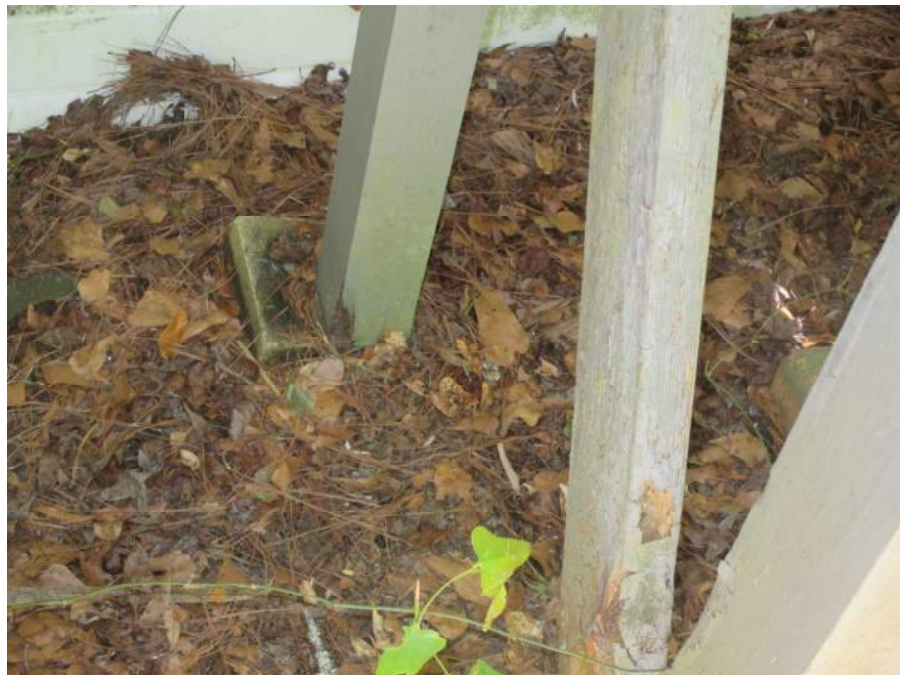
**Photograph 14**  
**Stair Column Not on Stable Foundation**

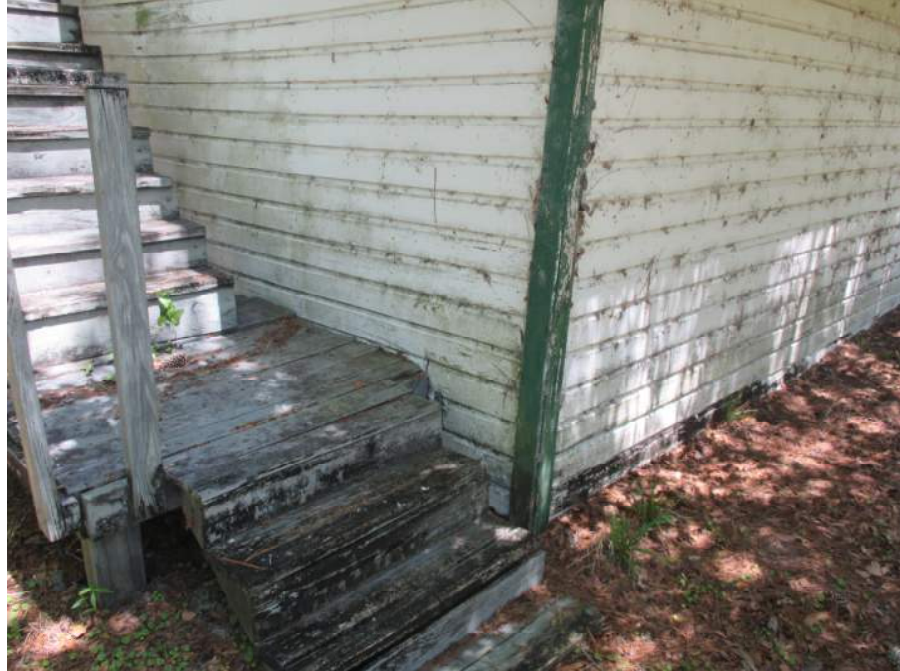
**Photograph 15**  
**Severely Deteriorated Attic Access Stair**

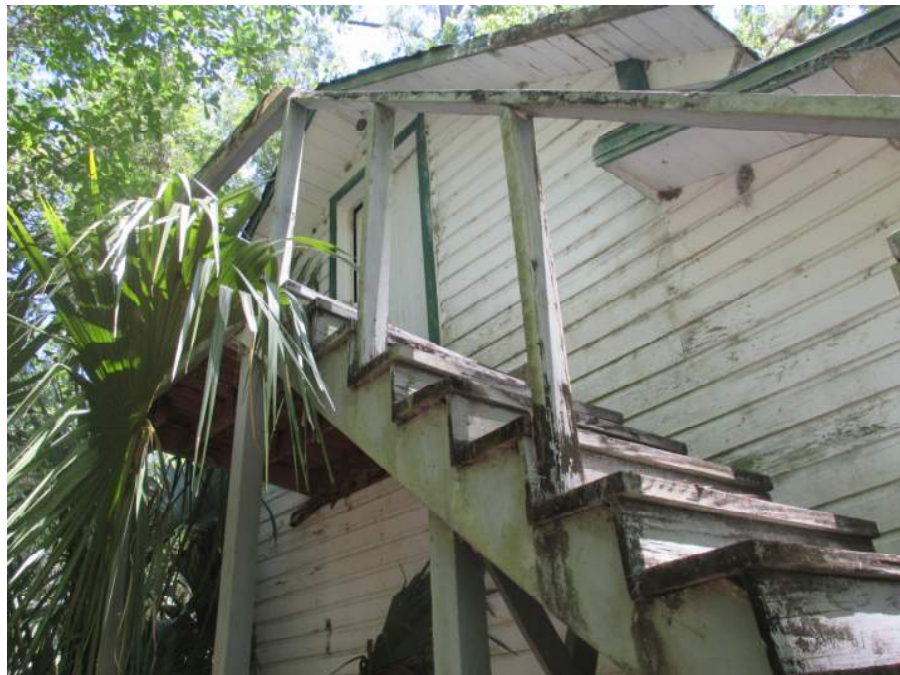
**Photograph 16**  
**Severely Deteriorated Attic Access Stair**

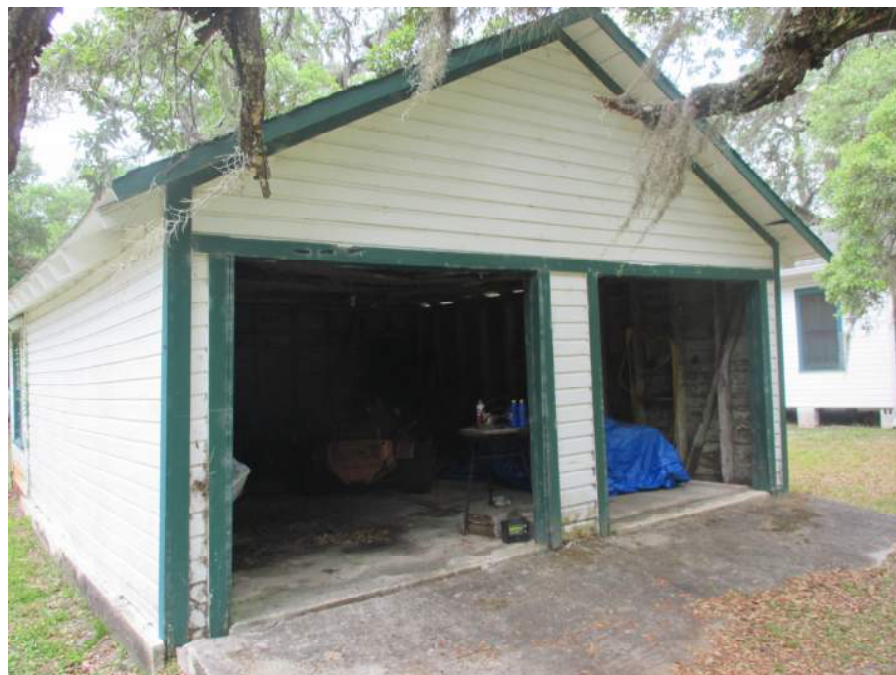
**Photograph 1**  
**Overall Double Garage Entry**

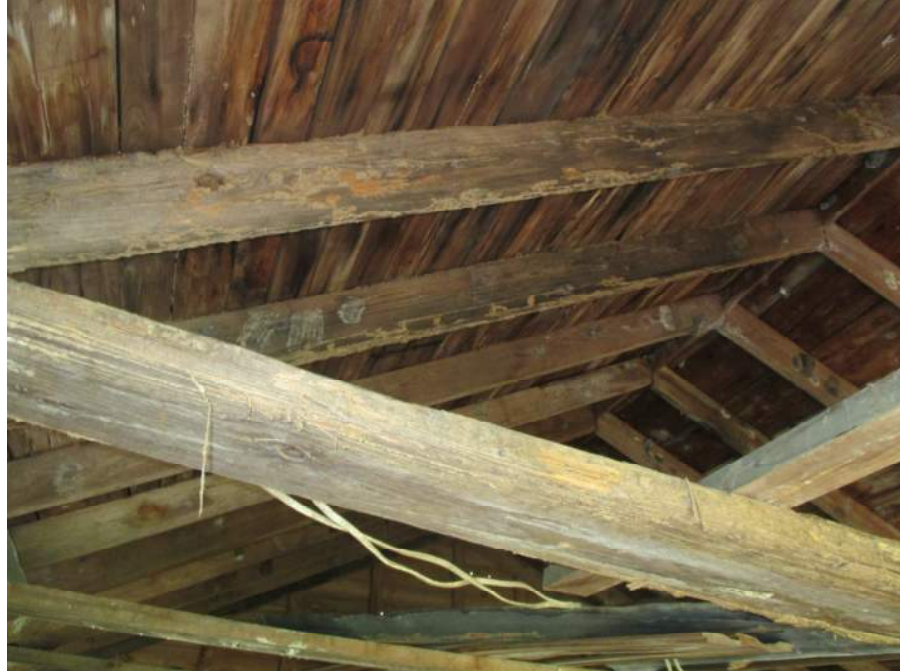
**Photograph 2**  
**Deteriorated Roof Rafters**

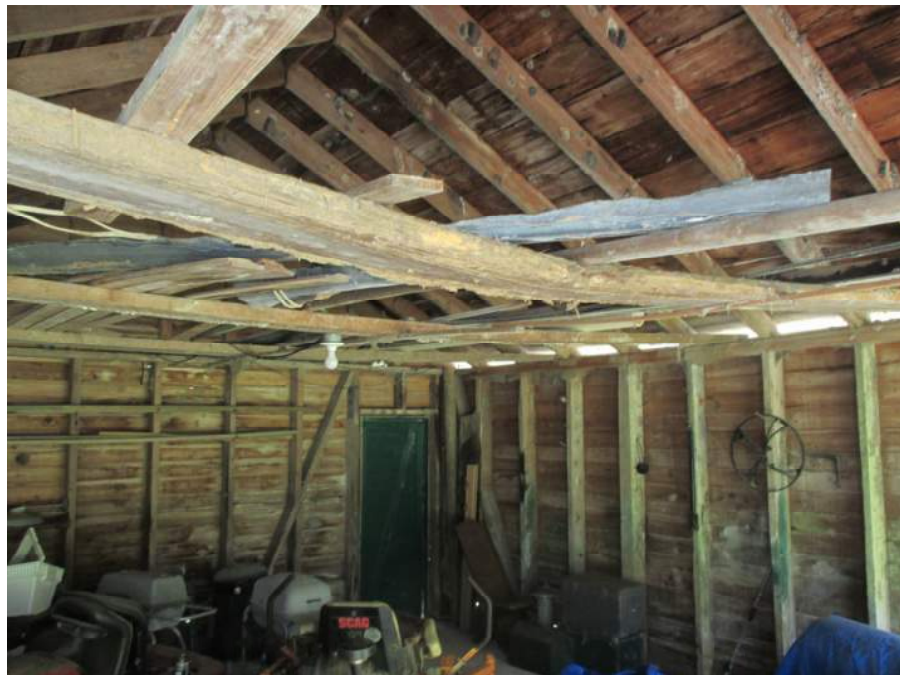
**Photograph 3**  
**Termite Damaged Framing**

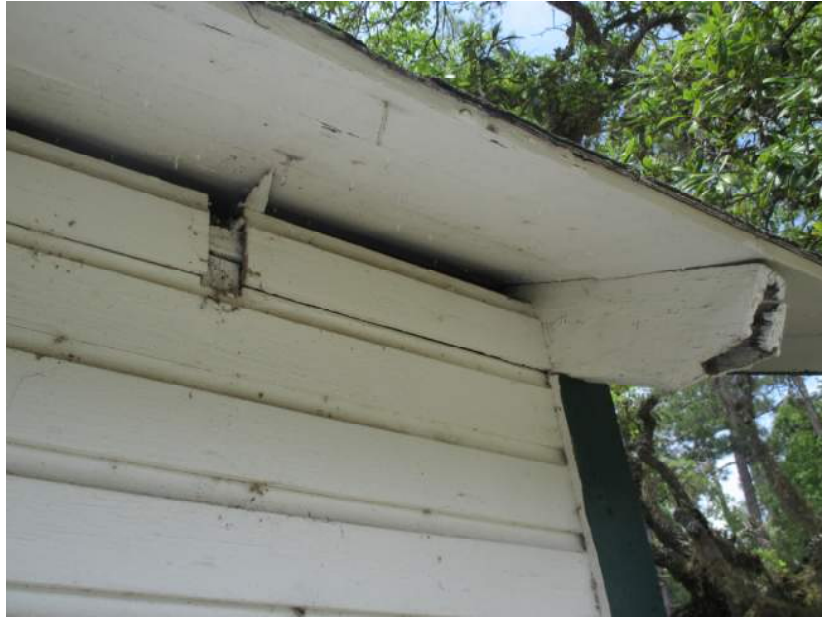
**Photograph 4**  
**Deteriorated Rafter Tails**

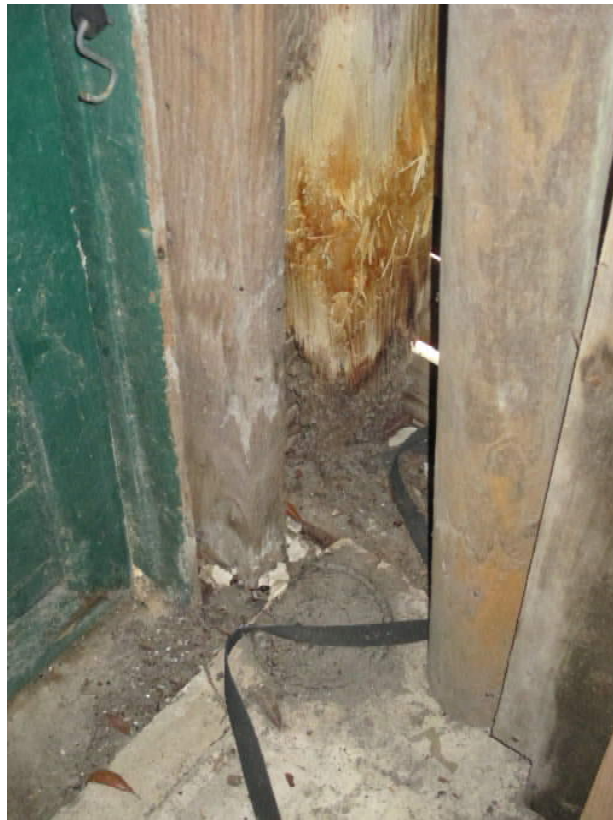
**Photograph 5**  
**Deteriorated Corner Column**

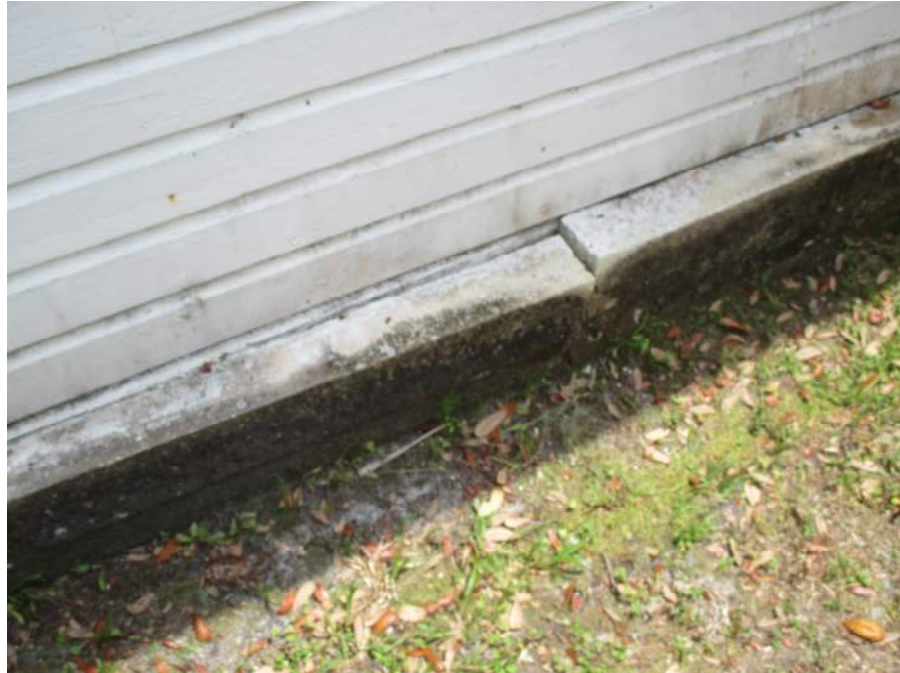
**Photograph 6**  
**Vertical and Horizontal Foundation Displacement**
