# **HISTORIC STRUCTURE ASSESSMENT REPORT**

## **VISTA HISTORIC SITE Lower Suwannee National Wildlife Refuge**

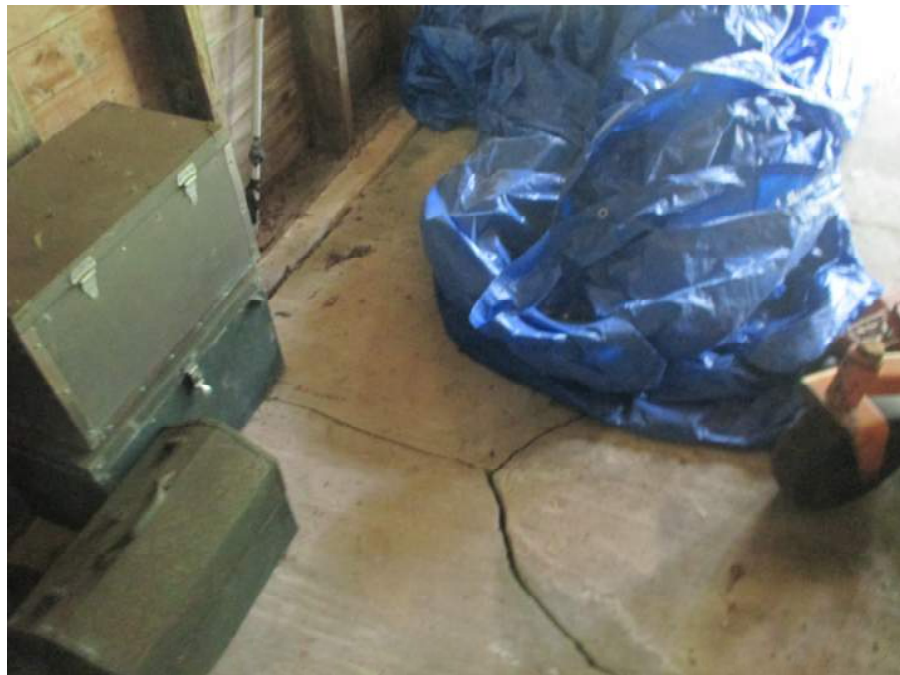
**Photograph 7**  
**Vertical and Horizontal Slab Displacement**

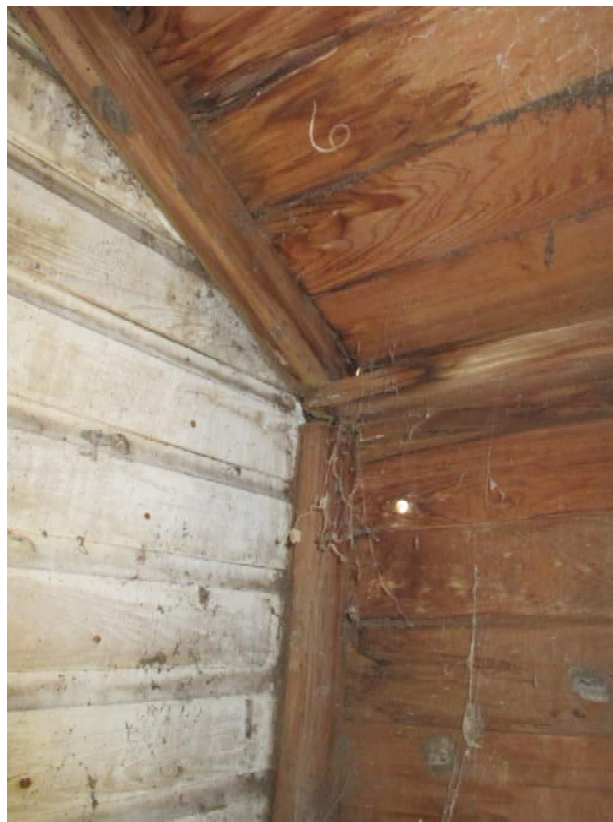
**Photograph 9**  
**Deteriorated Rear Shed Wall Framing**

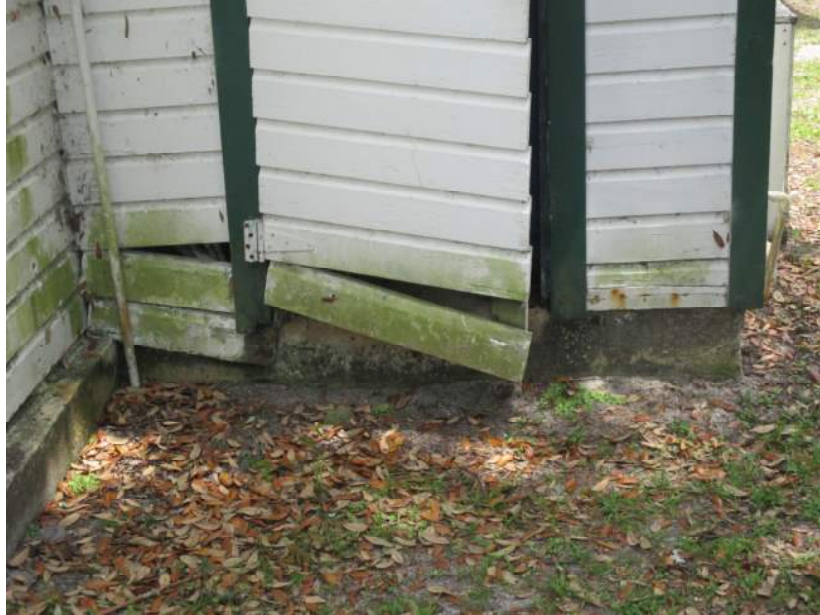
**Photograph 10**  
**Deteriorated Shed Siding**

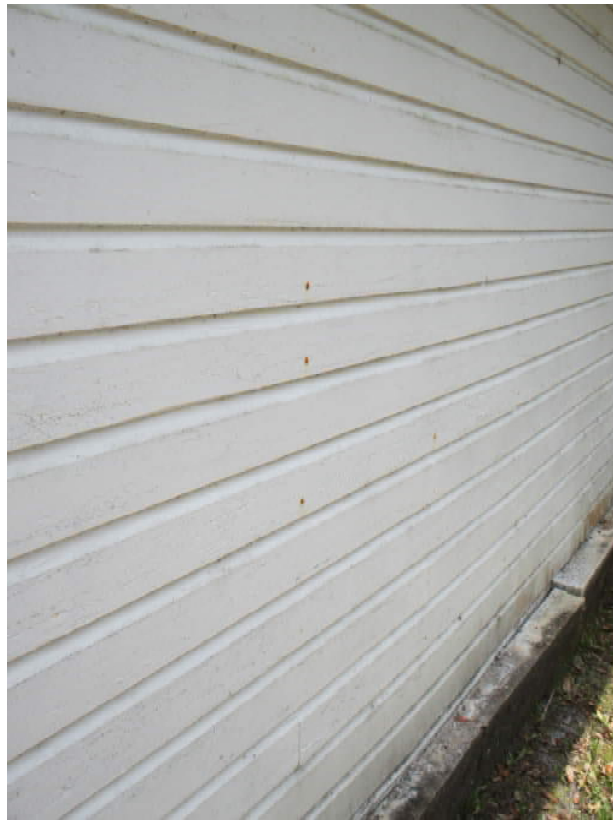
**Photograph 11**  
**Corroded Fasteners Throughout**

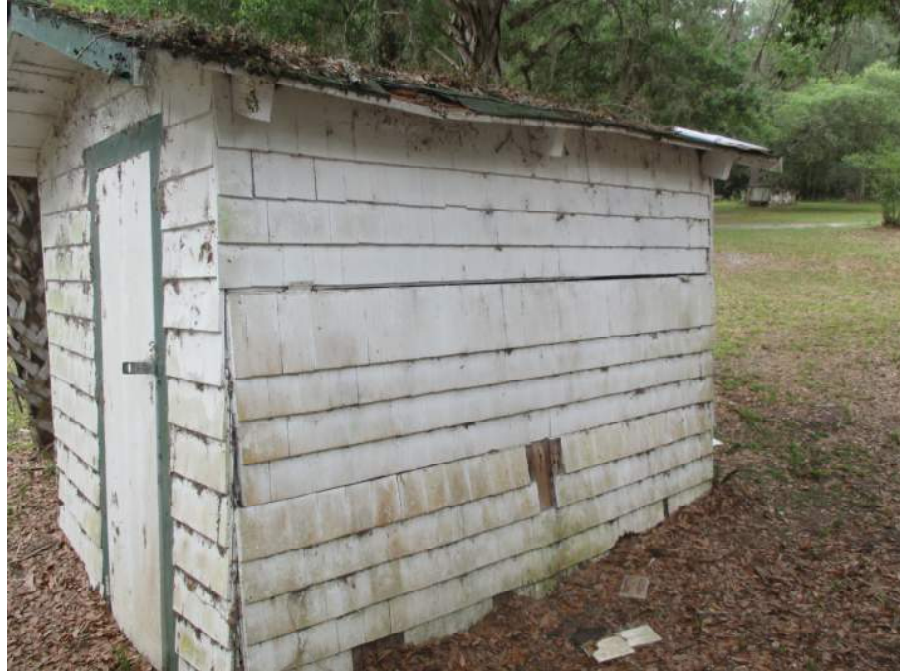
**Photograph 1**  
**Vertically Hinged Woodshed Access Door**

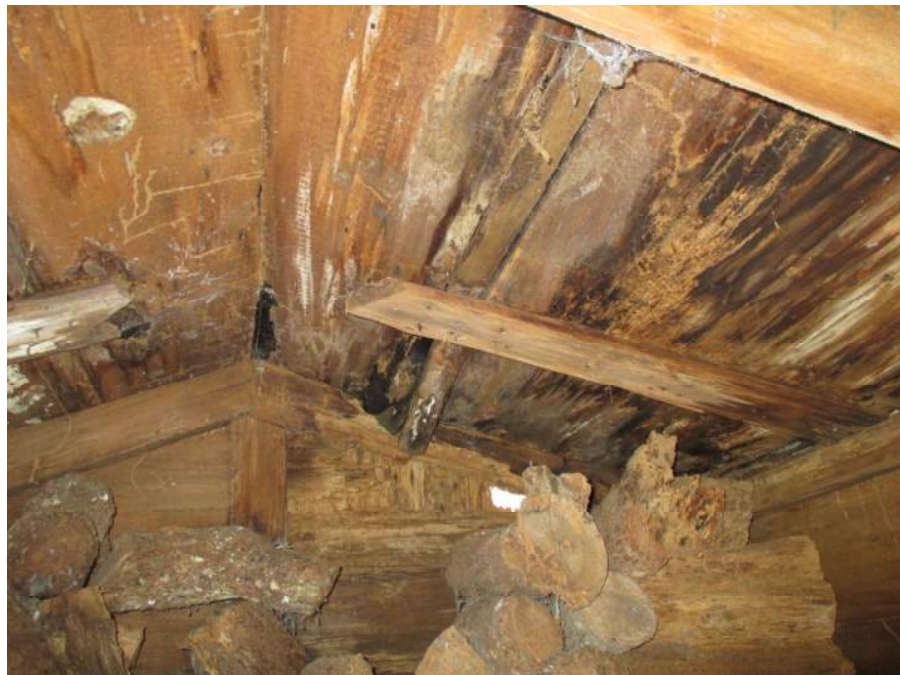
**Photograph 2**  
**Severely Deteriorated Roof Framing, Roof and Wall Sheathing**

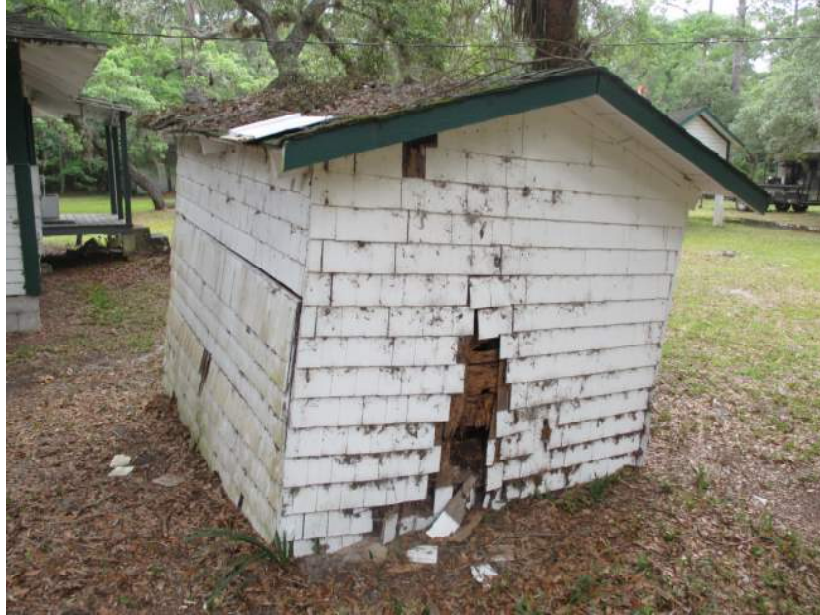
**Photograph 3**  
**Severely Deteriorated Wall Sheathing and Siding**

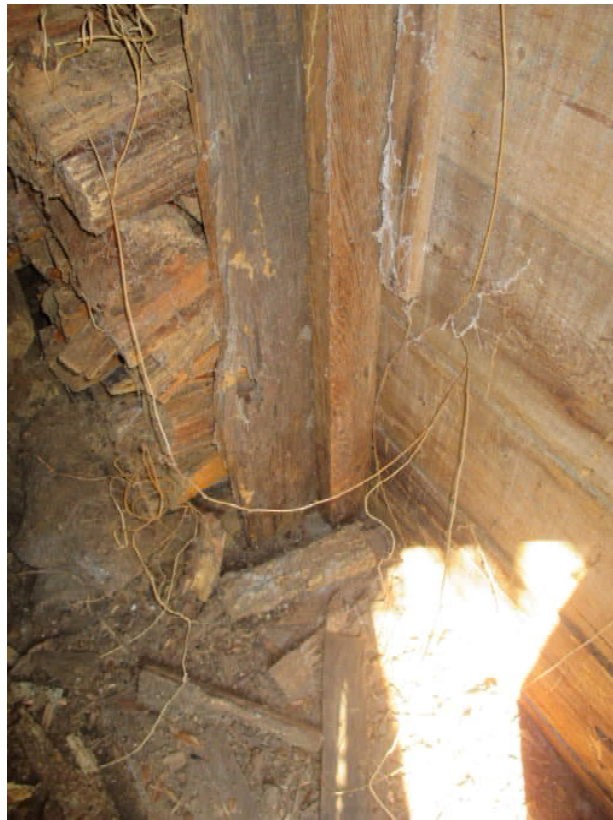
**Photograph 4**  
**Deteriorated Wall Framing and Sheathing**

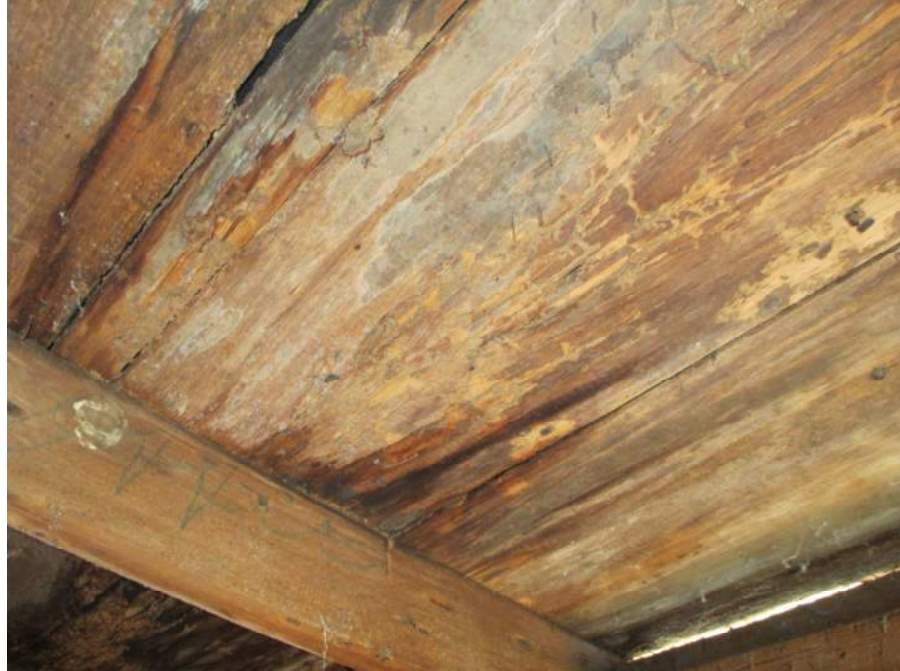
**Photograph 5**  
**Deteriorated Roof Sheathing**

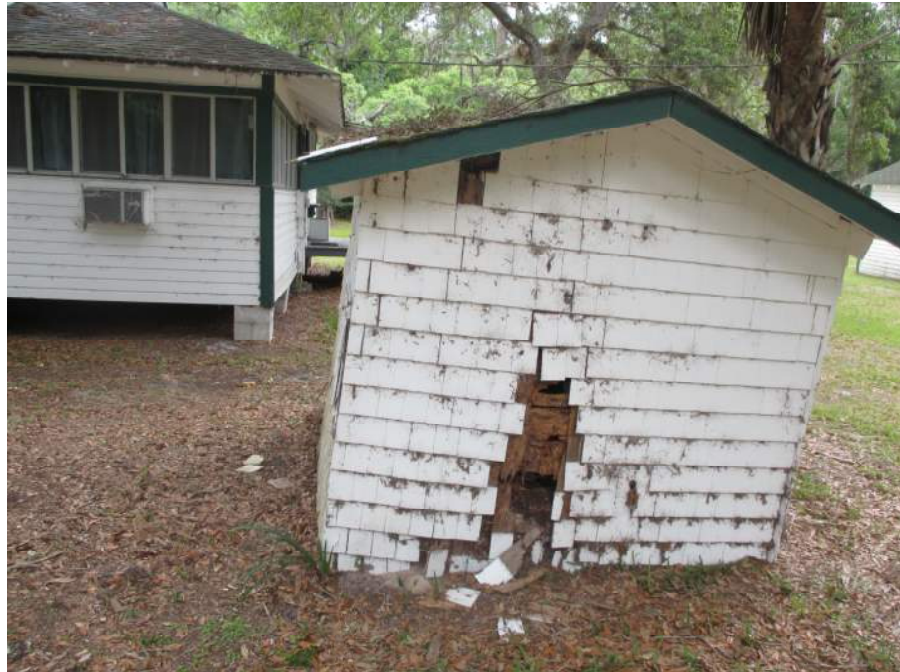
**Photograph 6**  
**Settled and Racked Structure**

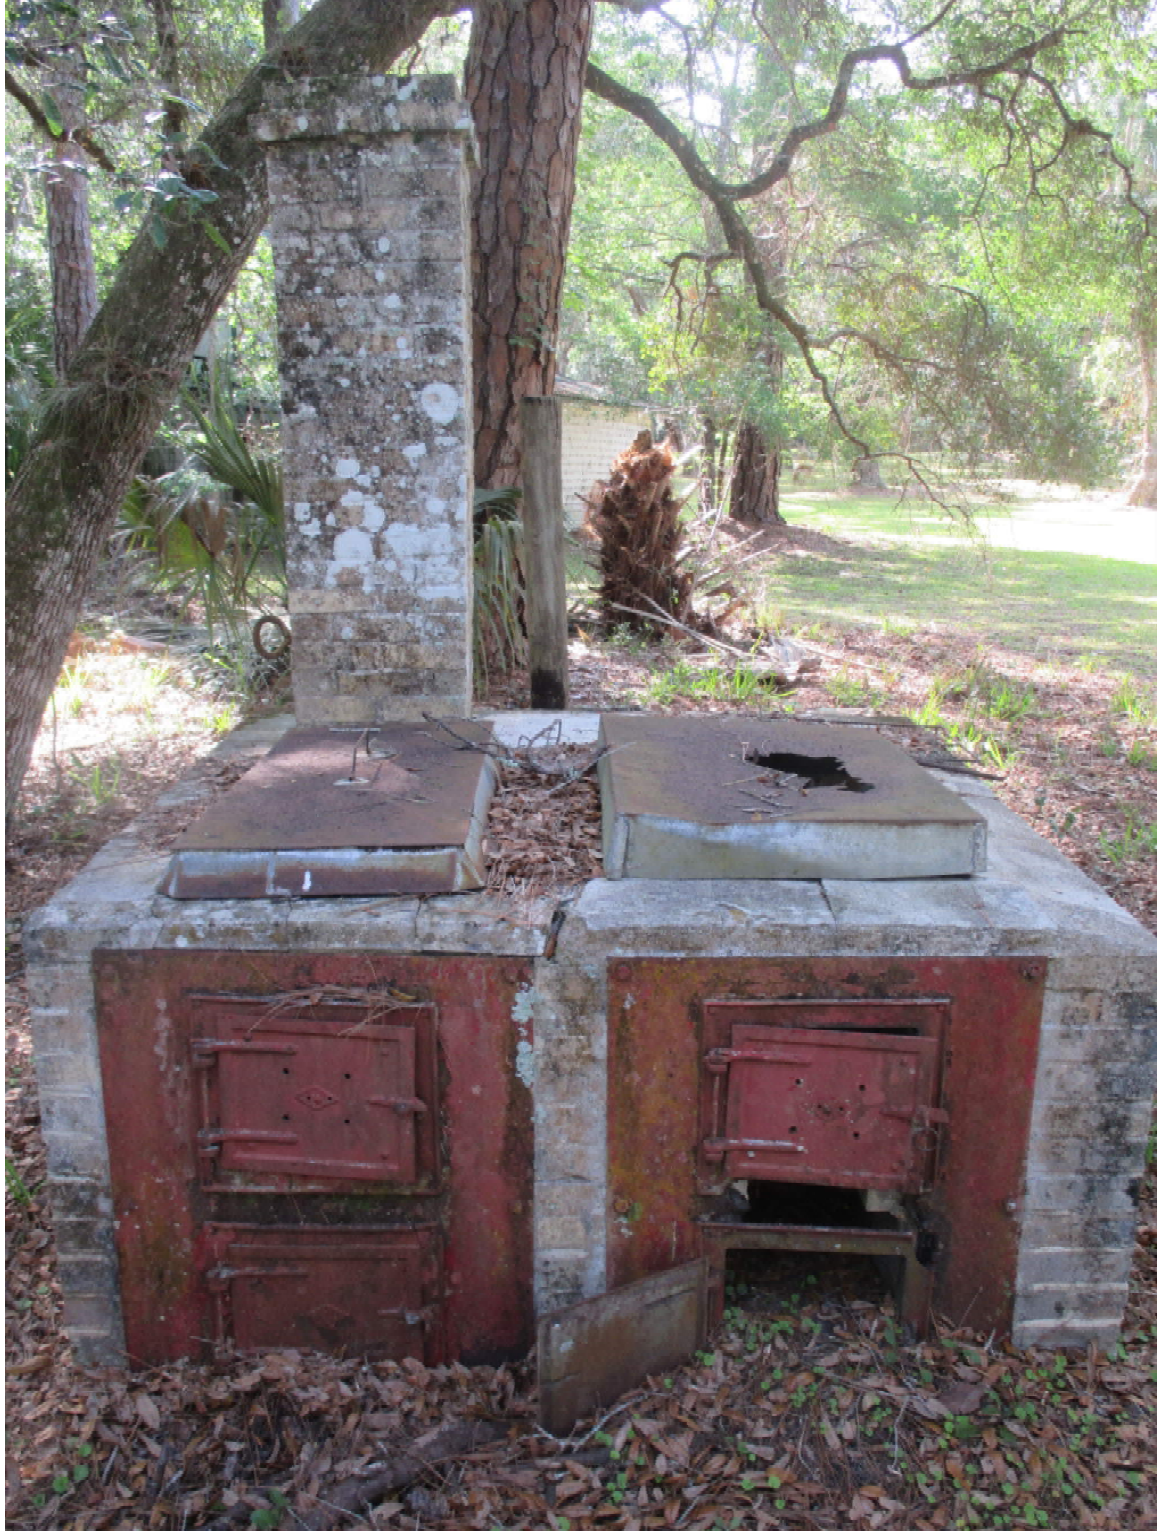
**Photograph 1**  
**Overall Outdoor Grill Front**

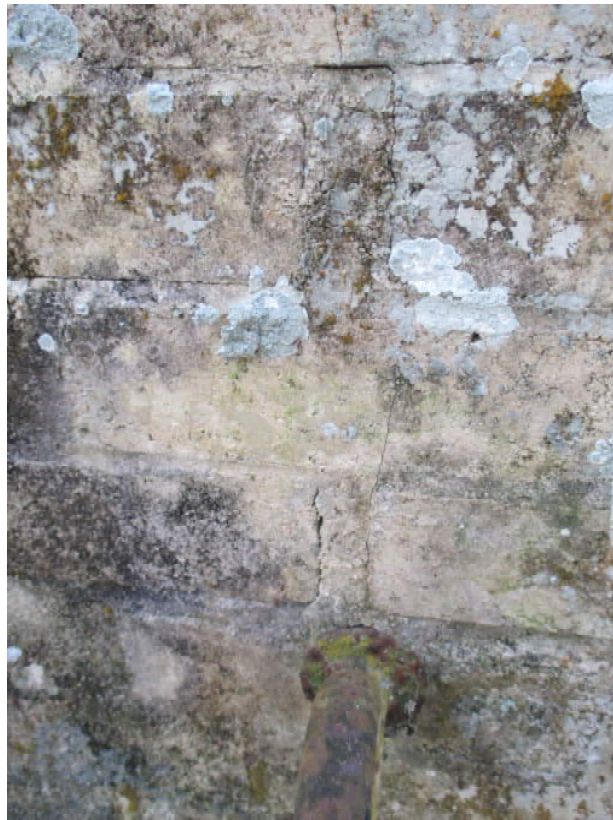
**Photograph 3**  
**Vertical Crack in Clay Brick**

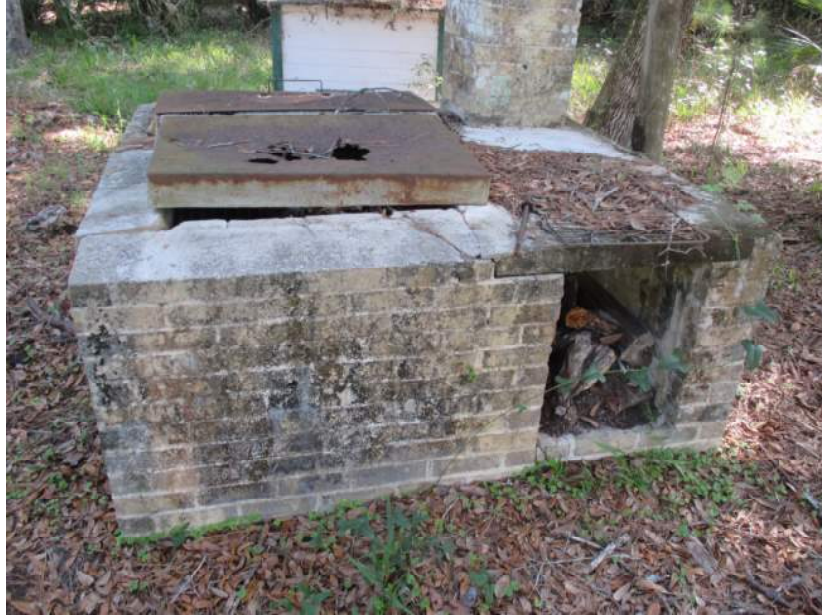
**Photograph 4**  
**Settling of Northwest Corner**

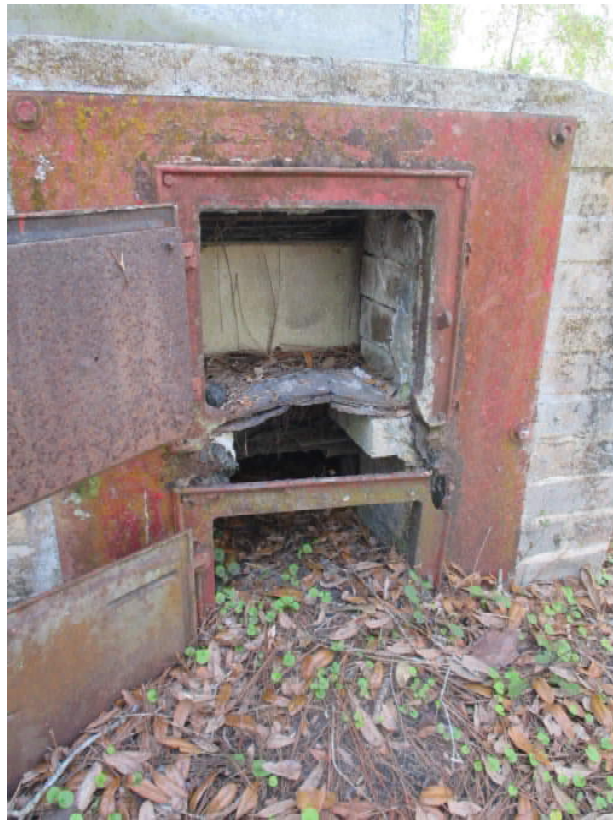
**Photograph 5**  
**Deteriorated Access Doors and Settled Corner**

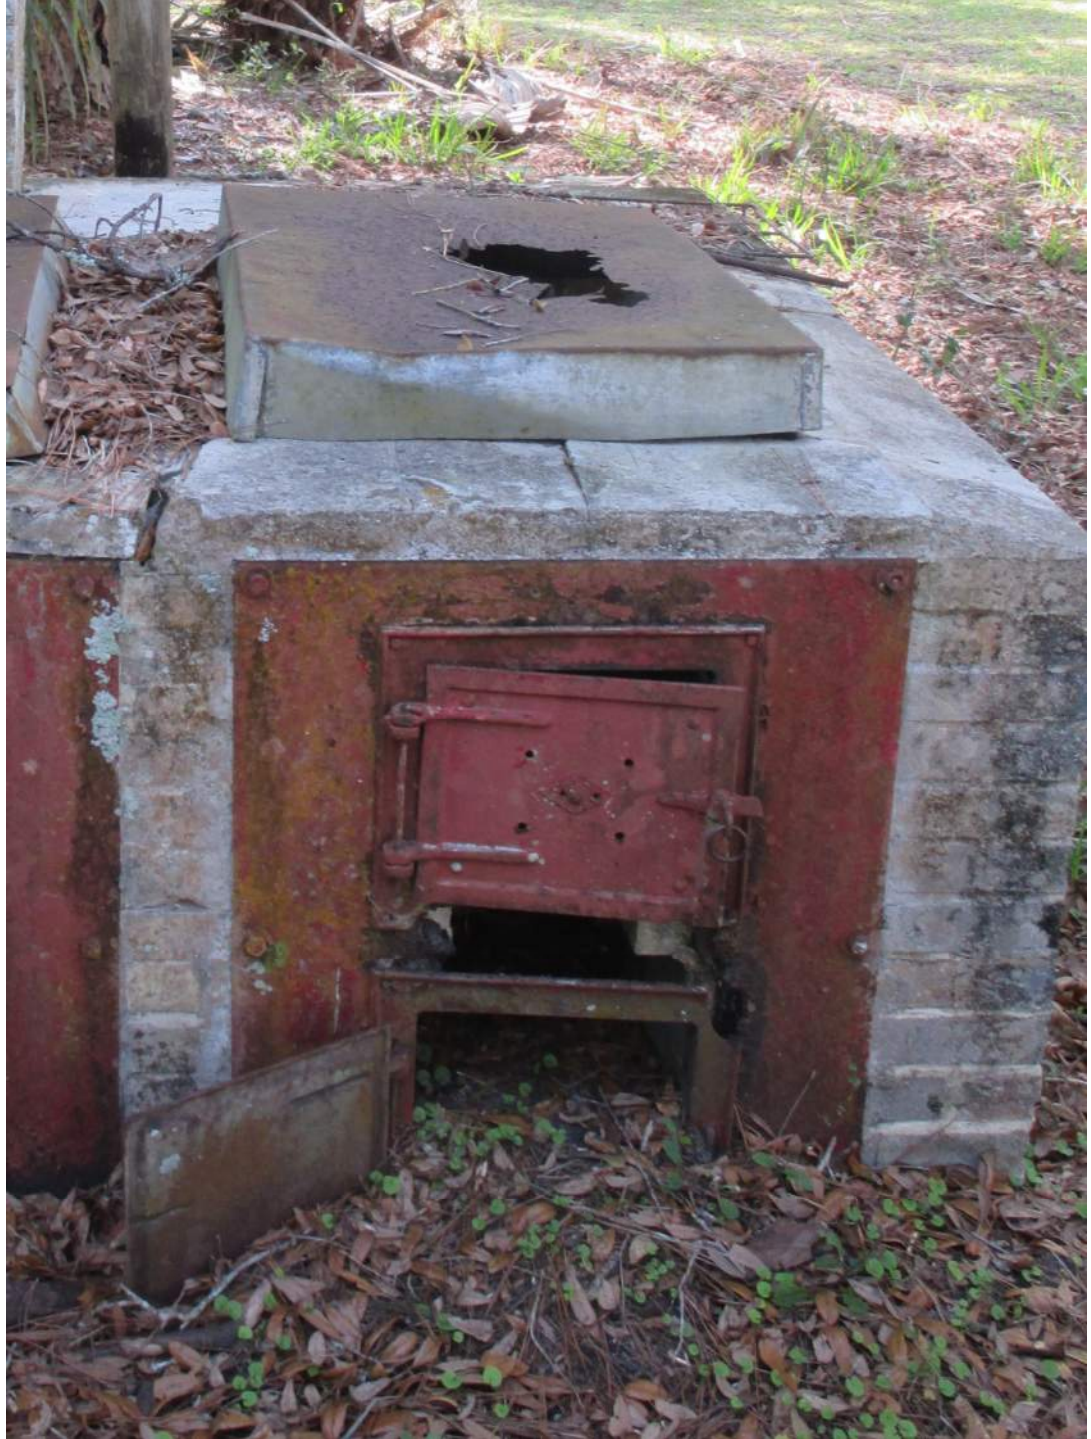
**Photograph 6**  
**Deteriorated Access Doors and Settled Corner**

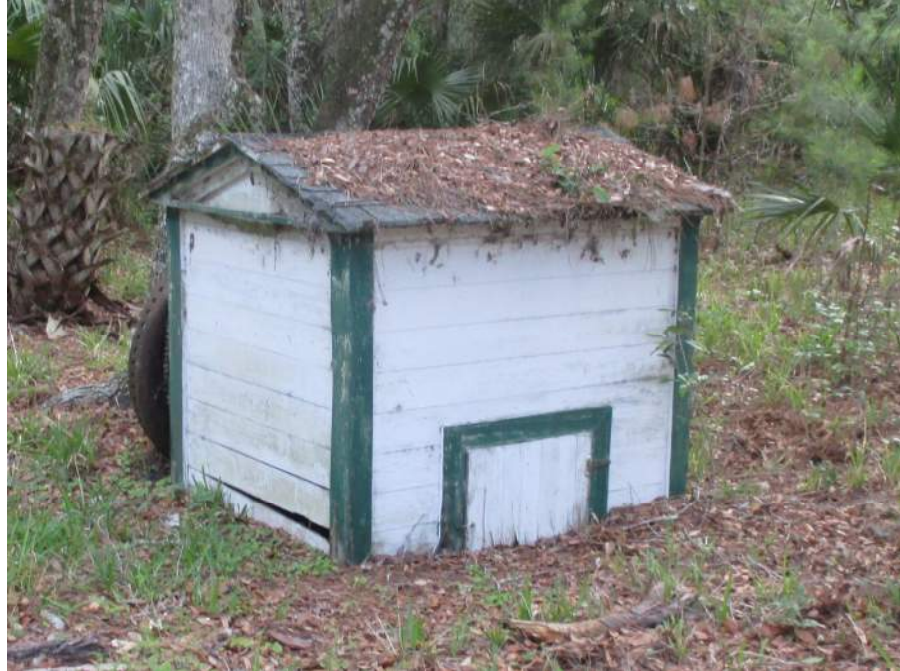
**Photograph 1**  
**Overall Smoker**

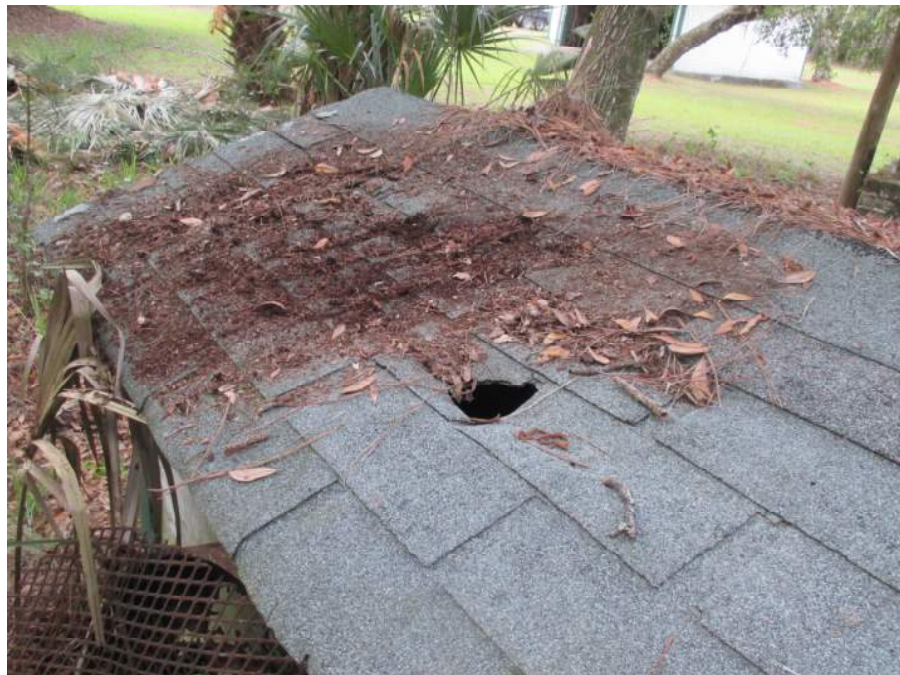
**Photograph 2**  
**Deteriorated Roof**

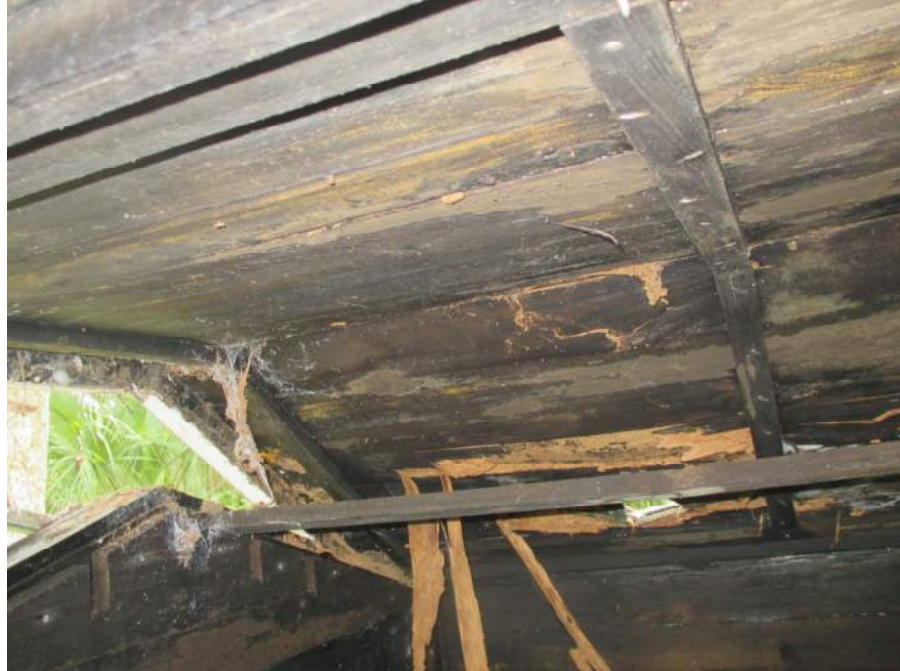
**Photograph 3**  
**Deteriorated Roof Sheathing and Framing**

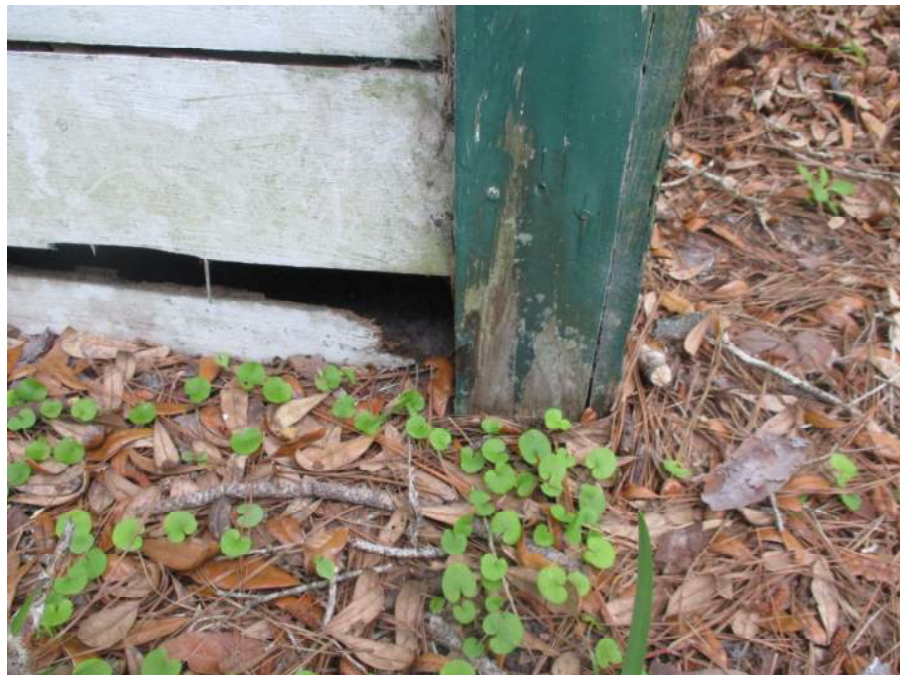
**Photograph 4**  
**Deteriorated Trim and Siding**

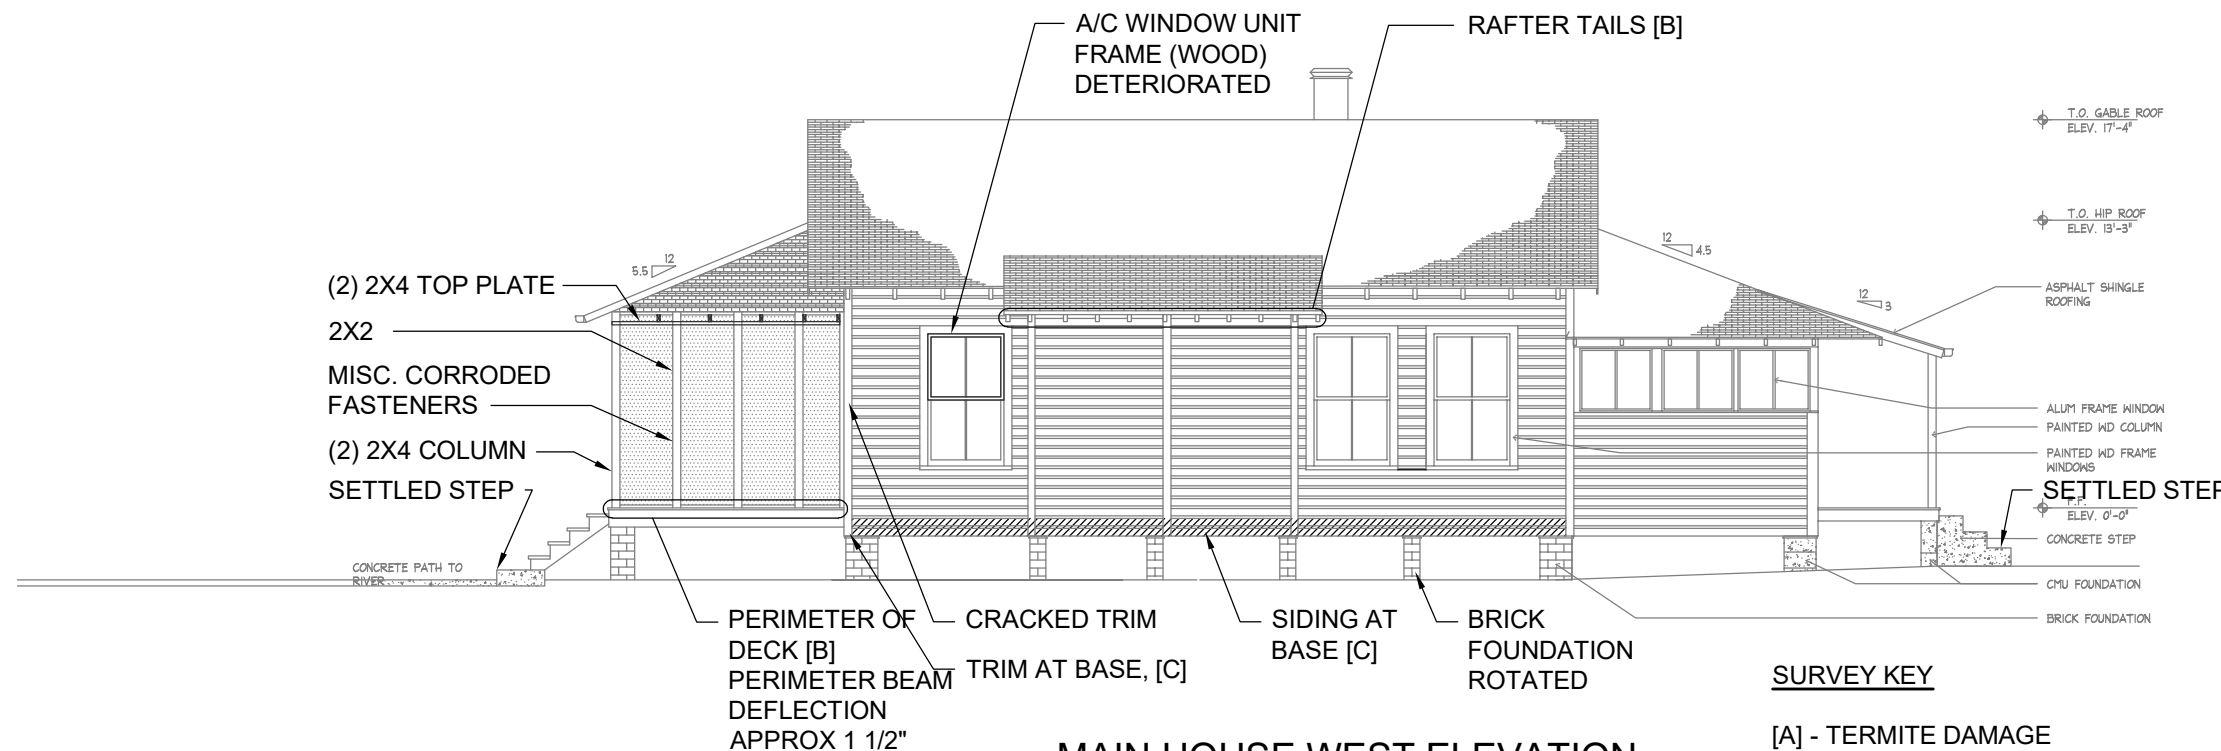
**MAIN HOUSE WEST ELEVATION**  
SCALE: 1/8" = 1'-0"

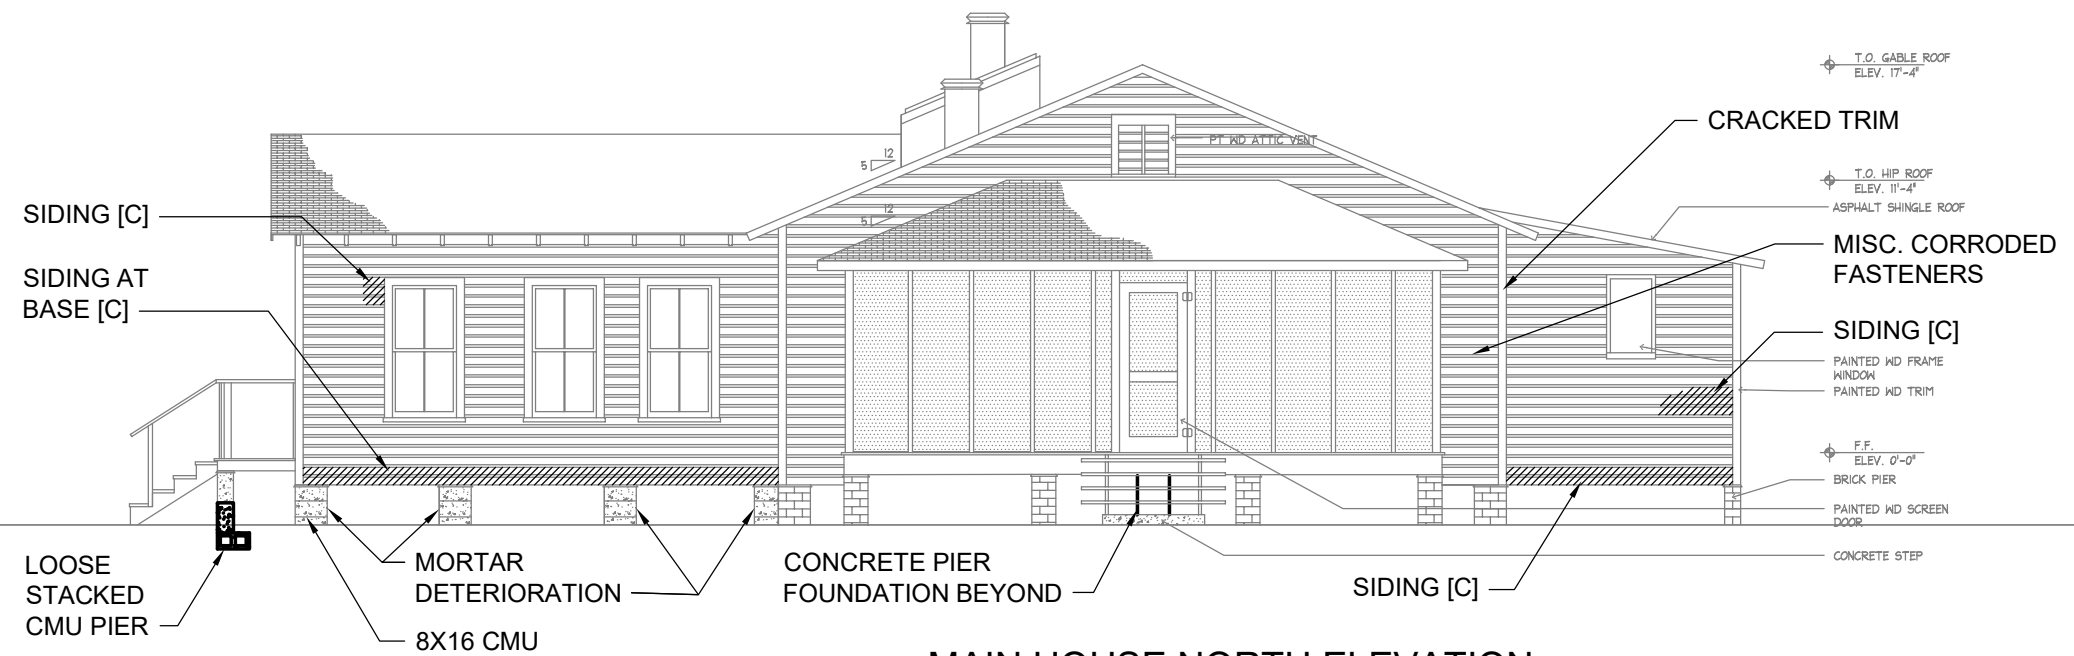
**MAIN HOUSE NORTH ELEVATION**  
SCALE: 1/8" = 1'-0"

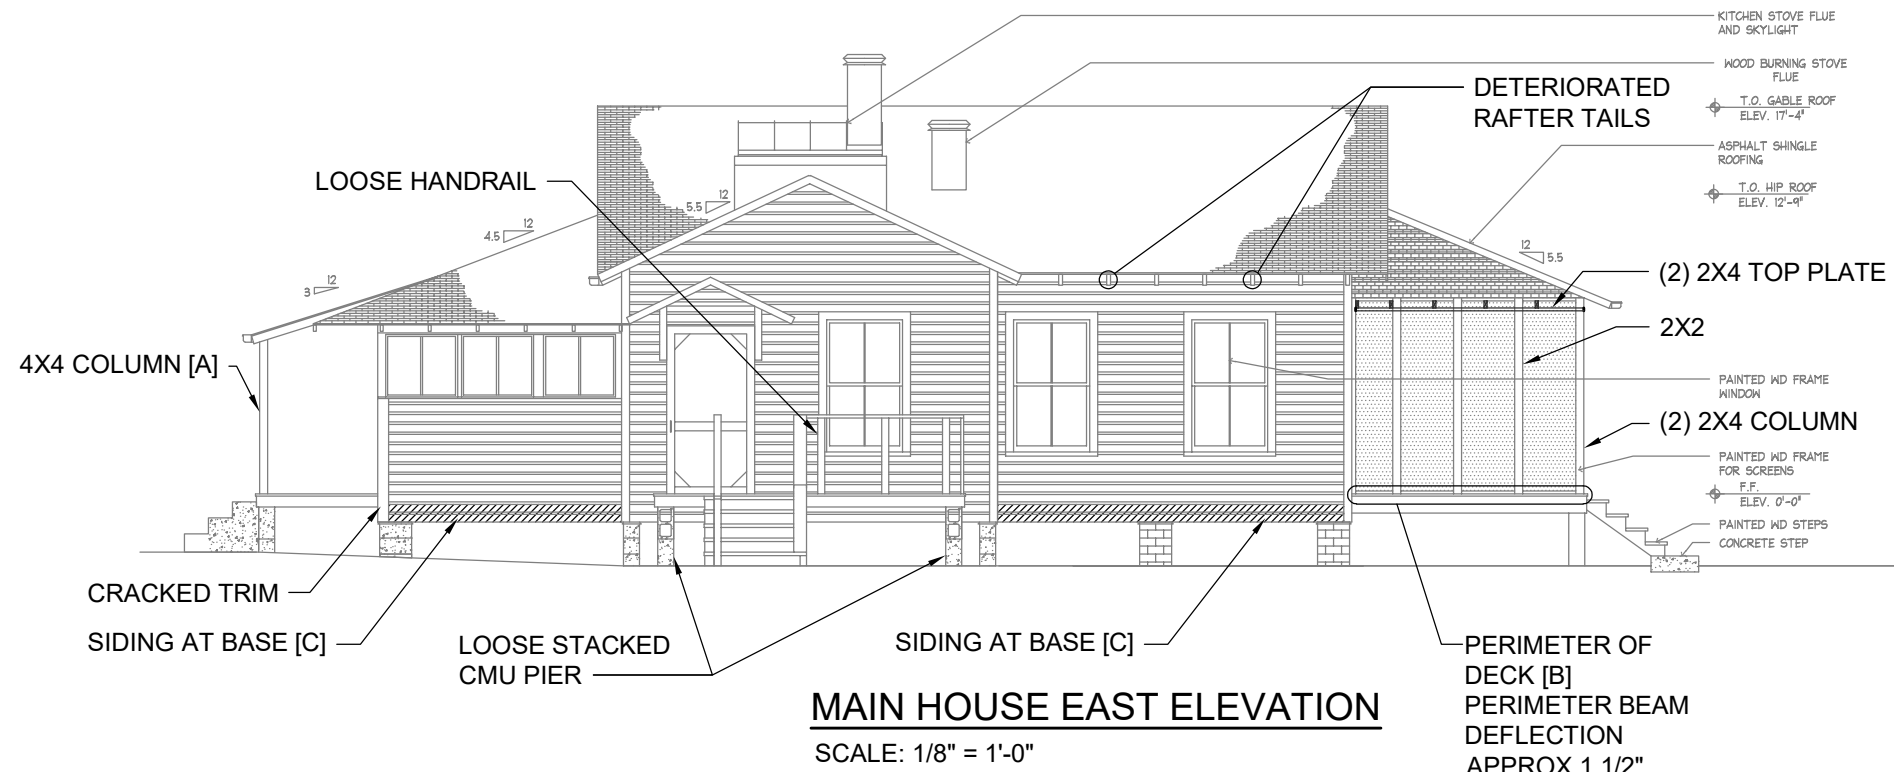
**MAIN HOUSE EAST ELEVATION**

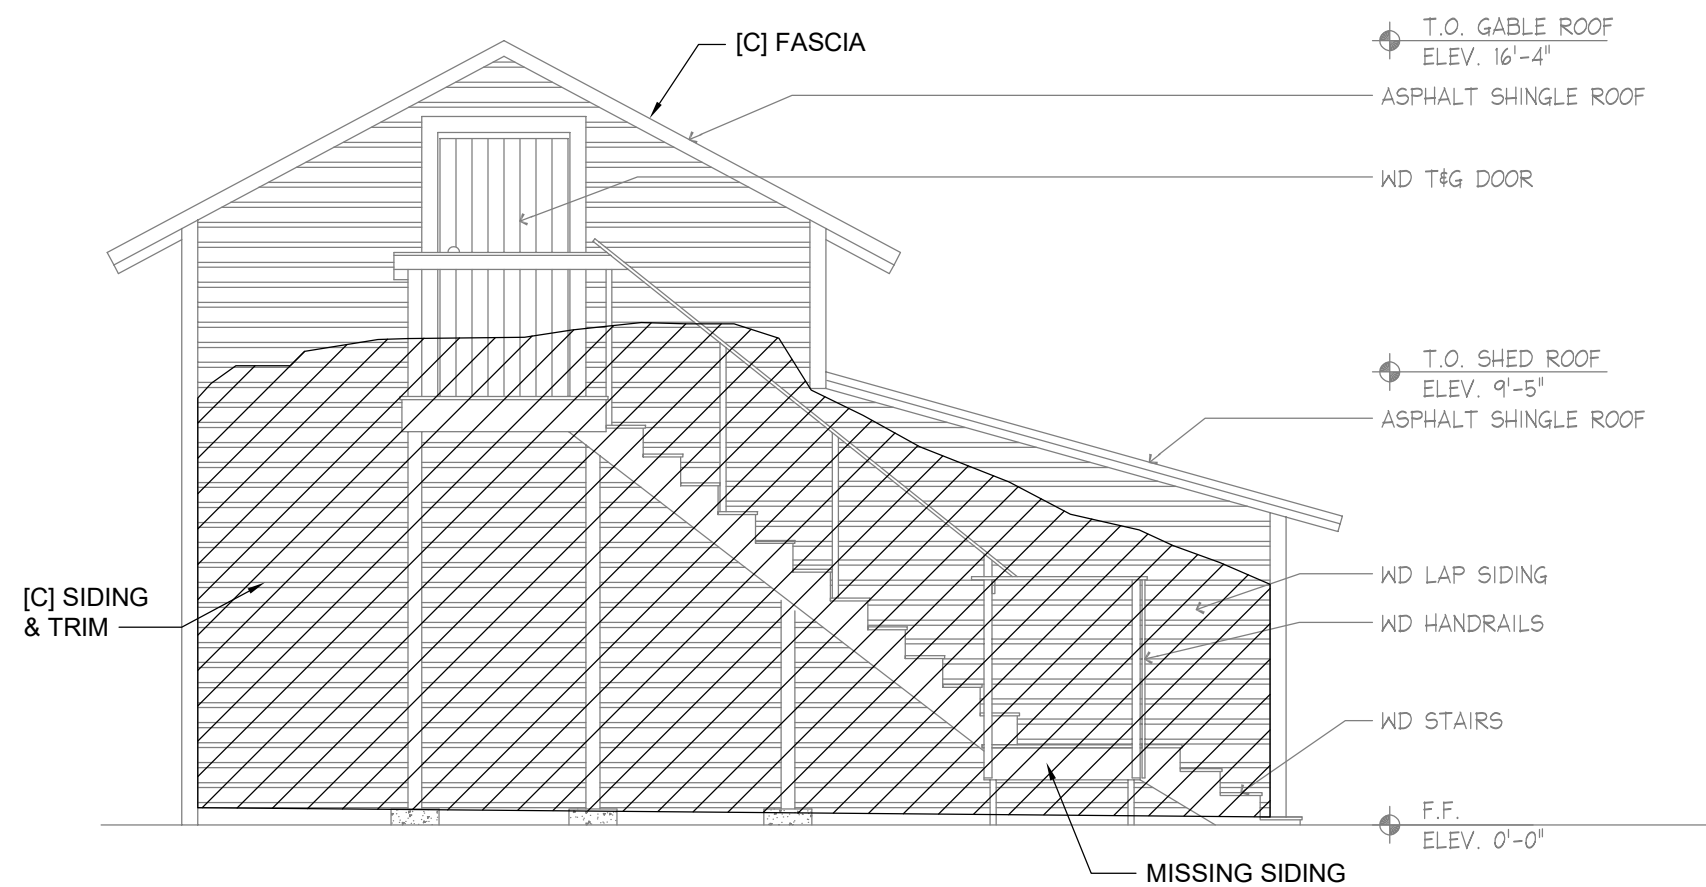
**ATTIC GARAGE NORTH ELEVATION**  
SCALE: 1/4" = 1'-0"

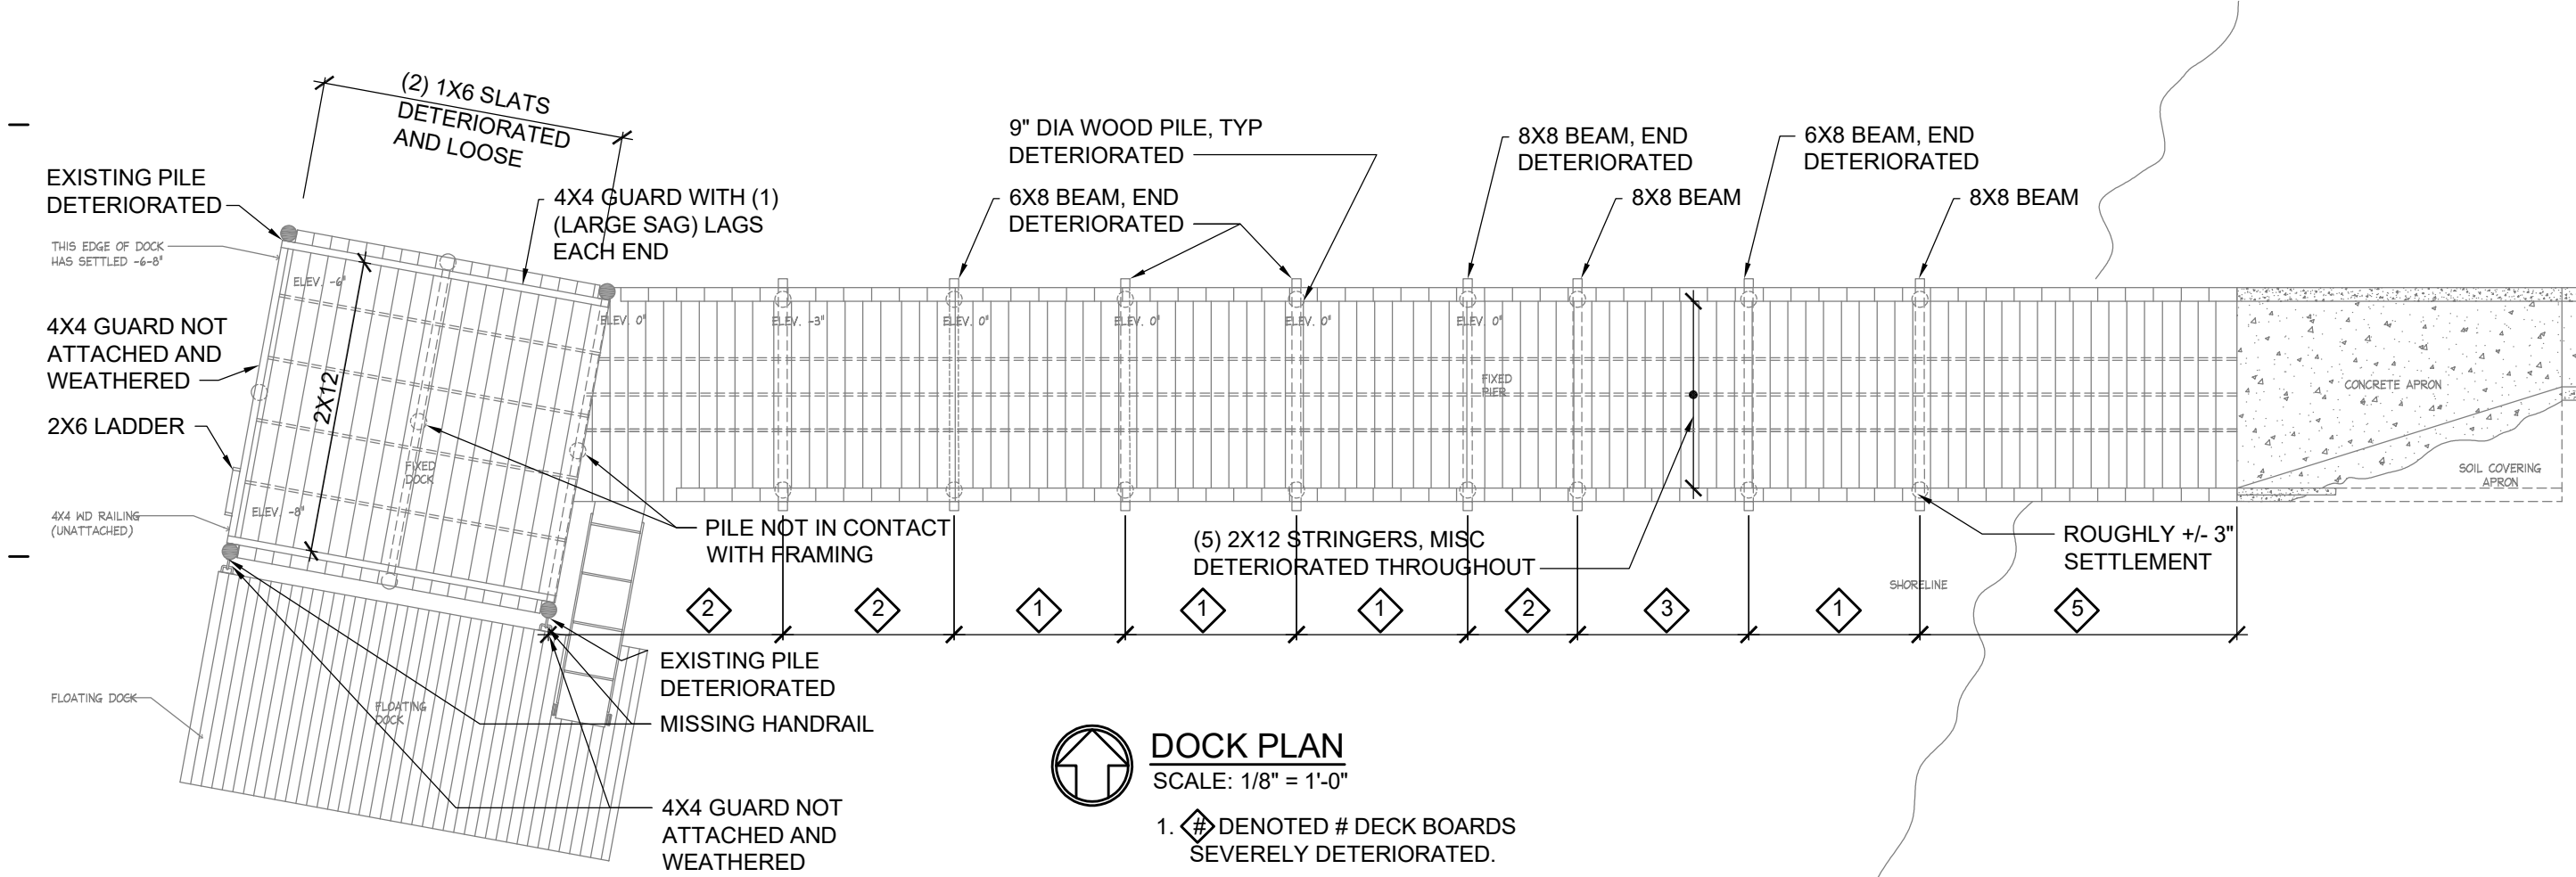
**DOCK PLAN**  
SCALE: 1/8" = 1'-0"
