# **HISTORIC STRUCTURE ASSESSMENT REPORT**

## **VISTA HISTORIC SITE Lower Suwannee National Wildlife Refuge**

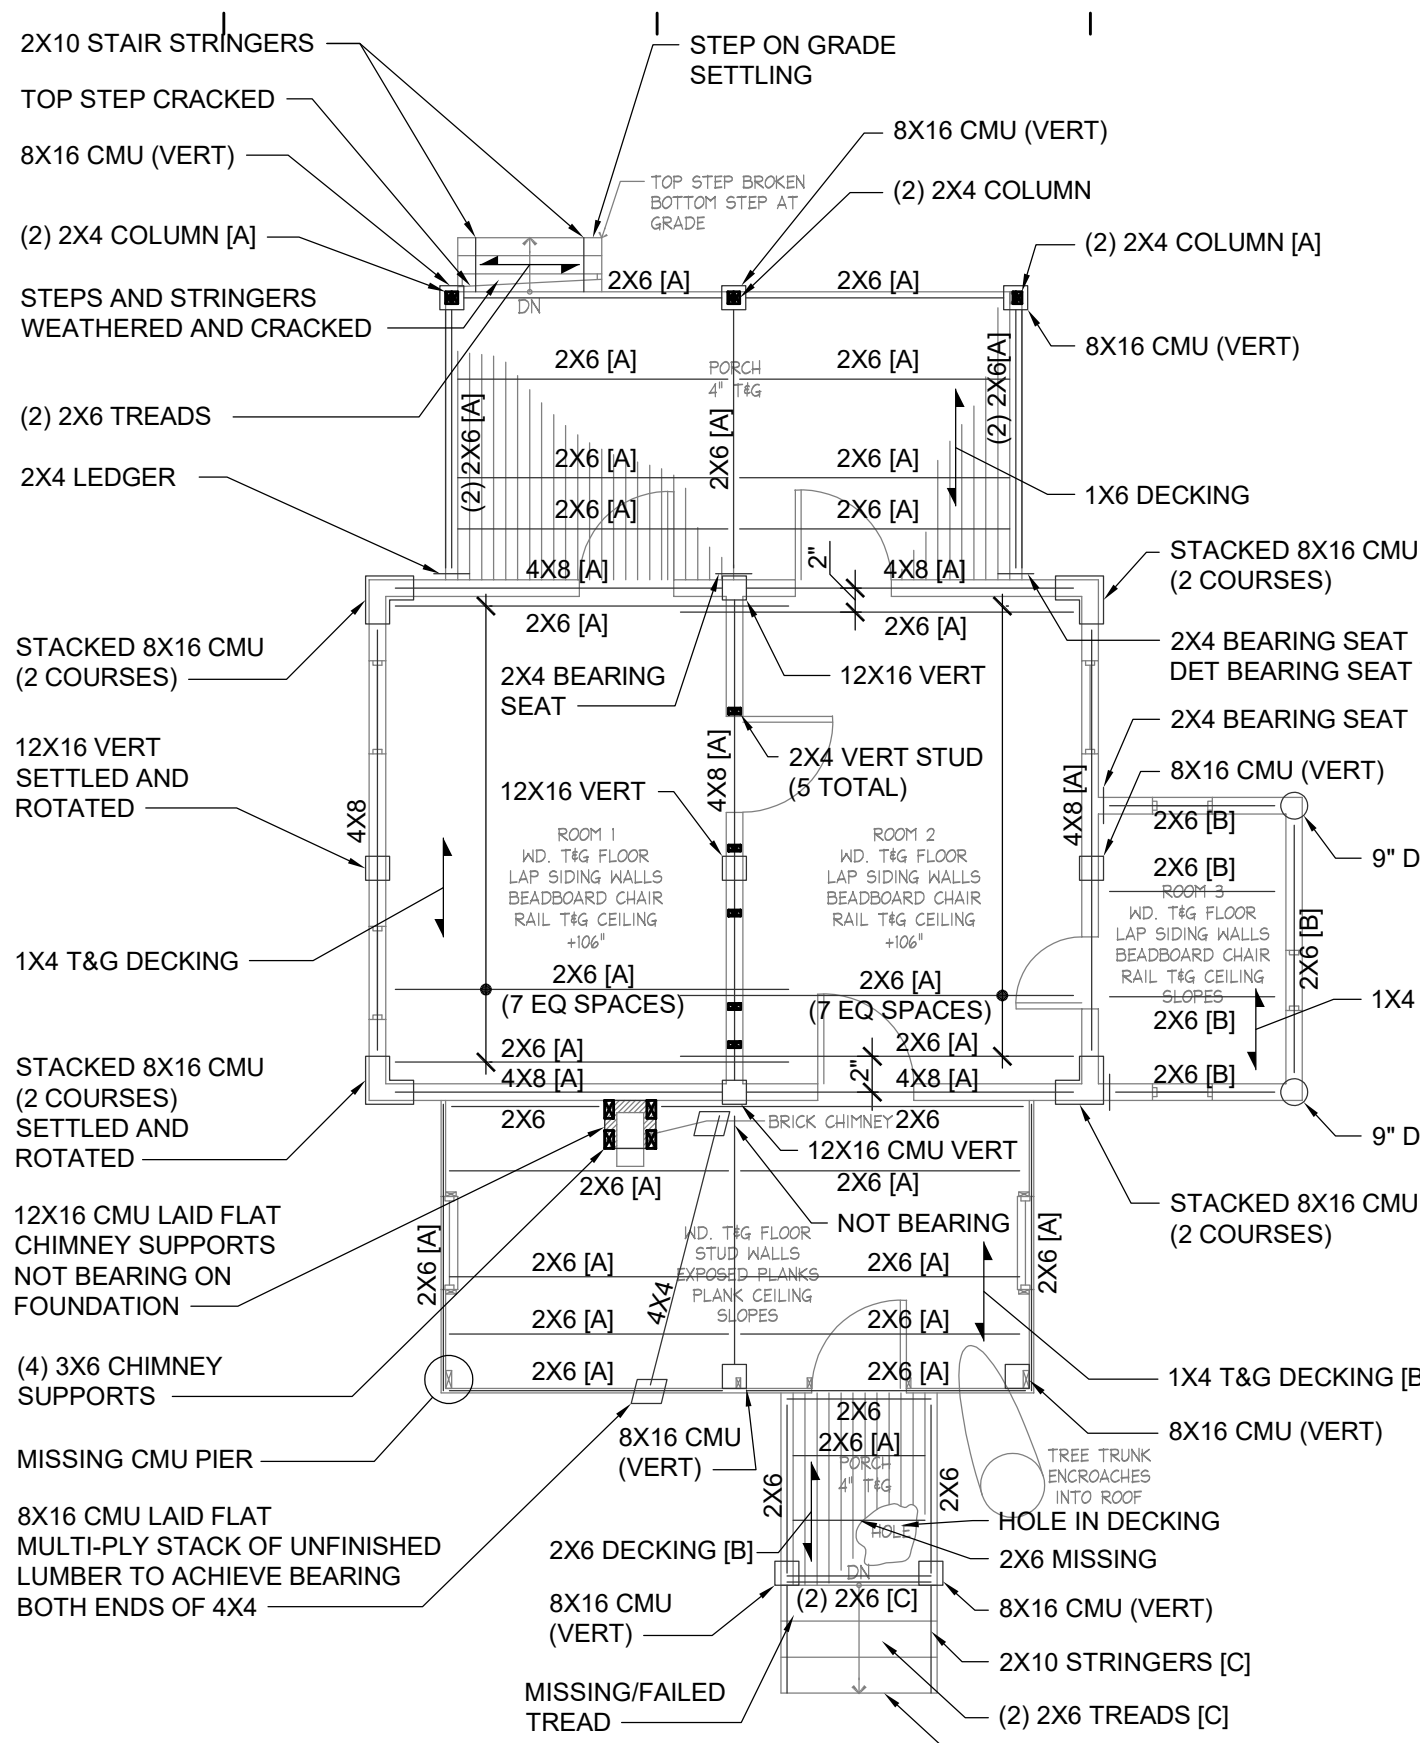
**COOKS HOUSE FOUNDATION FLOOR PLAN**  
SCALE: 3/16" = 1'-0"

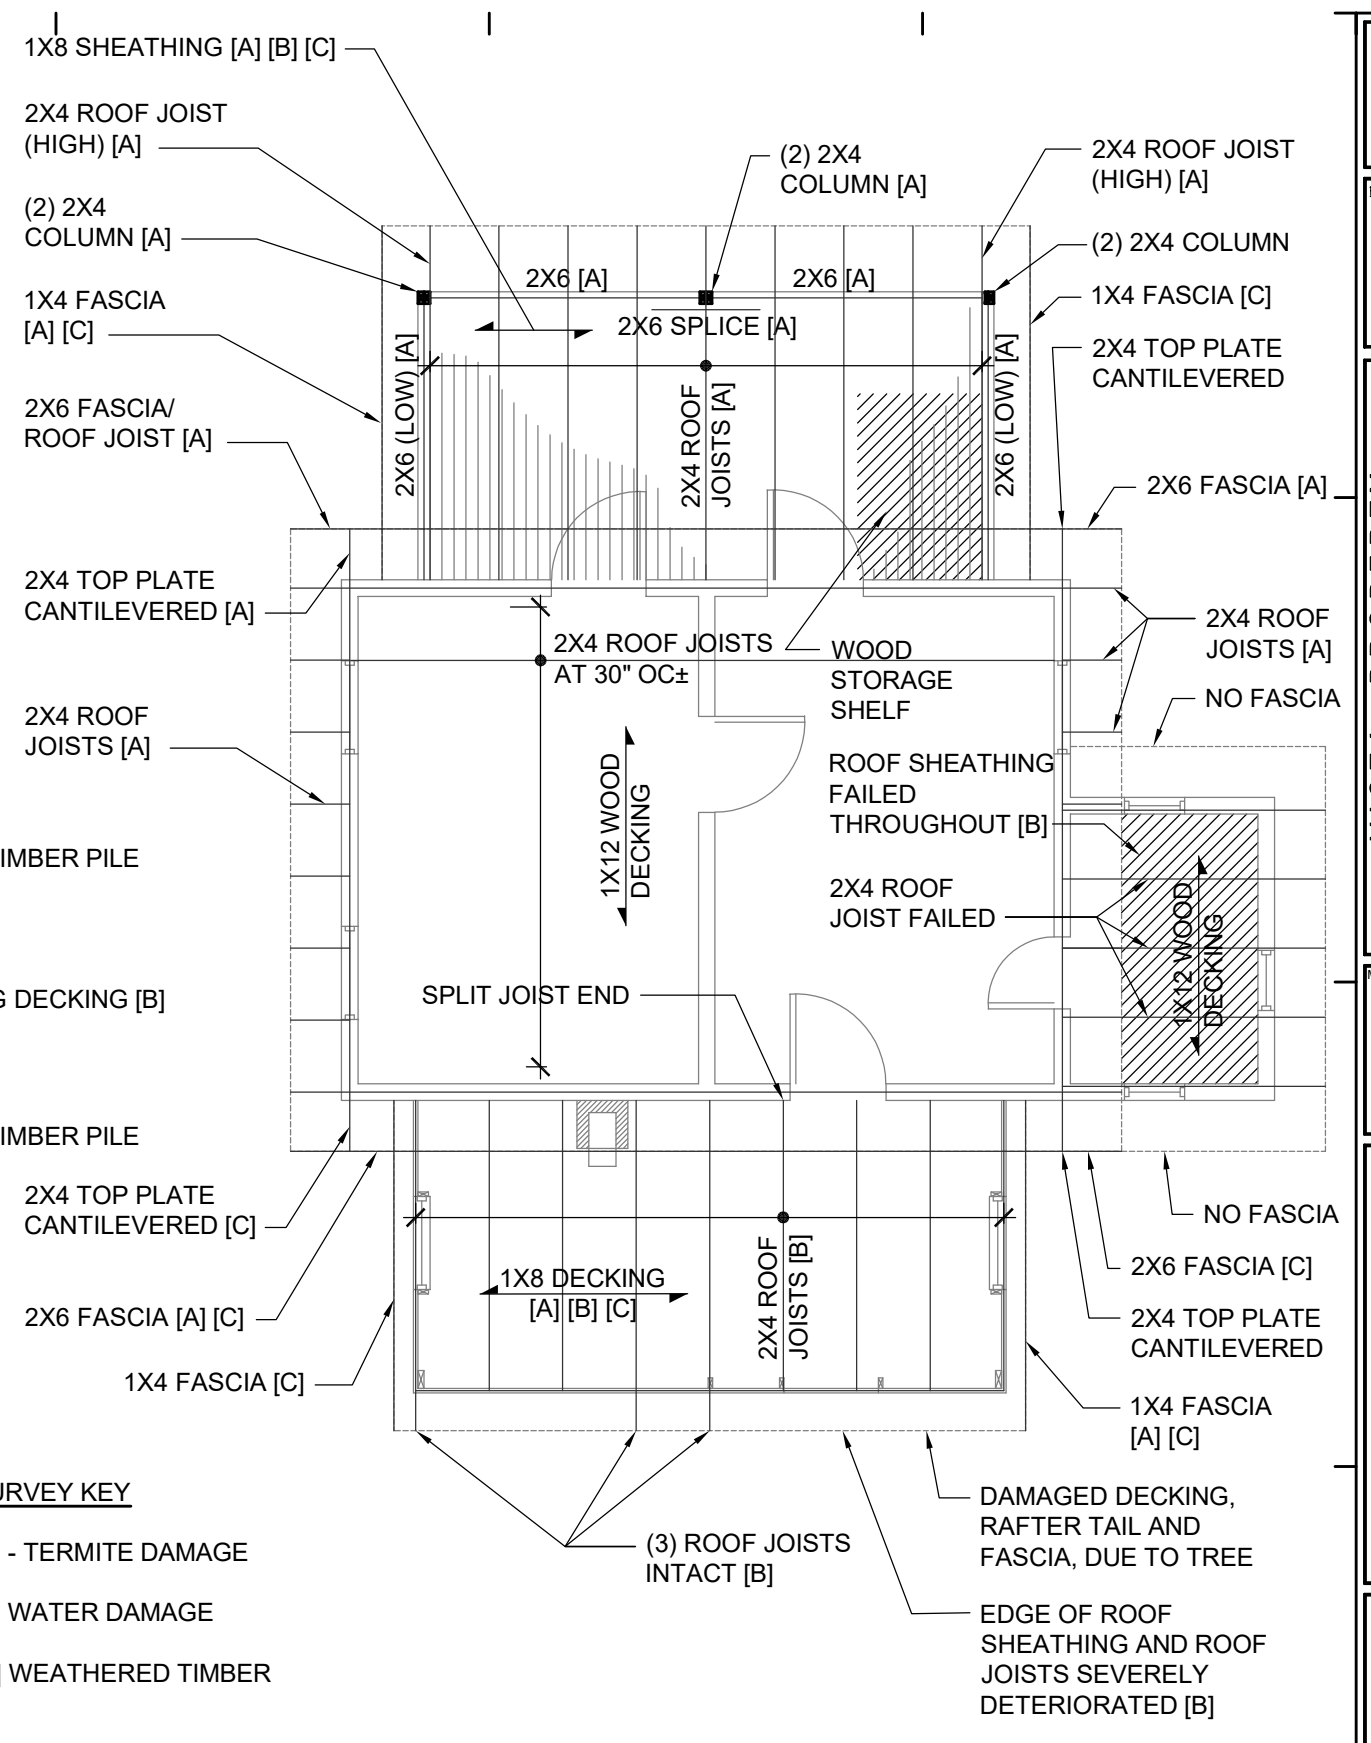
**COOKS HOUSE ROOF PLAN**  
SCALE: 3/16" = 1'-0"

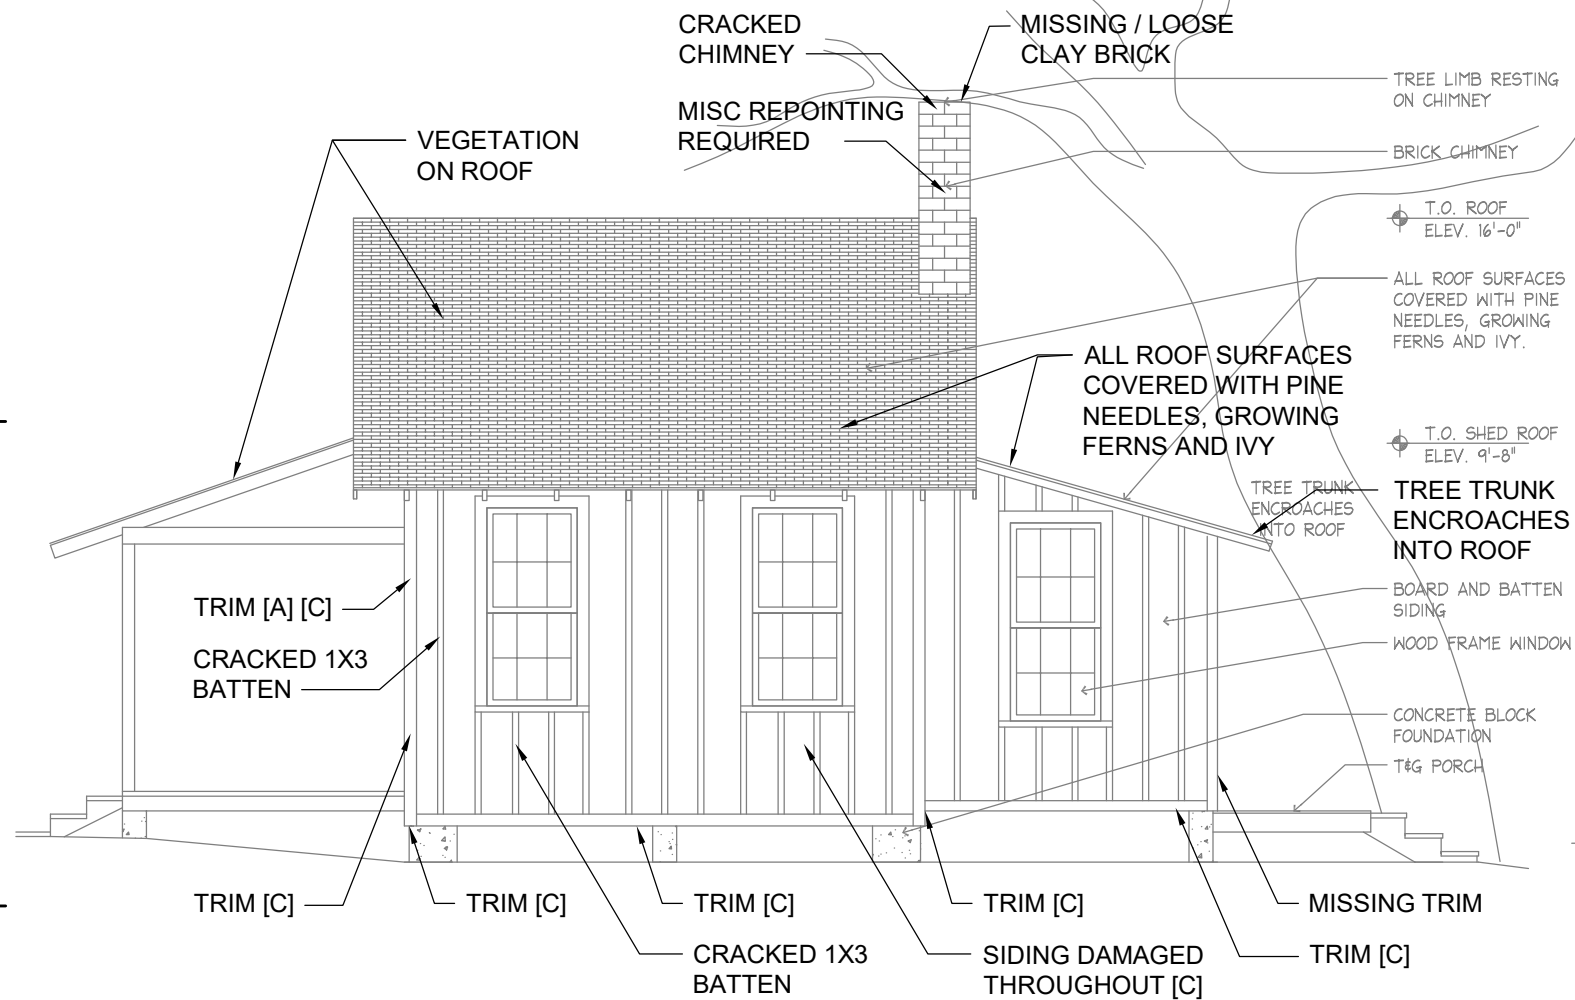
**COOKS HOUSE WEST ELEVATION**  
SCALE: 3/16" = 1'-0"

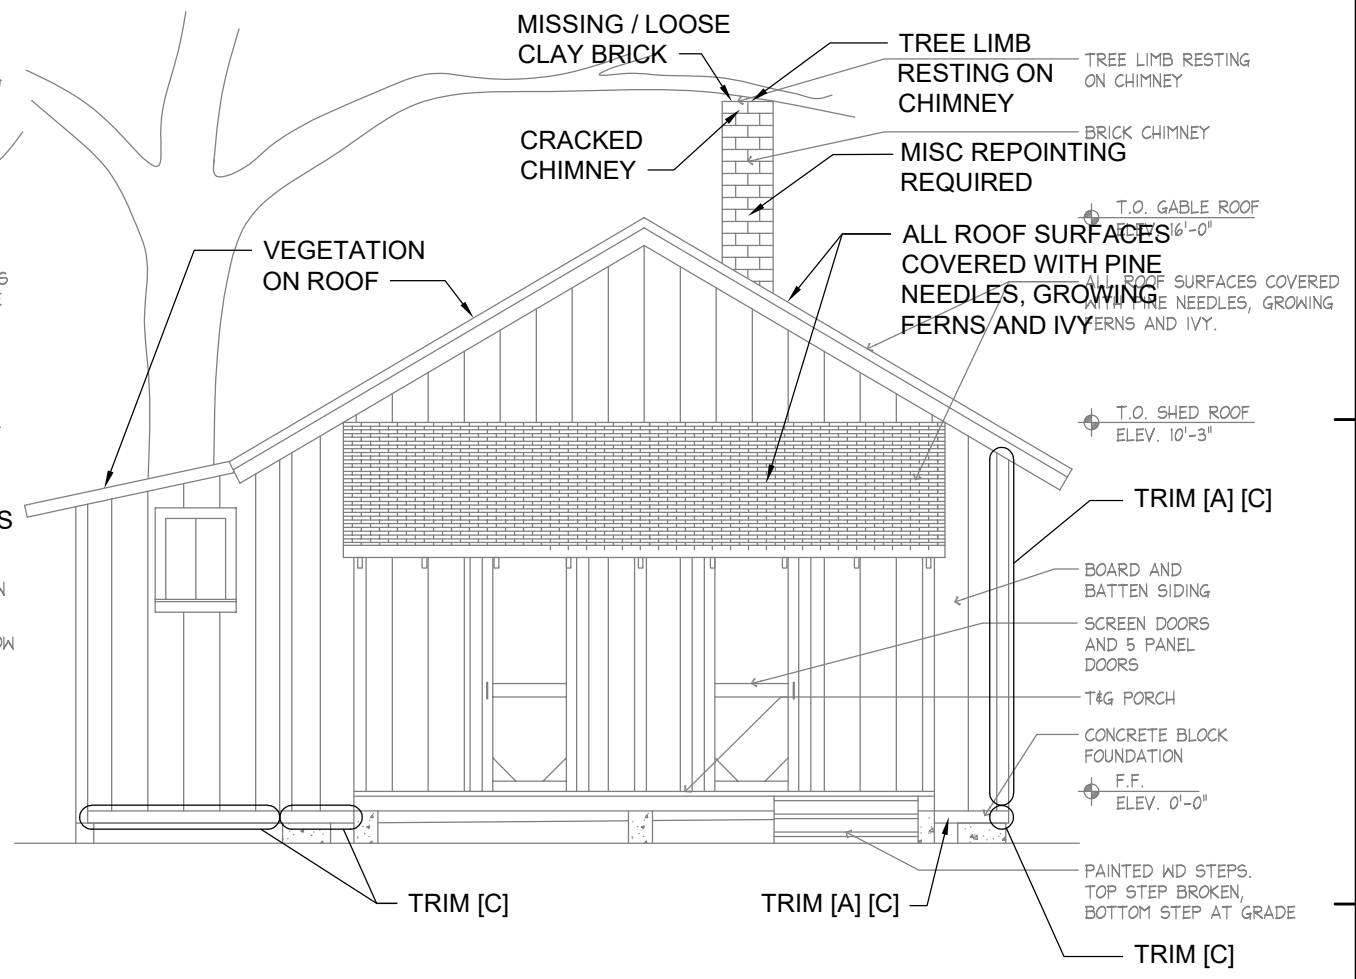
**COOKS HOUSE NORTH ELEVATION**  
SCALE: 3/16" = 1'-0"

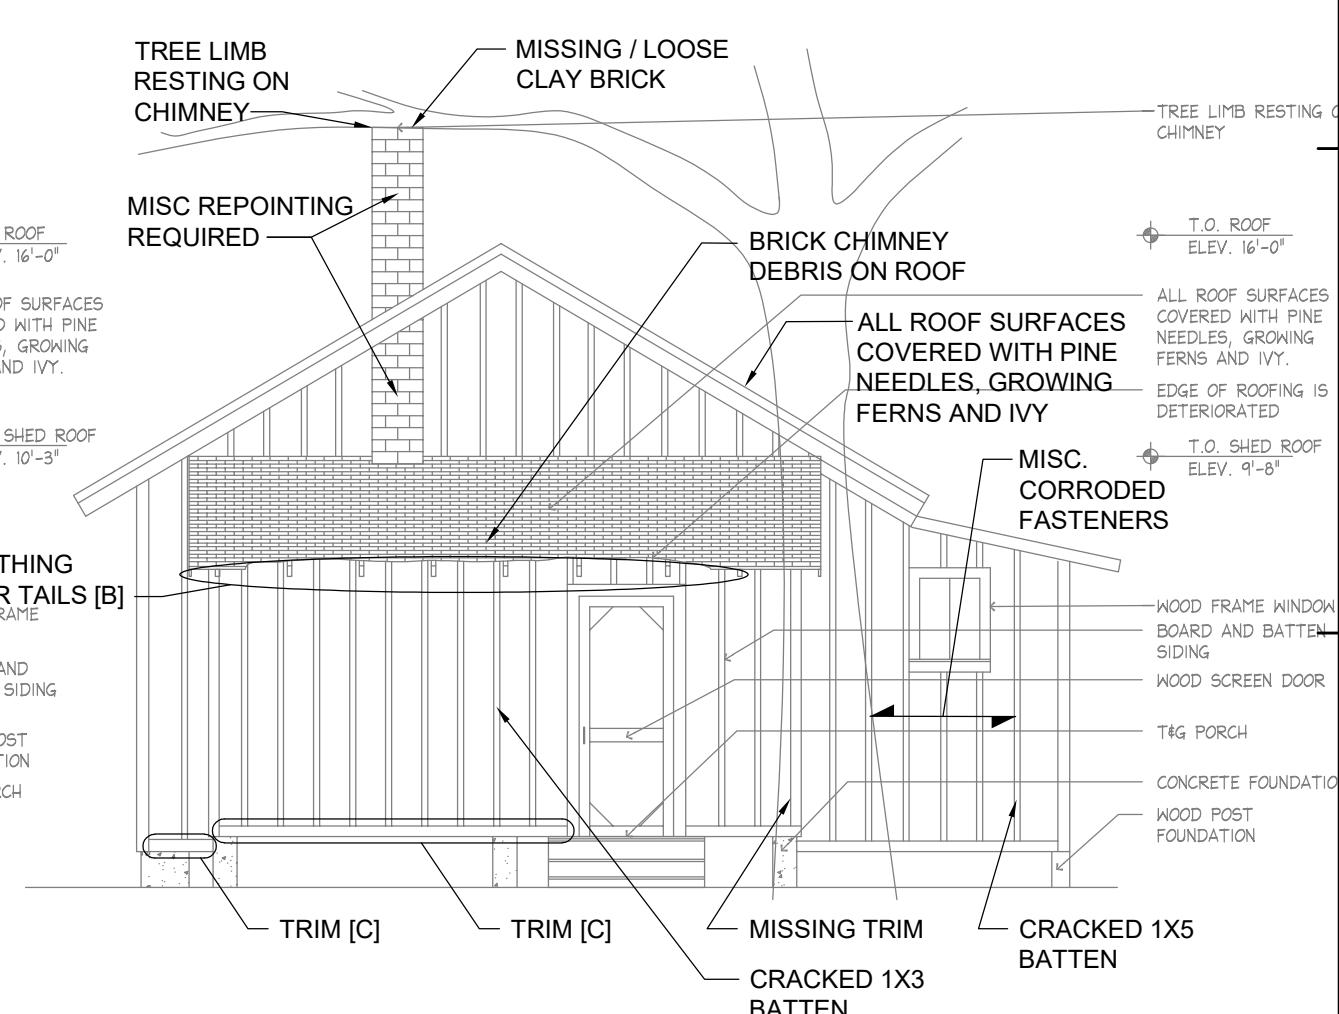
**COOKS HOUSE SOUTH ELEVATION**  
SCALE: 3/16" = 1'-0"

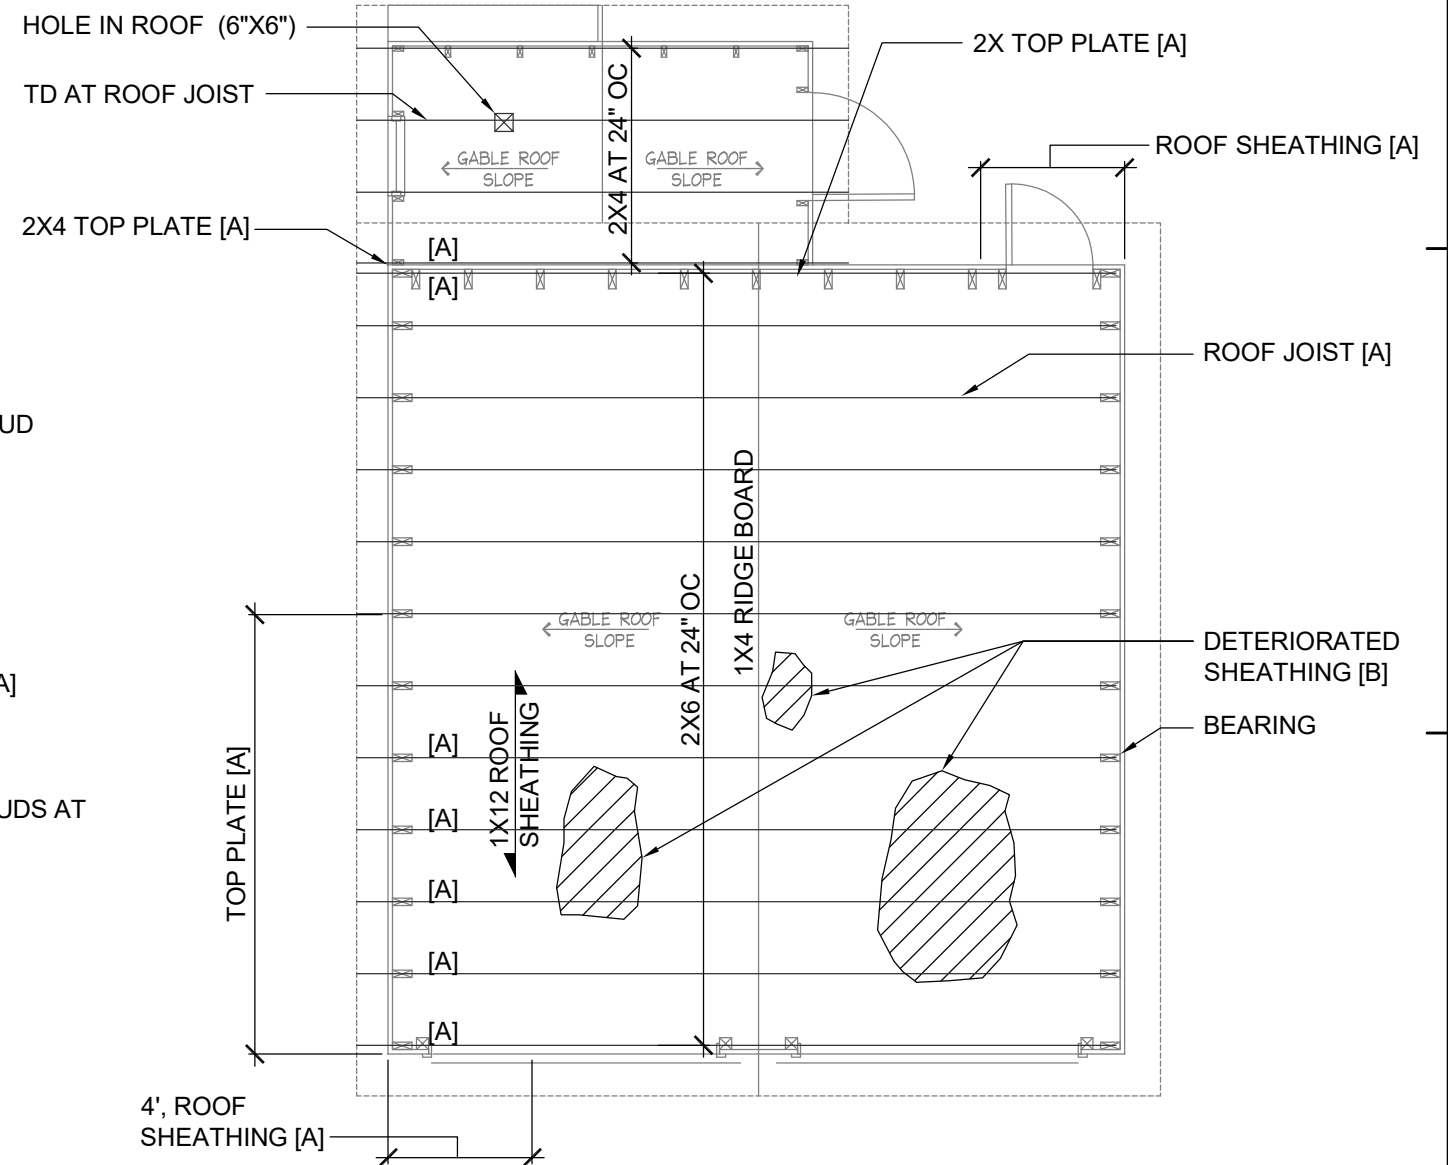
**DOUBLE GARAGE ROOF PLAN**

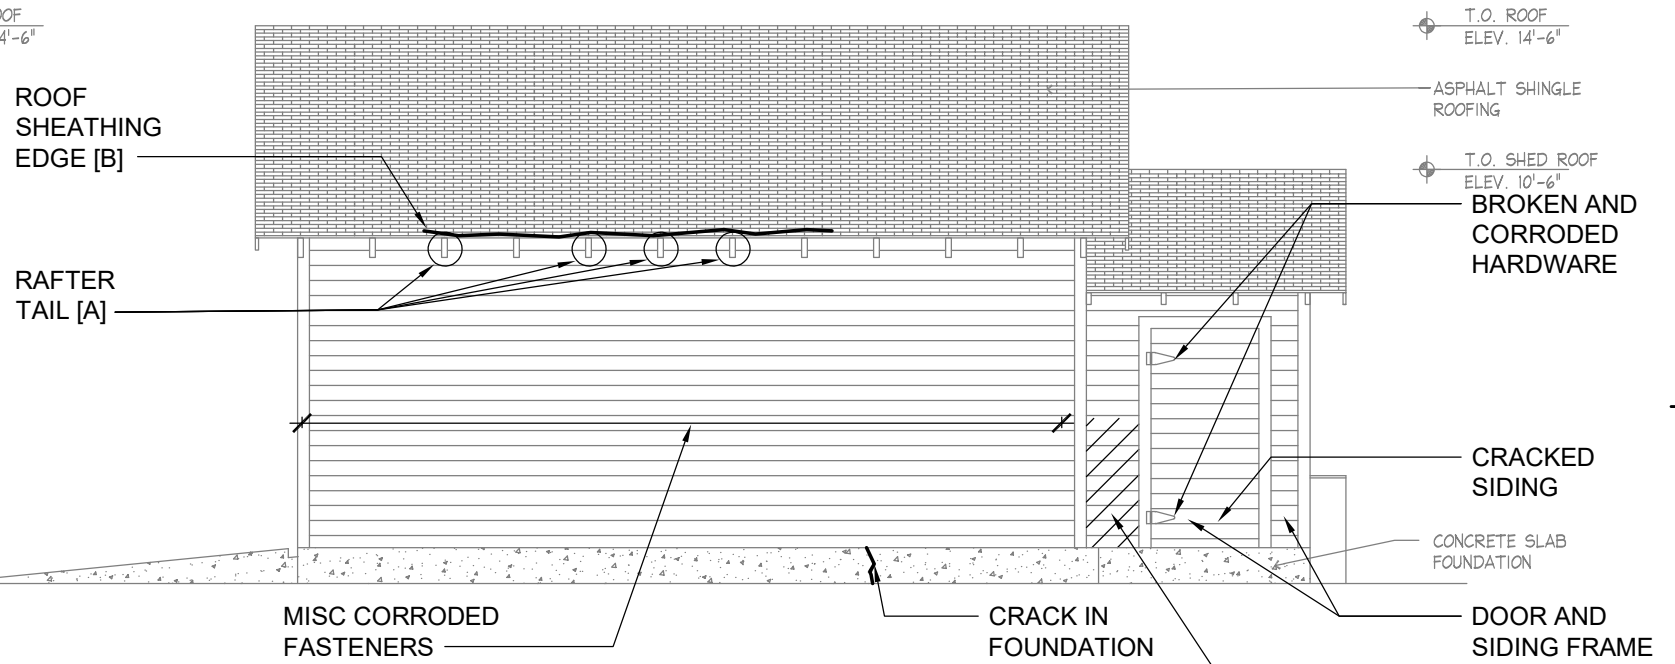
**DOUBLE GARAGE NORTH ELEVATION**  
SCALE: 3/16" = 1'-0"

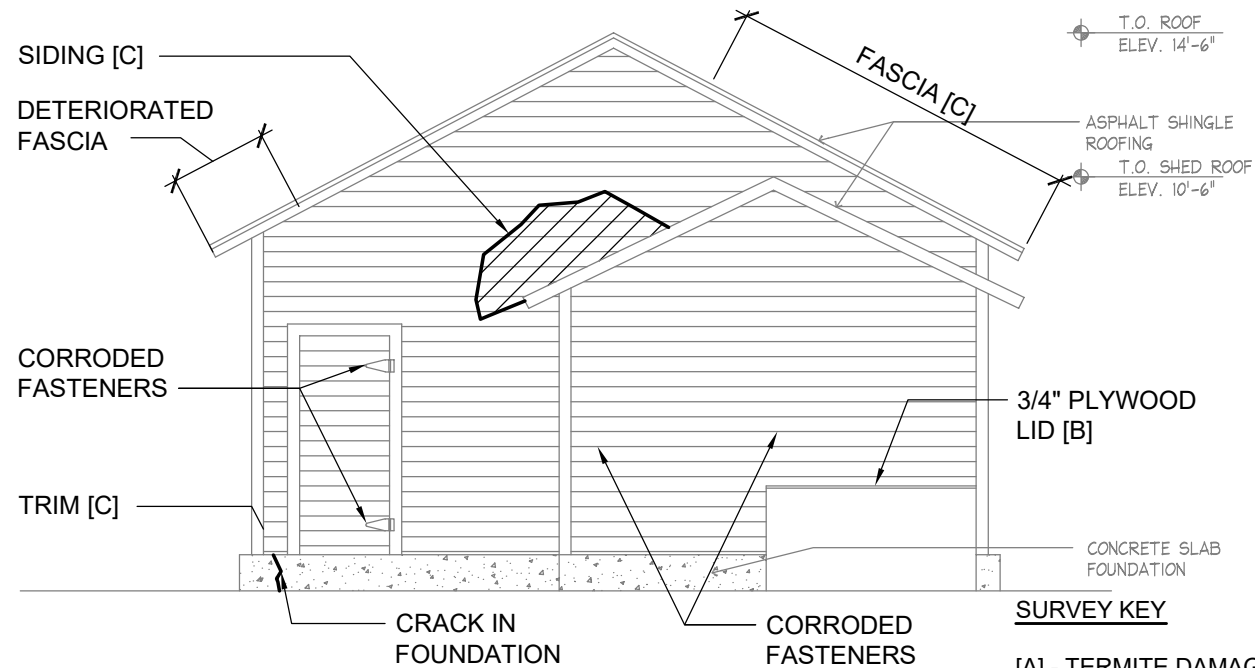
**DOUBLE GARAGE WEST ELEVATION**  
SCALE: 3/16" = 1'-0"

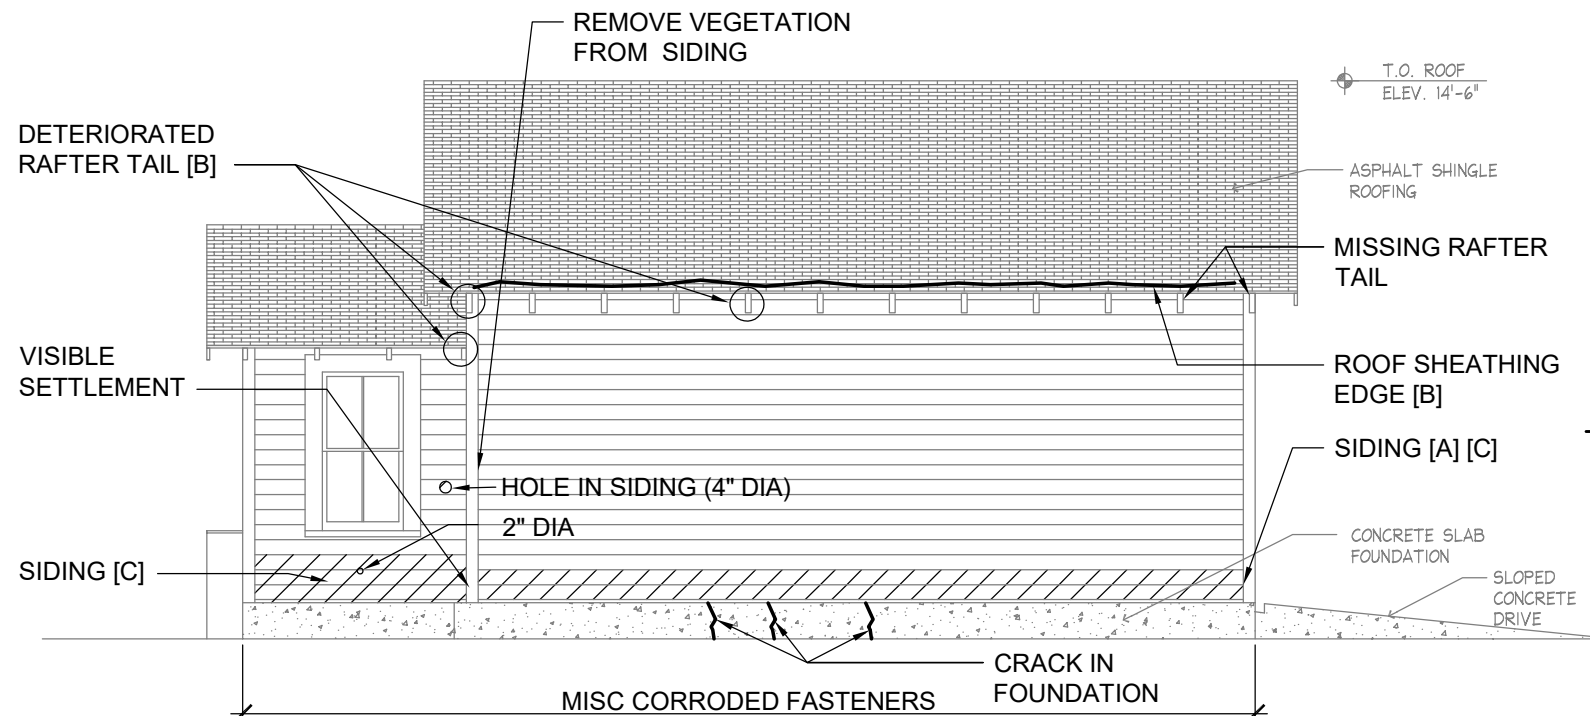
**DOUBLE GARAGE SOUTH ELEVATION**  
SCALE: 3/16" = 1'-0"

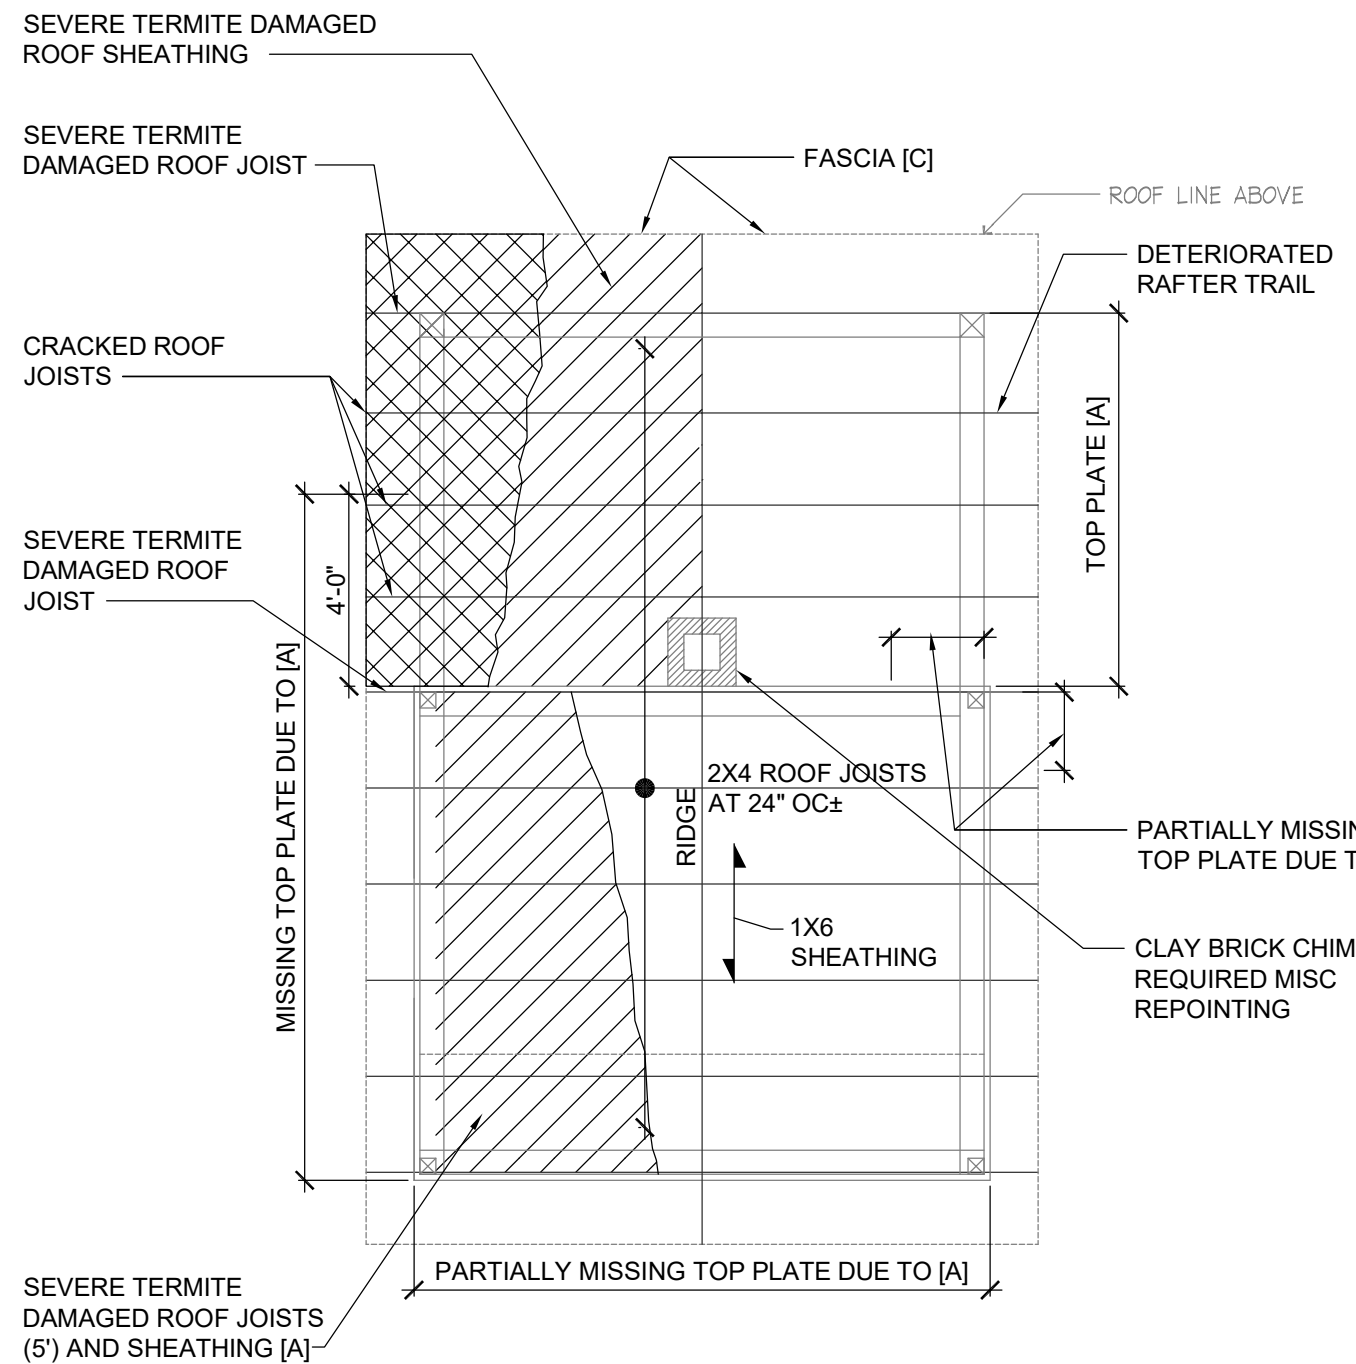
**FRYER SHED ROOF PLAN**  
SCALE: 1/4" = 1'-0"

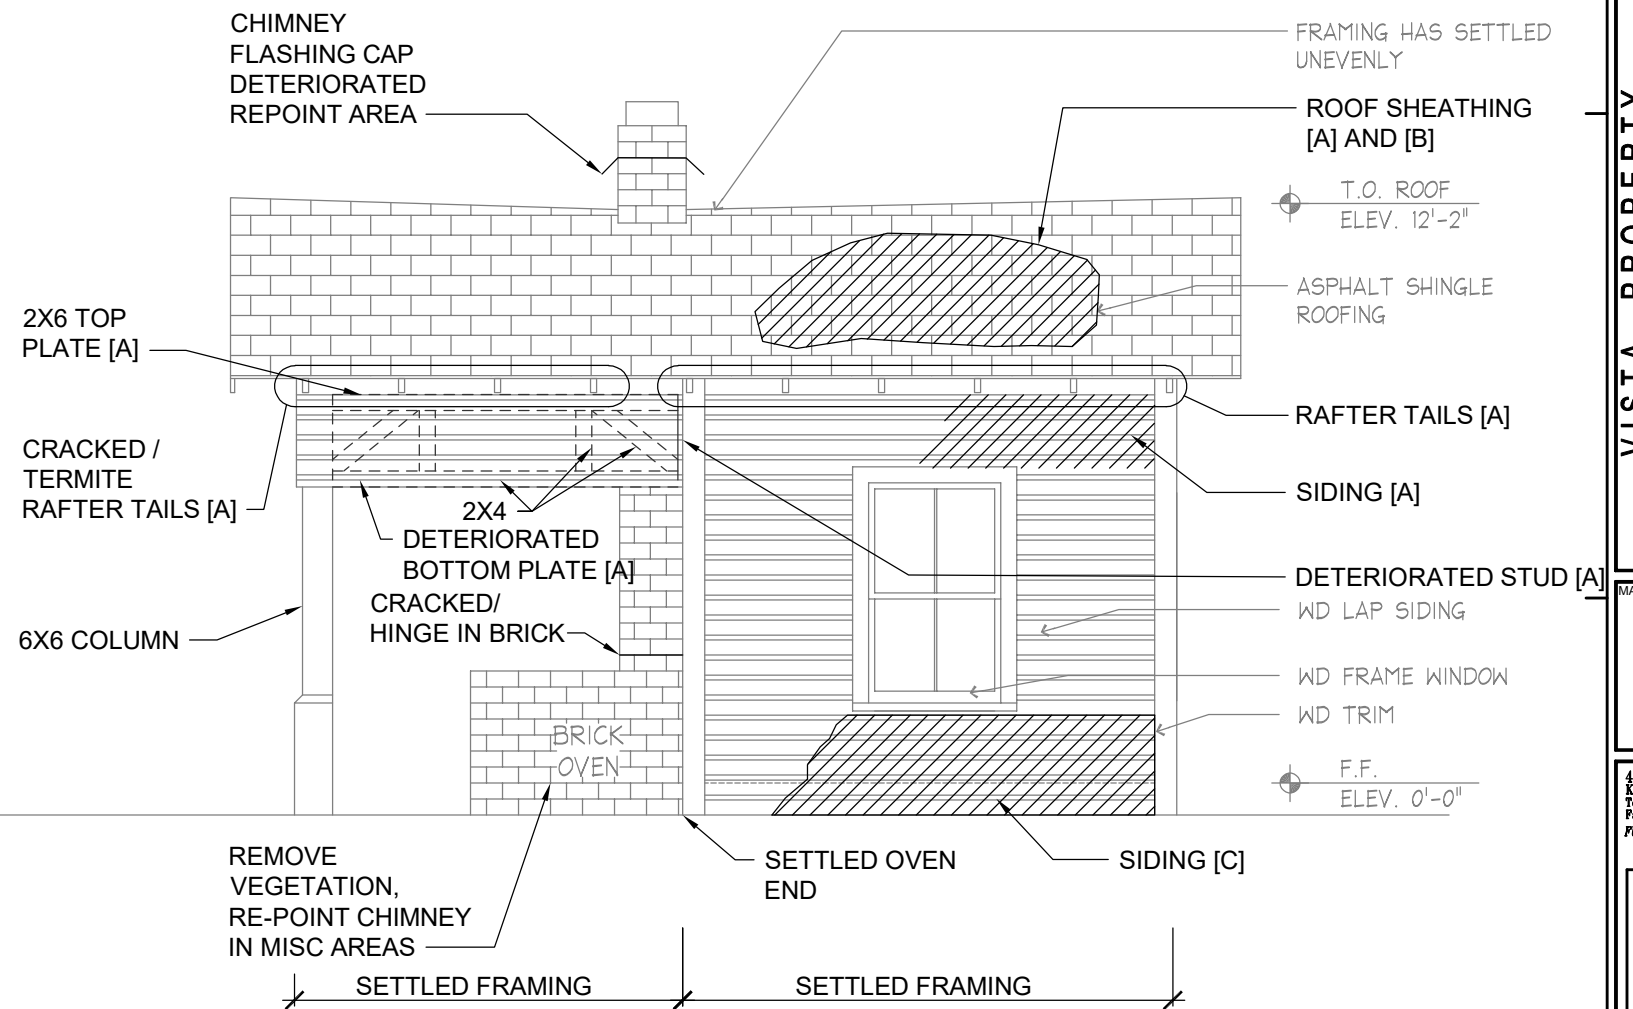
**FRYER SHED SOUTH ELEVATION**  
SCALE: 1/4" = 1'-0"

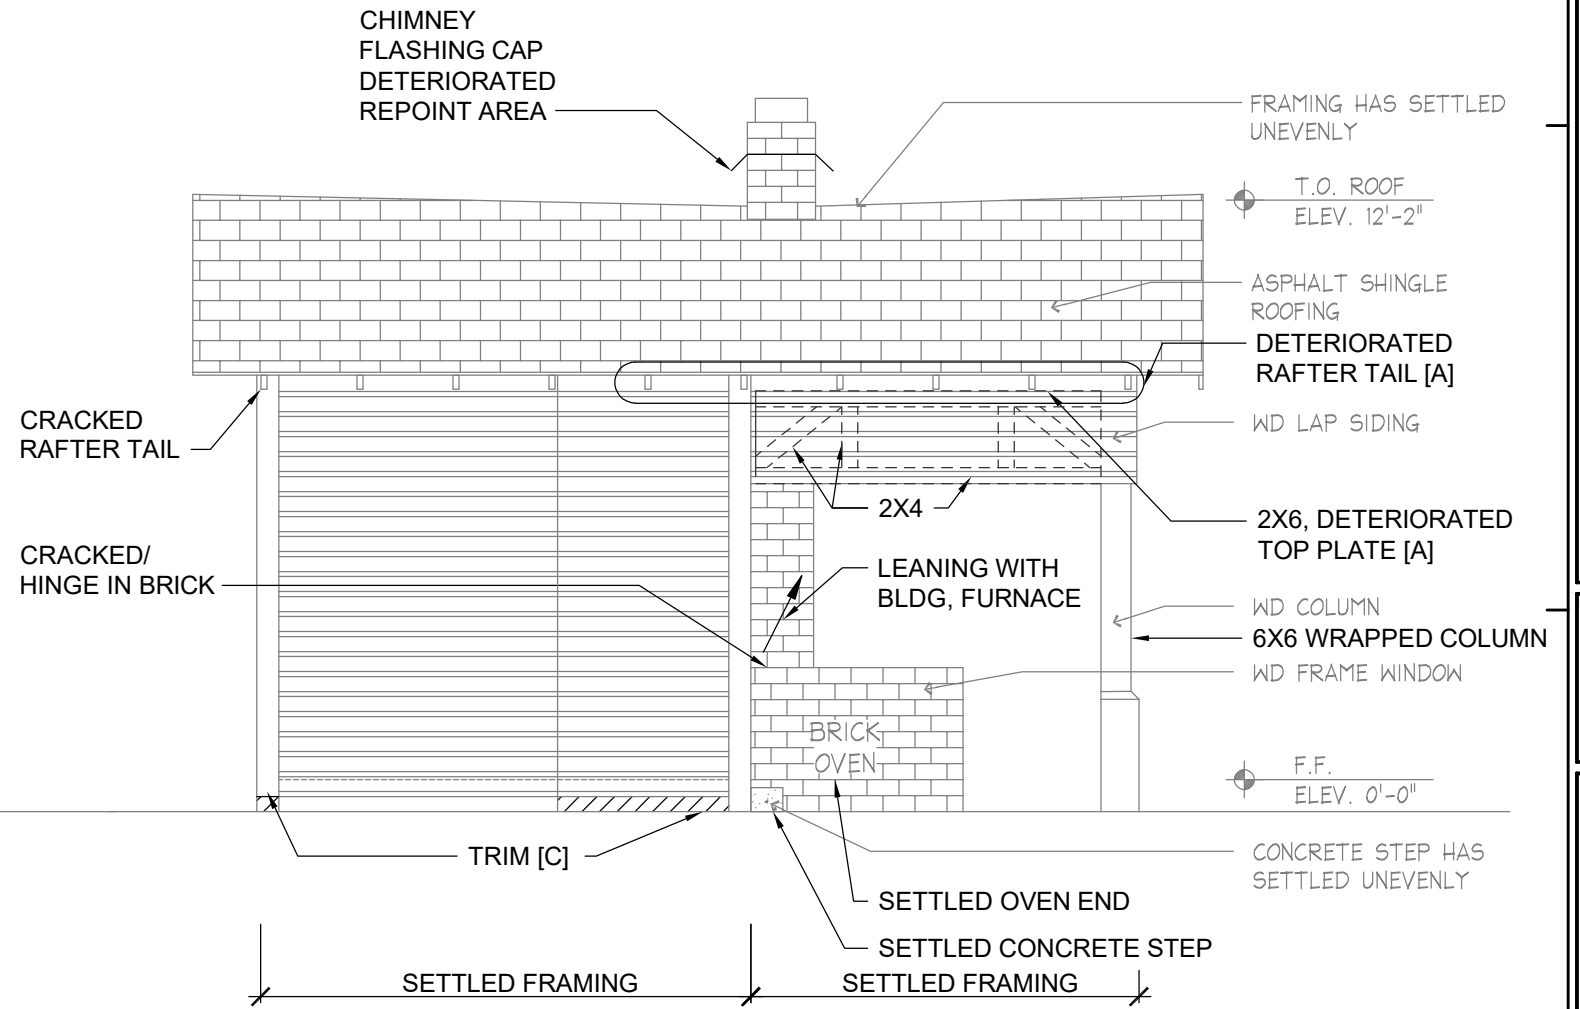
**FRYER SHED NORTH ELEVATION**  
SCALE: 1/4" = 1'-0"

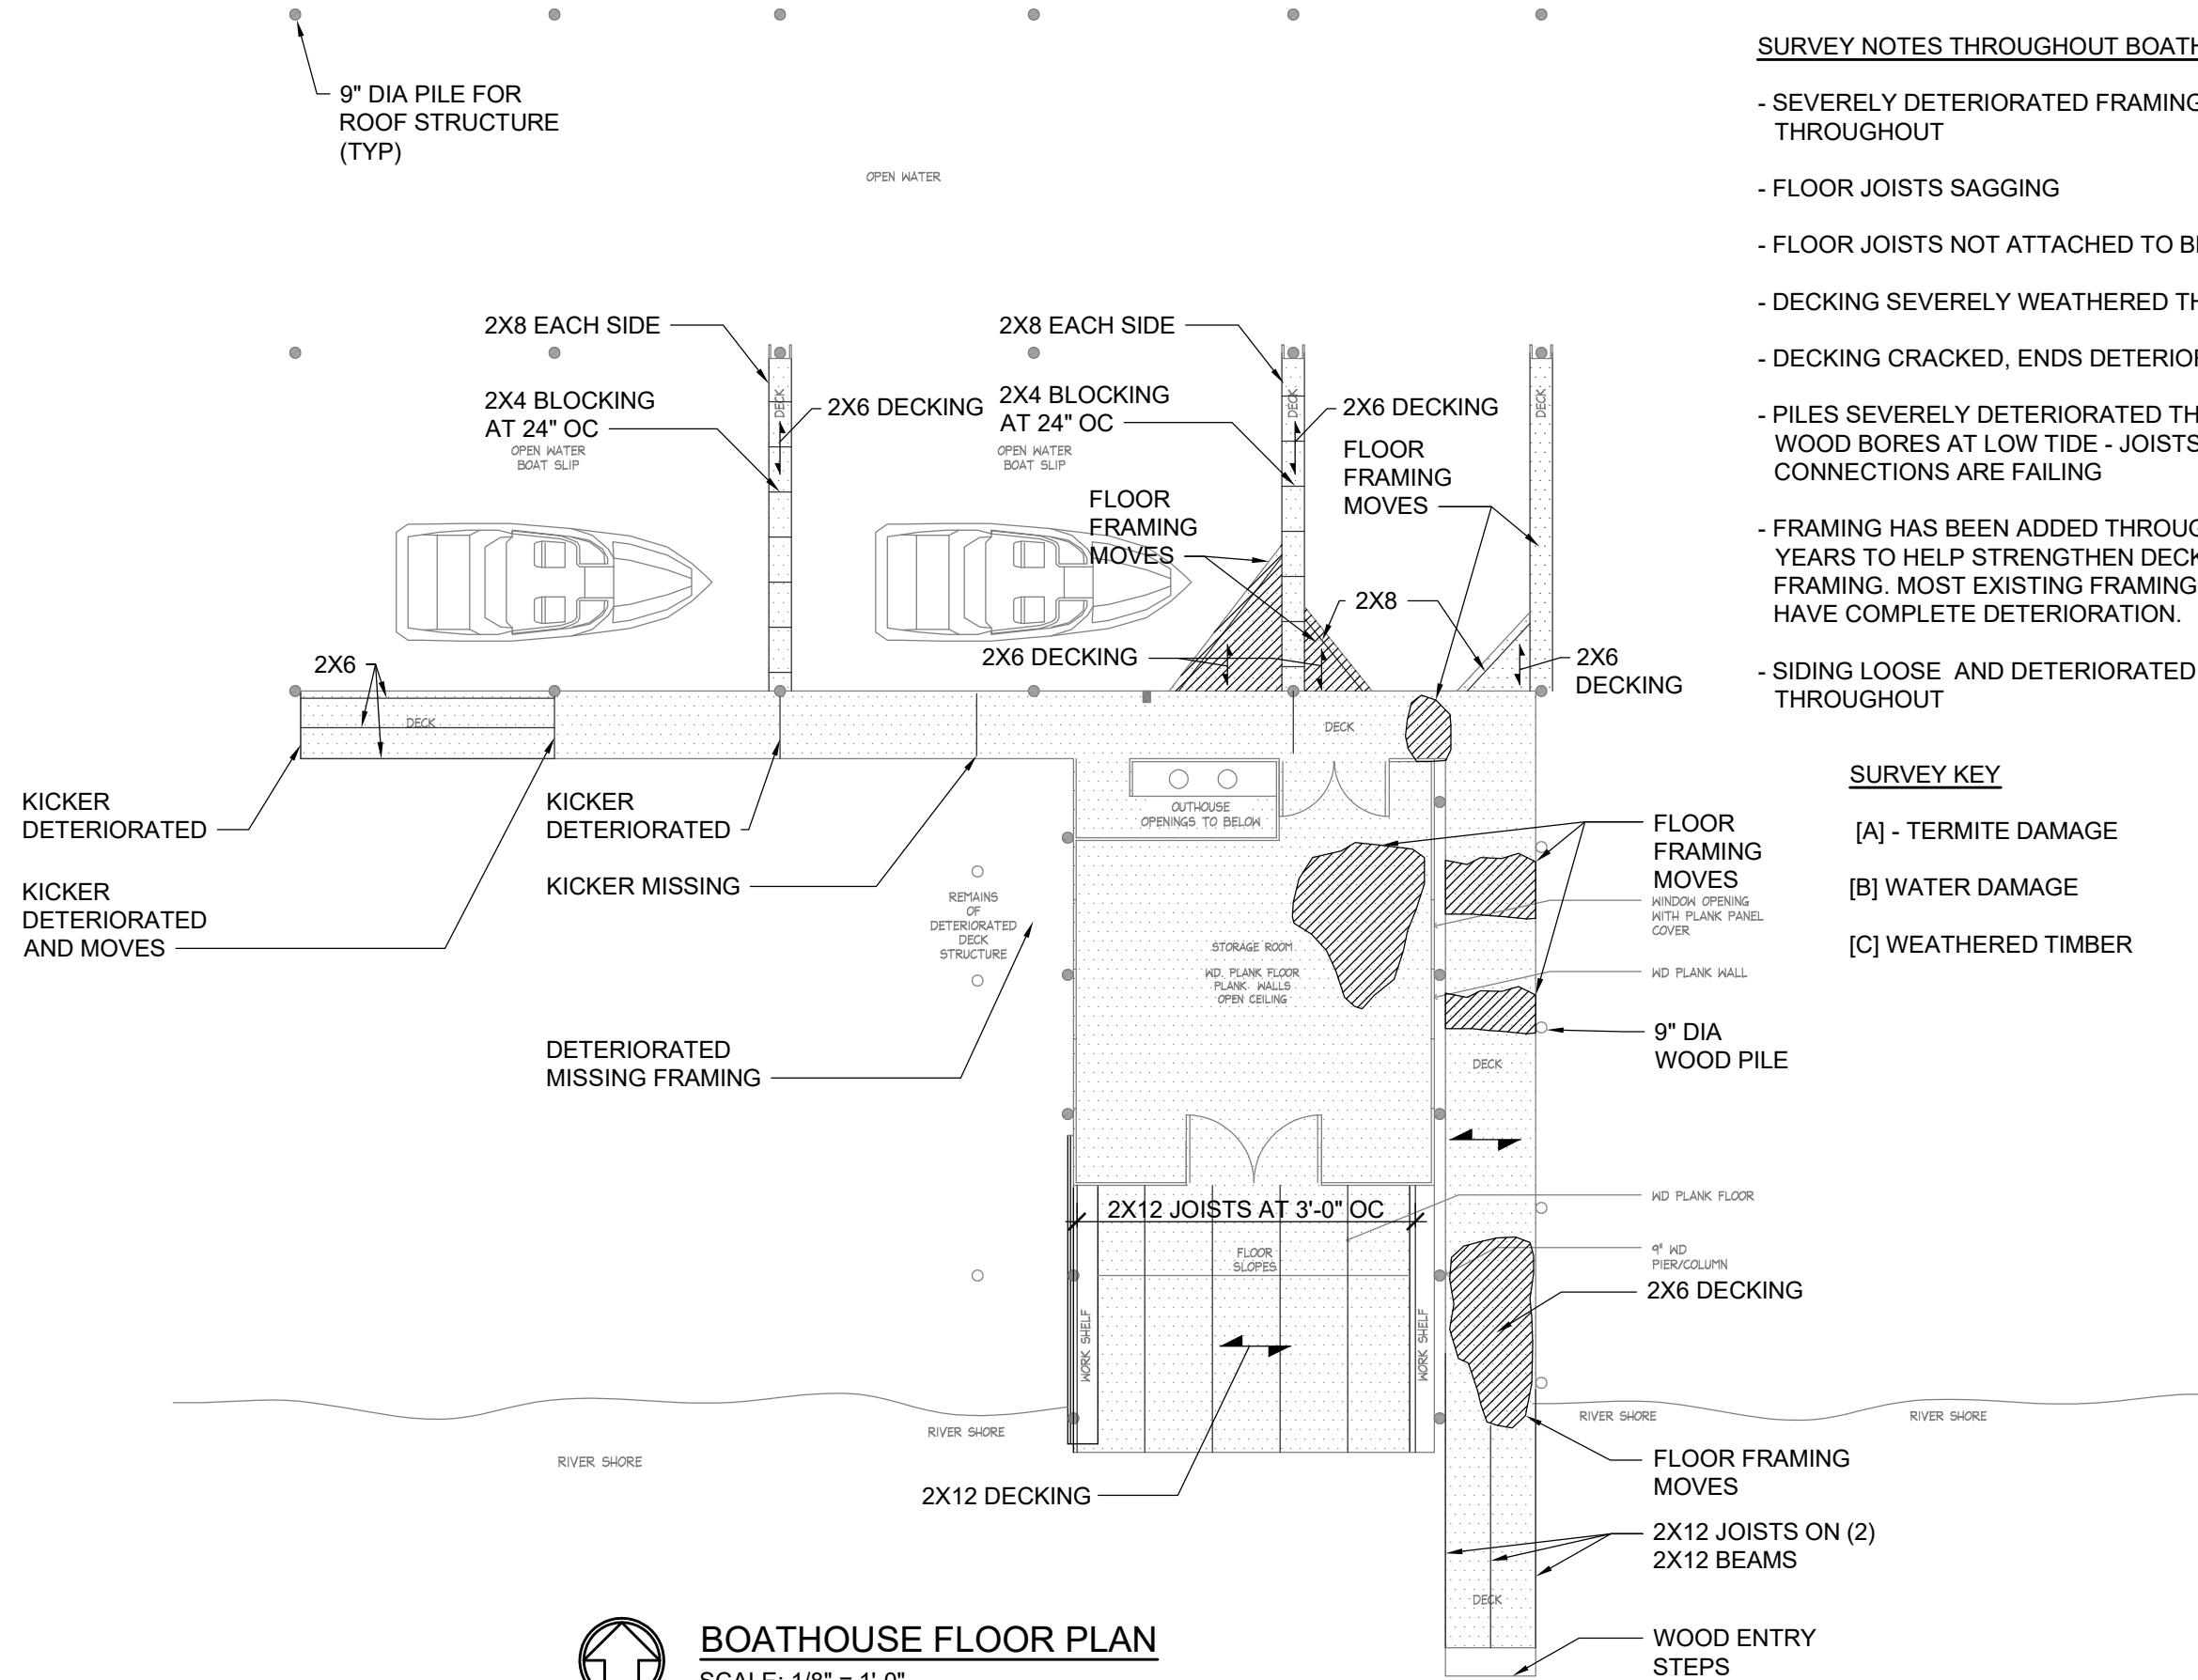
SURVEY NOTES THROUGHOUT BOATHOUSE
