# **HISTORIC STRUCTURE ASSESSMENT REPORT**

## **VISTA HISTORIC SITE Lower Suwannee National Wildlife Refuge**

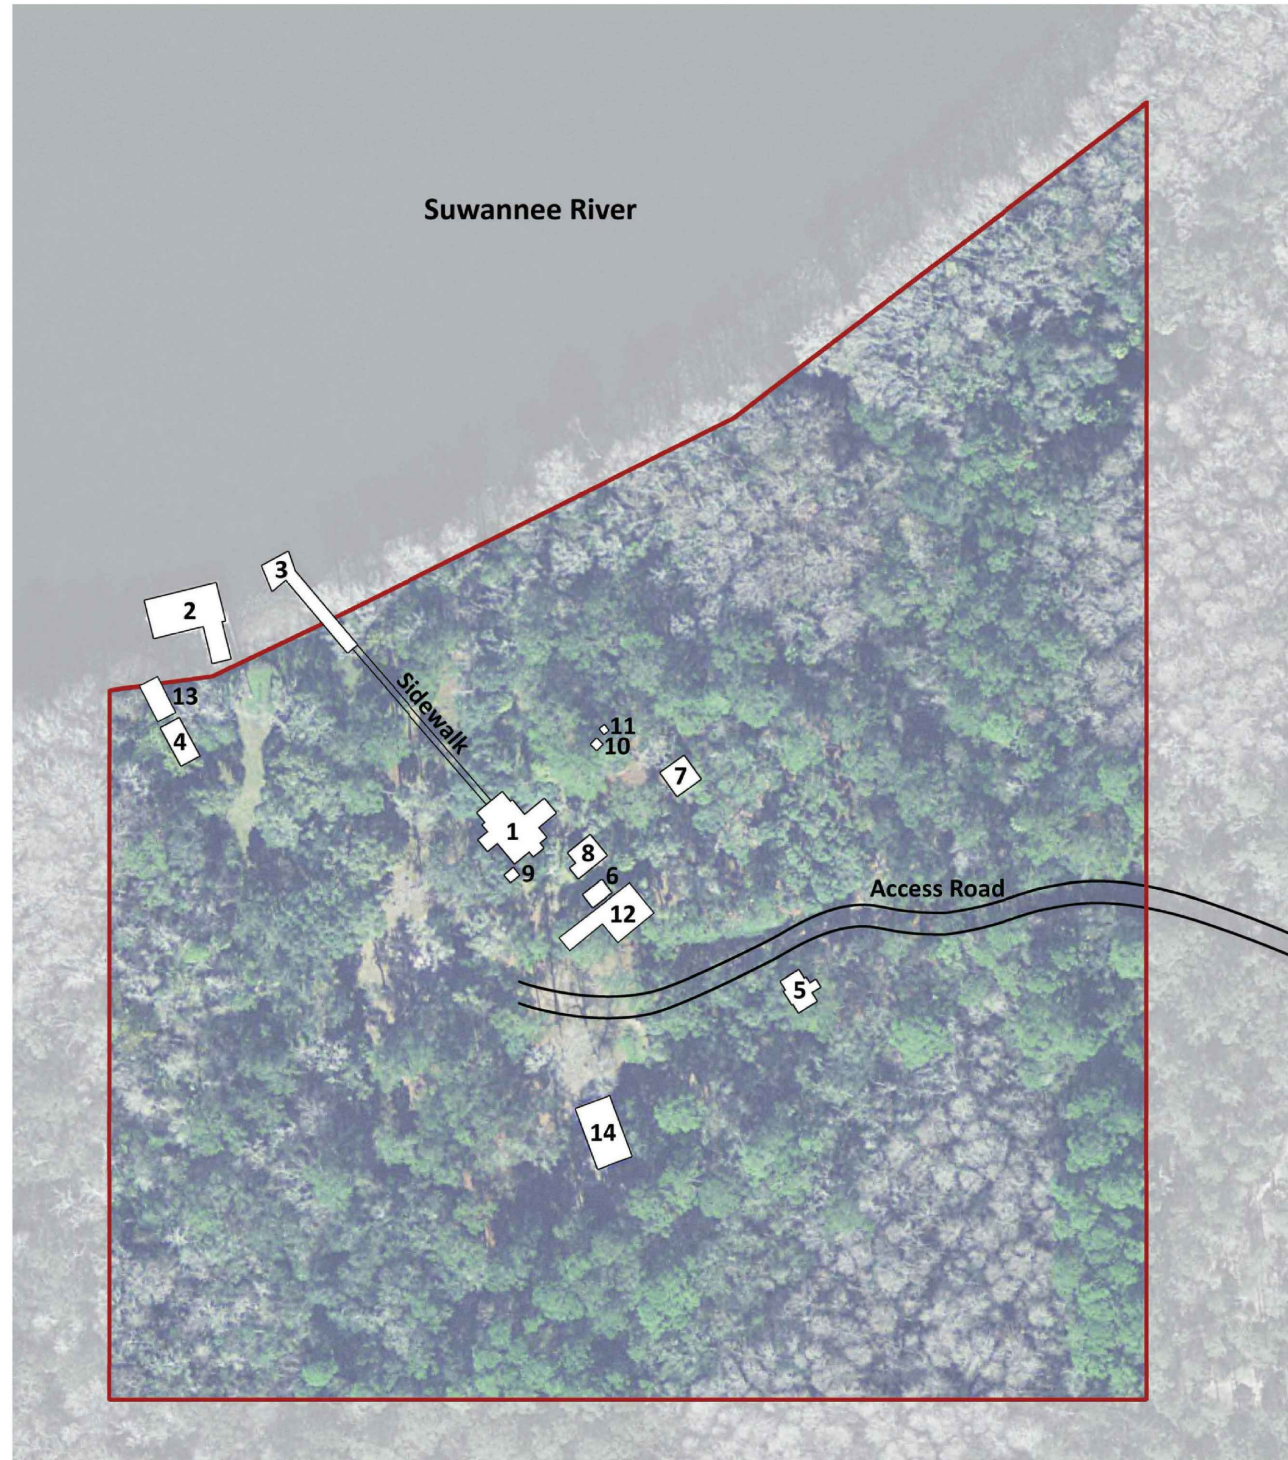
Site Map of Vista Property and Surrounding Area

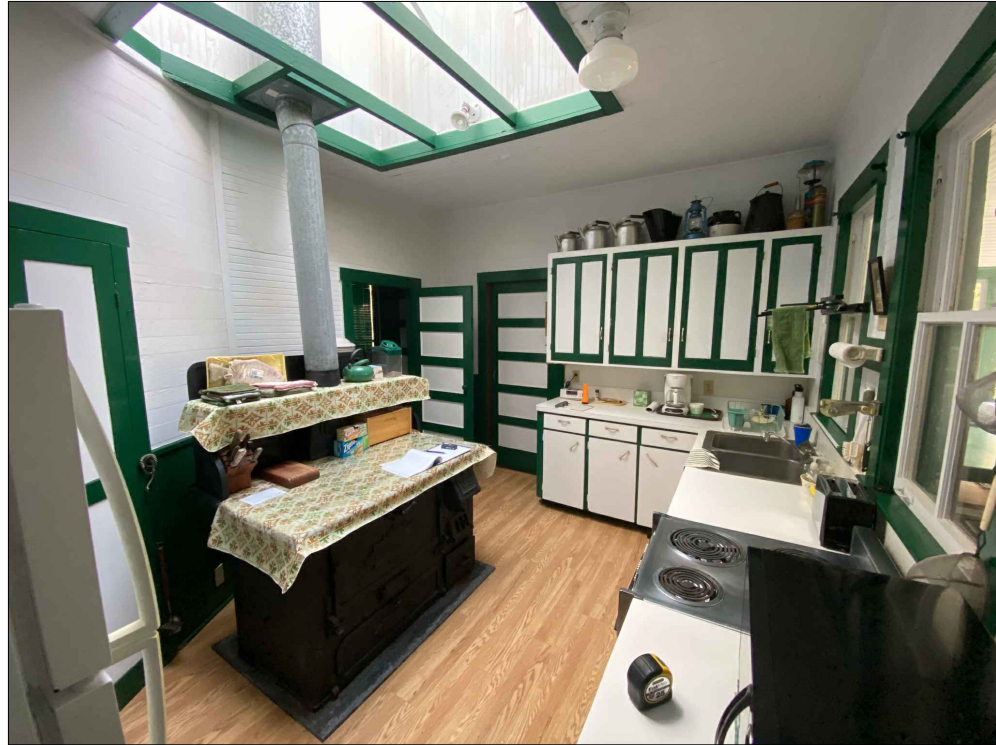
4 KITCHEN (DINING ROOM BEYOND)  
SCALE: N.T.S.

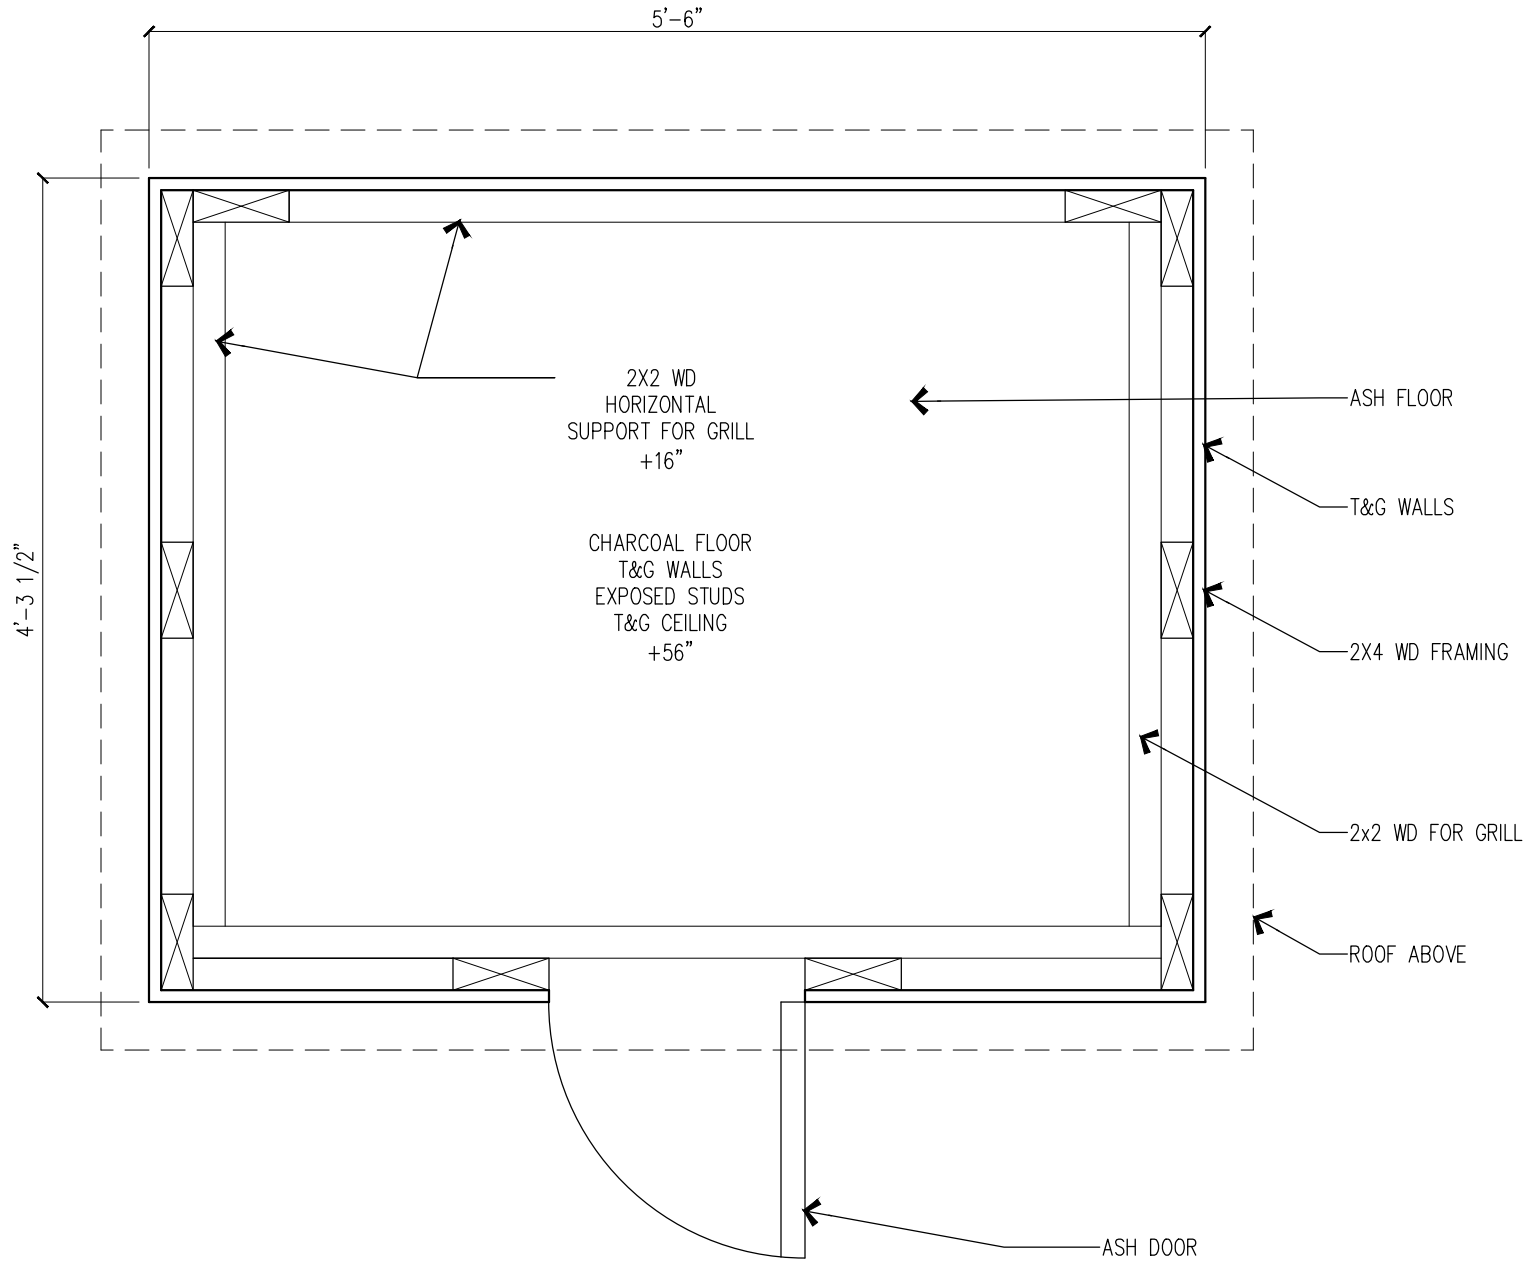
② SMOKER PLAN  
SCALE: 1" = 1'-0"

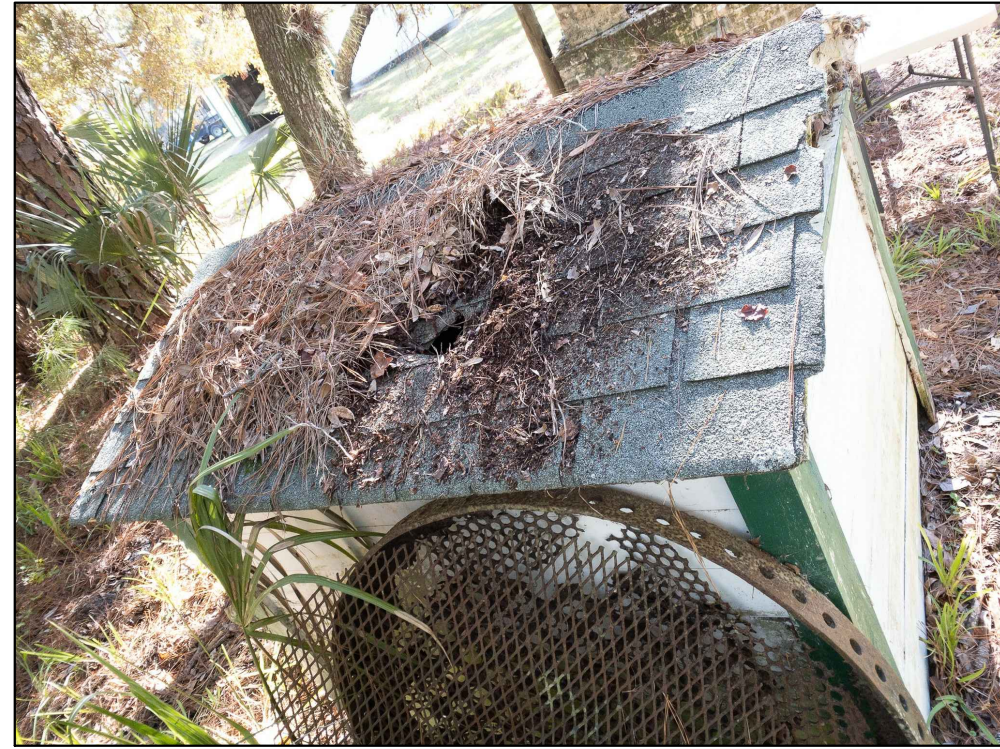
2 SMOKER ROOF DAMAGE (OYSTER GRILL IN FOREGROUND)  
SCALE: N. T. S.

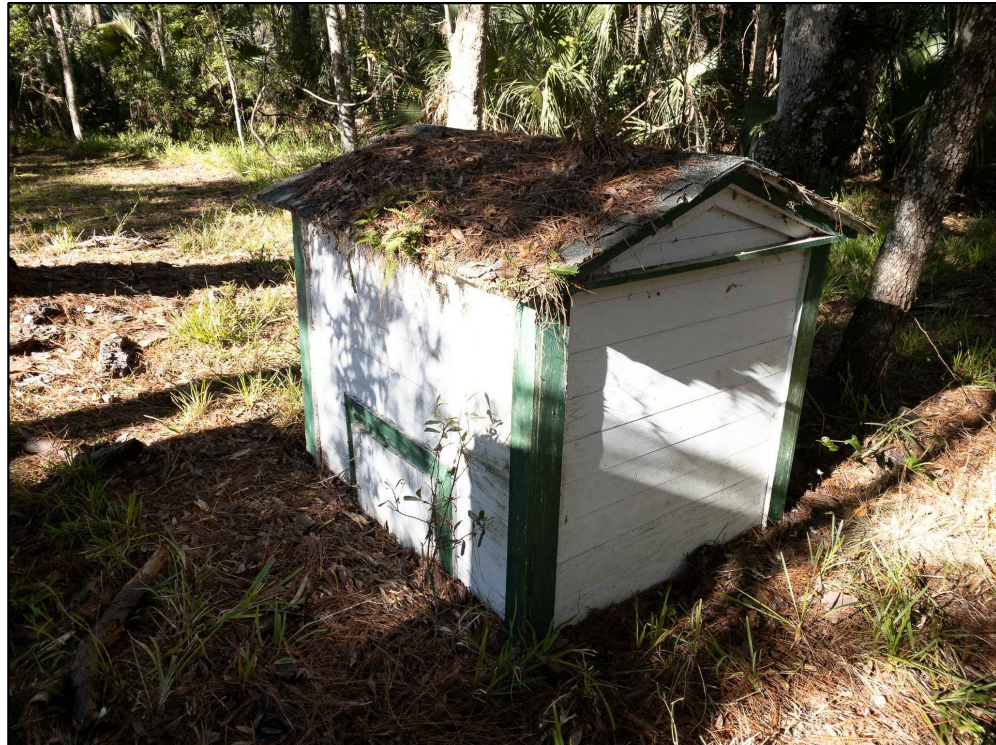
3 SMOKER OBLIQUE (SOUTHWEST)  
SCALE: N. T. S.

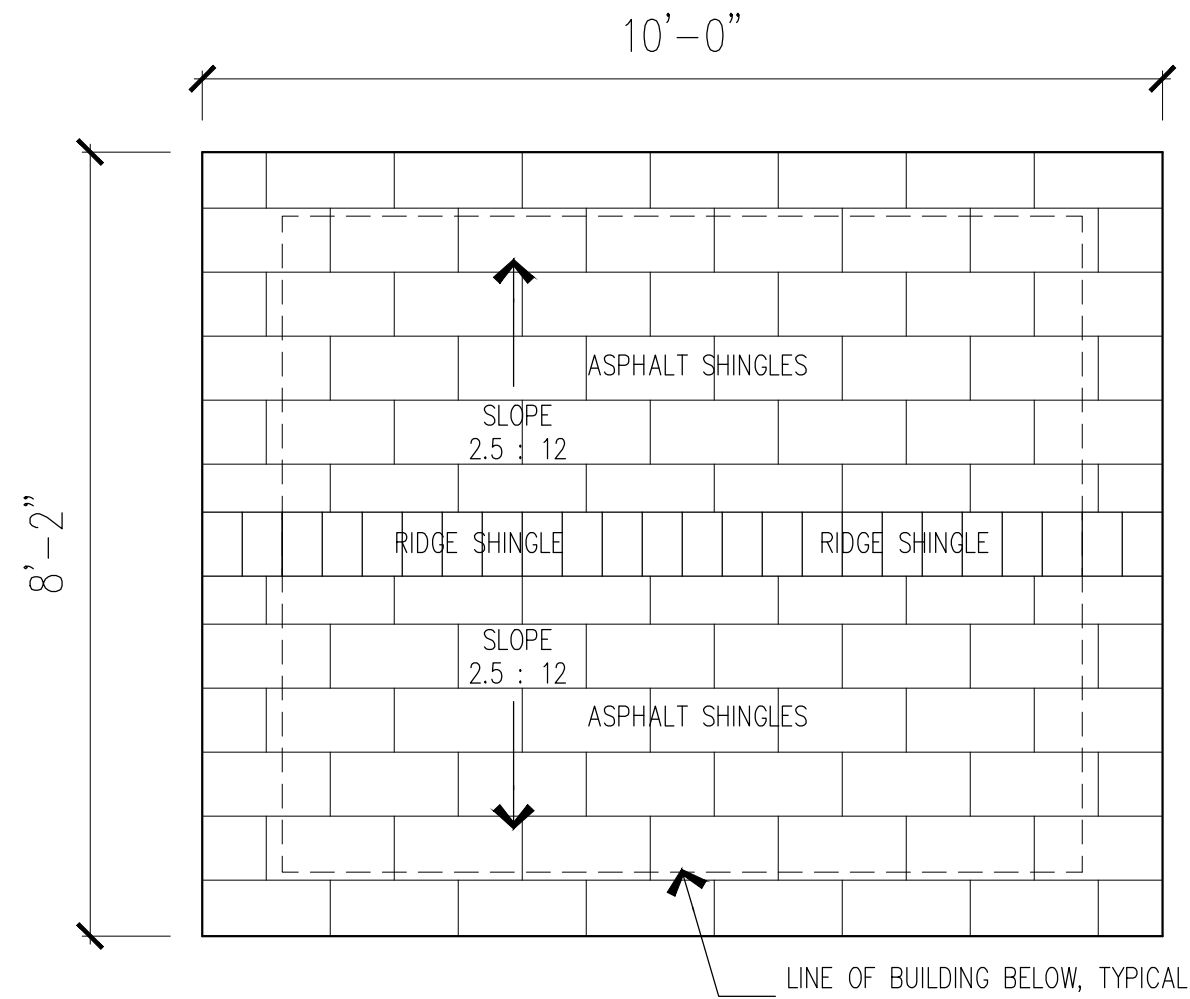
2 WOODSHED ROOF PLAN  
SCALE: 1/2" = 1'-0"

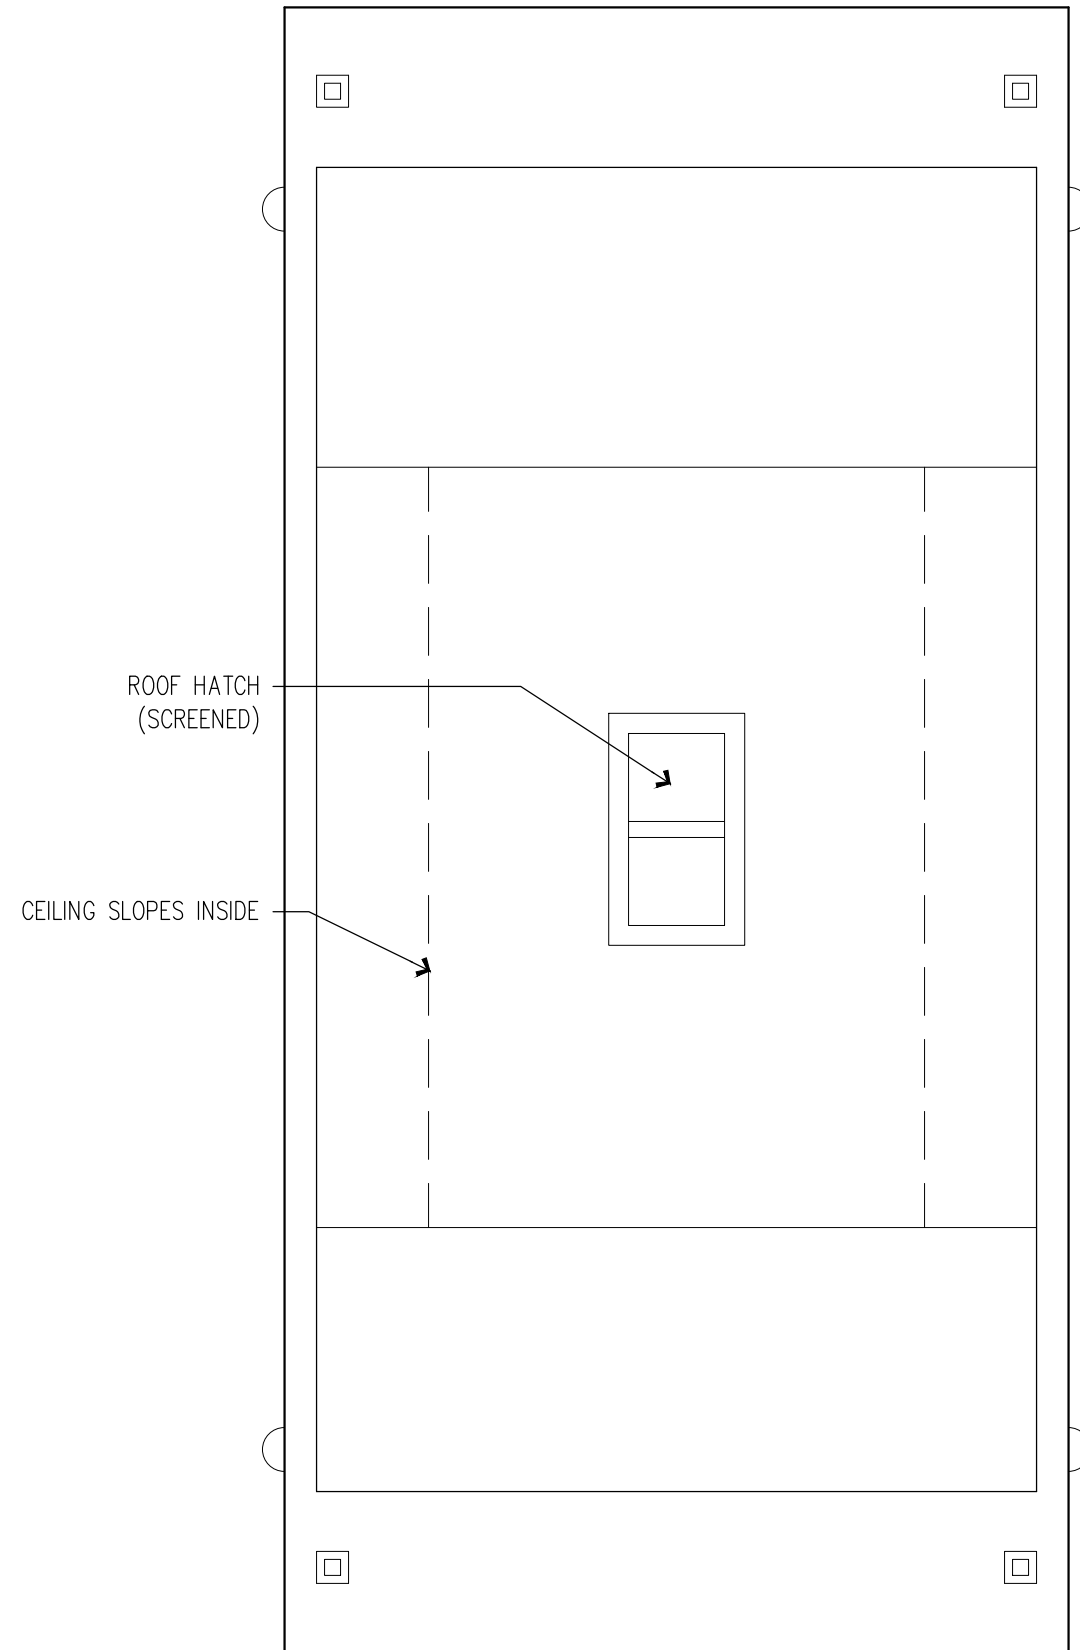
2 HOUSEBOAT ROOF PLAN  
SCALE: 1/4" = 1'-0"

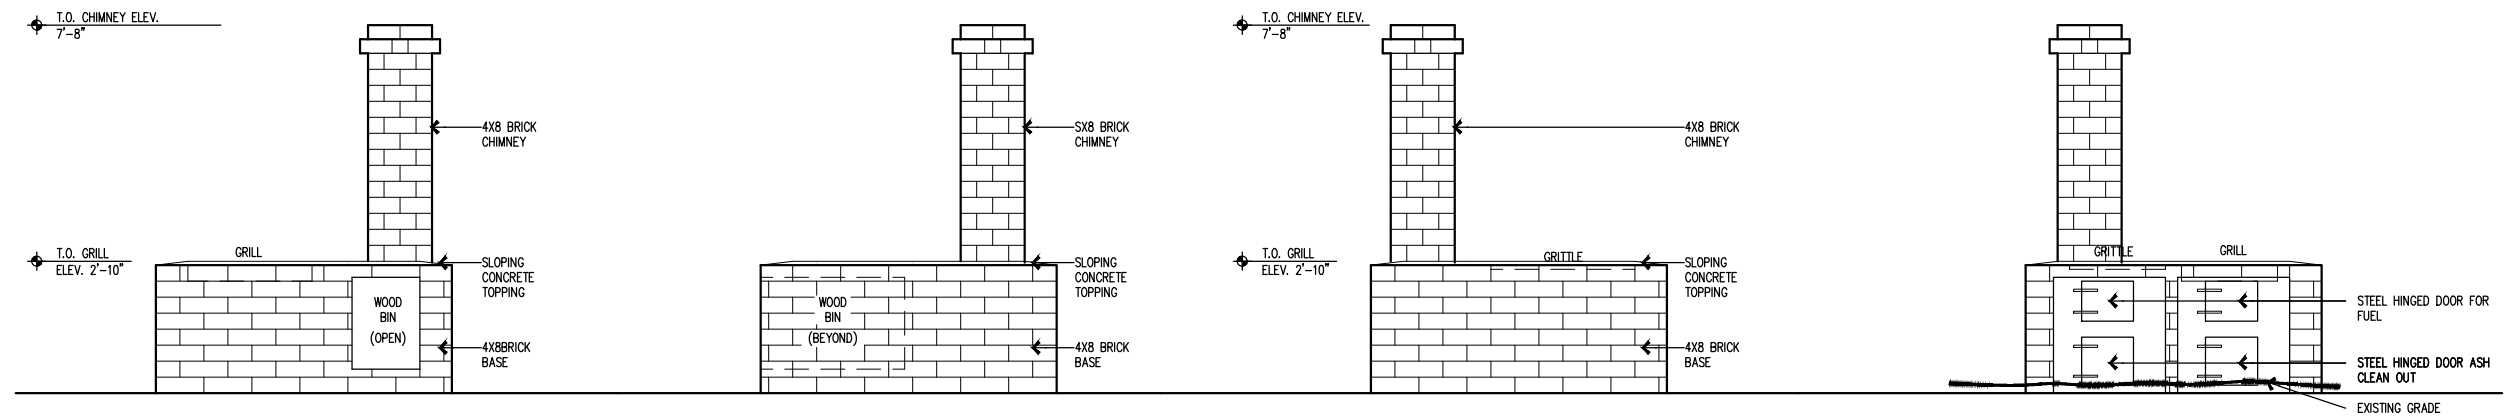
5 RIGHT ELEV  
SCALE: 1/2" = 1'-0"

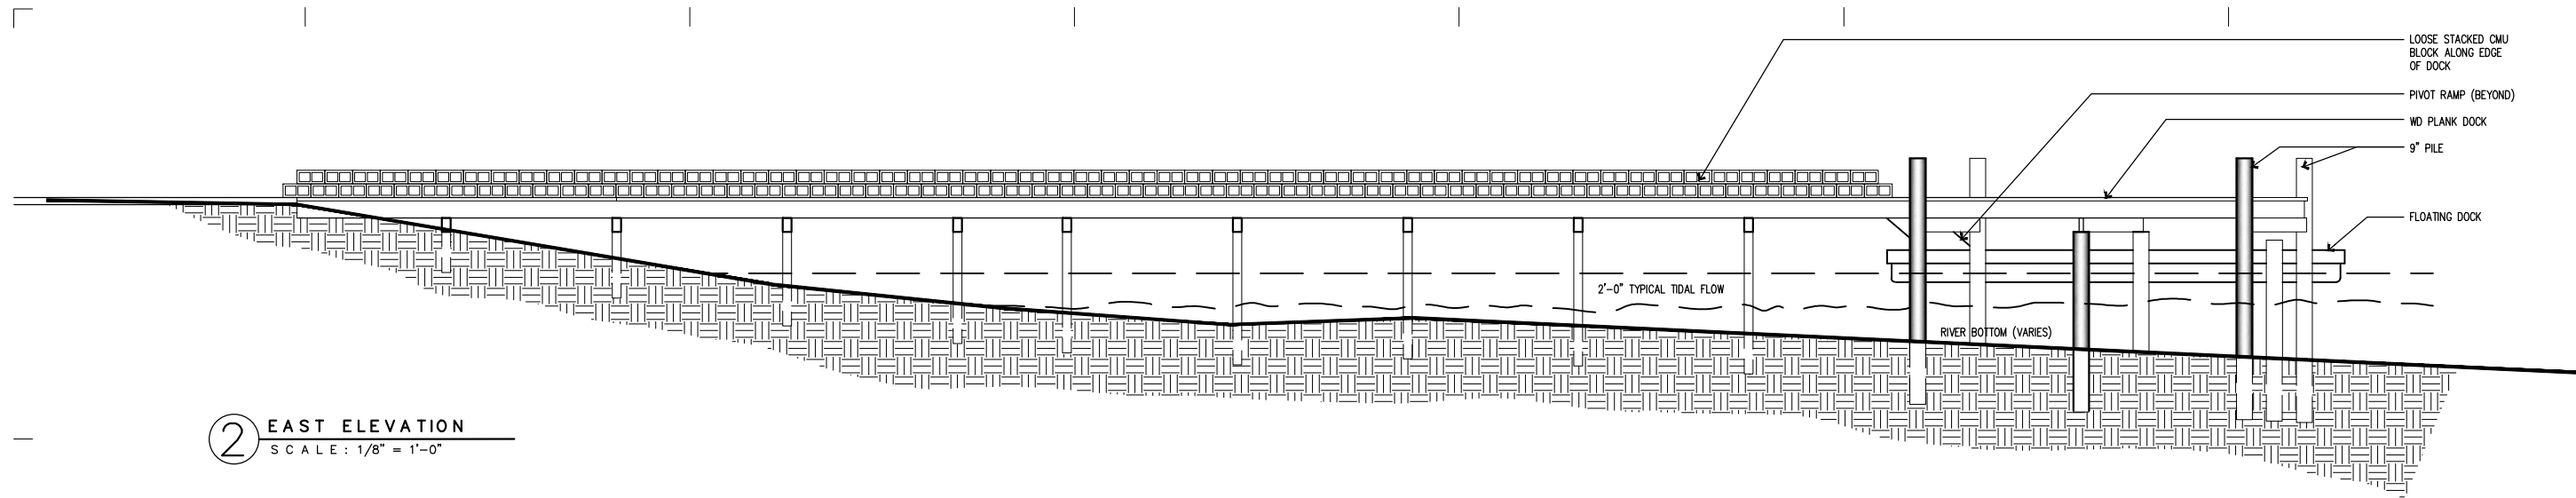
**2 EAST ELEVATION**  
SCALE: 1/8" = 1'-0"

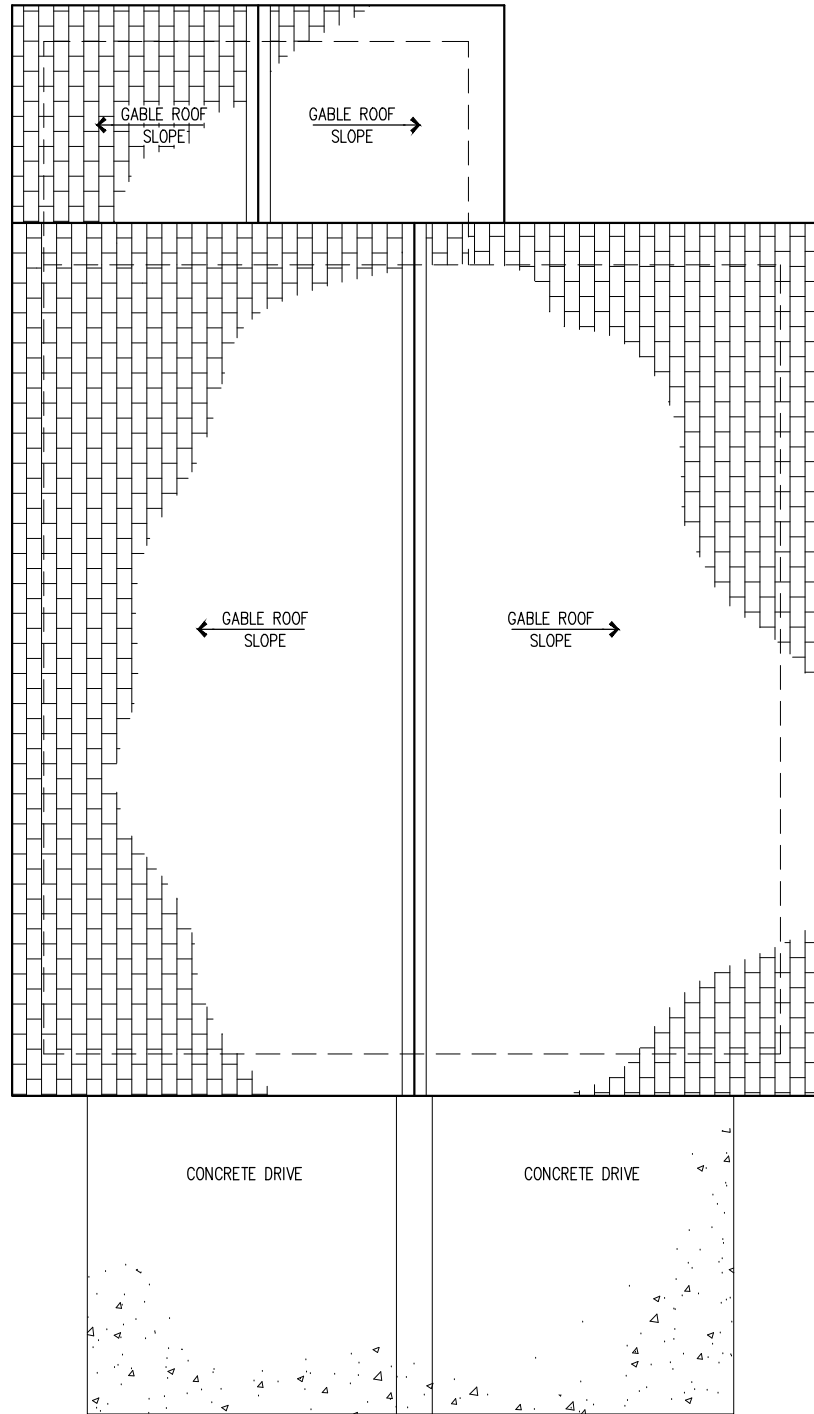
**2** DOUBLE GARAGE ROOF PLAN  
SCALE: 3/16" = 1'-0"

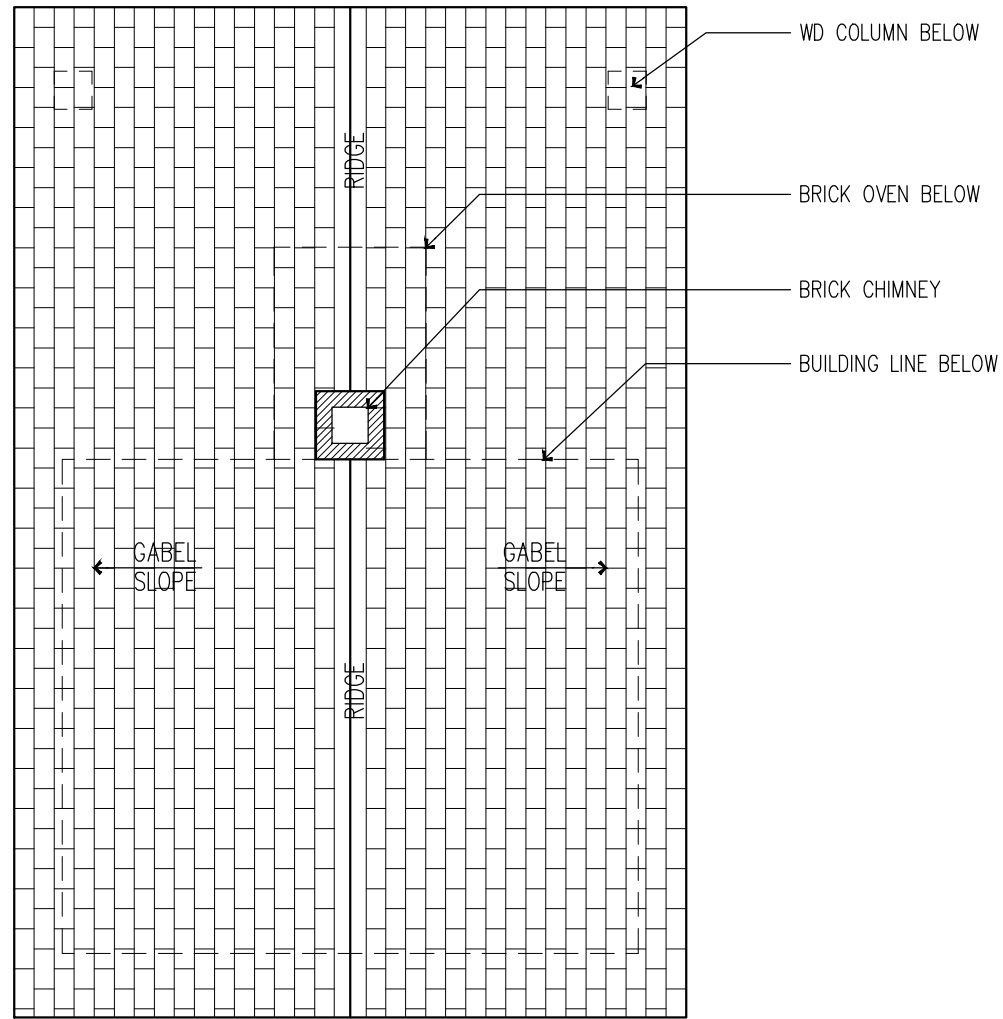
2 FRYER SHED ROOF PLAN  
SCALE: 1/4" = 1'-0"
